RESPONSE TO DEFERRAL OF DA FROM SYDNEY WEST CENTRAL PLANNING PANEL (2016SYW116)
PROPOSED BUNNINGS DEVELOPMENT (DA 2016/171)
1-15 STURT STREET, SMITHFIELD

Annexure Two: "Hazardous Building Materials Assessment", prepared by EIS, dated 17 March 2017, Ref: E27497Krpt-HAZ.rev1

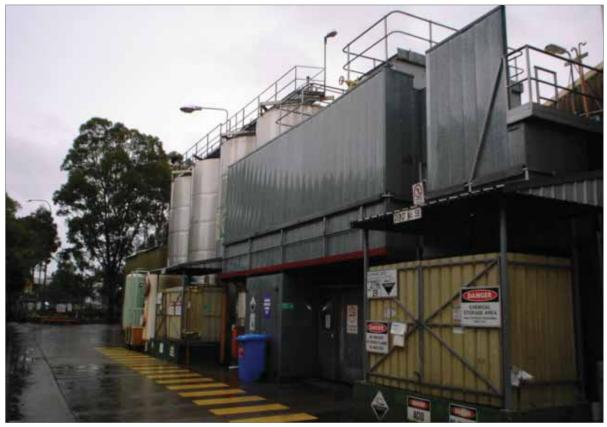
Plate 2: former chemical storage area in the north-western section of the site (20/4/2015).

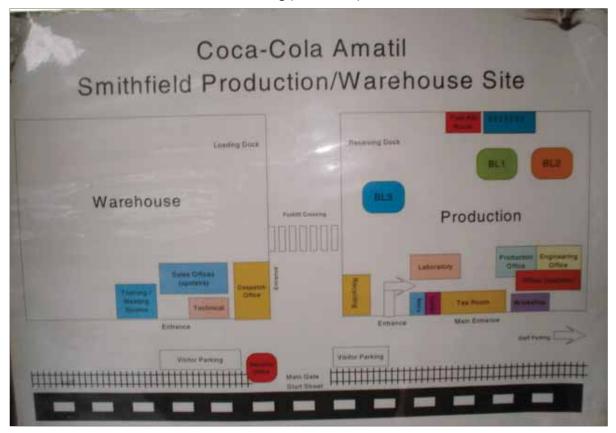
Plate 4: internal diagram showing the location of various site processes during the site's use by Coca-Cola Amatil (20/4/15).

During the 2015 assessment the site was being used by Coca Cola Amatil. The production building contained a receiving dock, first aid room and bottling machinery along the western wall and a laboratory, tea room, workshop, toilets and offices along the eastern wall. A number of above ground petroleum gas and chemical storage tanks were located in the north-west corner of the building and within the central loading area. Hazardous goods storage areas were located at a number of locations throughout the building. The warehouse building consisted of a large open storage area with a sales office, training room, technical office and despatch office in the north-eastern corner of the building.

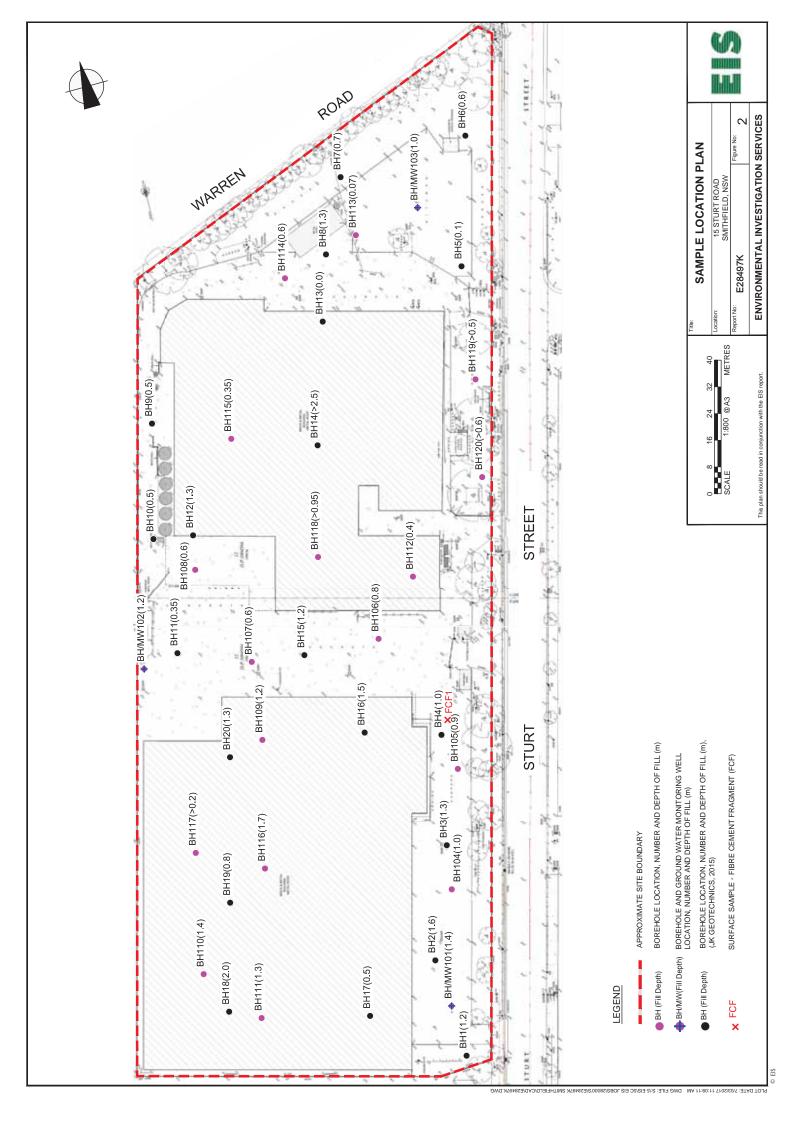
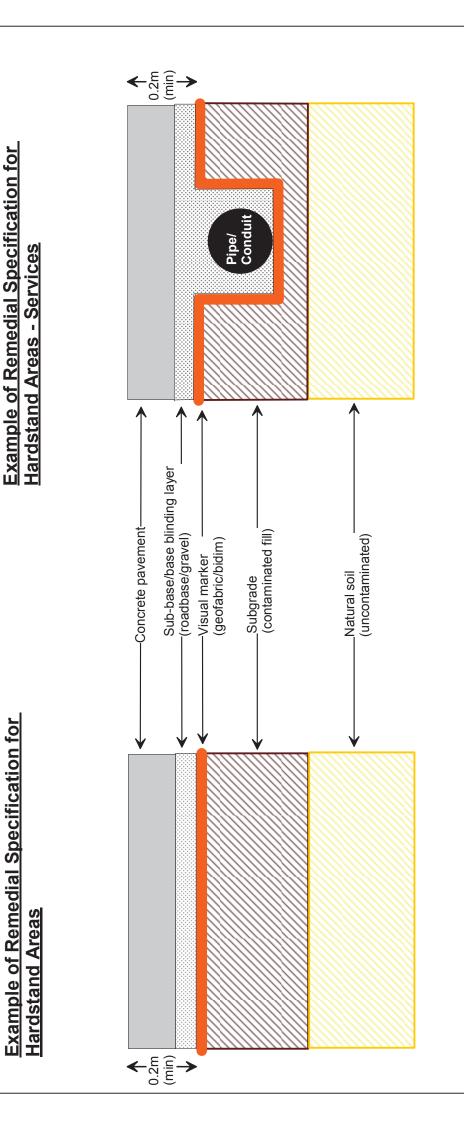
Froject Number: Title: CAPPING SPECIFICATION, HARDSTAND AREAS AND SERVICES

NOTES: Sketch is indicative only. Not to scale.

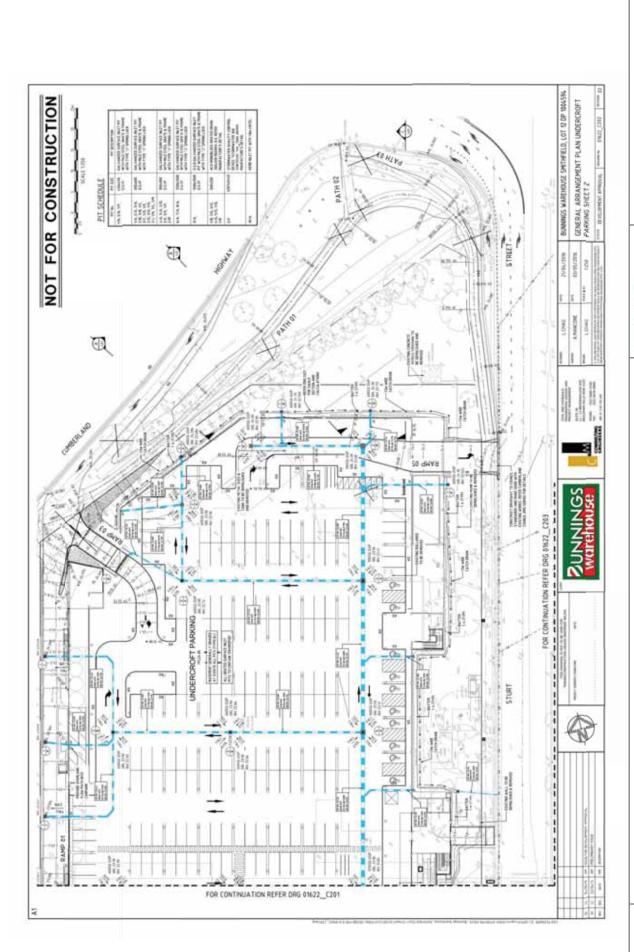
Proposed Development Plan North Section 15 Sturt Street, Smithfield
