SUBJECT: Phase 2 Environmental Assessment Addendum - Soil Delineation Sampling
SITE: 60 - 80 Edmondson Avenue, Austral NSW

Phase 2 Environmental Site Assessment Addendum
60 - 80 Edmondson Avenue
Austral, New South Wales

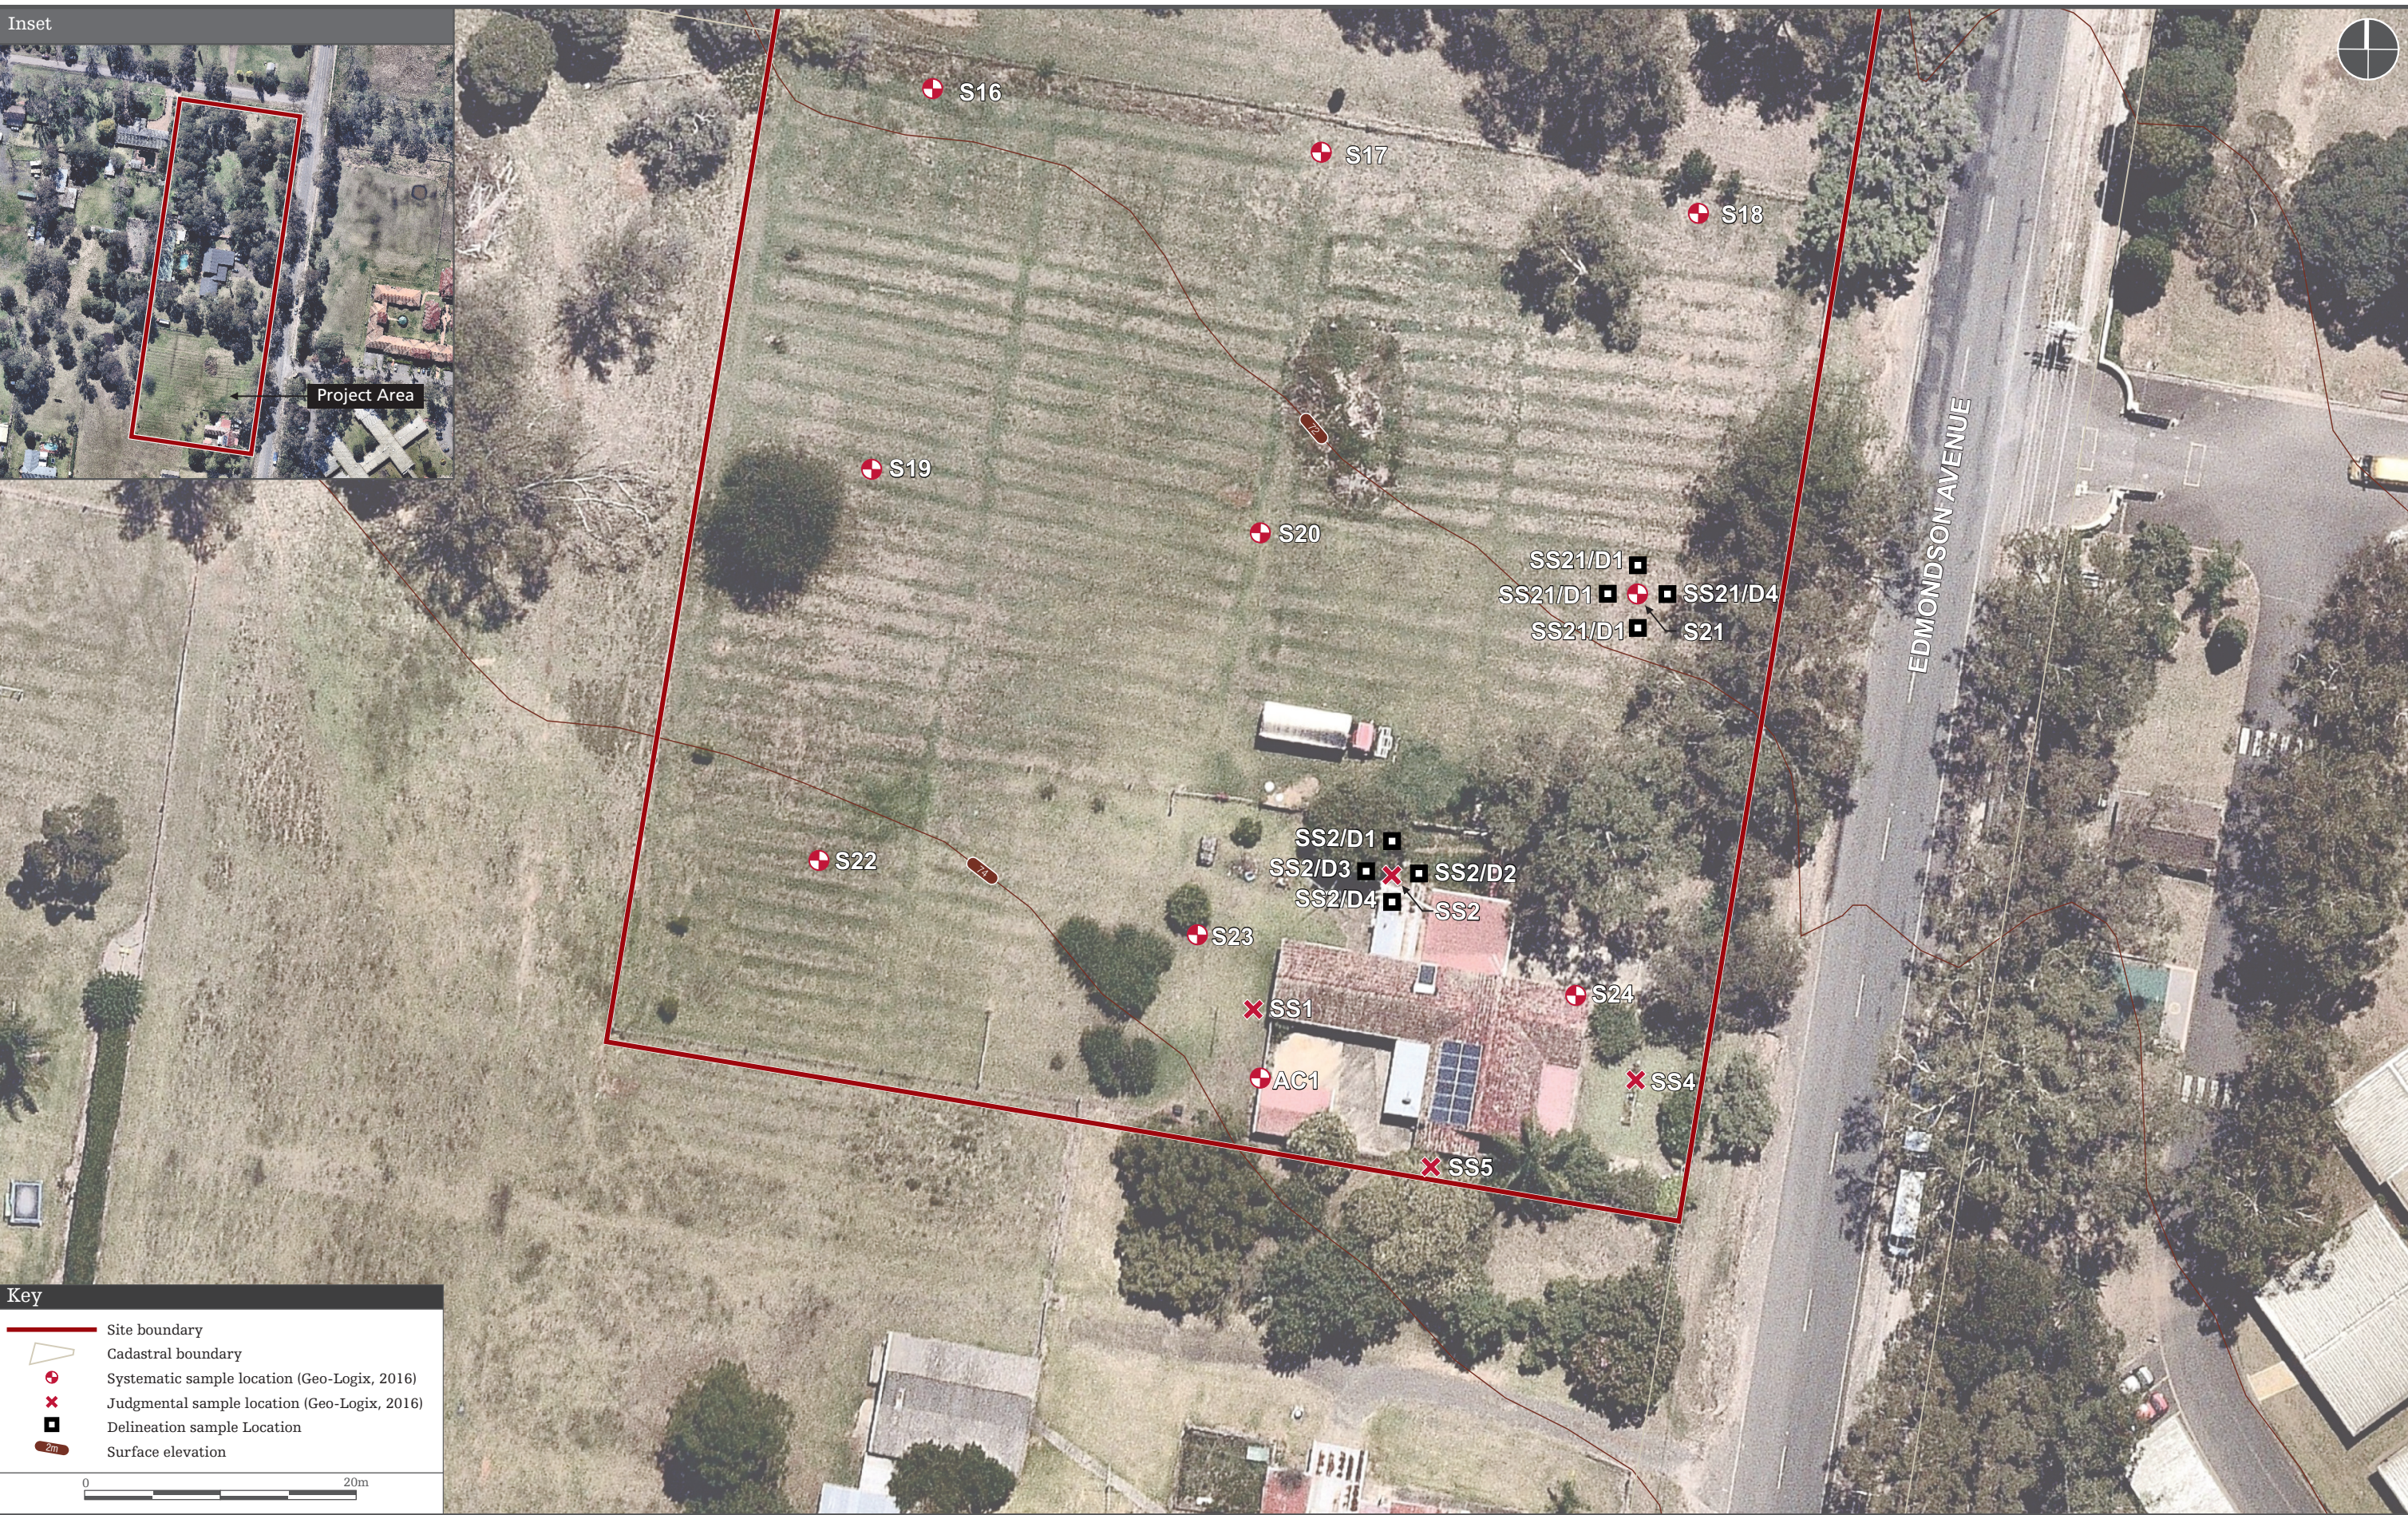
Figure 2

To define the extent of asbestos impact to soils in the vicinity of SS2 the following scope of works was undertaken. Sampling locations are shown on Figure 2.

- Site boundary
- Cadastral boundary
- Systematic sample location (Geo-Logix, 2016)
- Judgmental sample location (Geo-Logix, 2016)
- Delineation sample Location
- Surface elevation

SAMPLE LOCATION MAP

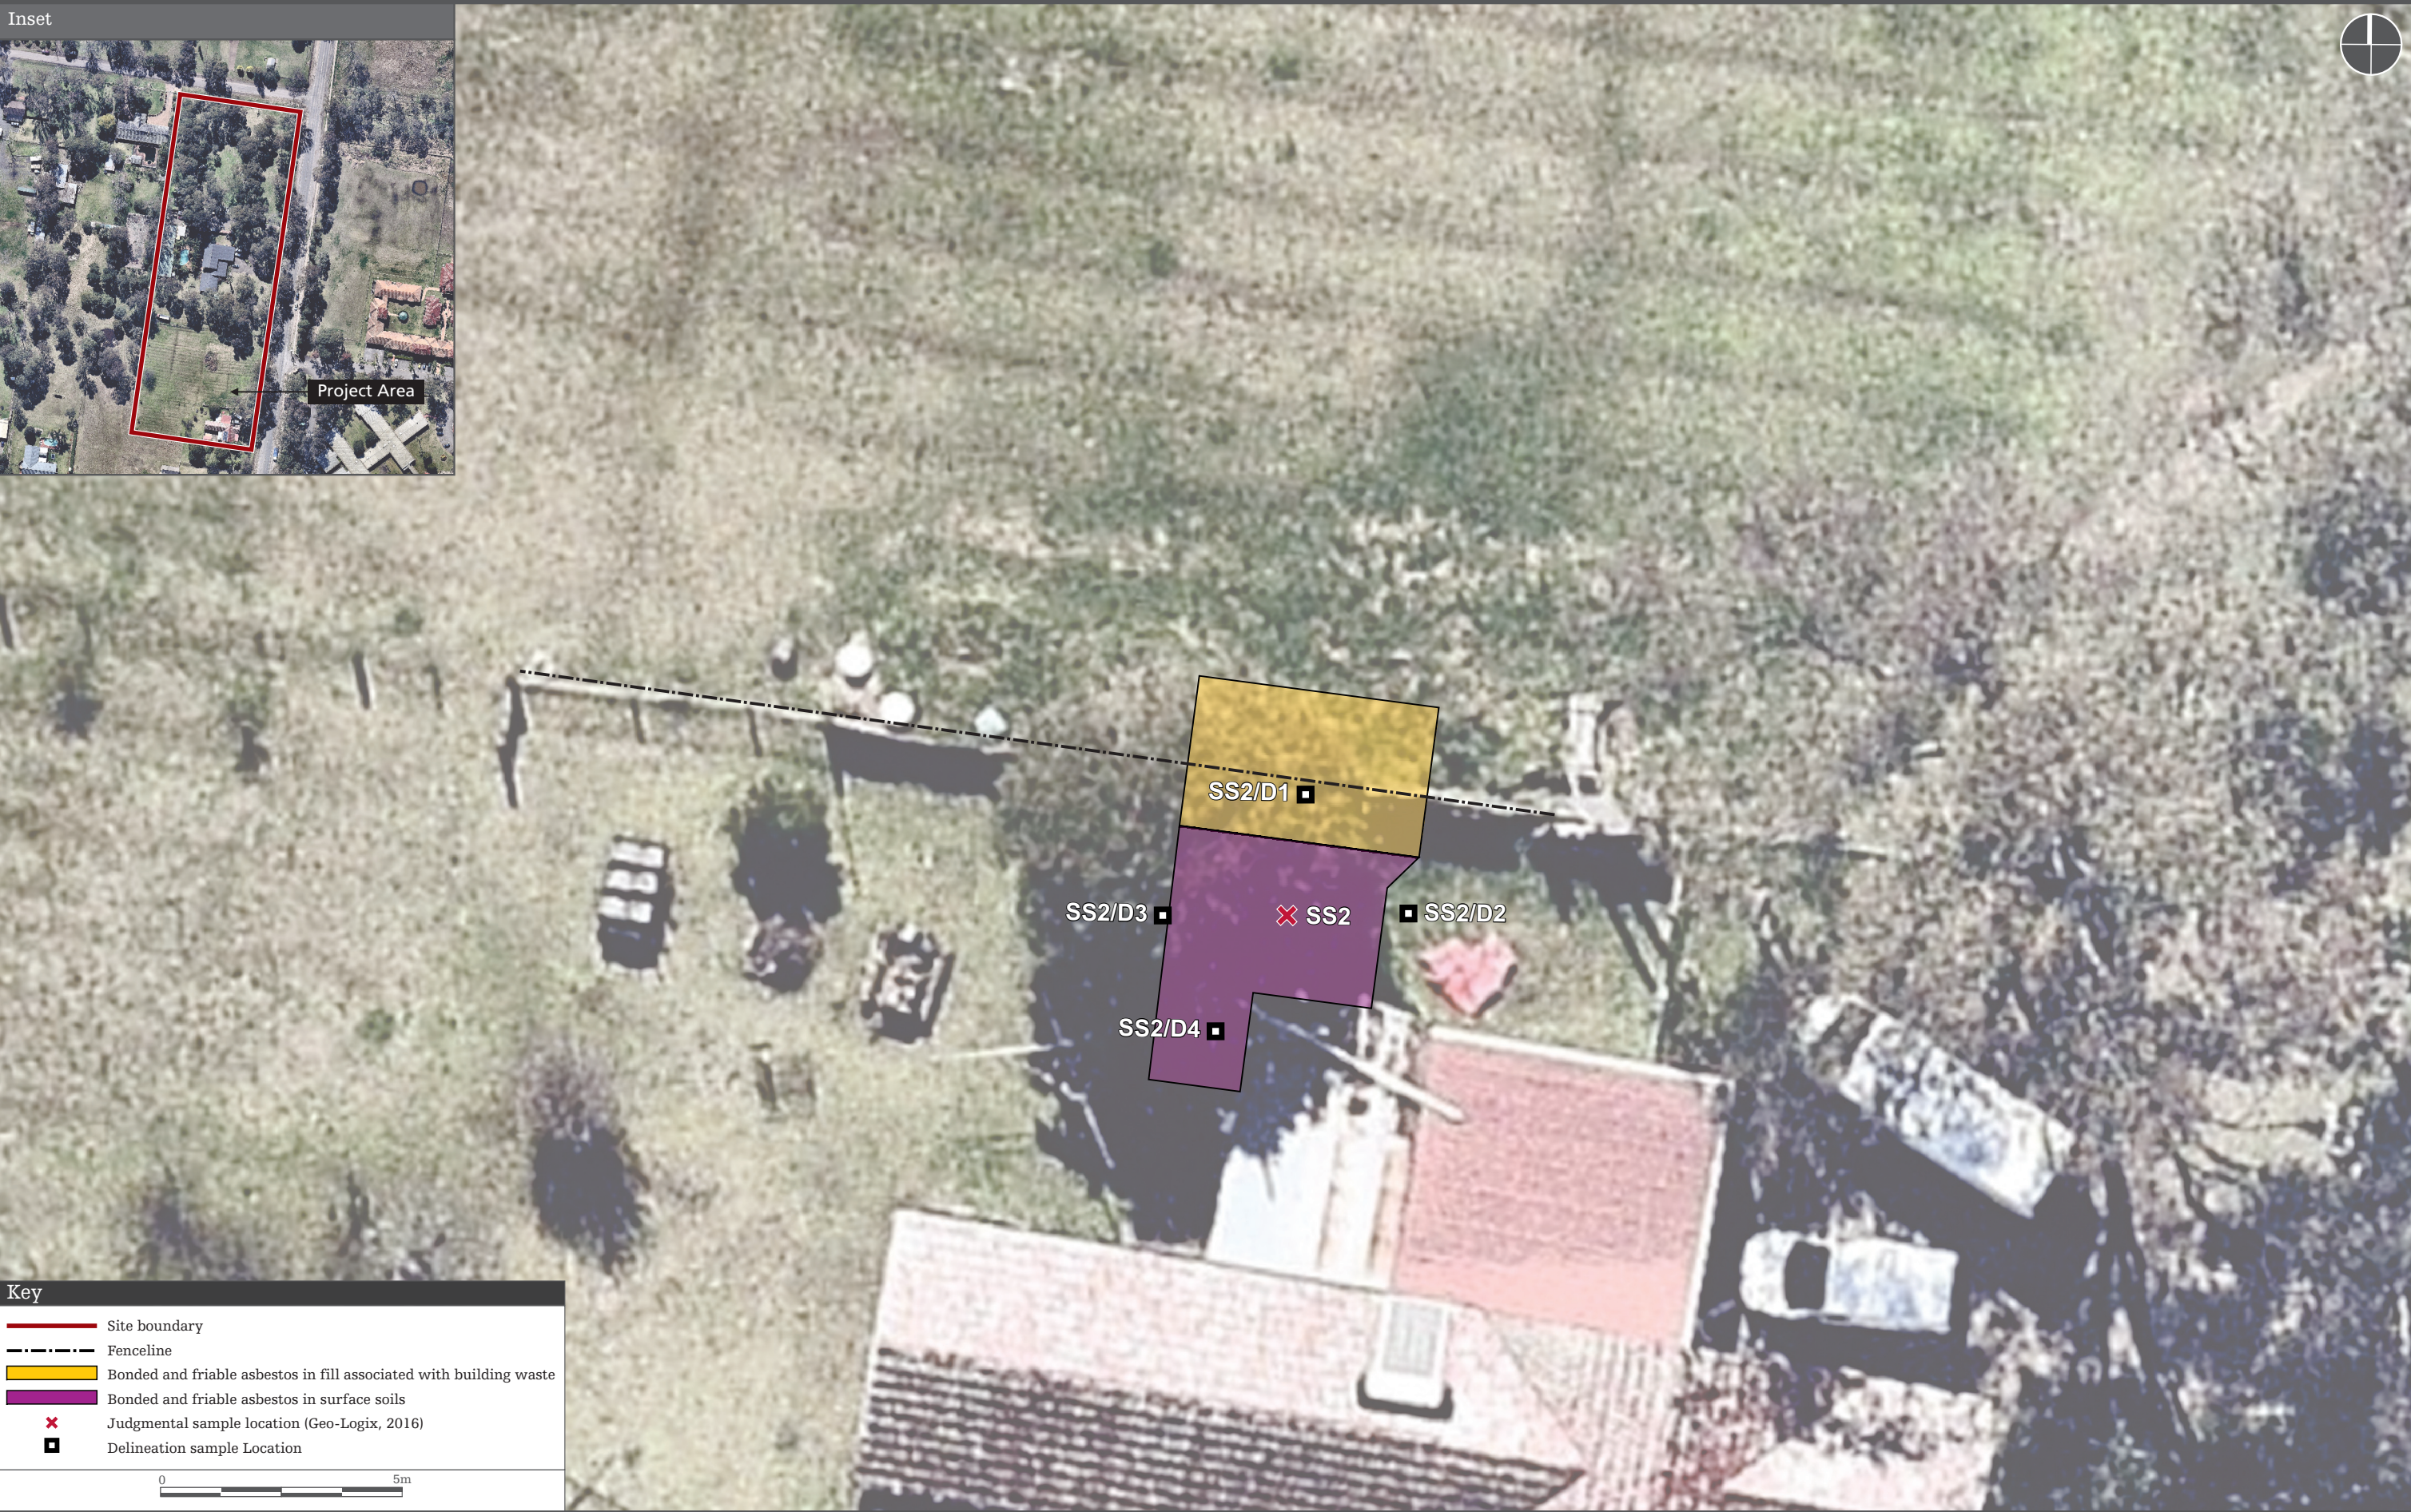
Results of the investigation identified bonded and friable forms of asbestos in shallow surface soils and fill to the north of the dwelling at 60 Edmondson Avenue in the vicinity of sample location SS2 (Figure 3). Friable and bonded asbestos in the southern portion of the impacted area is confined to shallow surface soil (0.0-0.1 m) with asbestos in the northern portion associated with building waste including brick, glass and ceramics to an approximate depth of 0.25 mbg.

The approximate volume of impacted material is approximately 7 - 9 m³. As the concentration of friable asbestos exceeds residential land use criteria, remediation of asbestos impacted material is required for the site to be considered suitable for residential land use.

Figure 3: Asbestos Impacted Area

- Site boundary
- Fenceline
- Bonded and friable asbestos in fill associated with building waste
- Bonded and friable asbestos in surface soils
- Judgmental sample location (Geo-Logix, 2016)
- Delineation sample Location
