Geo-Logix
environment • geotech

28 February 2017

SUBJECT: Phase 2 Environmental Assessment Addendum - Soil Delineation Sampling
SITE: 230 Sixth Avenue, Austral NSW

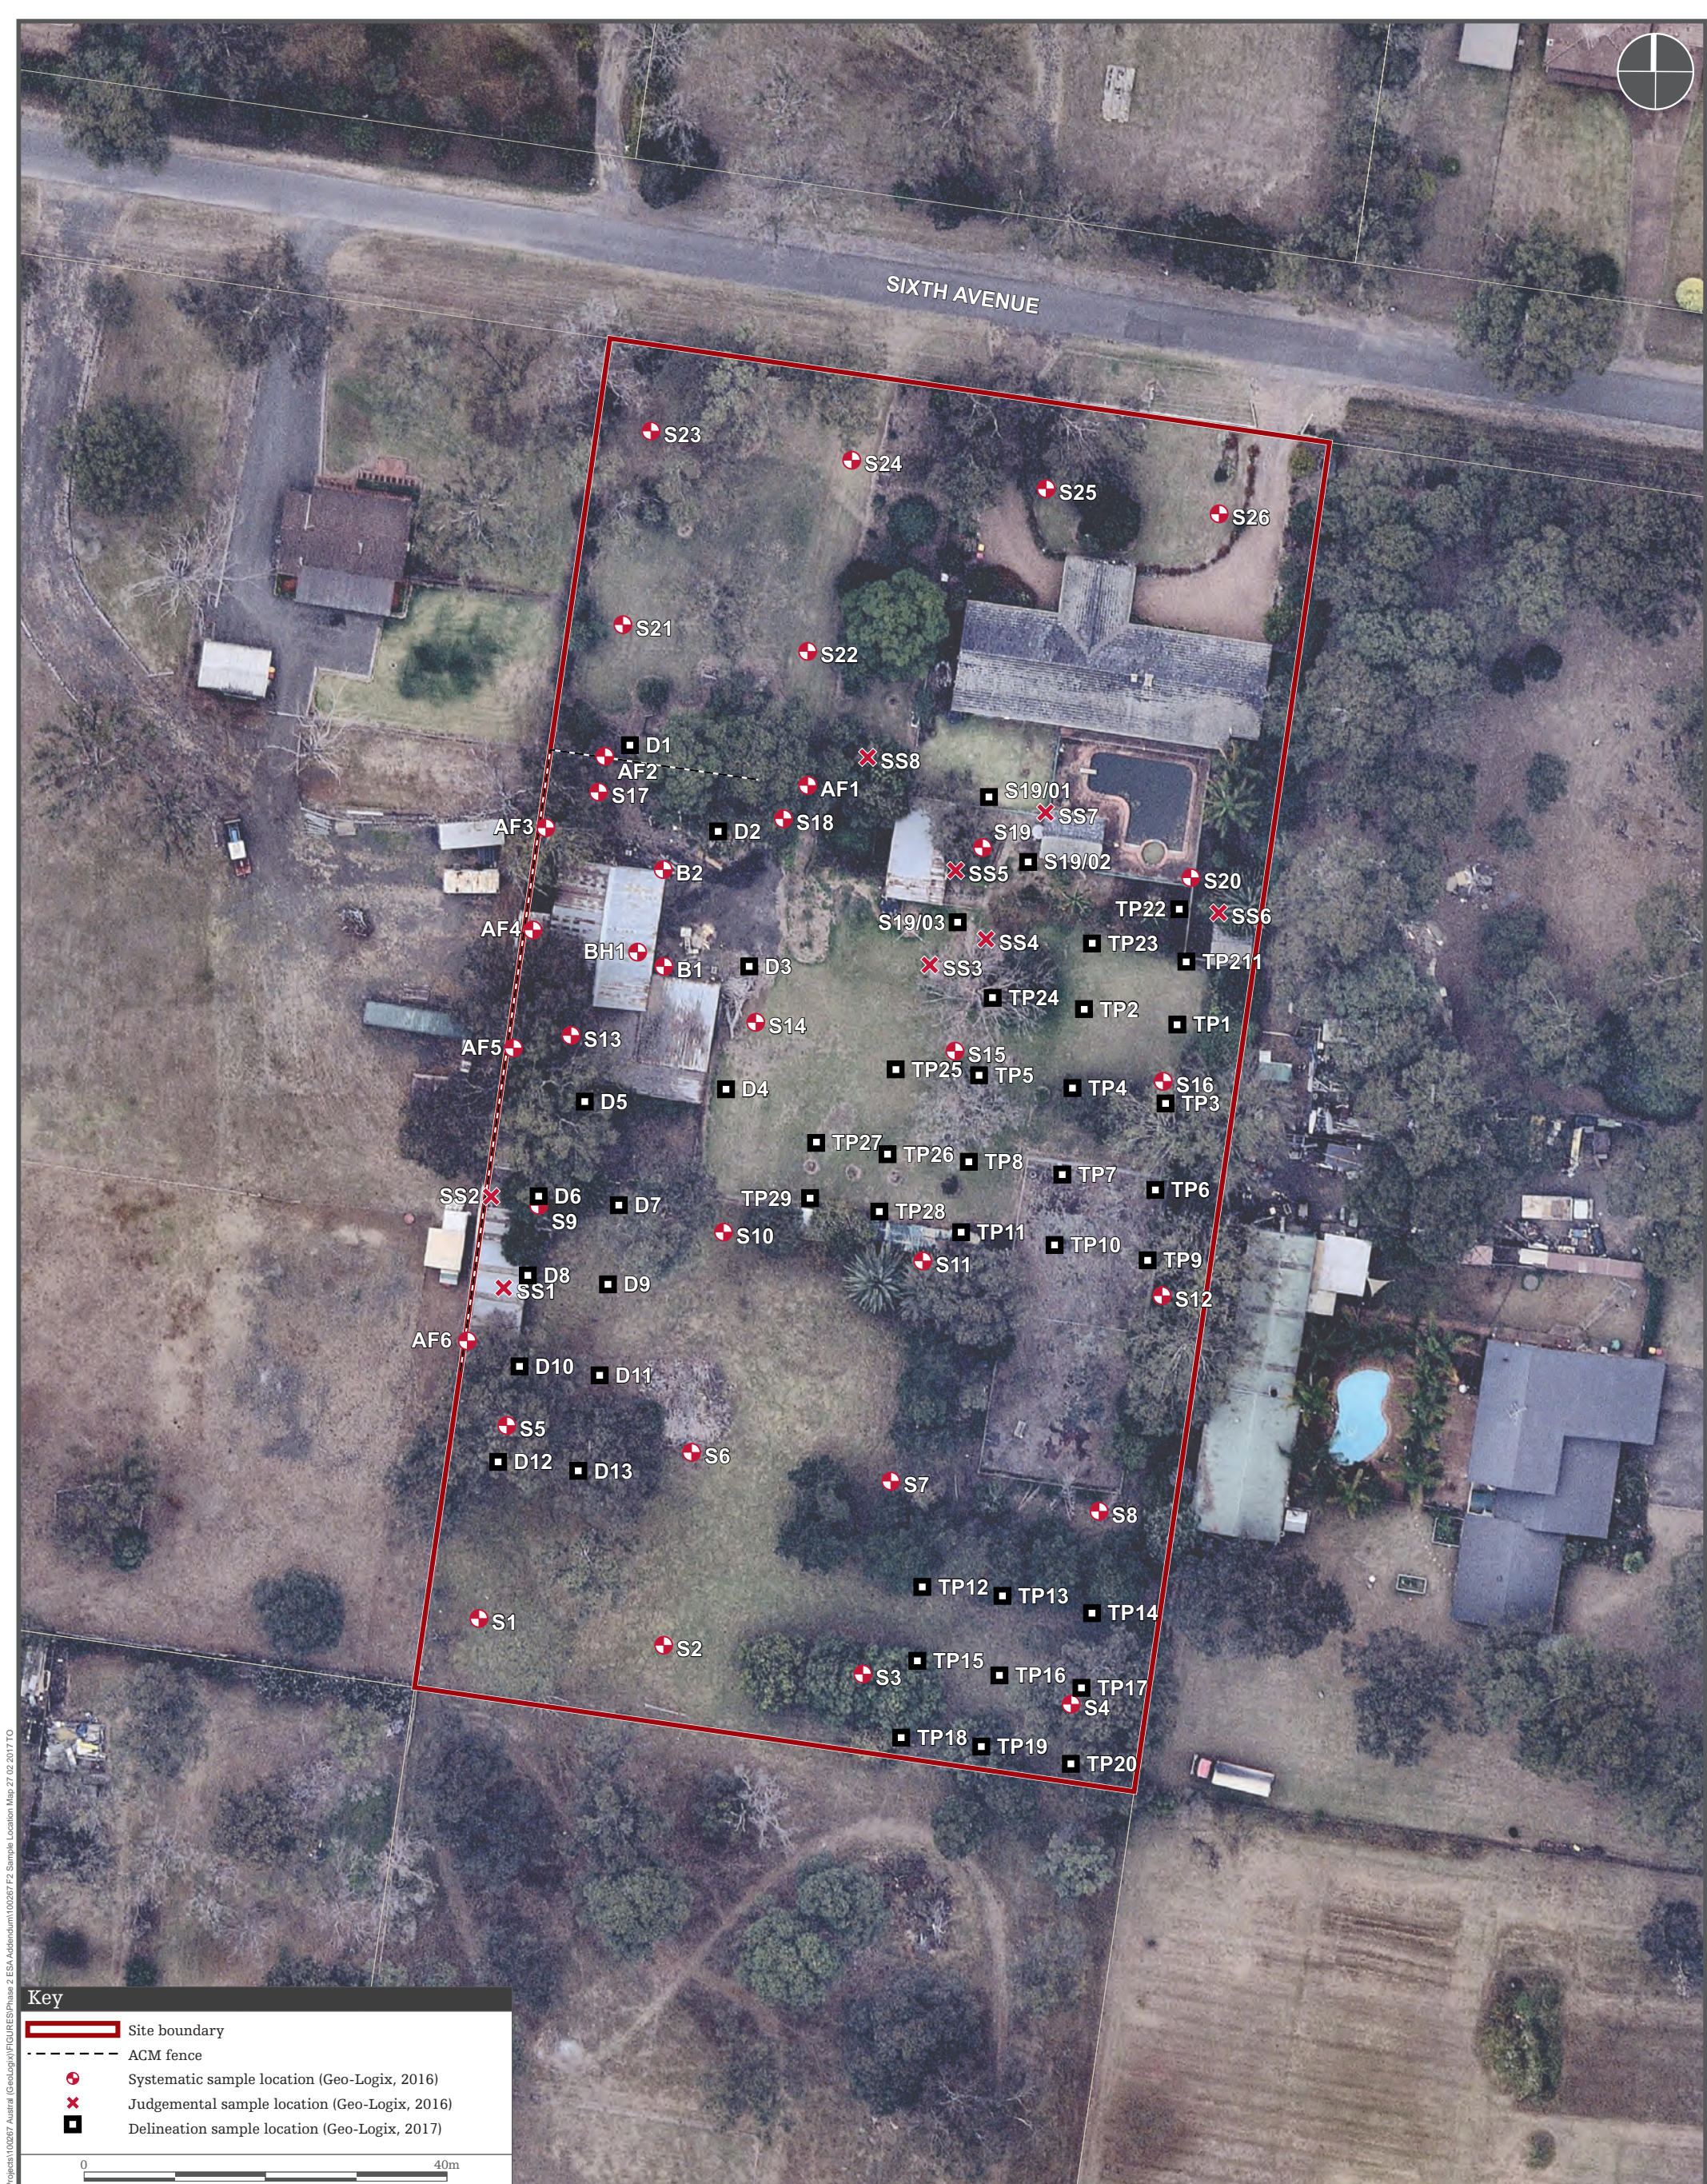
Figure 2: Delineation Sample Locations

To define the extent of petroleum impact to soils in the vicinity of shed in the western portion of the site the following scope of works was undertaken. Delineation sample locations are shown on Figure 2:

E:\Projects\10267 Austral GeoLogix\FIGURES\Phase 2 ESA Addendum\10267 F2 Sample Location Map 27 02 2017 TO

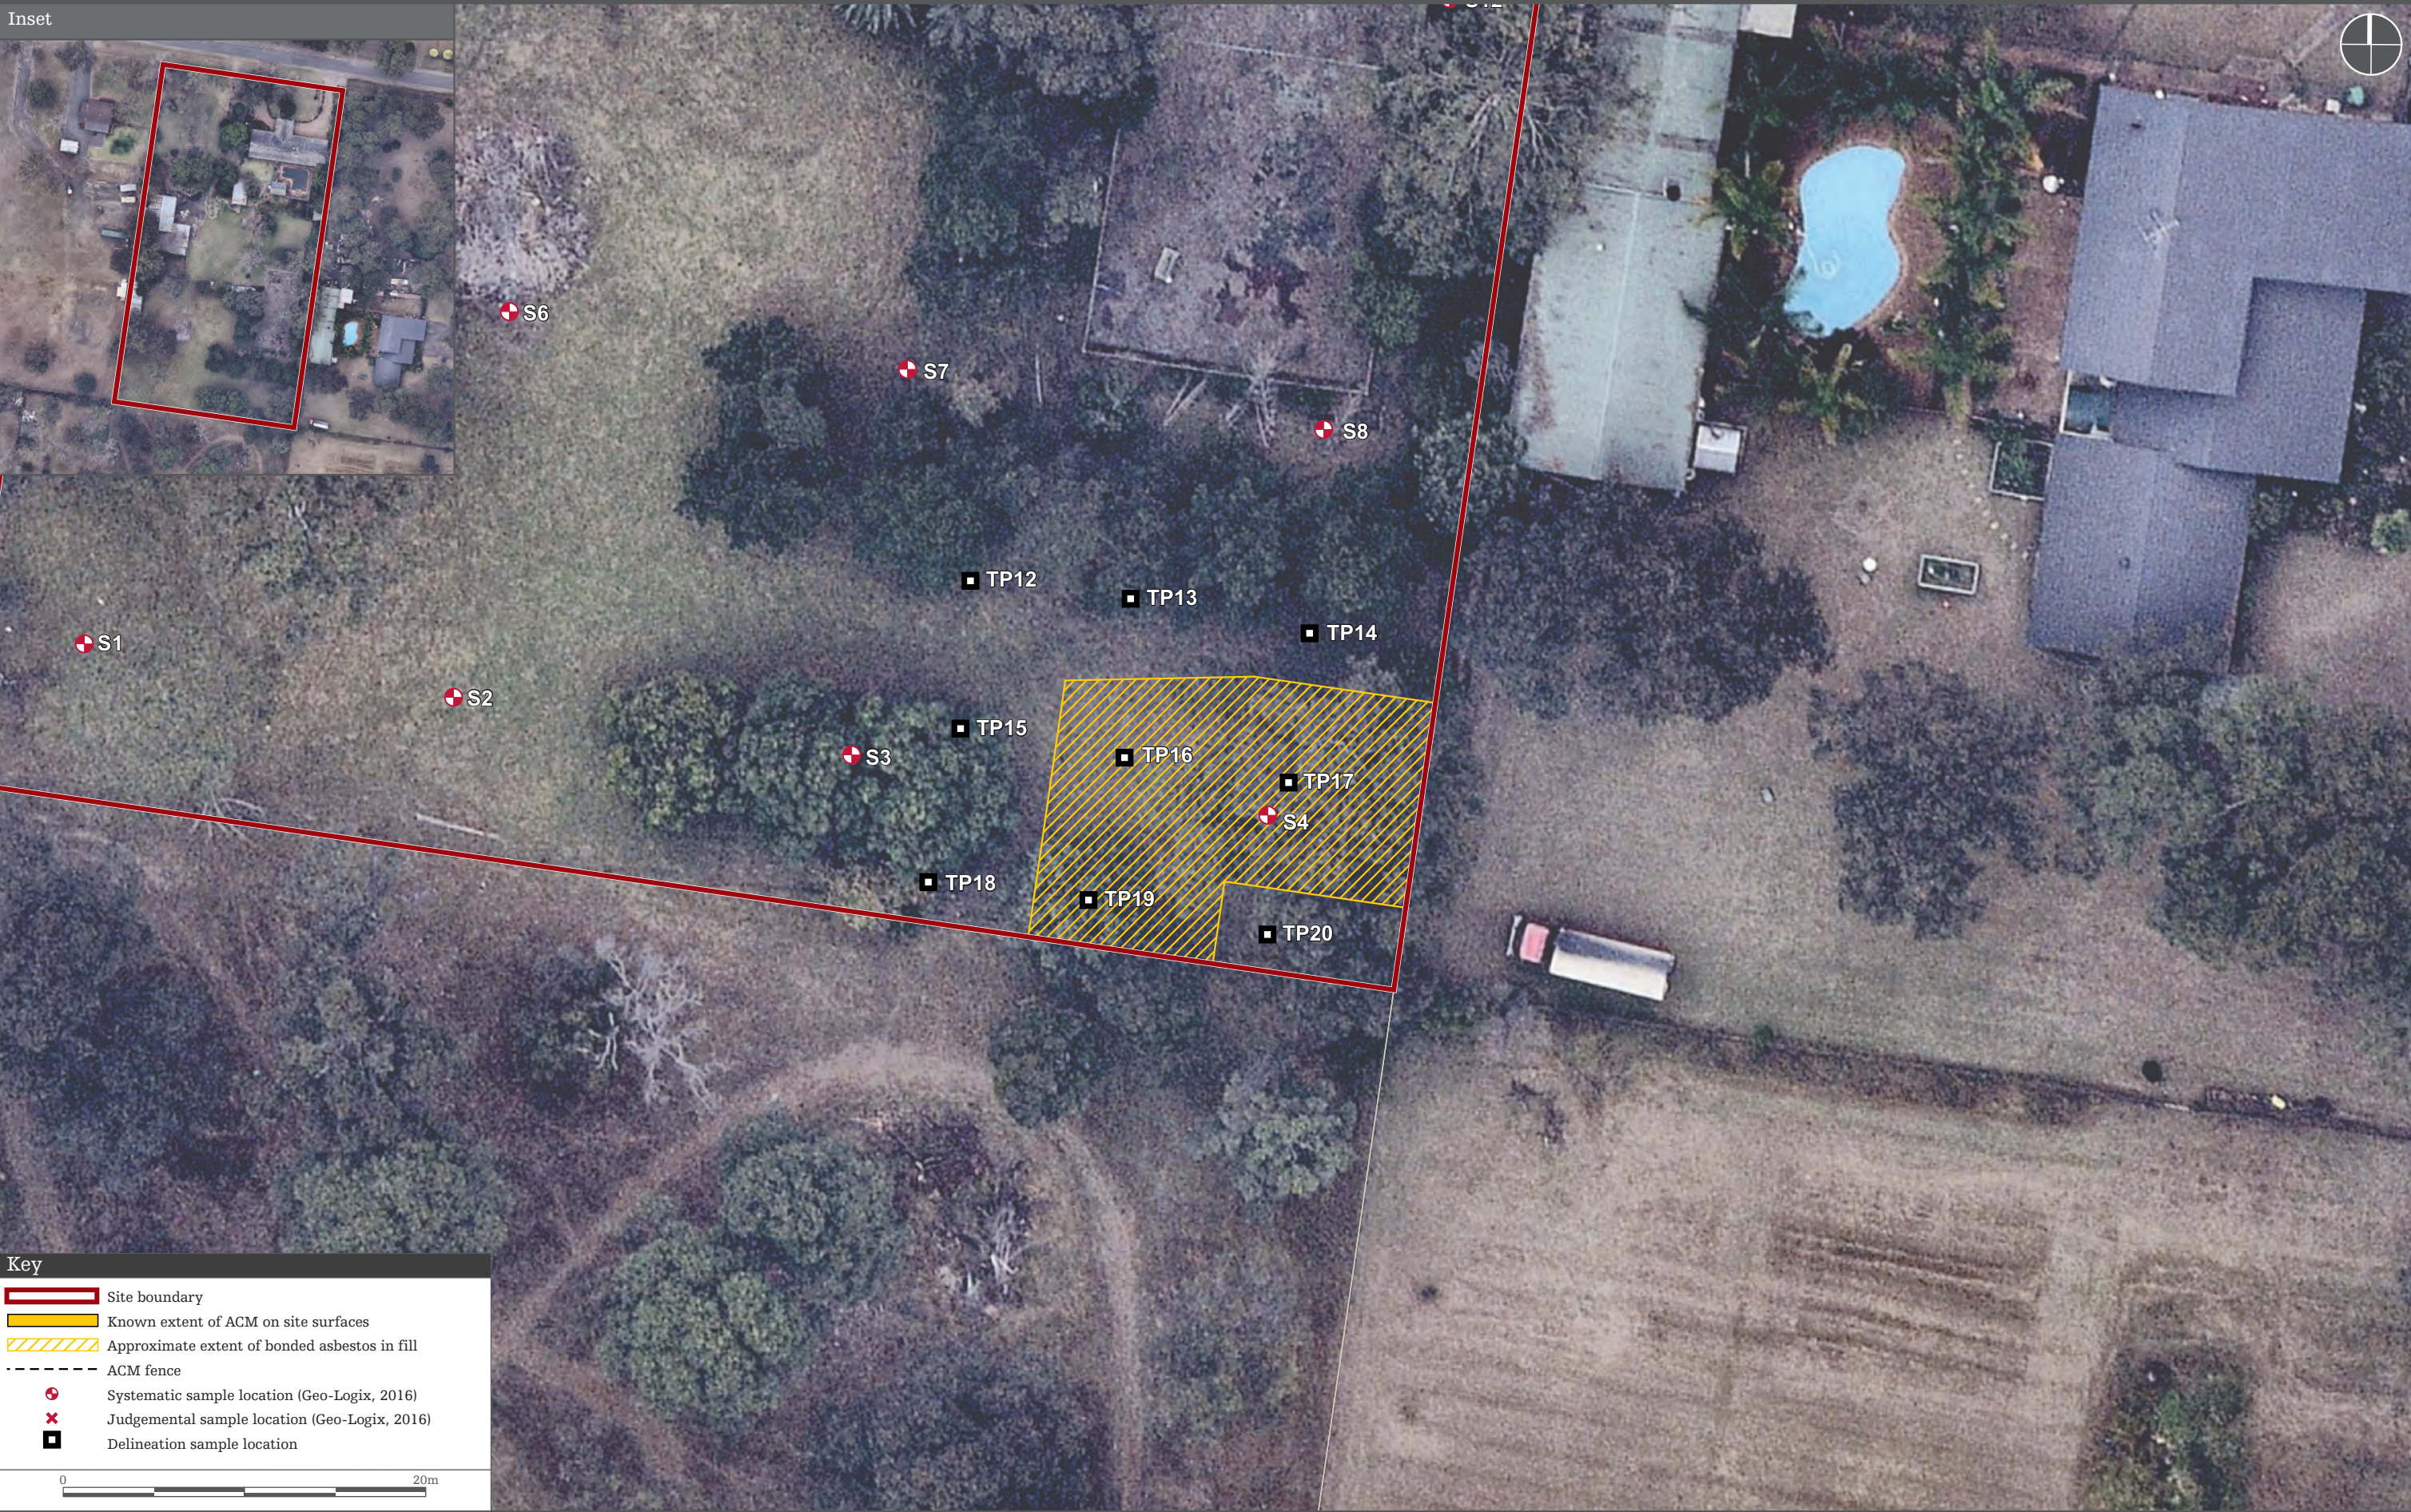
Figure 3a: Asbestos Impacted Areas

- Fragments of bonded ACM were identified at sample location D2 in shallow fill (0.0 - 0.15 mbg) associated with building waste comprising of tiles and other ceramics. ACM appeared to be isolated and restricted to shallow fill along a narrow strip between the asphalt surface of the truck shed to the south and ACM fence to the north, an approximate area of 60 – 75 m². The estimated extent of impact is presented on Figure 3A.
- Fragments of bonded ACM were identified in fill at concentrations above residential landuse criteria in seven out of 20 testpits completed in the vicinity of

sample S16 (Figure 3a). Fragments of bonded asbestos do not appear associated with demolition of any former site structures but with fill used to create a level lawn area. Given bonded ACM fragments have been encountered throughout this fill, the results suggest the whole fill unit it is impacted. Approximately 700 m³ of fill is considered to require remediation or management;

E:\Projects\100267 Austral (Geo-Logix)\FIGURES\Phase 2 ESA Addendum\100267 F2B Asbestos Impacted Area 27.02.2017 TO Rev A

The extent of soil contamination identified in the Phase 2 investigation has been defined. Remediation and / or management of the issues is required for the site to be made suitable for residential land use.
