CONSERVATION MANAGEMENT DOCUMENT

WICKHAM WOOLSTORES

ANNIE STREET, WICKHAM NSW 2293

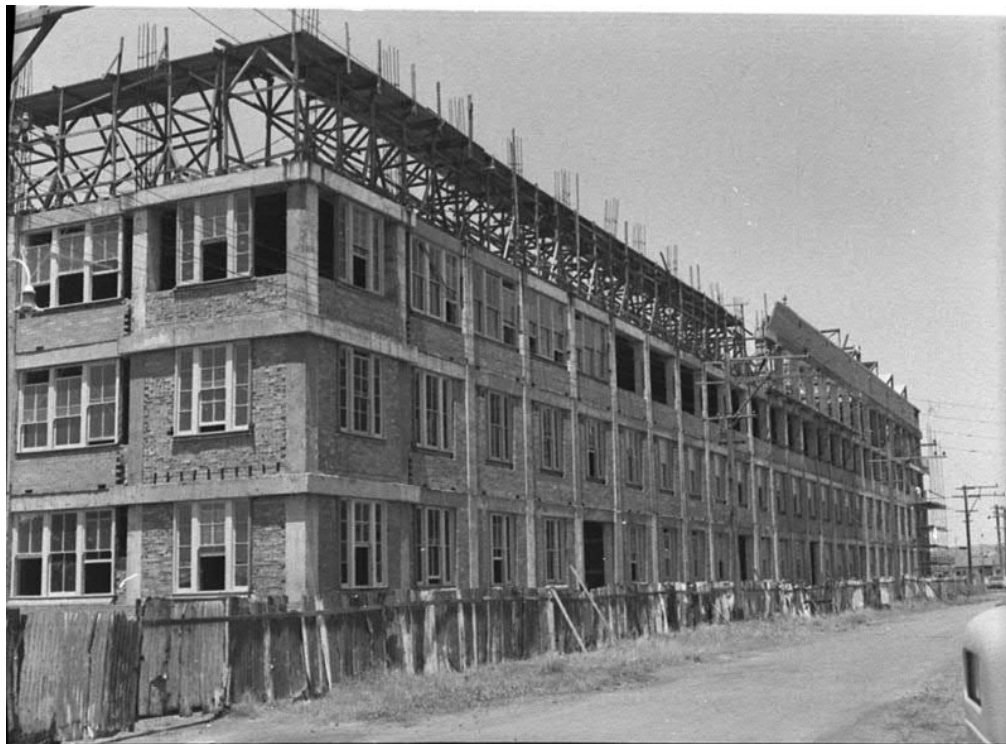
Figure 7. The AML&F building from Milford Street, November 1956. Close examination of the photograph reveals details of construction methods and the use of materials. *Newcastle Morning Herald*

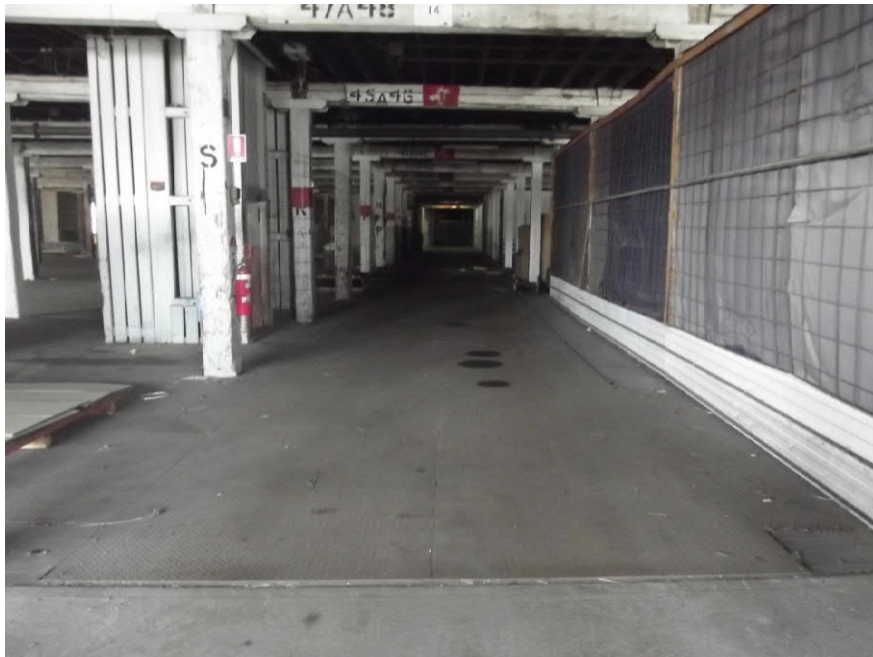
Figure 10: Ground Level of AML&F Woolstore, note partitioning for storage units.

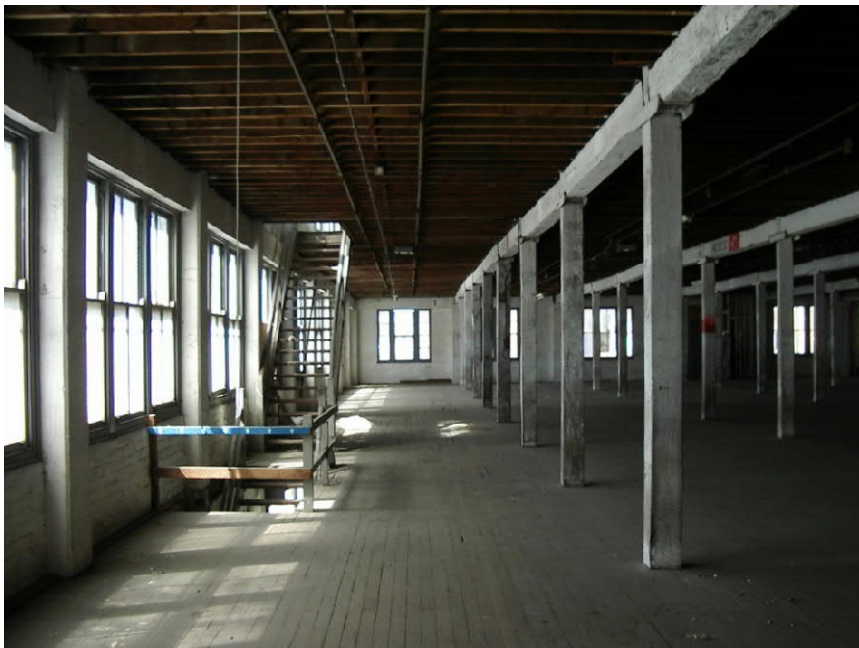
Figure 11: Typical Level 2 and 3 of AML&F Woolstore

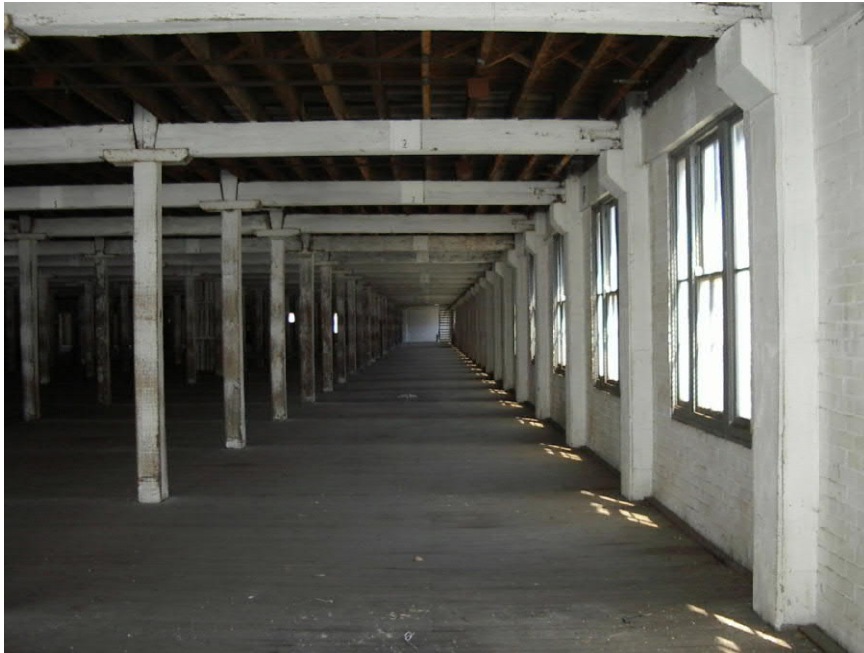
Figure 12: Typical Level 2 and 3 of AML&F Woolstore

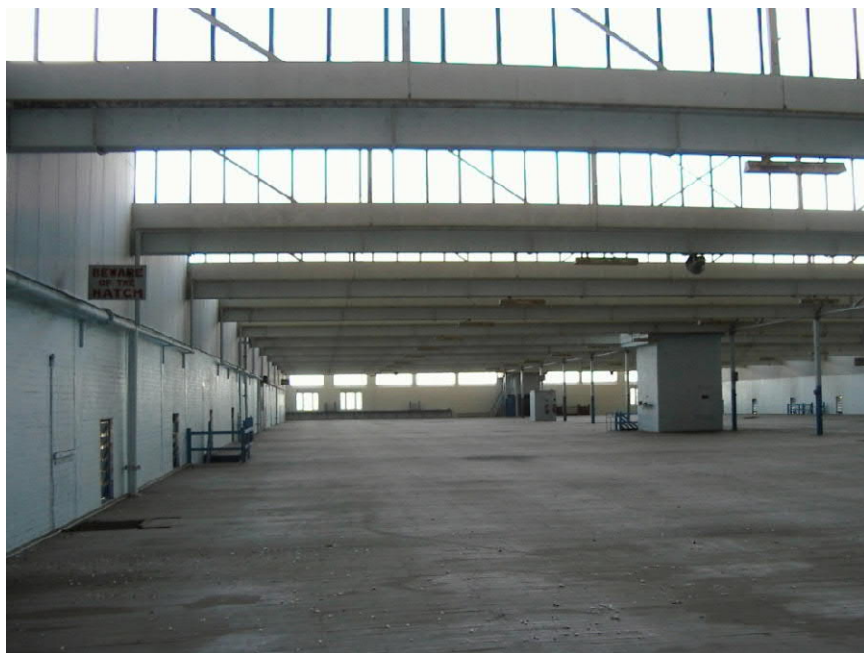
Figure 13: Typical Level 4 of AML&F Woolstore looking South with sky visible through the south lights. Abundant natural light is provided to the entire floor plate whilst avoiding direct sunlight. Note beside the south light glazing, the vertical and diagonal members of the trusses which support the sawtooth roof.

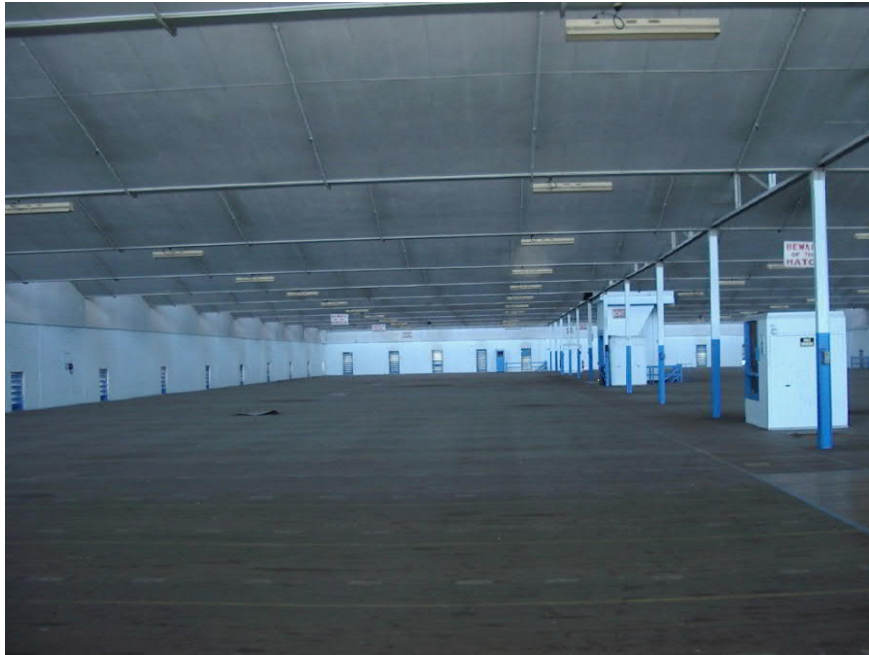
Figure 14: Typical Level 4 of AML&F Woolstore facing north.

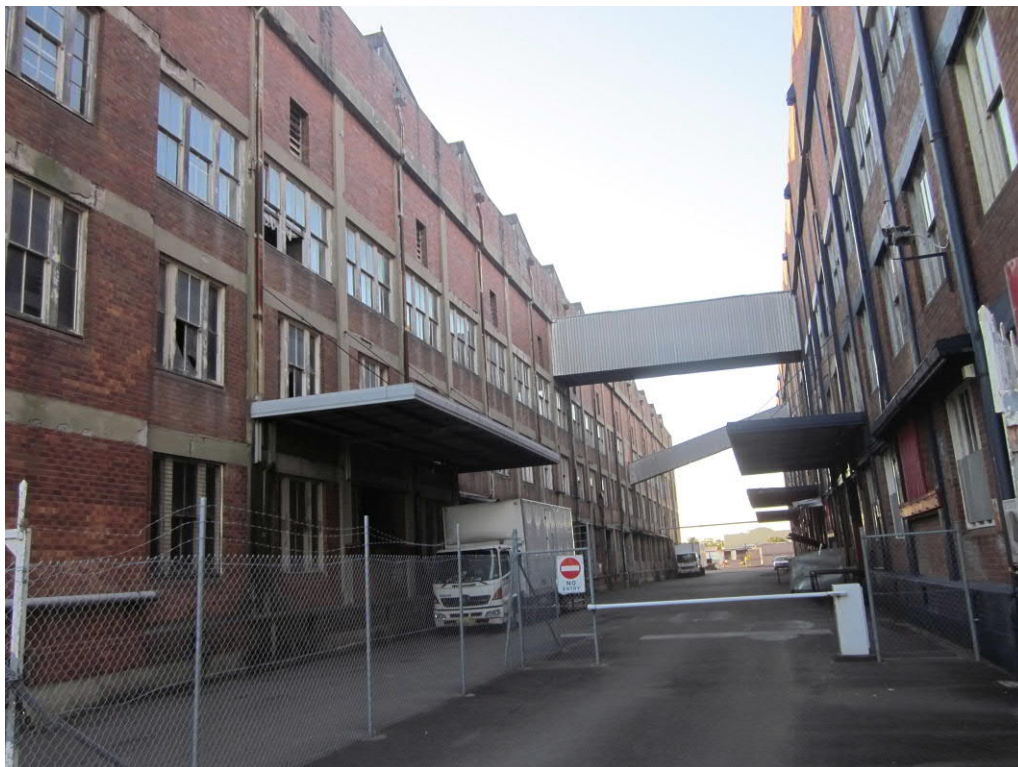
Figure 16: Driveway between AML&F and Dalgety looking north. Overhead walkway (horizontal) and wool chute (diagonal) are apparent. There is a horizontal water pipe between the two buildings just visible near the north end.

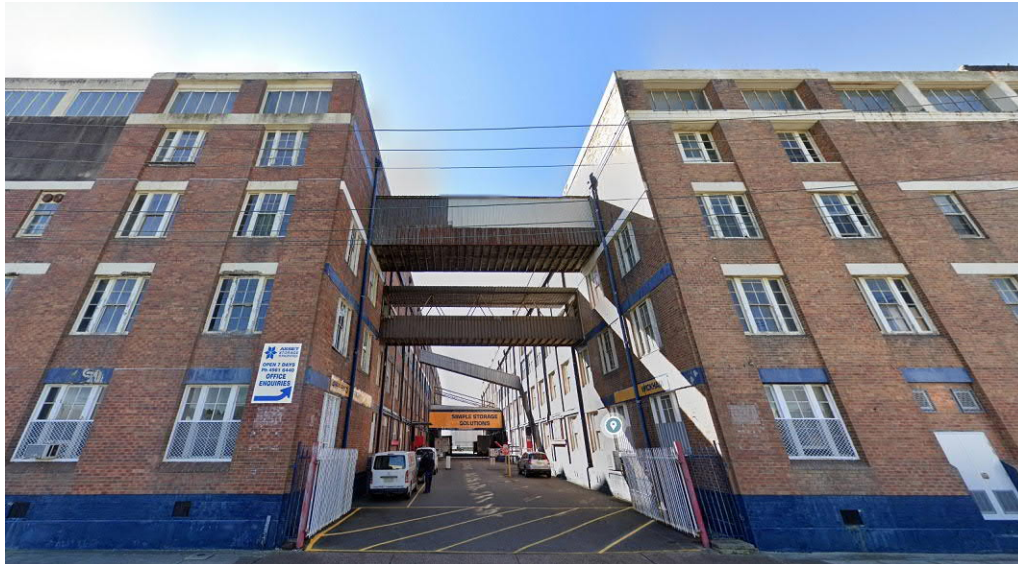
Overhead, three horizontal walkways (one at each upper level) and two diagonal wool chutes connect the two buildings. Fewer awnings exist within this driveway.

Figure 17: Driveway between the Dalgety to left and NZLMA to right buildings looking north. The multiple building connections are apparent. The entry to the current Self Storage Facility Office occurs partway along on the left. Source Google Streetview captured August 2019

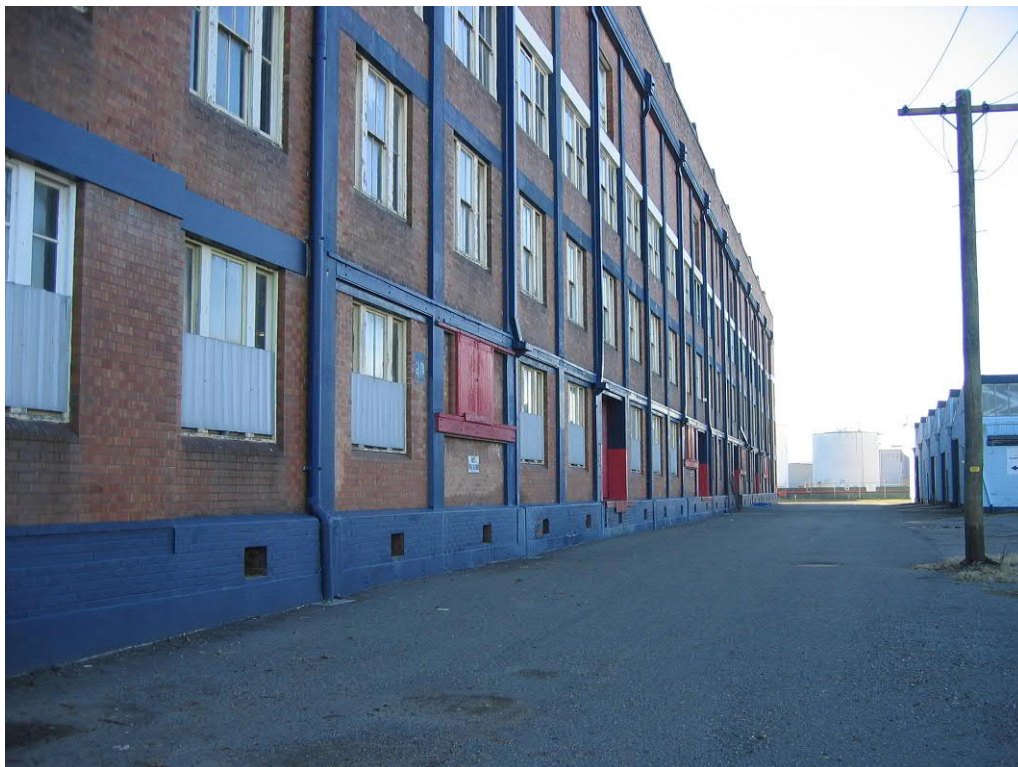
The easternmost driveway of the site is also finished in bitumen with an area of approximately 886m². It is different from the other driveways in that it is devoid of cantilevered awnings, suspended walkways and chutes. The eastern facade of the NZLMA building is exposed and visible from Annie Street from a distance of approximately 40 metres away. The southeast corner of the NZLMA building is visible however all the way from Hannell Street.

Figure 18: Driveway east of the NZLMA building looking north. Note absence of attachments to facade.

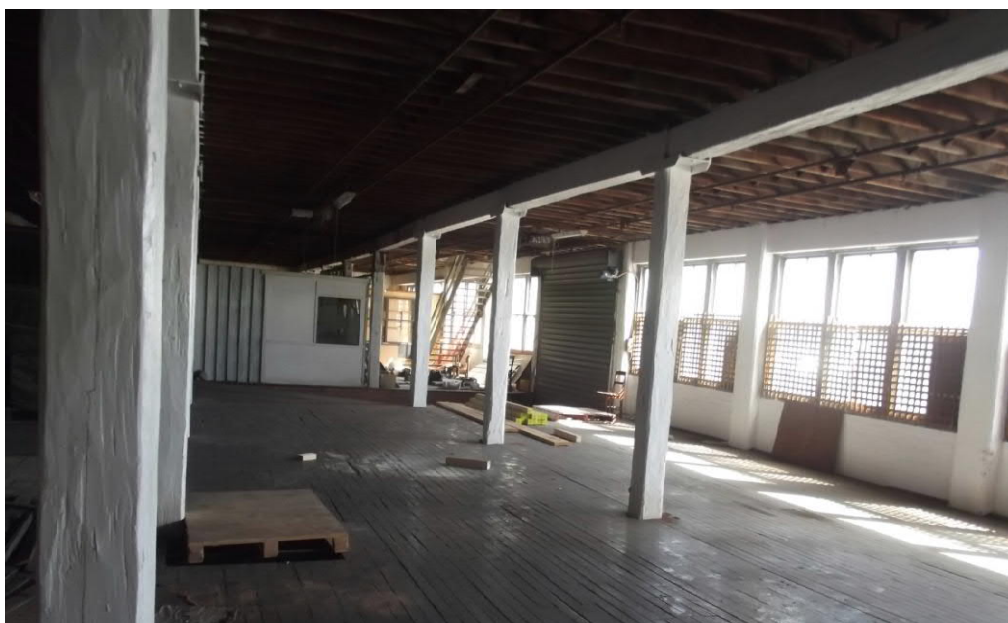
Timber flooring is used throughout the buildings and the bare boards form the finished surface in nearly all areas; the only exceptions being amenities areas, offices and the foyers. The timber boards are generally sound though extensively worn through use. There are localised areas of more severe damage or distortion through wear or impact or moisture. Water staining is visible on the underside of many sections of the floor and especially evident on the ground level. The incidence of borer or termite damage is very minor. Gaps between the floorboards and other building elements e.g. columns or external walls occur in many locations. Some in the Northeast corner in each building have been closed with expanding foam, many gaps remain open and daylight beyond is visible through them.

Figure 33: Ground Floor at Northern end of AML&F building shows uneven gaps, some cupping and warping from wear. Other areas have had sections cut out and replaced.

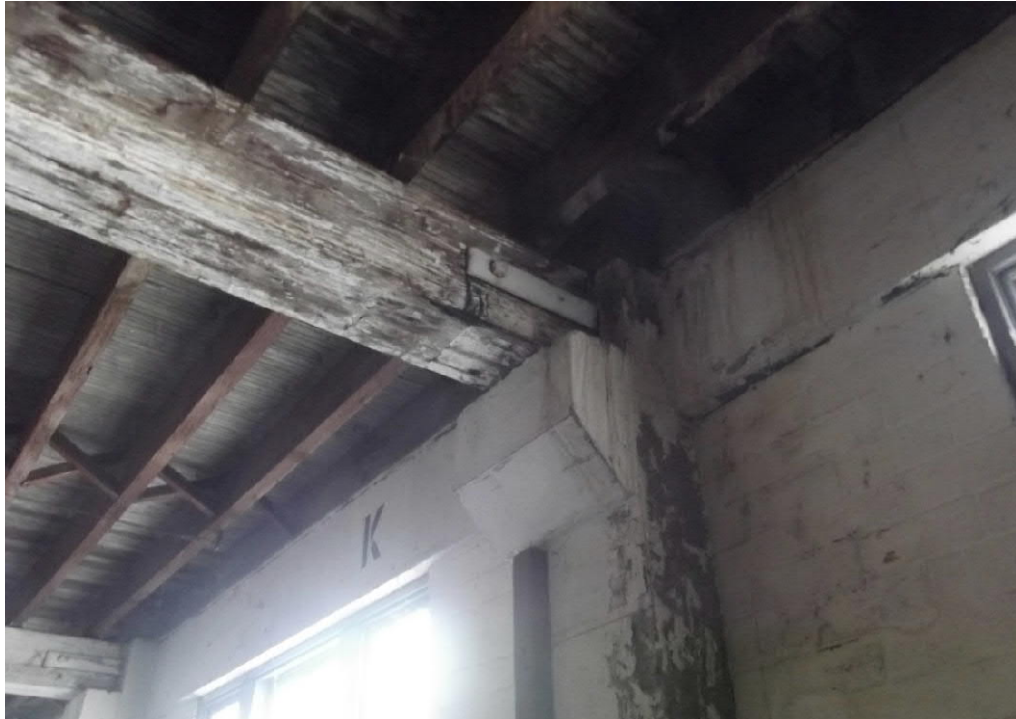
The internal timber structure consists of adze finished heavy hardwood columns which rise storey by storey from the ground to the underside of Level 4. The columns appear to be in good condition with very few showing splits in the grain. Most have been paint finished, though have not been refinished in a long time and the paint is worn especially on the corners of typical columns. The Draft Structural Condition Report notes that some columns have been replaced with new timber which is recognisable by its saw-finished surface rather than adze-finished. Connected to these columns are adze finished hardwood bearers which run east to west across the width of the building in single spans between the columns and are bracketed to each column on a bracket made from a length of Steel Universal Beam. At the external walls, the concrete columns engaged into the facade have cast-in corbels upon which the internal timber

bearers rest and are bolt fixed. The bearers are also typically in good condition. The Draft Structural Condition Report notes that some have been replaced at some stage and can be identified by their saw finished surface, not adze finished.

Figure 34: Bearer sitting on concrete corbel at external facade, paint finish deteriorated. Joists and herringbone blocking visible above left.

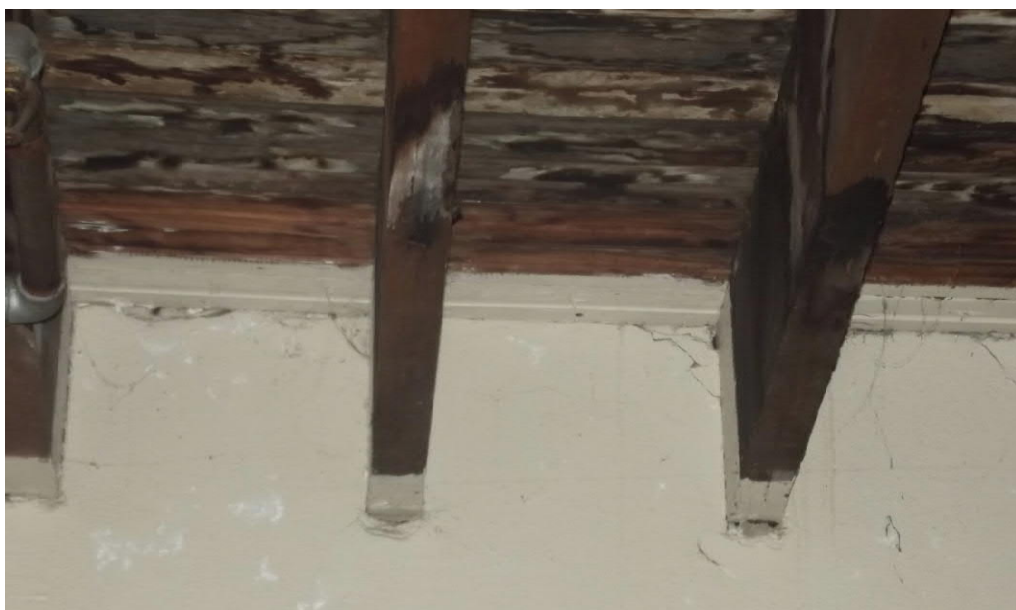
Above the level of the bearers are the joists which run north south along the length of the building spanning between bearers. Herringbone blocking at the mid span of the joists prevents twisting of the joists under load. The joists and blocking appear to be in sound condition throughout though some evidence of water ingress and staining is evident at many locations around the building.

Figure 35: Floor joists (intersecting with an internal wall) water staining is visible on the floorboards and has extended to the joists also.

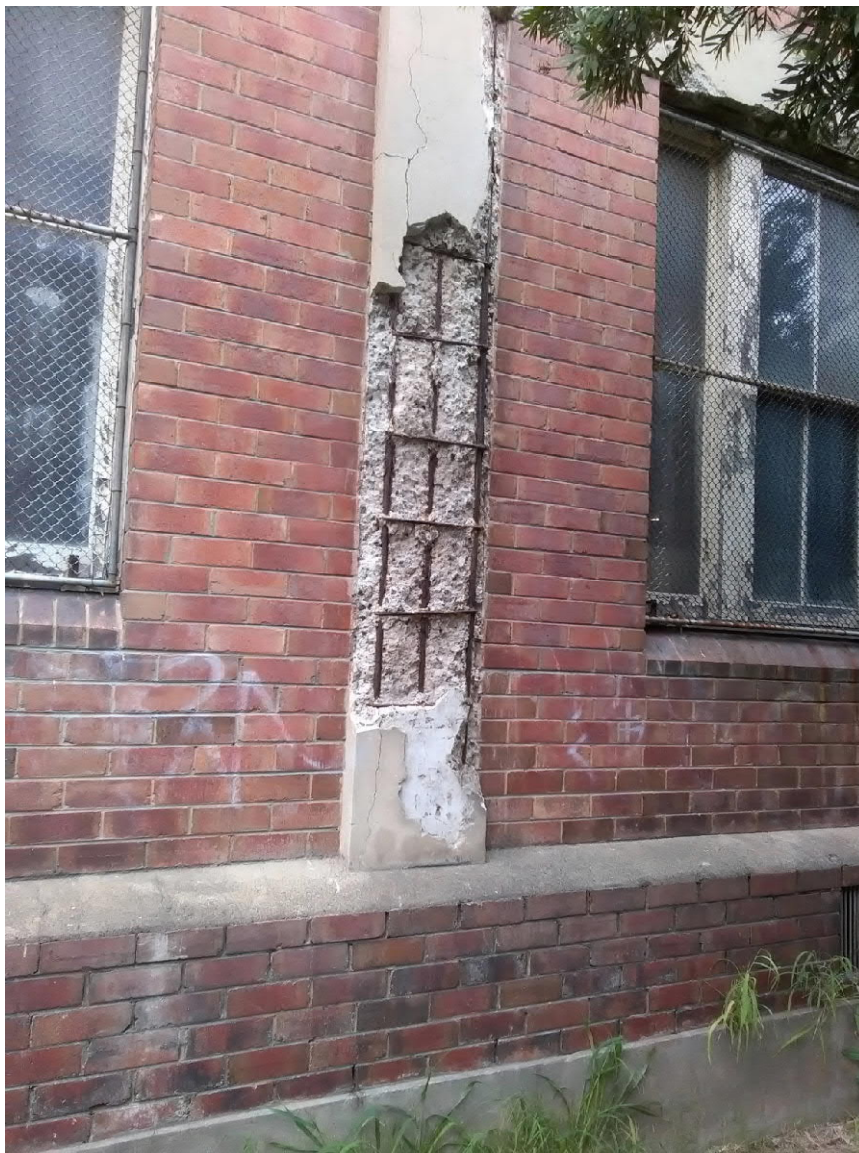
All three buildings are currently in a poor external condition. Reinforcing steel has corroded after the intrusion of salt, a hazard of the proximity of the harbour and Throsby Creek. This has caused some sections of concrete to explode and some brickwork to become displaced. This is particularly evident in so far as the AML&F building is concerned, as it alone continues to exhibit an unpainted concrete frame. The amount of spalling varies throughout the exterior of the building as some columns or beams appear mostly intact with cracking or spalling only along the bottom edge while other elements display multiple square metres of surface have sheared away and exposed the reinforcing underneath. The exposed concrete frame of the building provides a good deal of the structure to the envelope of the building allowing the brickwork to act as infill only. The Dalgety and NZLMA building both display sections of the concrete frame which have been repaired previously and the structure then painted.

Figure 36: Some of the worst visible damage to the existing concrete structure, spalling on the West side of the AML&F building.

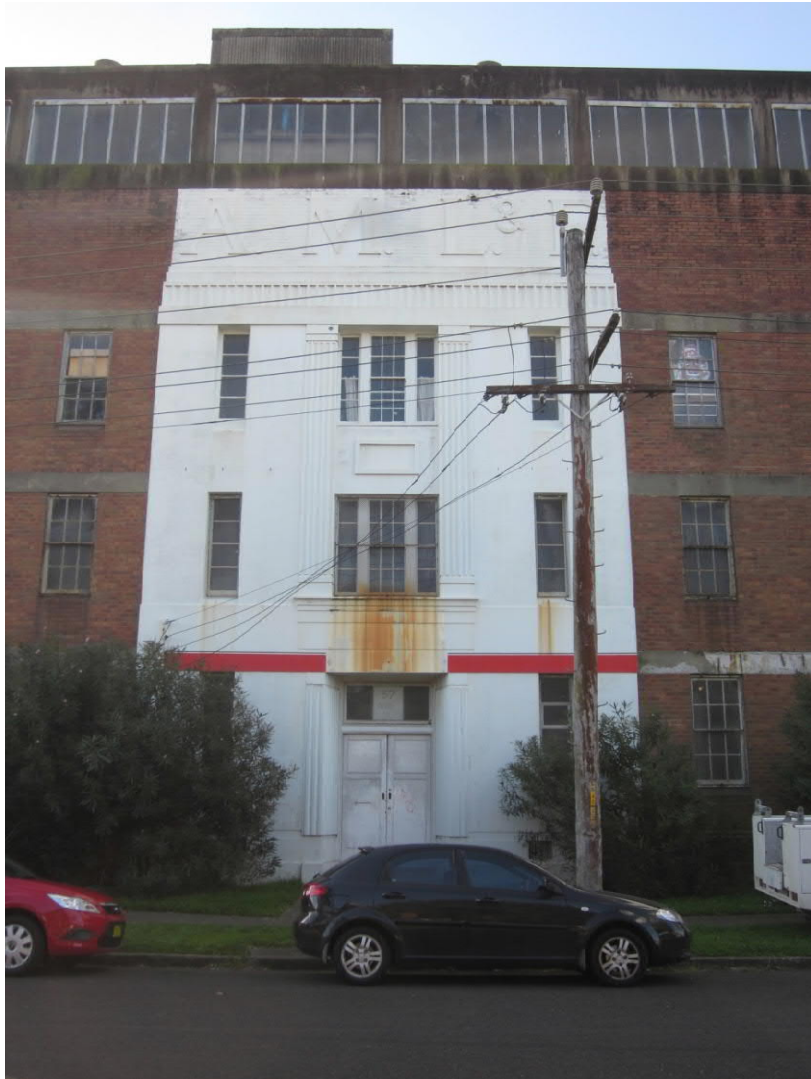
Figure 37: Annie Street Facade of AML&F building displaying detail of pilasters, cornices and friezes. Also visible is rust staining which washes down from the protective screens over the windows.

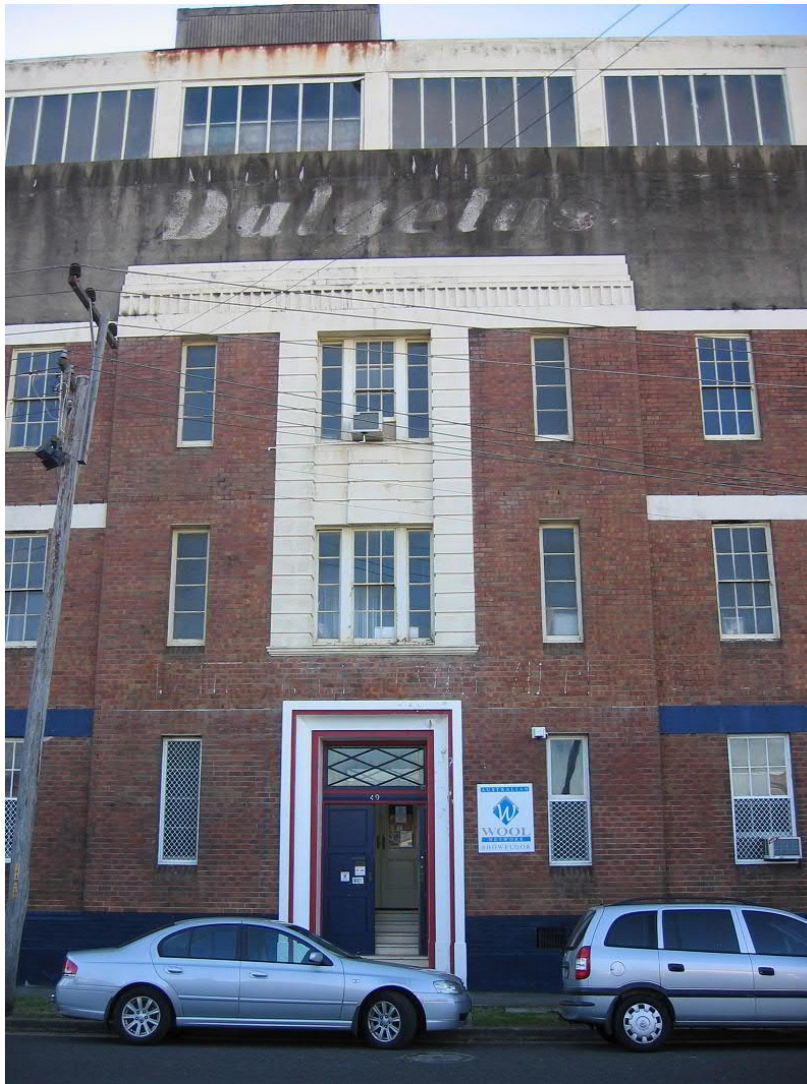
Figure 38: Annie Street Facade of Dalgety building displaying detail of quoining, cornices and friezes. A clear outline of the Dalgetys wording is still apparent on the rendered upper facade.

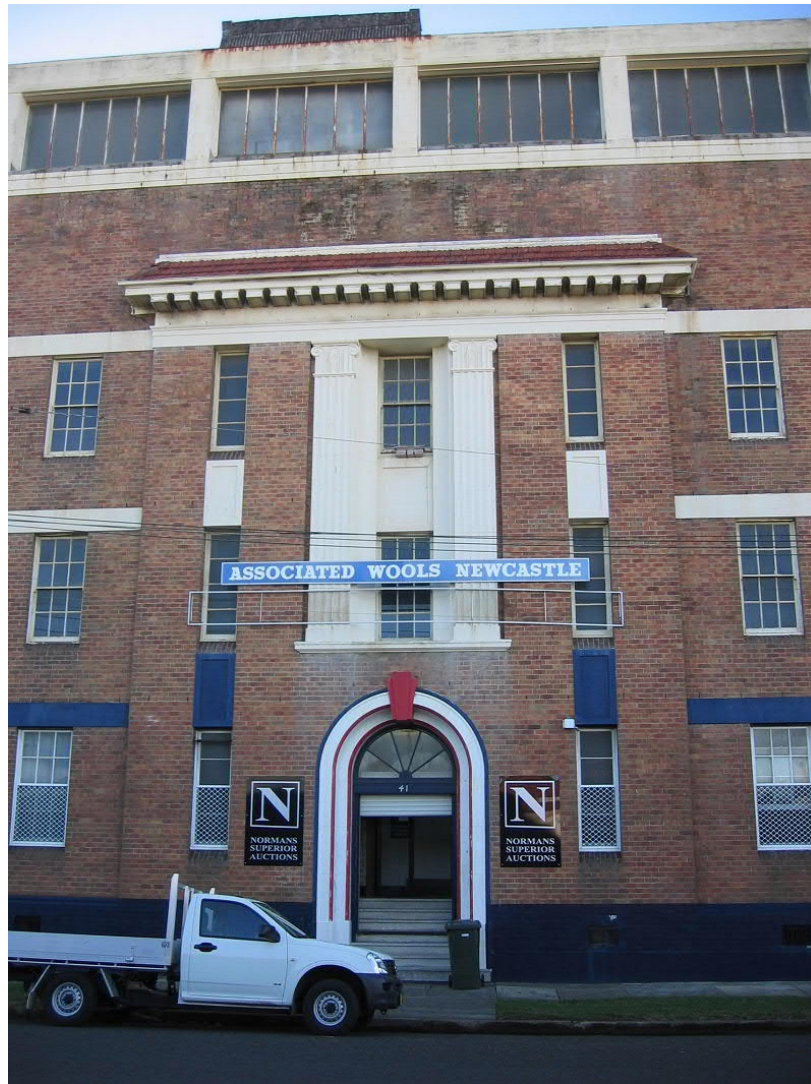
Figure 39: Annie Street Facade of NZLMA building displaying detail of pilasters, cornices dentils and friezes. Applied spandrel panels between the windows either side of the central door and the terracotta tiles over the entrance are unique to this building. There is a shadow of former NZL signage at the top of the building above the tiles.

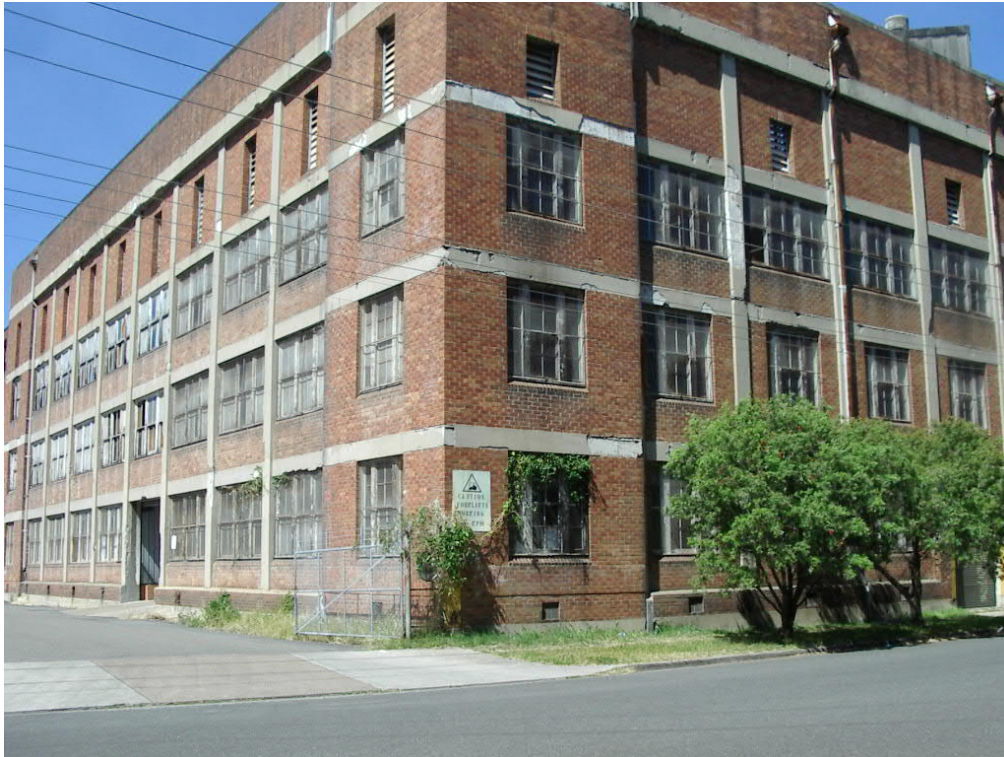
Figure 40: Window layout of AML&F building showing wider windows with spandrels on North side and third floor with narrower windows on corners and lower floors. Timber louvre vents on fourth floor.

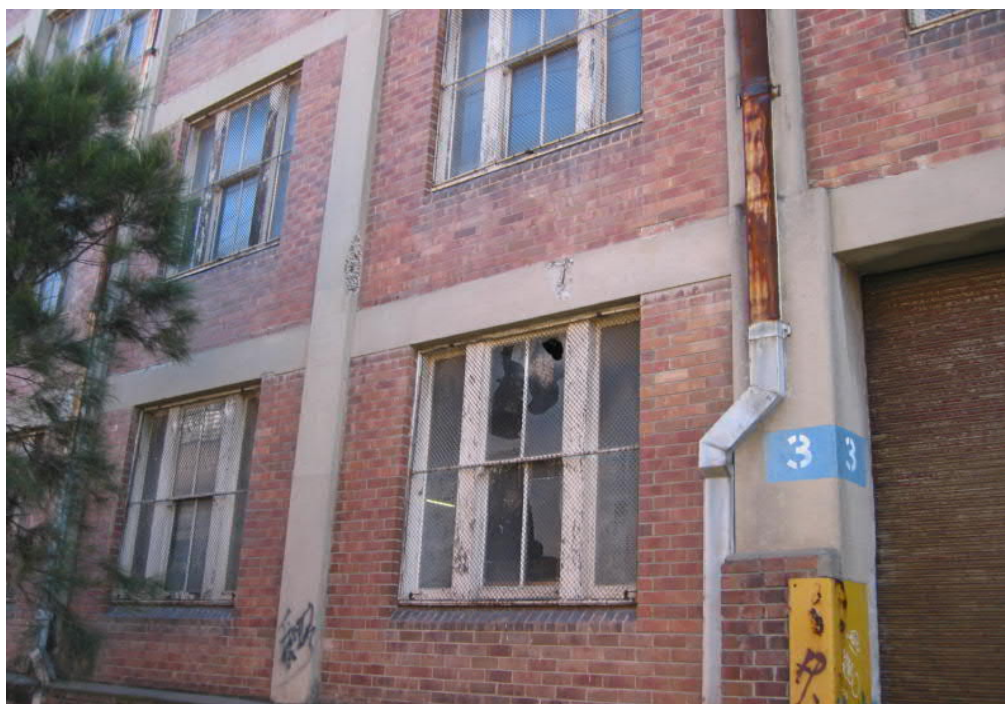
The timber window frames, originally painted have seen very little maintenance since that time. The paint has almost all flaked off and the timber underneath has greyed with age and exposure. Some windows show evidence of dry rot, particularly along sills though very few have holes exposed or are visibly coming apart.

Figure 41: Western Facade of AML&F Building from Milford Street; note smashed windows, dry rot to sills, and rusted downpipes.

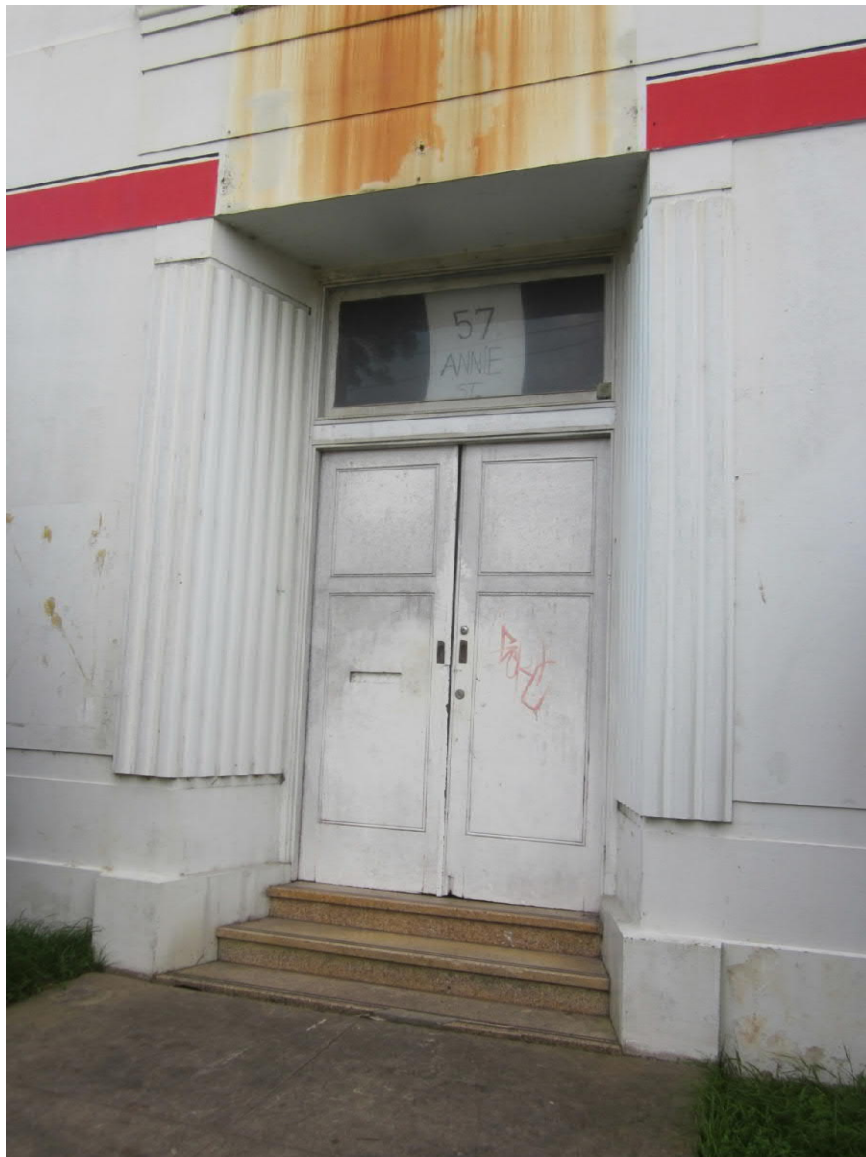
The primary entrance doors to the AML&F building are heavy timber sliding doors which have a deadlock catch. They appear to be sagging somewhat on the runners and form an uneven gap at the meeting stile of the two door leaves making locking and unlocking difficult.

The main entrance doors to the other buildings are of similar configuration and condition.

Figure 42: Main entrance (sliding) doors to AML&F building

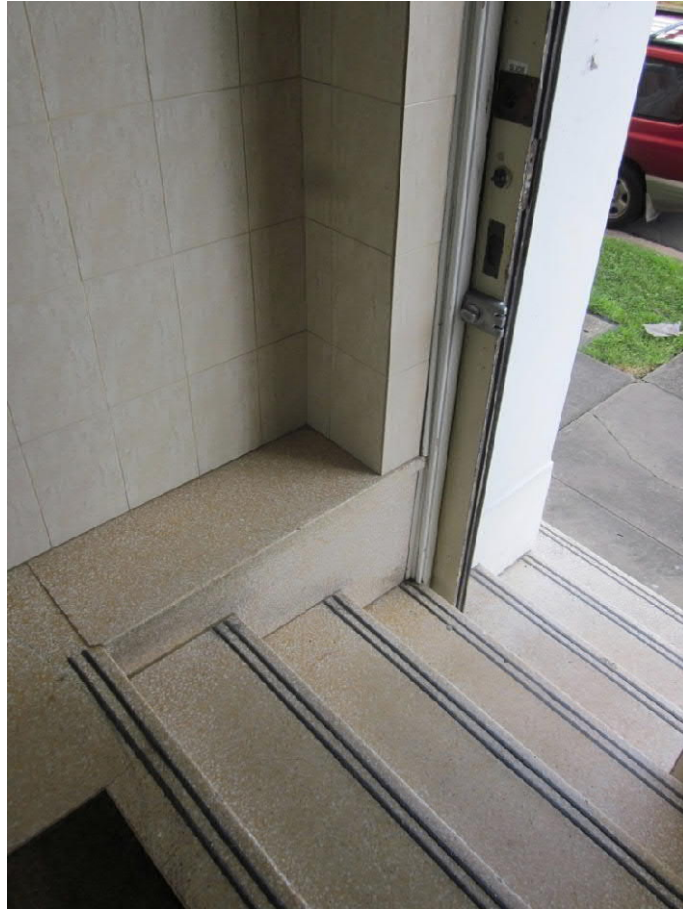
Figure 43: Inside the Annie Street Entrance door of one of the Woolstores. Note the main doors slide into the wall either side of the doorway.

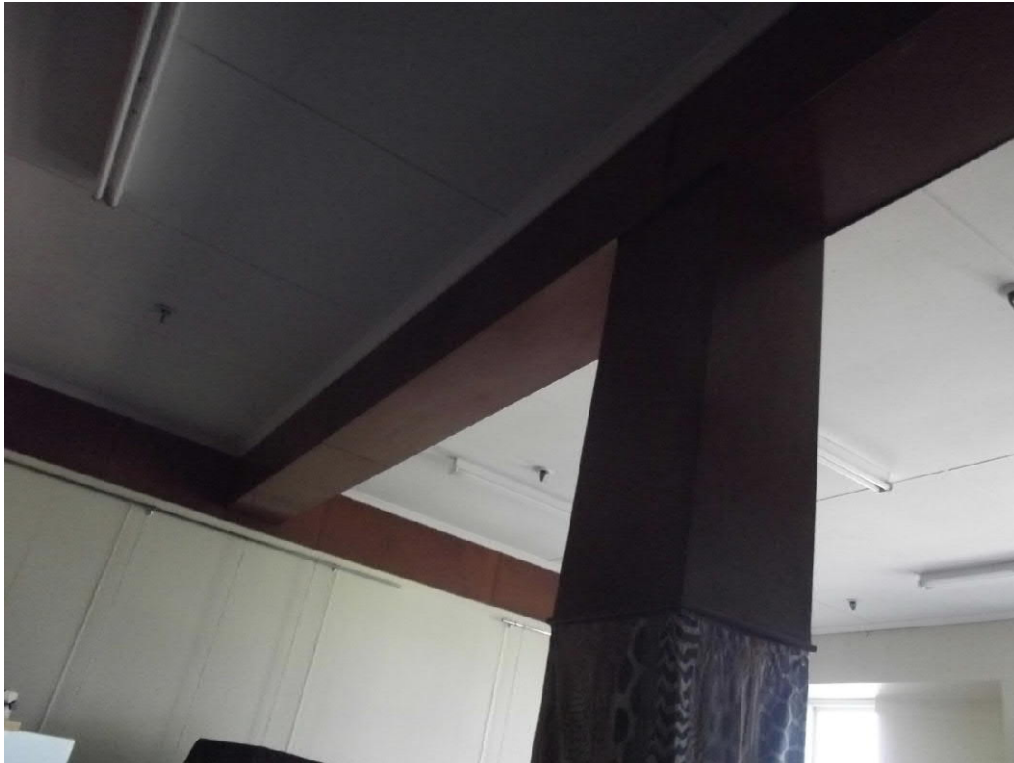
Figure 45: One of the rare ceilings in the AML&F building in the offices on the third floor. Ceiling appears to be lined with expressed jointed fibre cement. The Bearer and columns have been boxed in and lined with timber panelling.

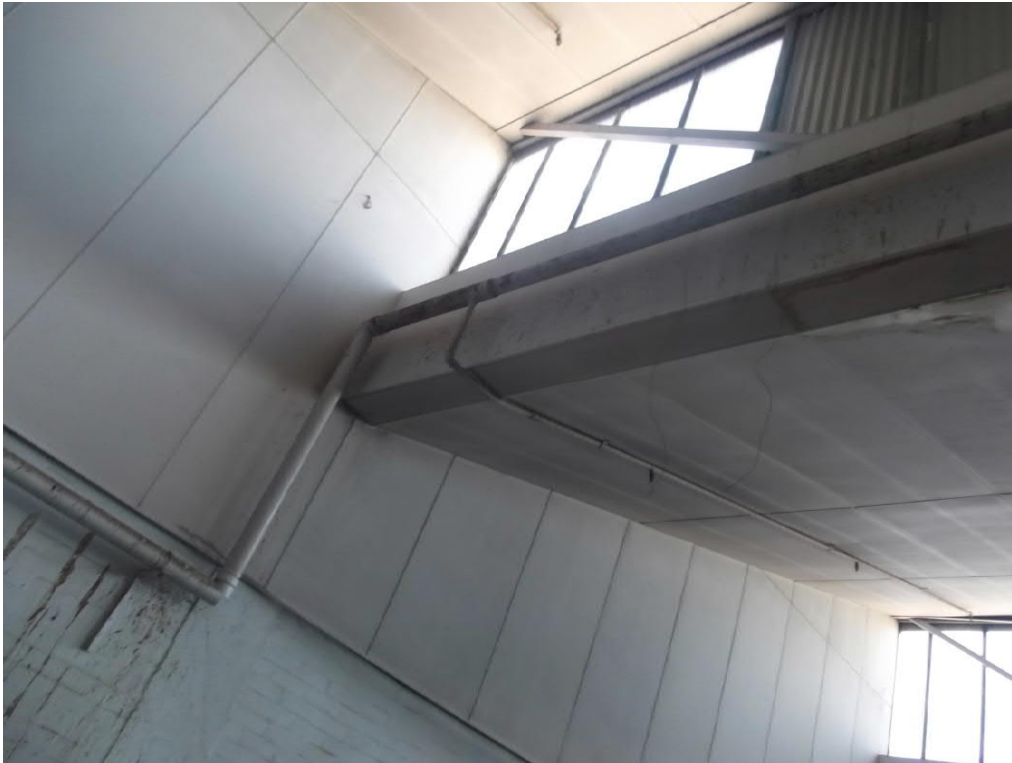
Figure 46: Small section of Sawtooth roof demonstrating internal linings, mixed infill to glazing frames, water leak damage to ceiling (centre right) and existing fire sprinkler services.

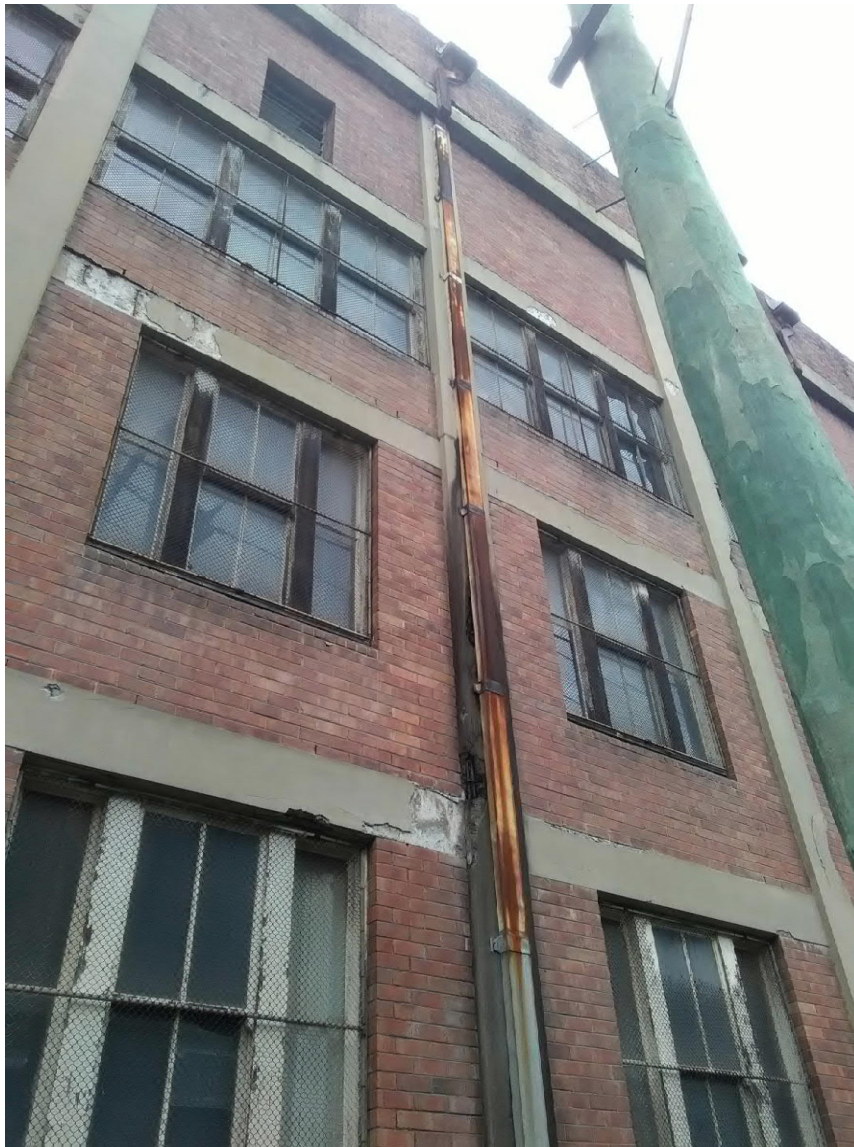
Figure 47: West facade of AML&F building showing rusted rainwater head and downpipe with offset and water staining on the concrete column caused by water escaping the downpipe.

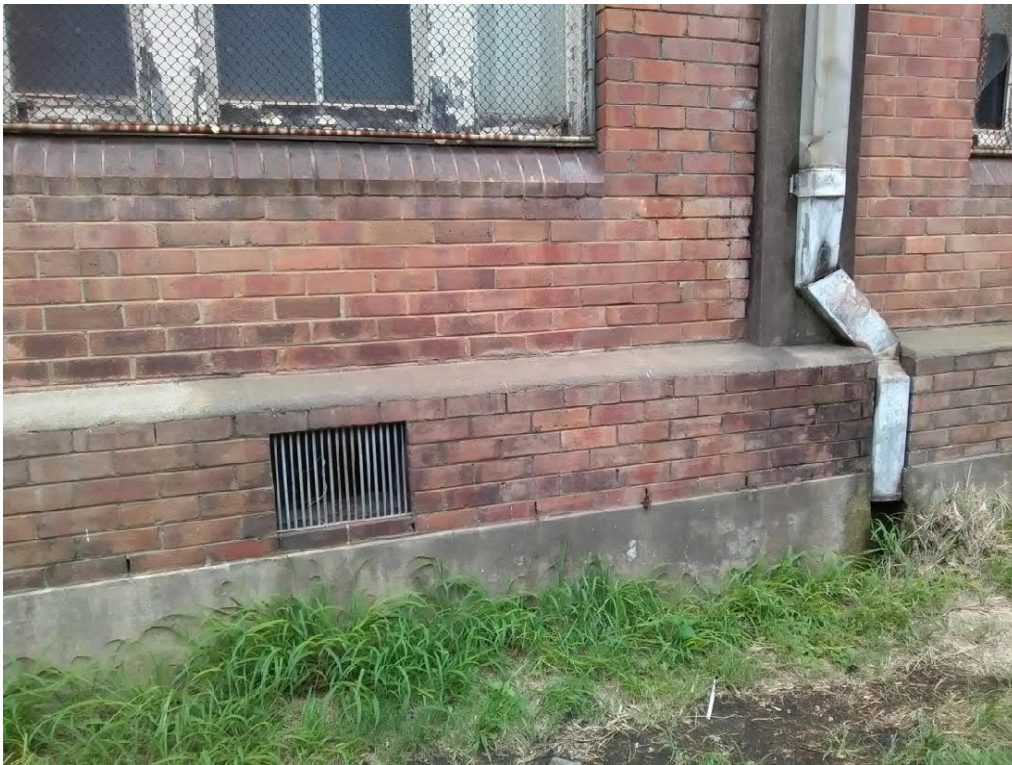
Figure 48: Base of same downpipe showing physical damage to downpipe as well as offset and constriction all contributing to water staining on the column. Downpipe does not appear to be connected to underground services, discharging onto the ground adjacent to the building's footings.

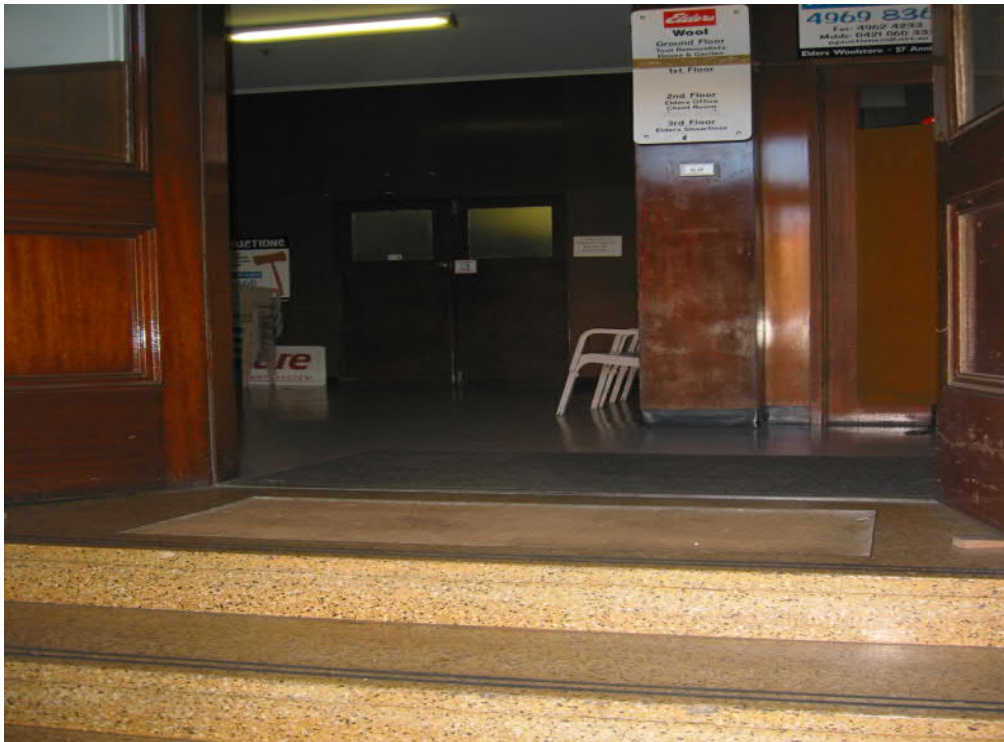
Figure 49: Main Entrance to the AML&F building, with timber panelling and vinyl floor covering. Note the terrazzo steps with integrated mat well.

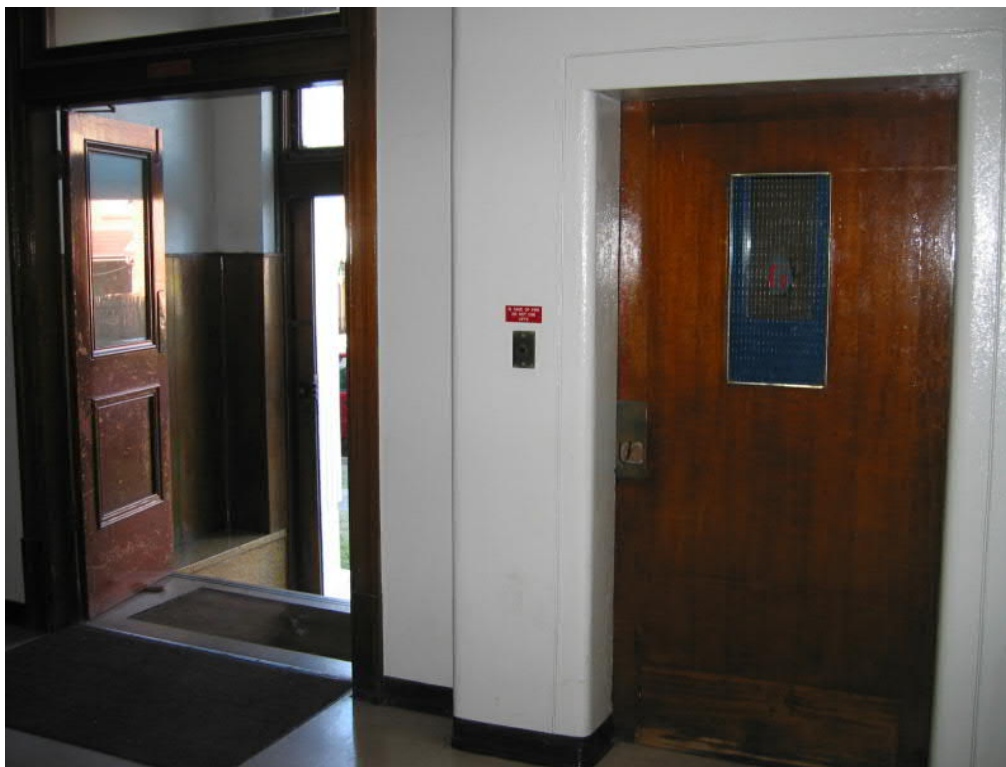
Figure 50: Main Entrance Foyer of the AML&F building, with timber panelling and vinyl floor covering, passenger lift servicing upper floors.

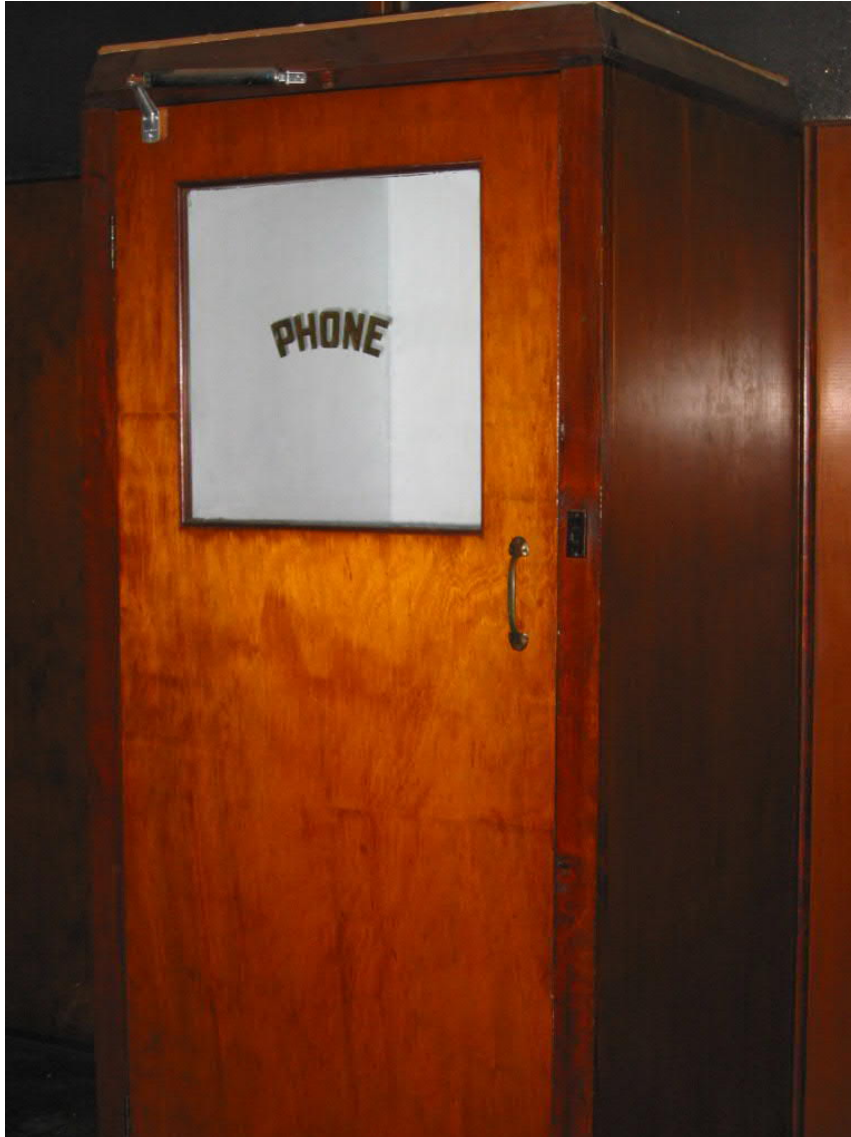
Figure 51: Joinery items such as the timber panelled public phone booth provided for wool buyers punctuate the public spaces of the buildings.
