CONSERVATION MANAGEMENT DOCUMENT

WICKHAM WOOLSTORES

ANNIE STREET, WICKHAM NSW 2293

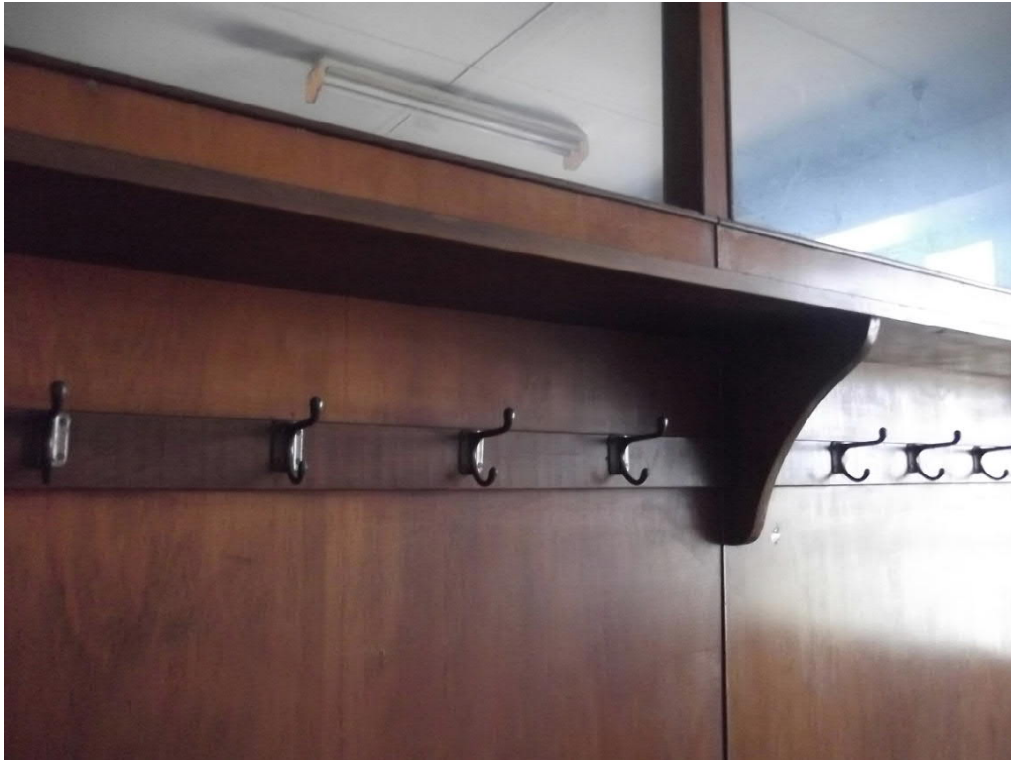
Figure 52: beautiful timber hat and coat rails provided for clients on the third floor of the AML&F building.

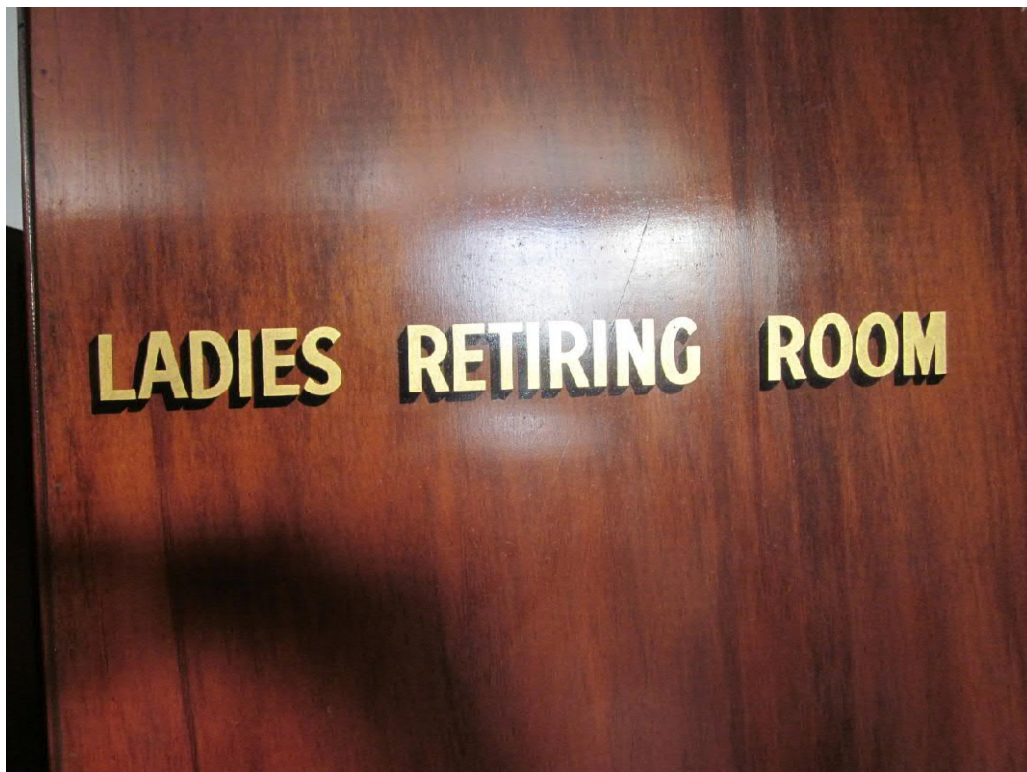
Figure 53: Gold leaf signage appears in numerous places through the public areas of the building.

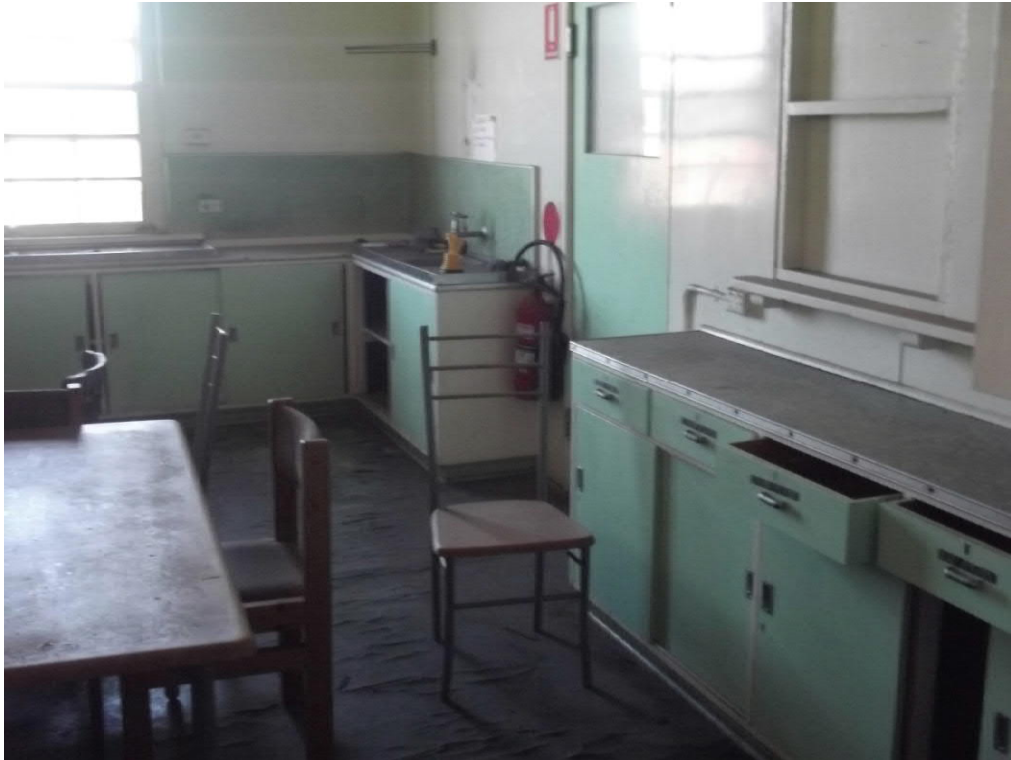
Figure 54: Kitchen on Level 3 of the AML&F Building sits between two dining rooms, the larger of which bears the signage 'Wool buyers only'

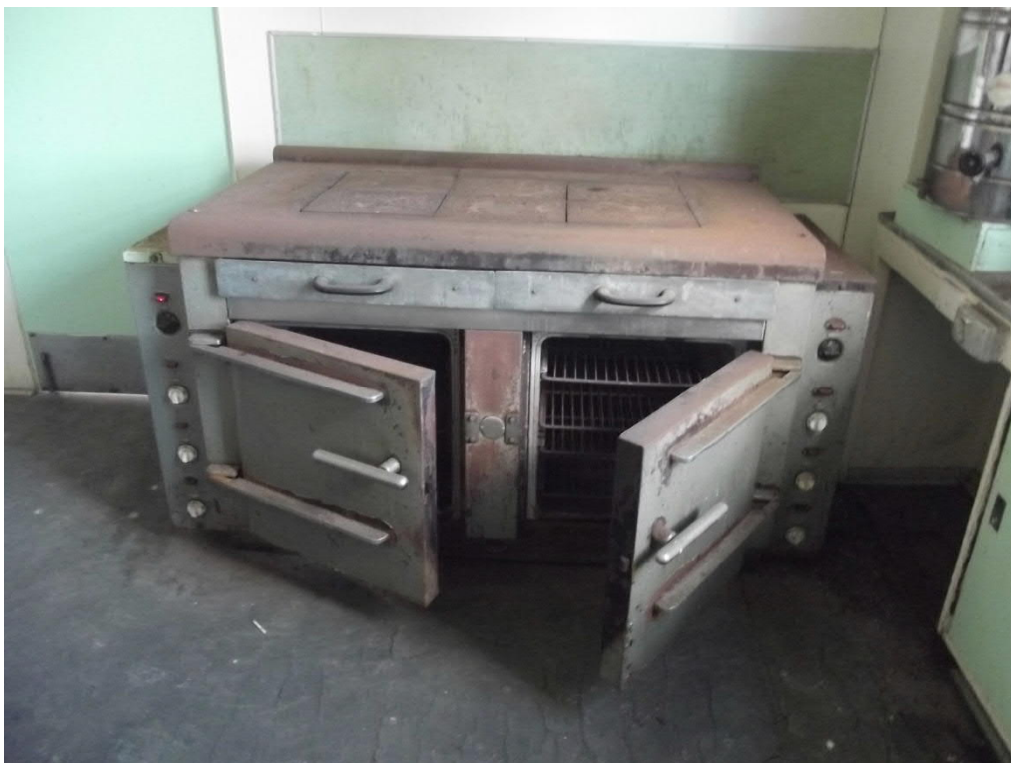
Figure 55: The large range in the kitchen of the AML&F building is connected to electrical power and has an equally large range hood above.

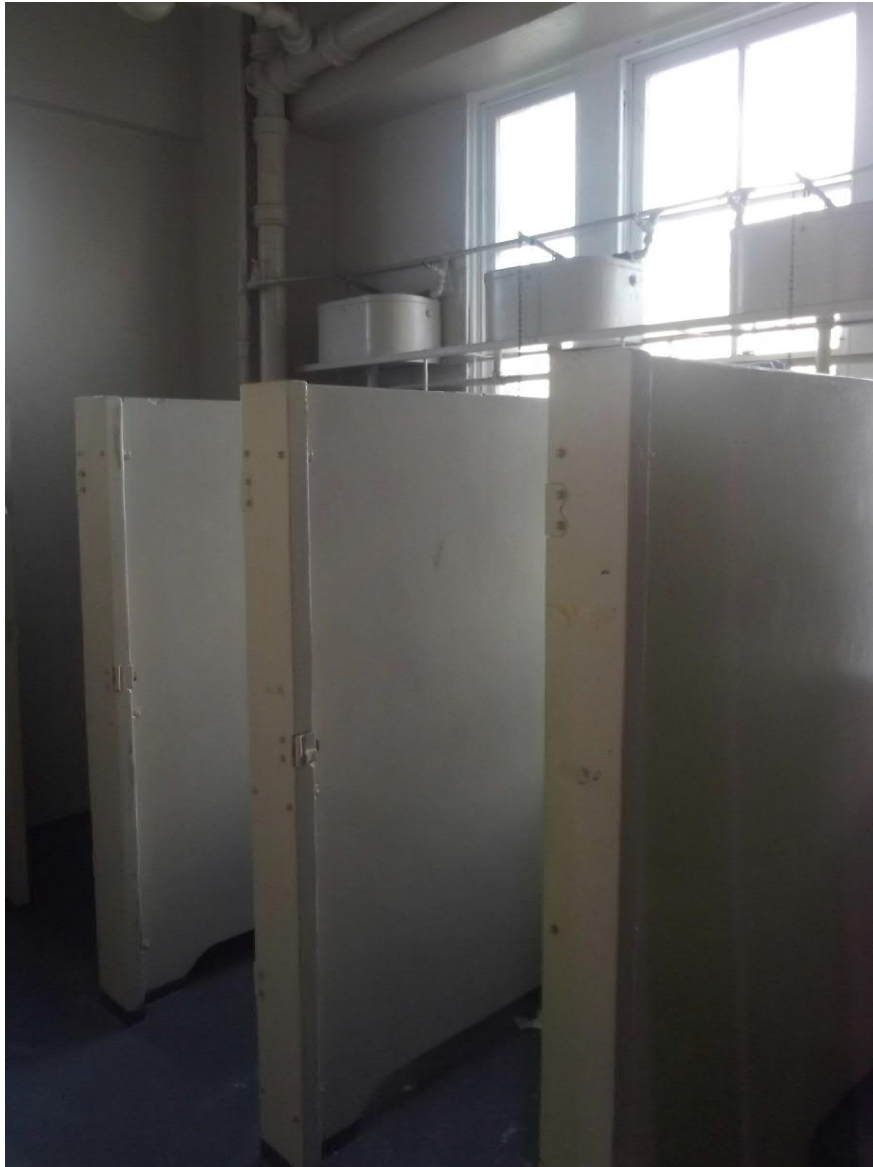
Figure 56: Amenities on ground floor of AML&F building display timber partitions and elevated cisterns. Level 3 amenities have terrazzo partitions which were likely to be an upgrade for the level that wool buyers would have frequented. Low level cisterns which extant on level 3 were probably installed in the 1980s.

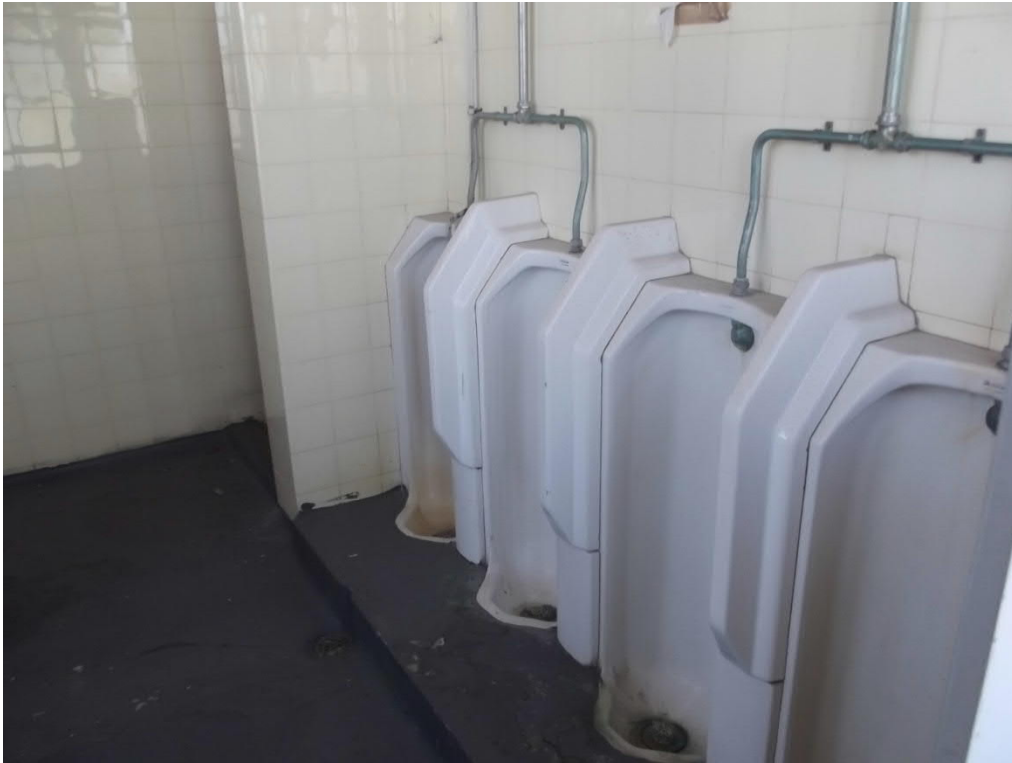
Figure 57: Porcelain Urinals throughout are almost certainly original fitments.

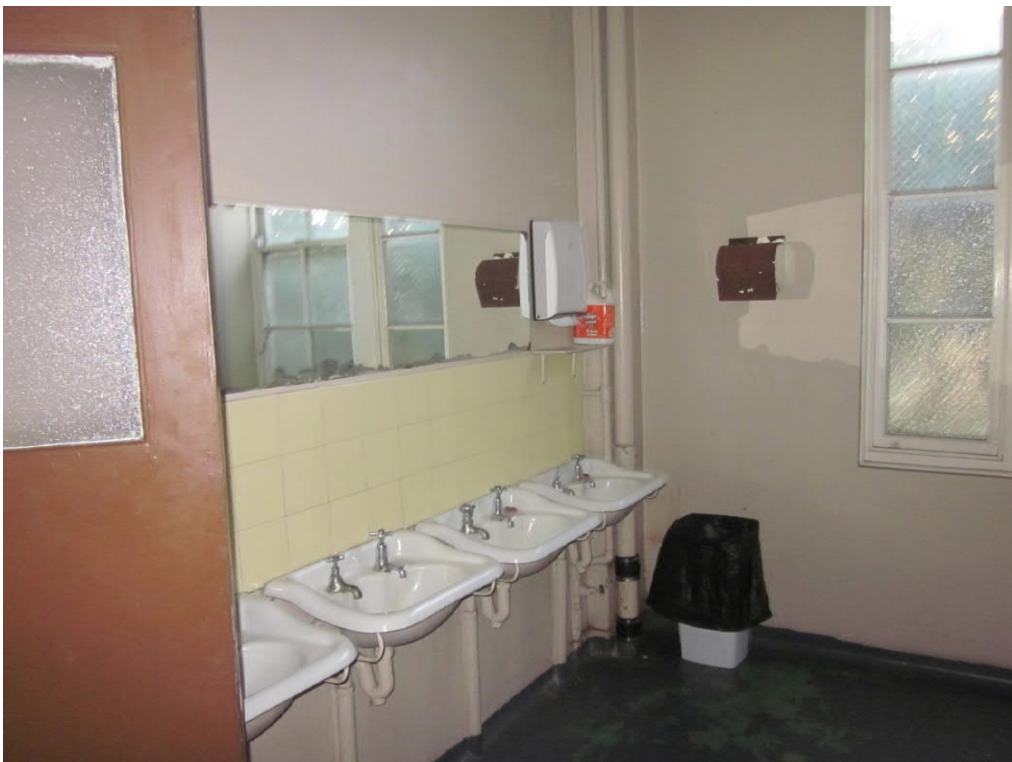
Figure 58: Washbasins throughout are also expected to be original fitments.

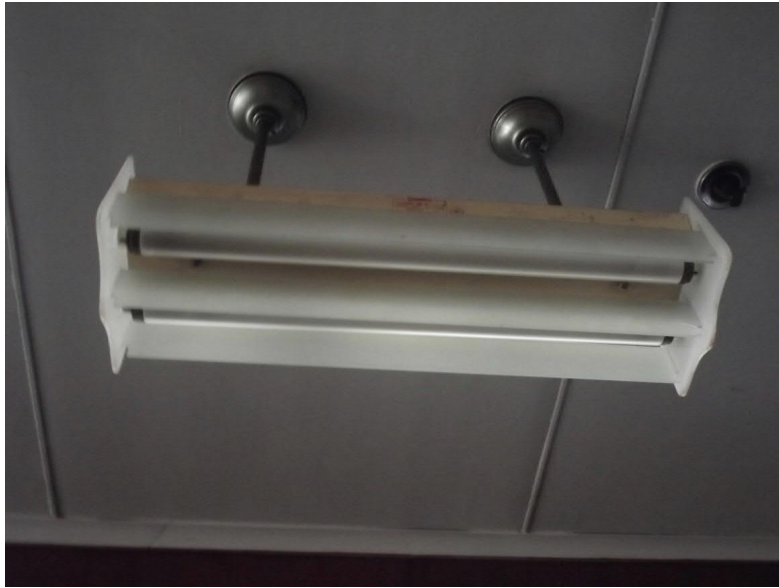
Figure 59: In various locations exist electrical fittings and switchgear which date back to the earliest days of the building.

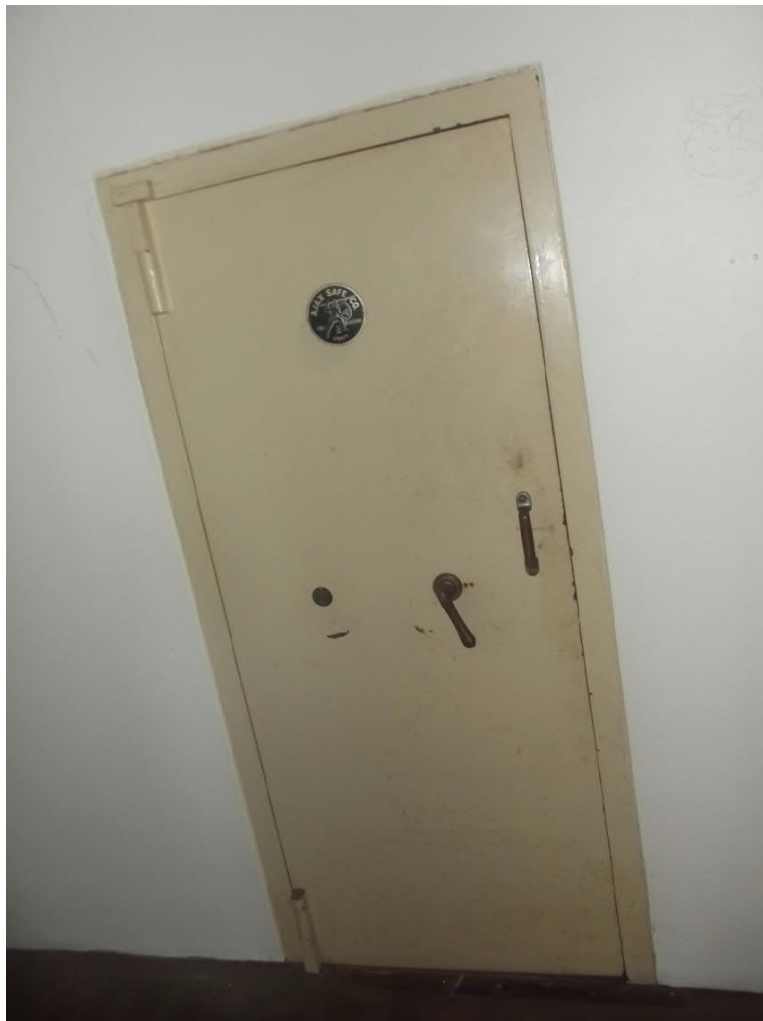
Figure 60: In the ground floor office of the AML&F building is a fully built-in safe.

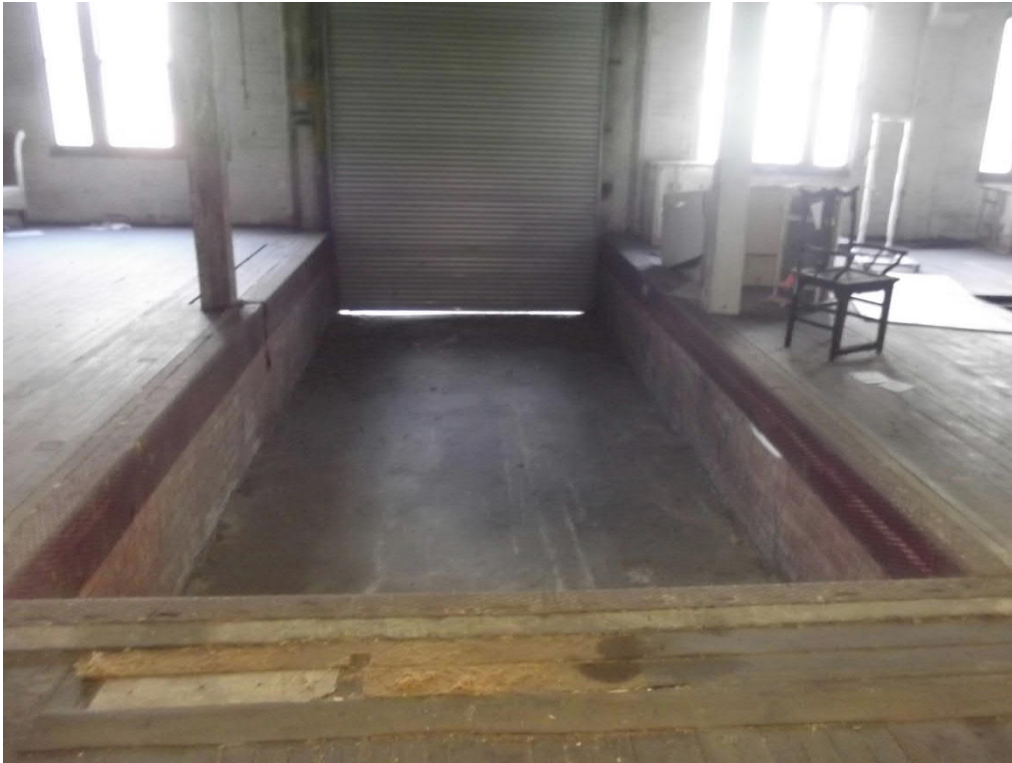
Figure 61: Loading Docks sunken below the floor level and fronted by roller doors demonstrate how wool bales arrived at and left the buildings. Some examples have been fitted with ramps up to the floor level.

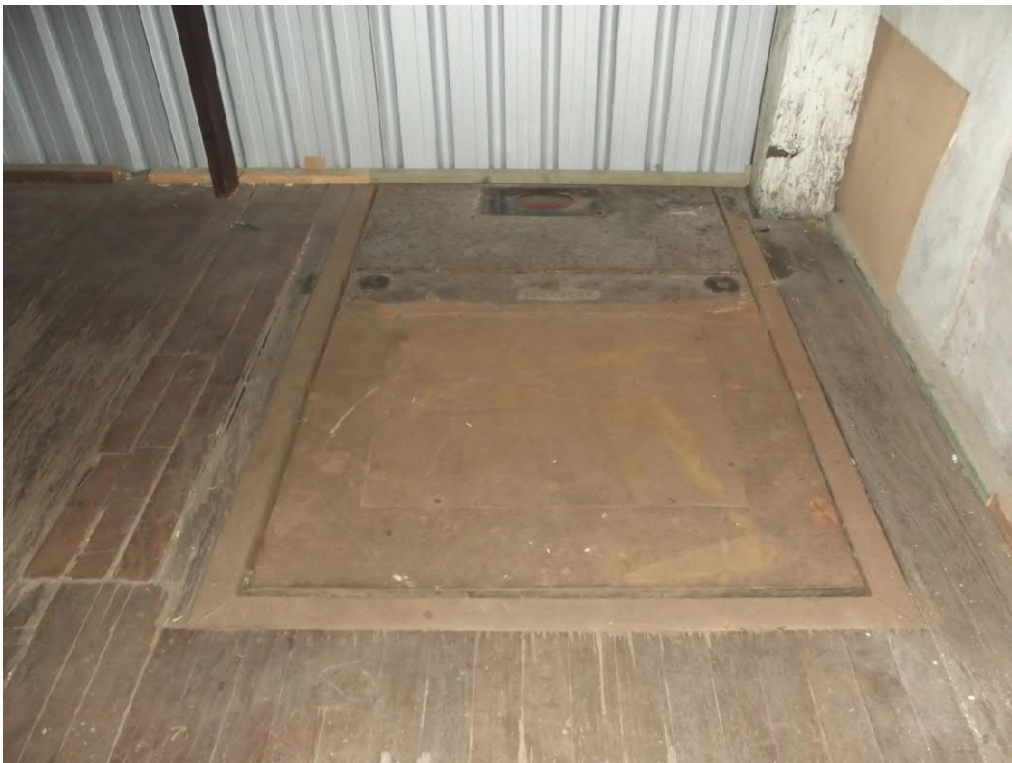
Figure 62: Trapdoors in the floor link between levels and to shafts demonstrate elements of the operation of the buildings.

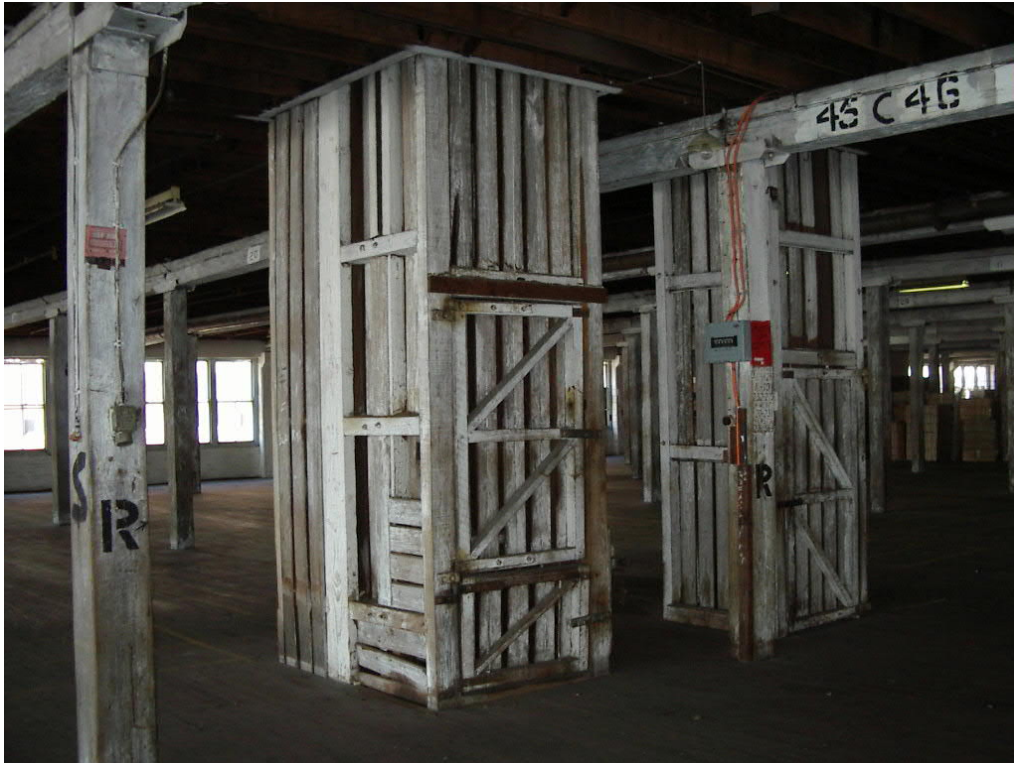
Figure 63: Wool Drops link most levels and demonstrate the operation of the buildings. They are constructed of heavy timbers with thick steel hinges and catches.

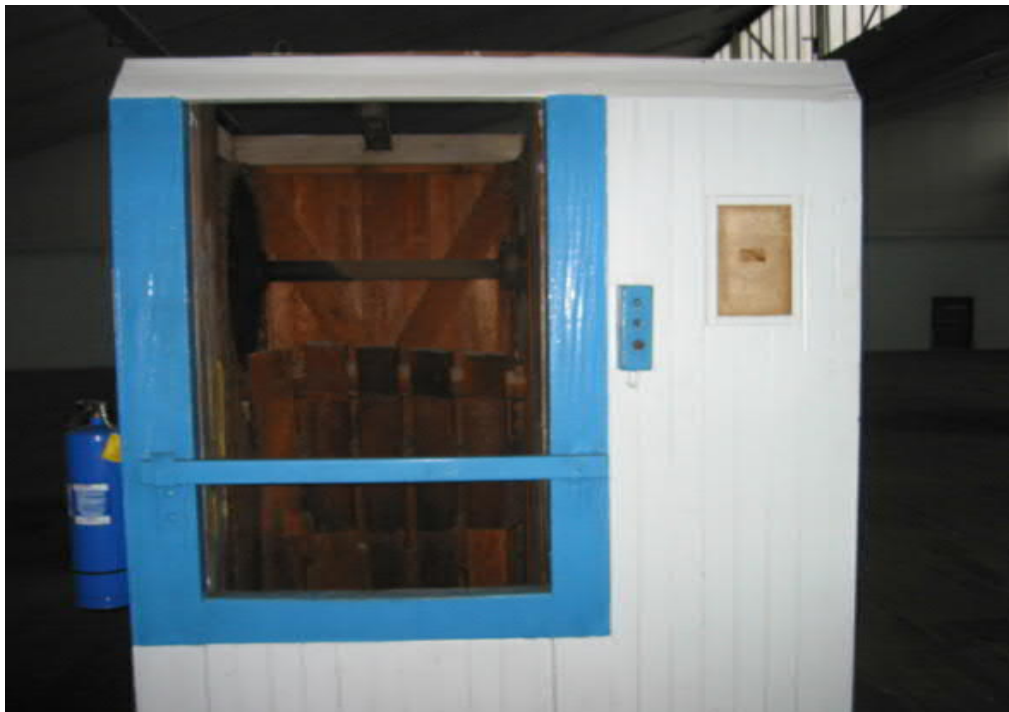
Figure 64: On level 4 some Wool drops are distinguished by having winch mechanisms with painted casings.

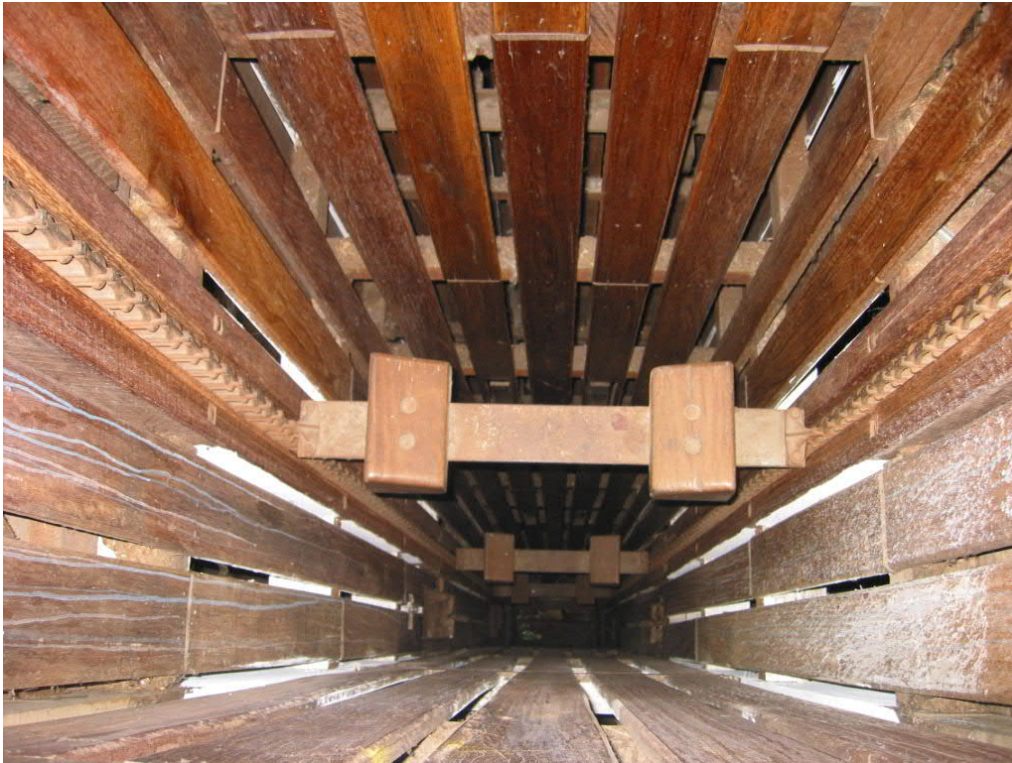
Figure 65: Winch mechanisms can be discovered inside some of the drop shafts.

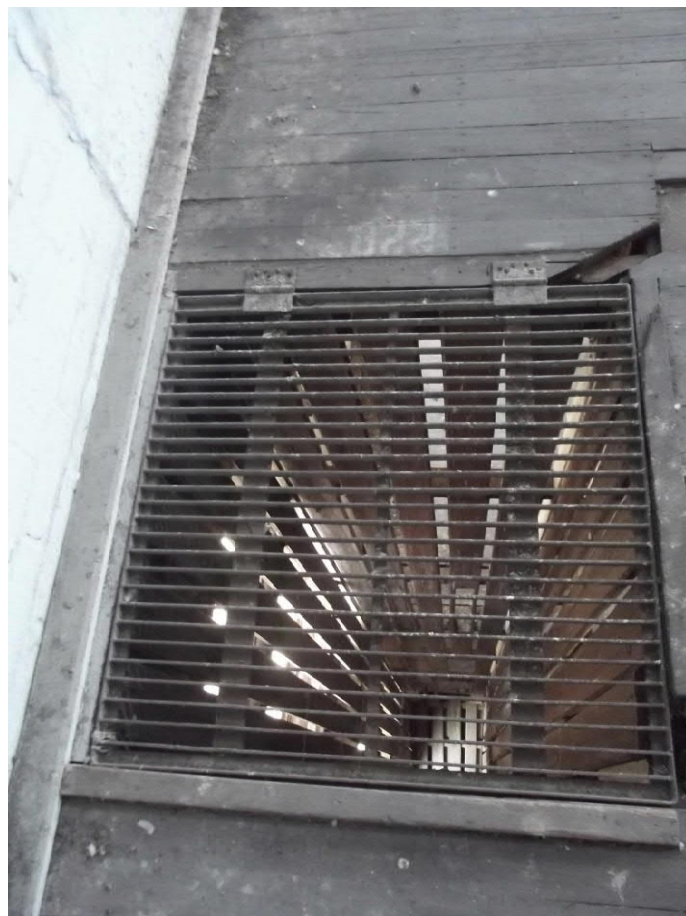
Figure 66: Other Wool drops, clearly only for dropping only have trapdoors on level 4.

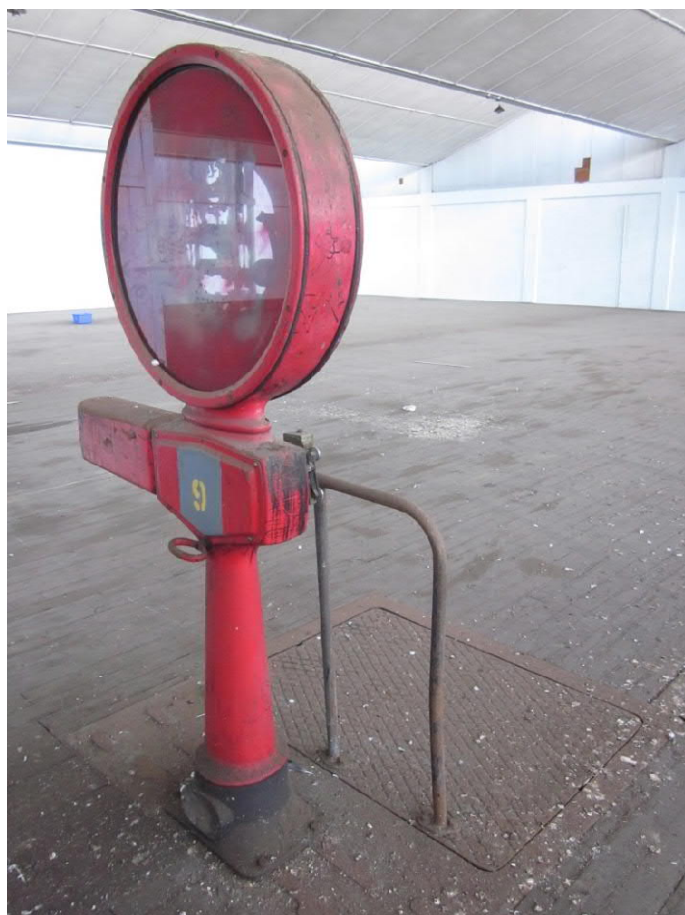
Figure 67: Weighing Scales are located in a few positions in the NZLMA building and should be retained for interpretation.

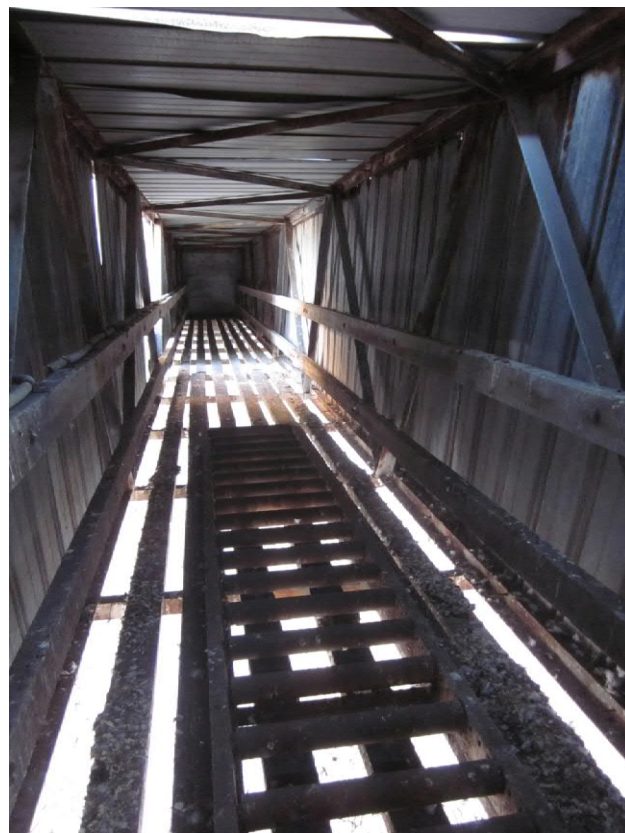
Figure 69: Chutes and bridges to other buildings will need to be removed for building compliance reasons, however provide an interesting perspective on the former operation of the woolstores.

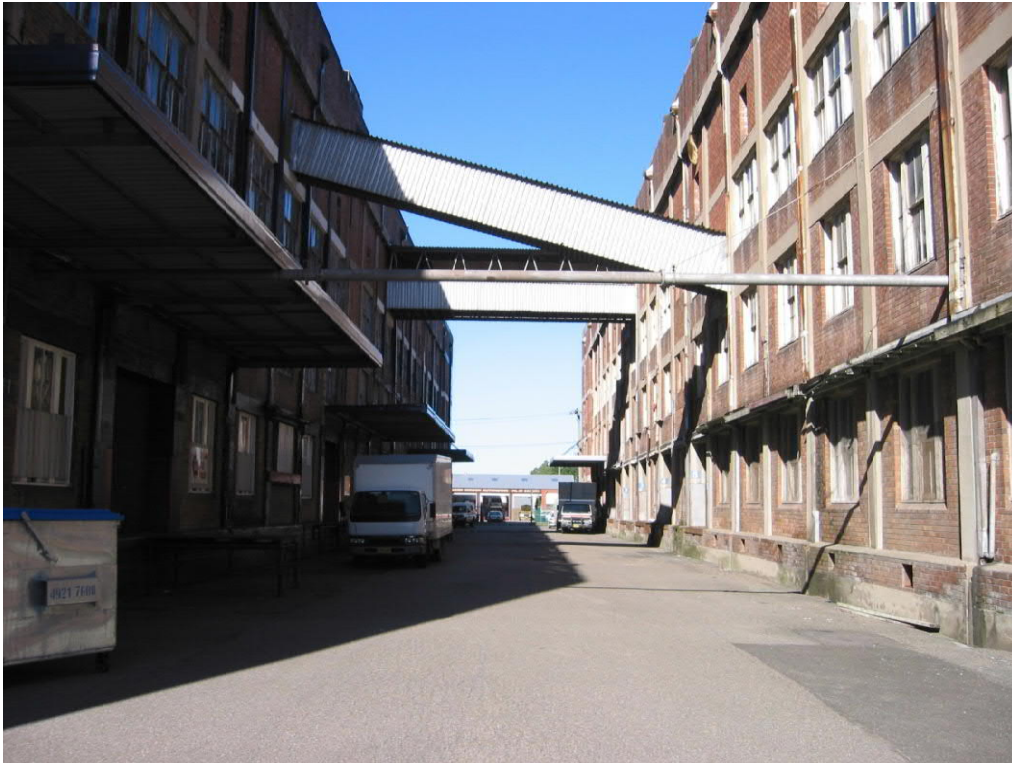
Figure 70: A wool bale chute and covered walkway link the AML&F wool store at right with the Dalgety wool store at left. An overhead water pipe which appears to be part of the fire sprinkler system is also evident.
