Report on  
Preliminary Site Investigation (Contamination)

Proposed Tourist Development  
Lot 22 Palmers Road, Pokolbin

Prepared for  
Hephzibah Hunter Valley Property Pty Ltd

Project 81850.02  
September 2017

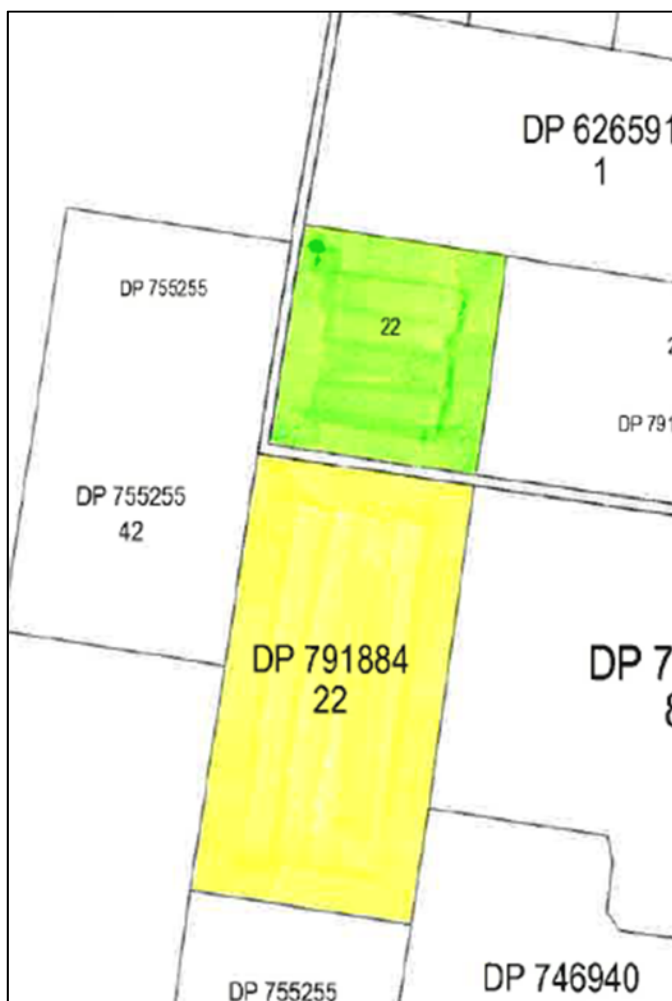
Figure 4: Key to historic title search

A historic title deeds search was carried out by Scott Ashwood Pty Ltd, the results of which are provided in Appendix B and summarised in Table 1 below. The results of the search indicated that different parts of the site have a different ownership history (refer Figure 4).

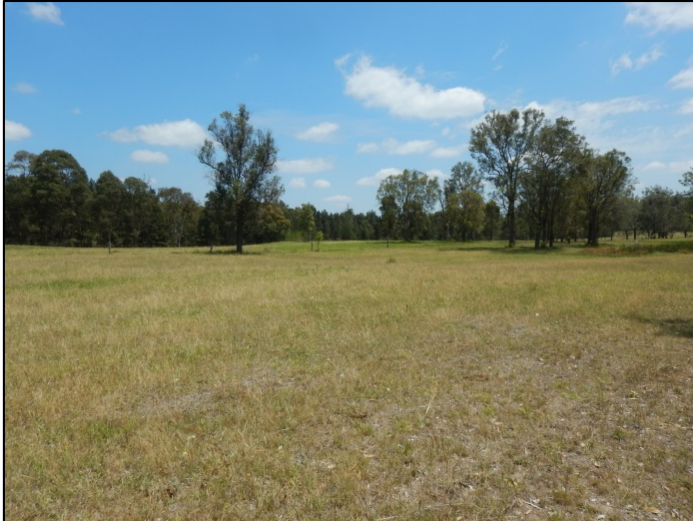
**Figure 5: Typical view of site**

- The majority of the site is typically grass covered with scattered trees (refer Figure 5);

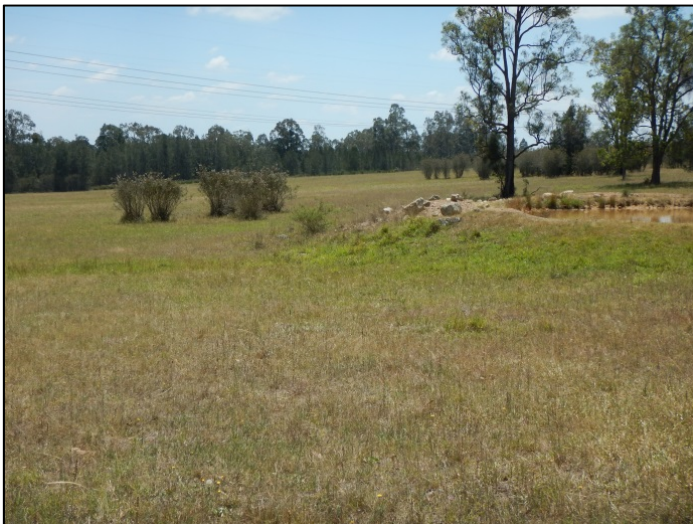
**Figure 6: Existing dam on site**

- A stand of dense forest is present within the central and eastern part of the site;
- Several small dams are present within the site which appear to have been created by local cut and fill operations (refer Figure 6);

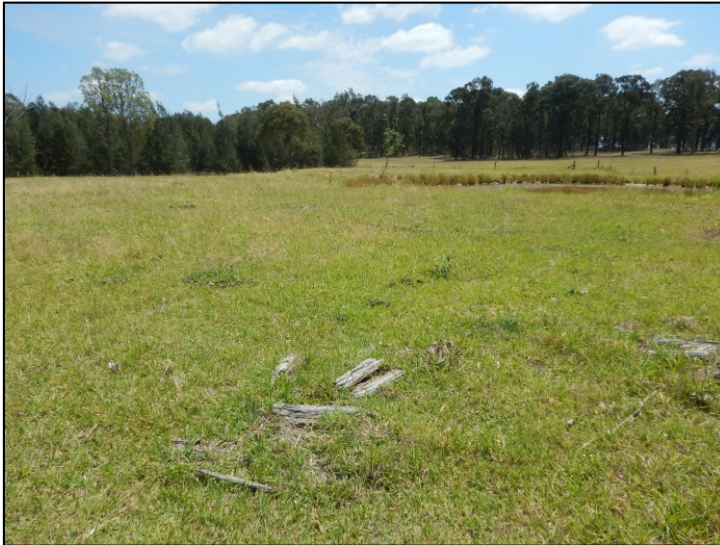
**Figure 7: Timber visible in surficial filling associated with dam**

- Some timber was observed within the embankment filling associated with the southernmost dam (refer Figure 7);

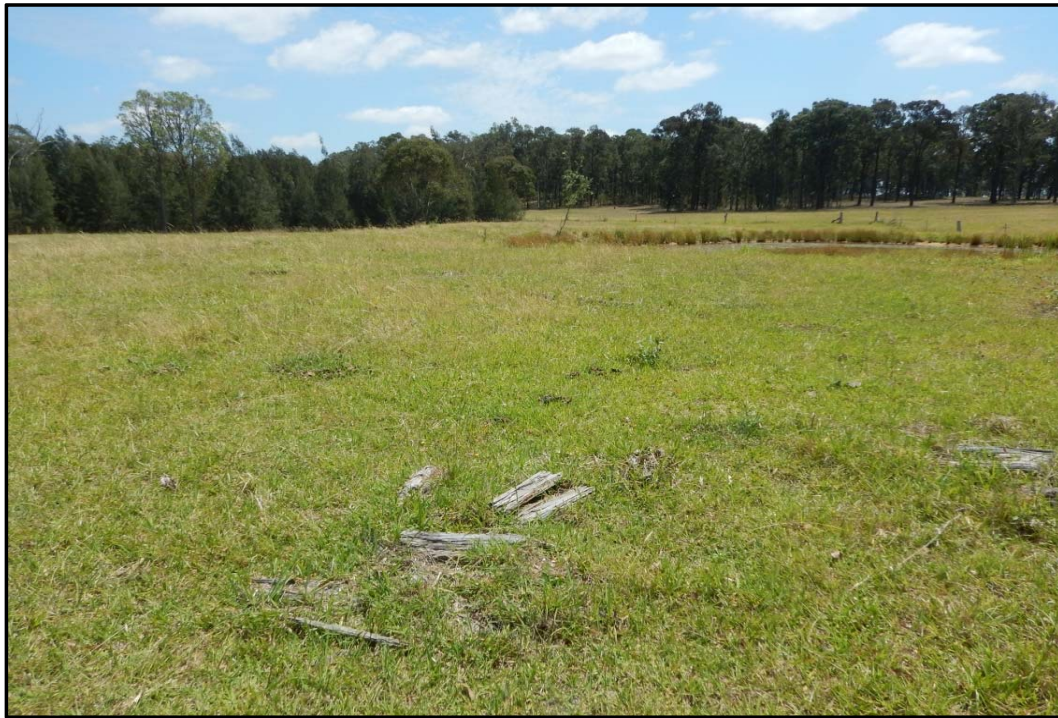
**Photo 3: Timber exposed in surficial filling**
