ARBORICULTURAL IMPACT ASSESSMENT REPORT

**648 – 652 Princes Highway & 1 – 3 Ashton Street
Rockdale**

12th December 2017

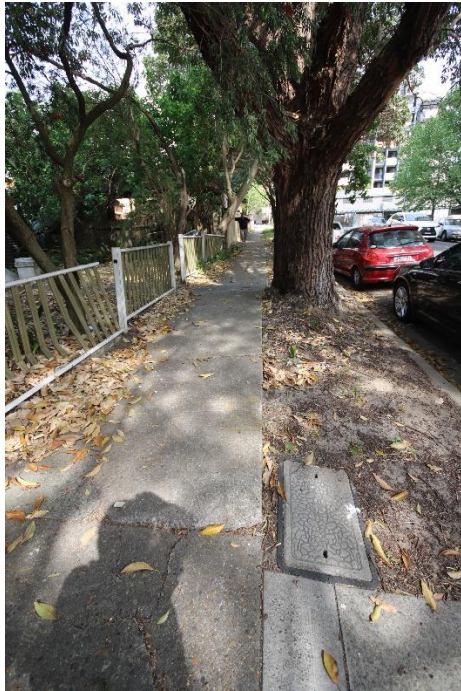
Plate 1 footpath beside tree 2

1. Tree 1, 2, 3 & 4 *Lophostemon confertus* show good vitality and are located in the nature strip in Ashton Street. The development works have an encroachment of 8.6% (tree 1), 20.8% (tree 2), 15.1% (tree 3) & 6.8% (tree 4) within these trees TPZ. The encroachment is considered acceptable as the existing structures have limited root growth into the site, thus limiting potential root disturbance. In addition, no canopy pruning is required to undertake the development works. Care will need to be exercised when re-doing the concrete footpaths along Ashton Street as the root crown and roots of these valuable street trees have heaved the existing footpaths – refer plate 1 & 2. Note these trees for retention and protection in the Tree Management Plan (TMP);

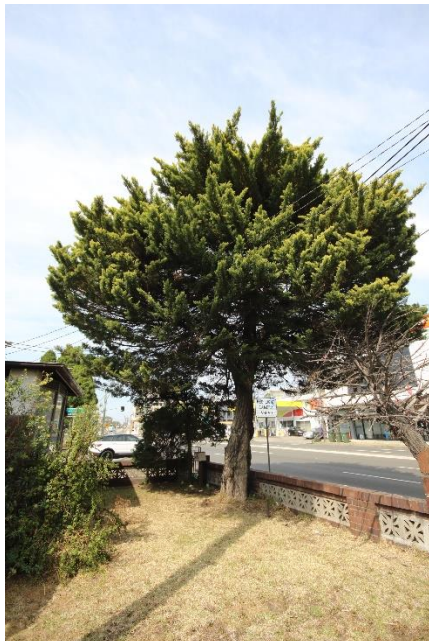
Plate 3 – tree 20

10. Tree 20 *Cupressus macrocarpa Brunniana* shows good vitality with previous lower branch pruning – refer plate 3. This tree is within the proposed commercial premises and will require removal to allow the development to proceed. Removal is supported as there are over 20 trees being replanted on site to compensate for the loss of this tree. Note for removal in the TMP;

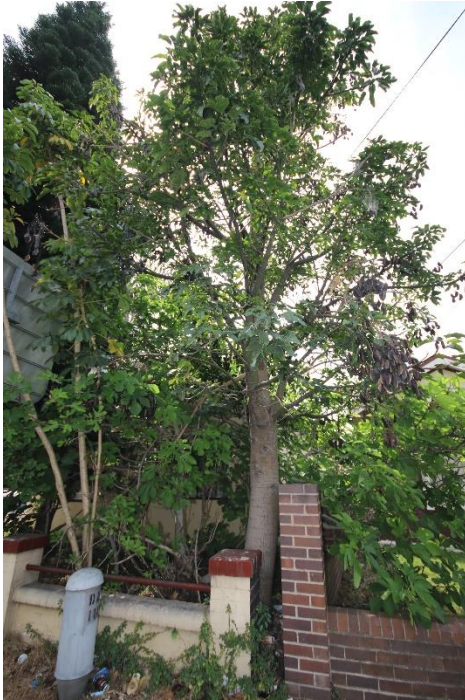
Plate 4 – tree 22, 23 & 24

11. Tree 22 *Brachychiton acerifolius* shows good vitality and form – refer plate 3. This tree is within the proposed commercial premises and will require removal to allow the development to proceed. Removal is supported as there are over 20 trees being replanted on site to compensate for the loss of this tree. Note for removal in the TMP;

12. Tree 24 & 27 *Schefflera actinophylla* show good vitality. These trees are considered to be of low landscape significance with tree 24 (refer plate 4) being within the footprint of the commercial premises and tree 27 (refer plate 5) located within the garden at the corner of Ashton Street and the Princes Highway. Removal of both trees is supported to allow the construction of the commercial premises and to provide space for replanting of more appropriate plants at the corner of Ashton Street and the Princes Highway. Note for removal in the TMP;

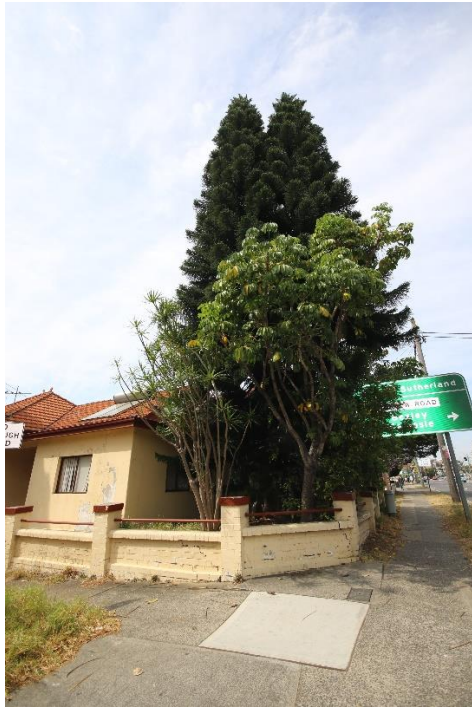
Plate 5 – tree 26 & 27

14. Tree 26 *Araucaria columnaris* shows good vitality, with typical twin leaders from mid canopy – refer plate 5. This tree has an encroachment within its TPZ of over 60% - refer Annexure C. It is acknowledged this tree is within the building footprint and will need to be removed to allow the development to proceed. Removal is supported as there are over 20 trees being replanted on site to compensate for the loss of this tree. Note for removal in the TMP;

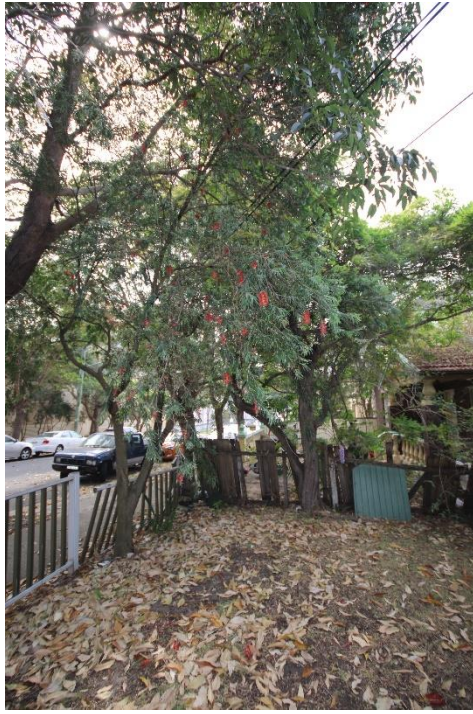
Plate 6 – tree 29 & 28

15. Tree 28 *Leptospermum petersonii* shows fair vitality but with Wisteria entwined in the upper canopy spoiling its form – refer plate 6. No amount of horticultural care would restore this tree to long term good form and vitality. Removal is supported with replacement tree planting in the landscape works – refer Annexure C. Note this tree for removal in the TMP;

16. Tree 29 *Callistemon viminalis* shows fair vitality – refer plate 6. This tree is of low landscape significance and is recommended for removal as over 20 trees will be replanted on site to compensate for the removal of this tree – refer Annexure C. Note for removal in the TMP;

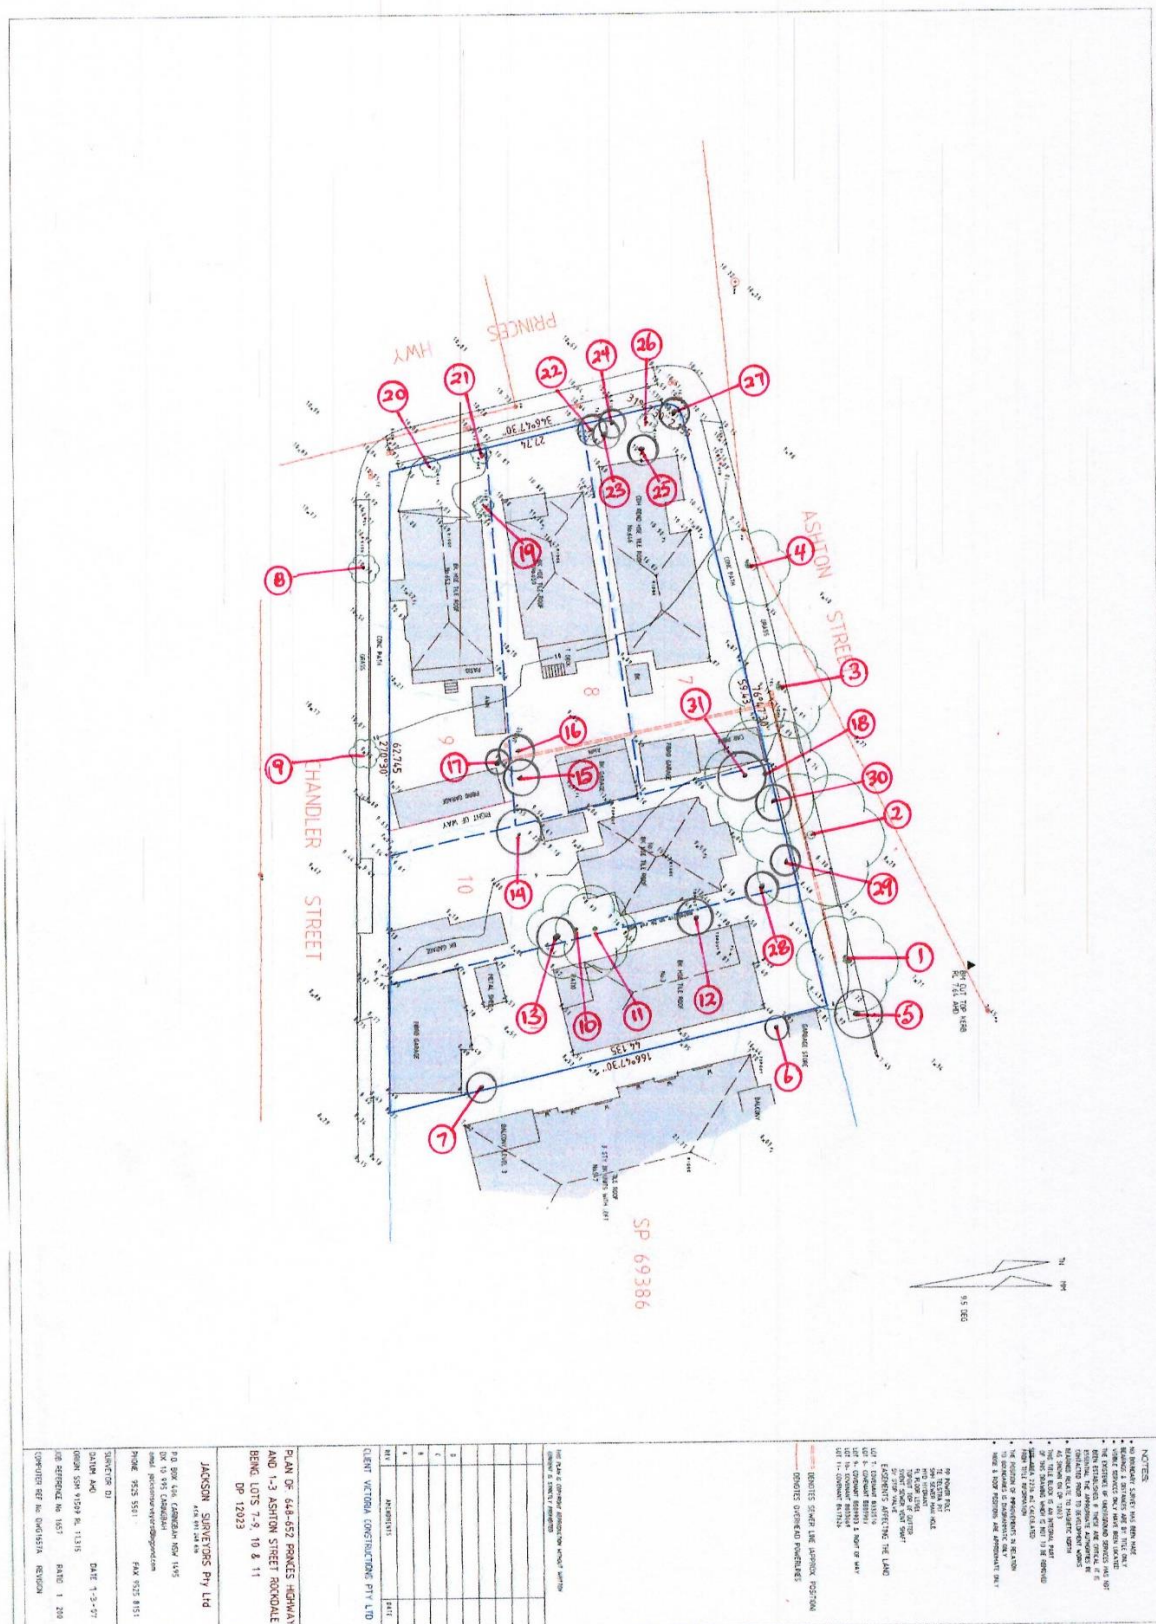
Annexure B: Tree location plan

- 1.7 The subject trees were located on plans supplied. The trees have been plotted and can be found on Annexure B – Tree Location Plan.
- 1.8 The trees were identified and their genus species and common name used. The trees were identified by the use of data collected and compared to G Burnie, S Forrester et al (1997) **Botanica** Random House, Milsons Point, NSW, Australia.
