**ADDITIONAL ENVIRONMENTAL SITE ASSESSMENT
AND REMEDIAL ACTION PLAN**

PROPOSED COMMERCIAL DEVELOPMENT

**950 PACIFIC HIGHWAY AND 2 BRIDGE STREET,
PYMBLE, NSW**

26 NOVEMBER 2018

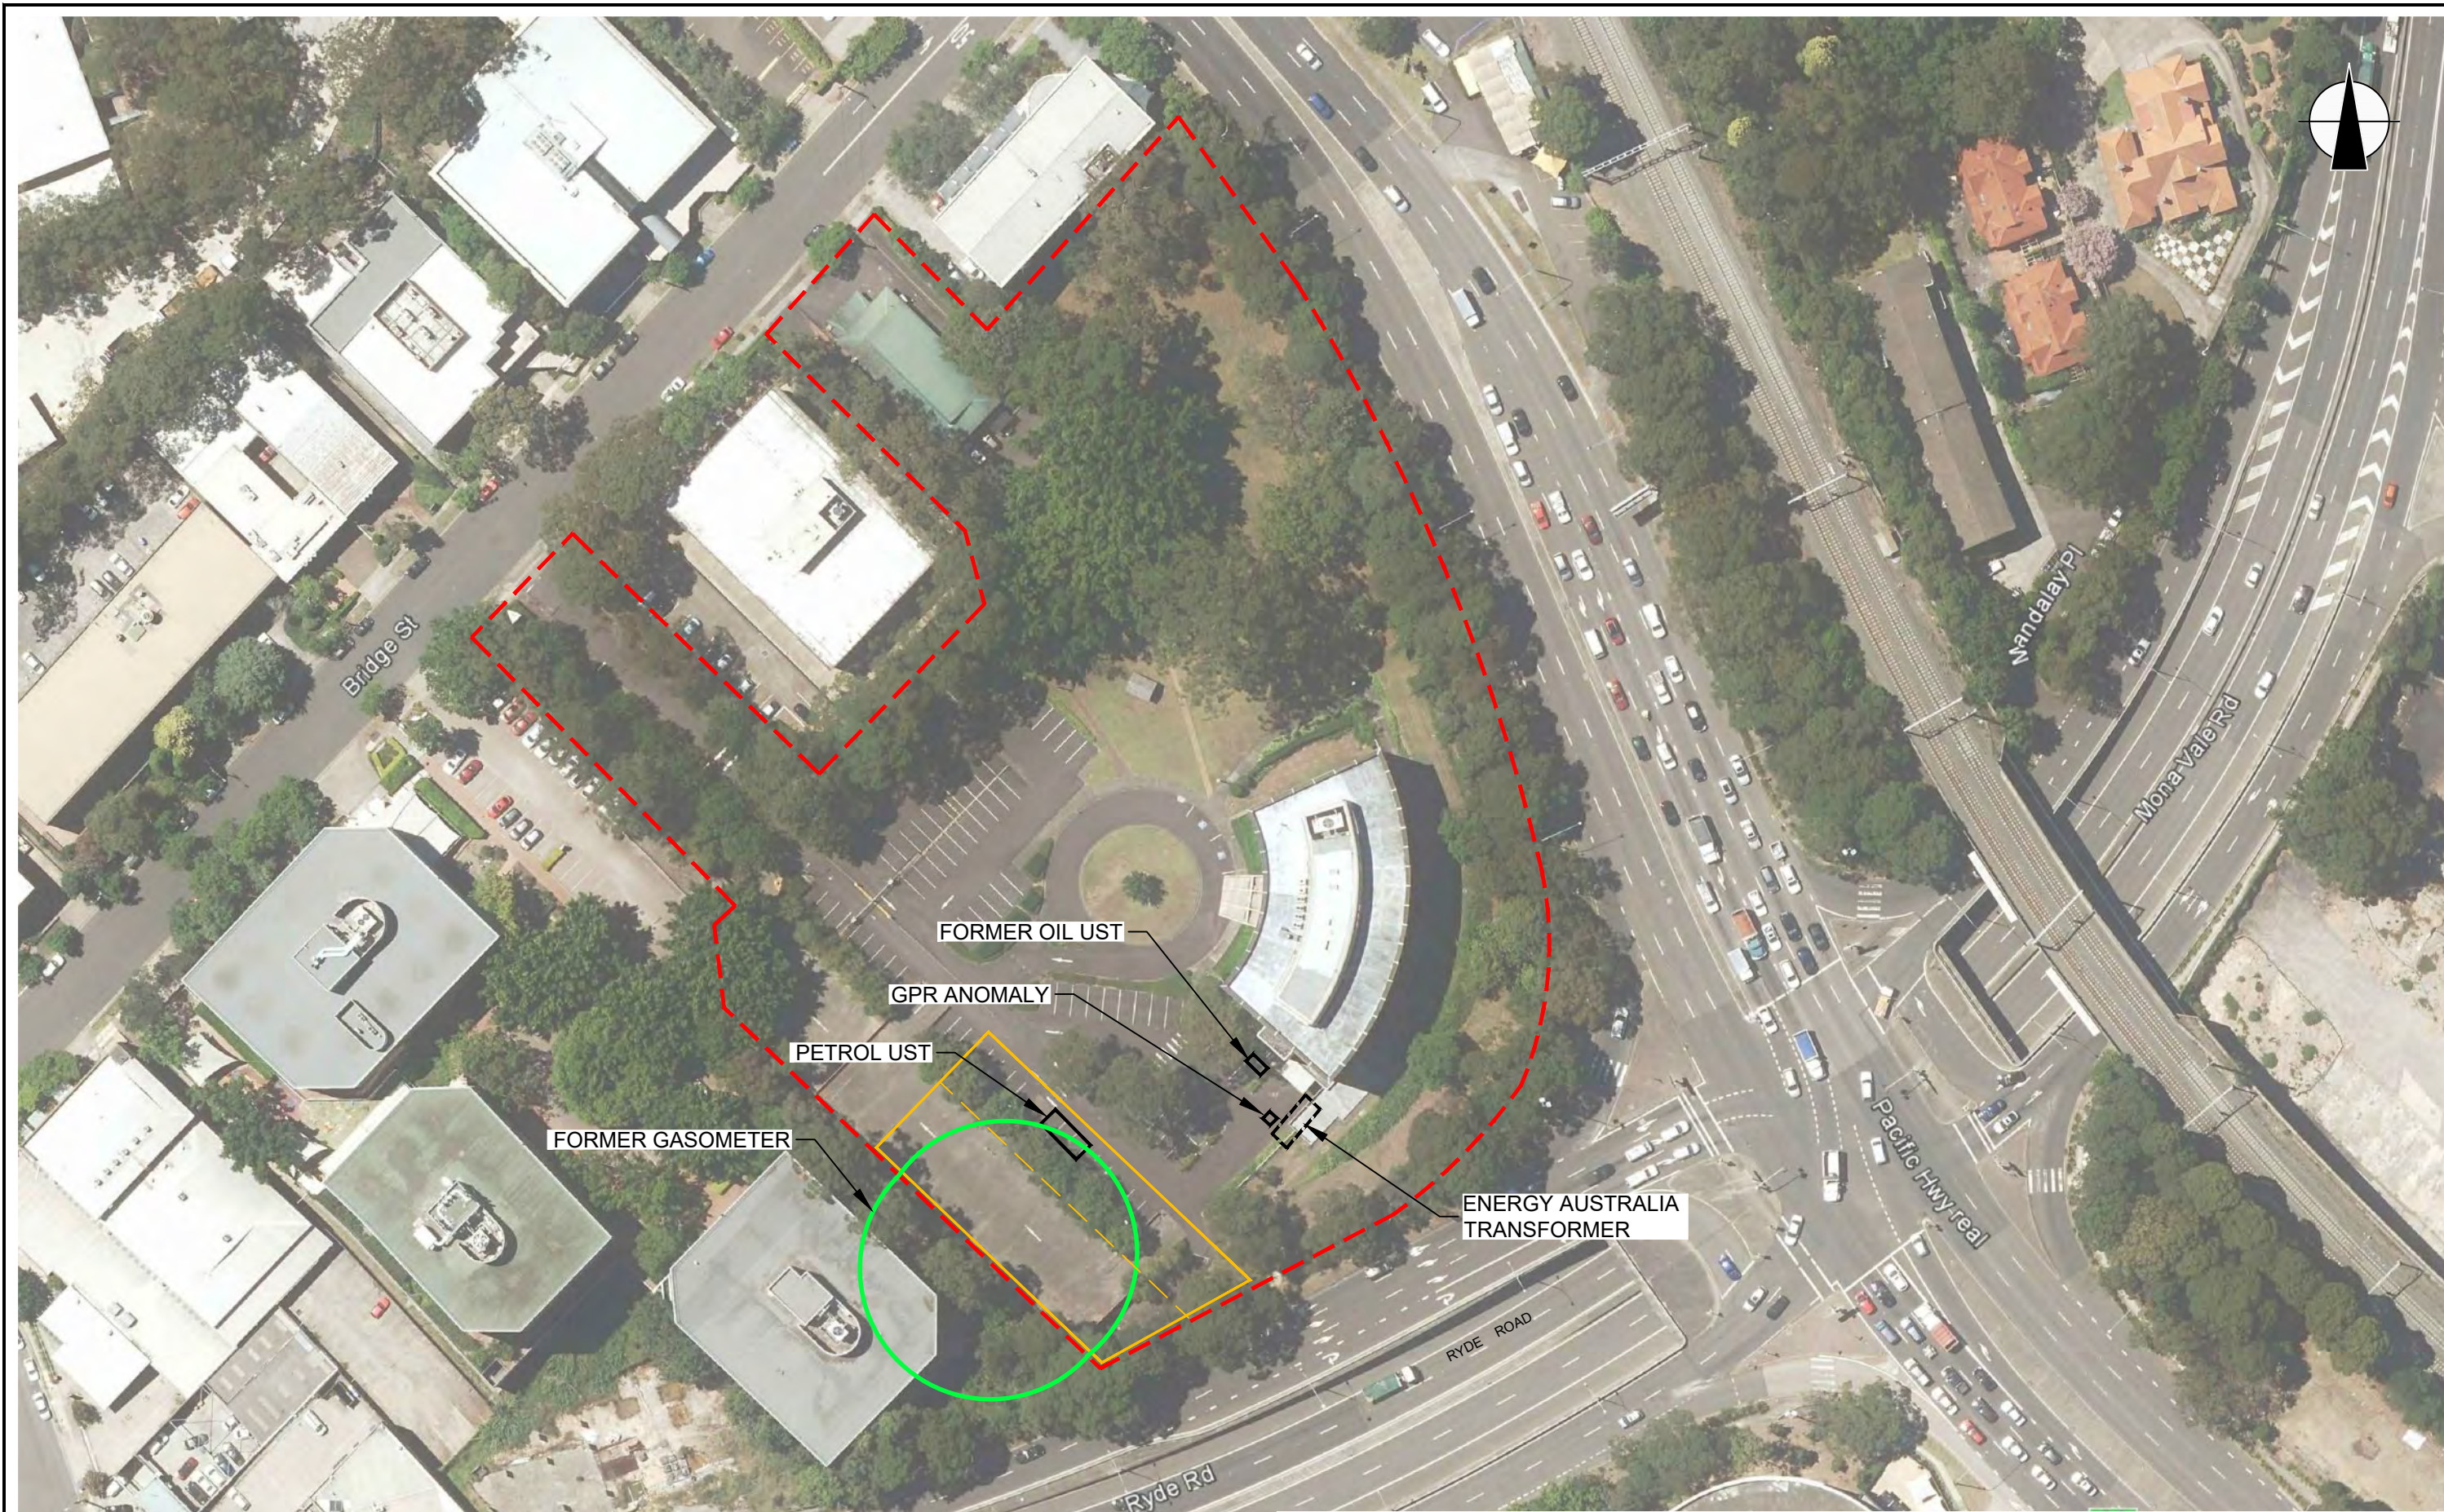
- - - - - APPROXIMATE SITE BOUNDARY
- EMP MANAGEMENT AREA

- A gas holder, or gasometer, was formerly located in the south of the site as shown on the attached Figure 2. Based on investigations conducted at the site, the fill material, soil and rock *“is not generally contaminated at the site, but rather at approximately 8m depth in the vicinity of the gas holder (RL - 98) there exists a zone of weathered sandstone of approximately 1.5m thickness, with water filled fractures wherein exists contaminated groundwater”*;
- Odours and staining were observed within the former gas holder perimeter within the deep fracture zone. No odours or staining were observed in boreholes drilled outside the gas holder.

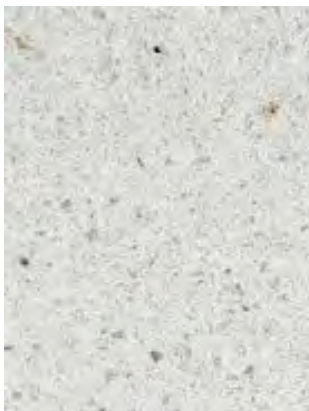
PRECAST OFF WHITE CON-
CRETE TO COLLONADE -SHOT
BLAST FINISH WITH QUARTZ
AGGREGATE

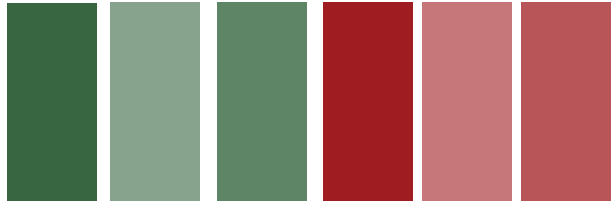
TRANSLUCENT COLOURED GLAZING /
PERSPEX TO SCREEN
