REVISED/ADDITIONAL DOCUMENTATION PART 8

1-21 Dillwynnia Grove, Heathcote

GHD Pty Ltd (GHD) was commissioned by Fuzortinn Pty Ltd (Fuzortinn) to undertake a Phase 1 Contamination Assessment of a property located at 1-21 Dillwynnia Grove, Heathcote, NSW (the Site).

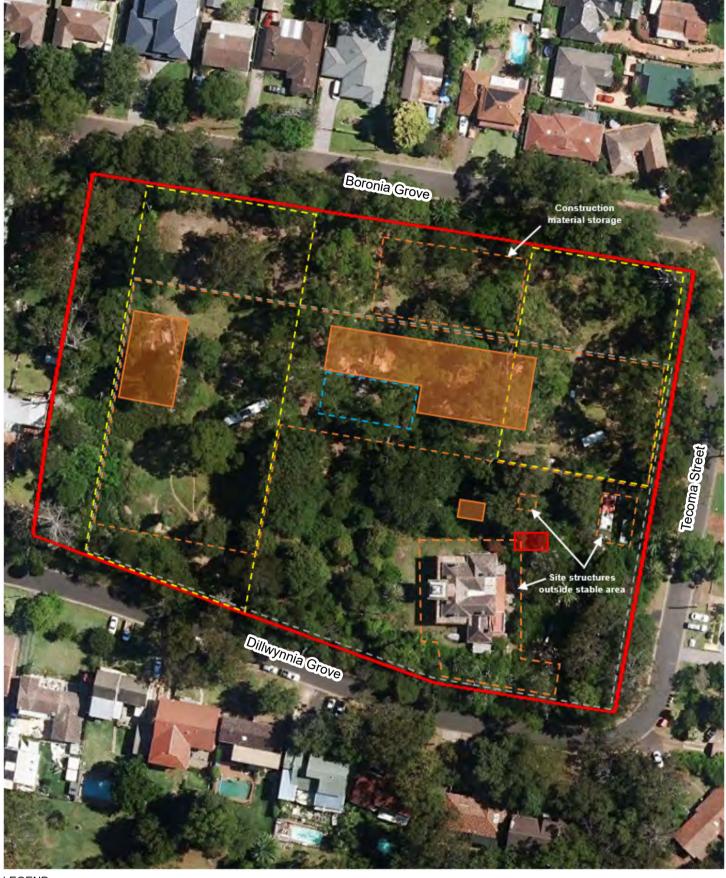
Figure 2 21 Dillwynnia Grove, Heathcote NSW 2233

AEC Potential Contamination Activity		Sub- Component Description	Potential Areas of Environmental Concern (See Figure 2)	Likel	COPC	
1	Weathering, demolition and stockpiling of	Weathering and demolition of stables and	Based on aerial photographs the former stable structures occupied much of the western and northern portion of the site.	Moderate to High	No suspected asbestos containing materials were observed within the footprint of the former stables and remaining structures were observed to be of timber and corrugated steel construction.	Asbestos
	hazardous building materials	other structures containing asbestos	Sheds and outhouse structures in the vicinity of the hall were observed to be of fibre cement construction and potential asbestos containing material fragments were identified within the southwestern corner of the garden area.		Potential ACM fragments were observed on ground surfaces within the garden area.

AEC 1 – Weathering, demolition and stockpiling of hazardous building materials

Site Features and Areas of Environmental Concern
