Table 9: Ancillary site buildings and structures

2.3.5 Archaeological Potential

2.3.6 Documentary Evidence

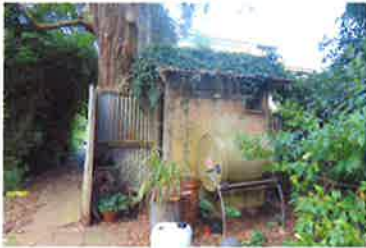
Building No.	Description	Photo
C5	Corrugated iron and flat sheet W.C. Currently the only functioning W.C. on the property. According to Ramon Farrelly, it has not been moved from this location for the duration of the Farrelly's residence.

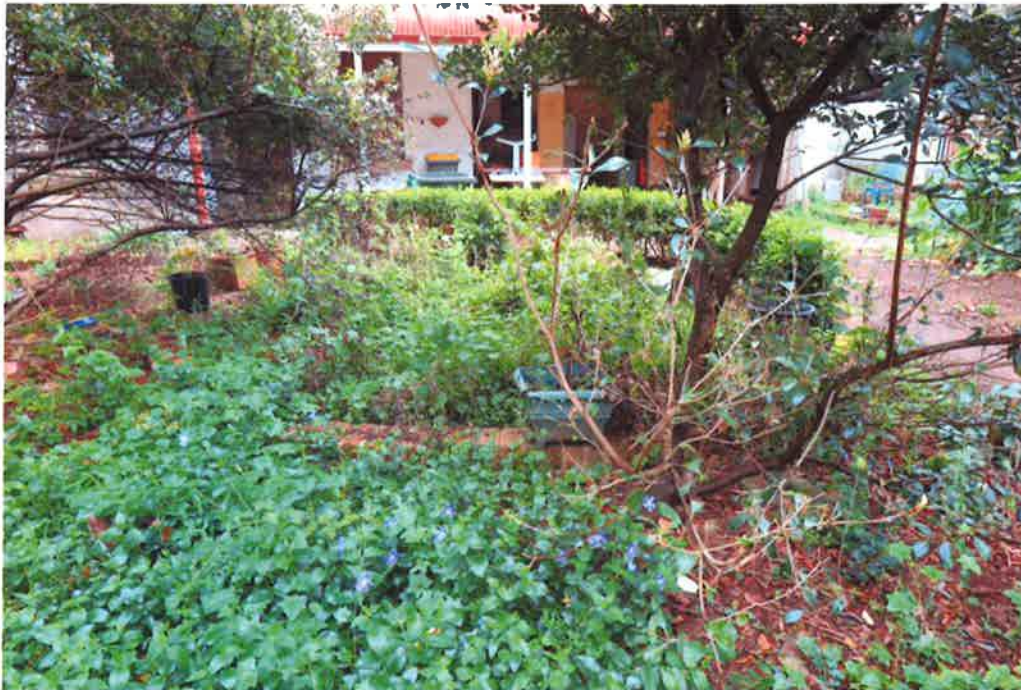
Figure 61: Circular garden feature in the back yard of the house said to be the backfilled cistern. View to the west. Source, C&L, dated 2017.

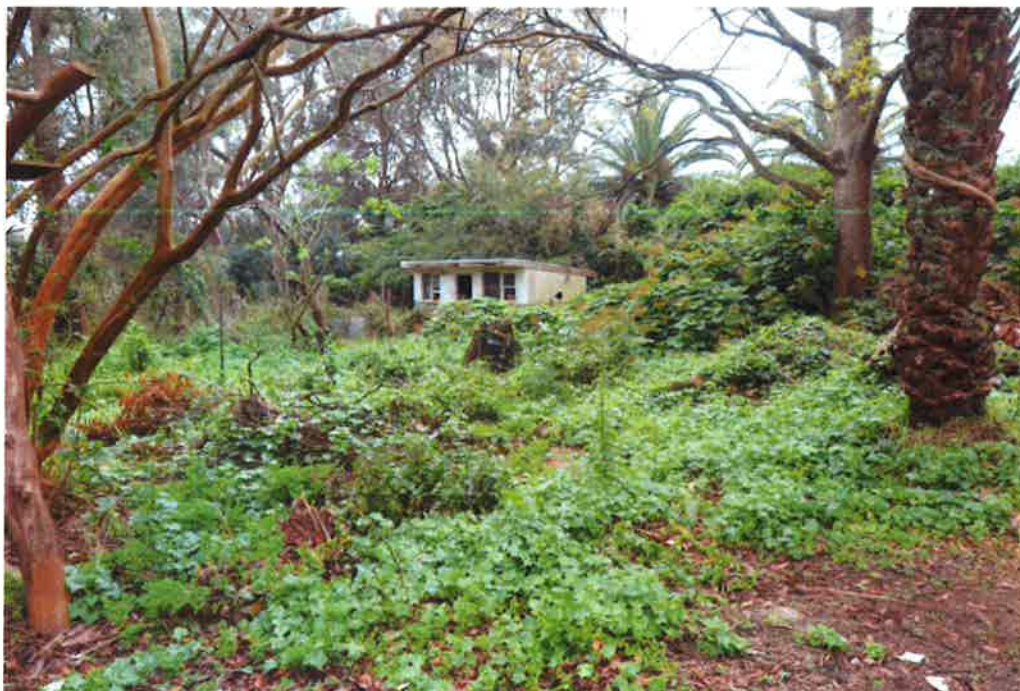
Figure 62: Thick vegetation in the rear yard, near the eastern fence. The structure is a garden shed built some time after 1970. Archaeological evidence of the coach house may be located in this area. View to the northeast. Source, C&L, dated 2017.

The land surrounding the house was very overgrown at the time of the visit, which impeded the identification of archaeological remains on the surface (Figure 62). Additionally, a large amount of building material and demolition rubble had been dumped throughout the site (Figure 63). This obscured potential archaeological remains, and made it difficult to distinguish potential *in situ* remains from dumped building materials. Nevertheless, several features made with machine-pressed brick were identified. Most of these were probably garden features such as garden beds and paths (Figure 60 and Figure 61), however, the footings of a demolished structure were located in the southeast corner of the site (Figure 62). These footings had a ceramic vent grill and appeared to be made of mismatched machine-pressed bricks. There were at least two types of mortar. The mortar consisted of a very hard grey cement with angular marine sand and a softer, paler grey sand mortar with frequent lumps of lime. The structure may date to the earliest phase of occupation, as a structure is shown in approximately this location on the 1889 subdivision plan (Figure 14). It may, however, be made from reused building materials and date to sometime in the 20th century. A larger structure is also located in the southwest corner of the site in the 1940s blueprint (Figure 18).

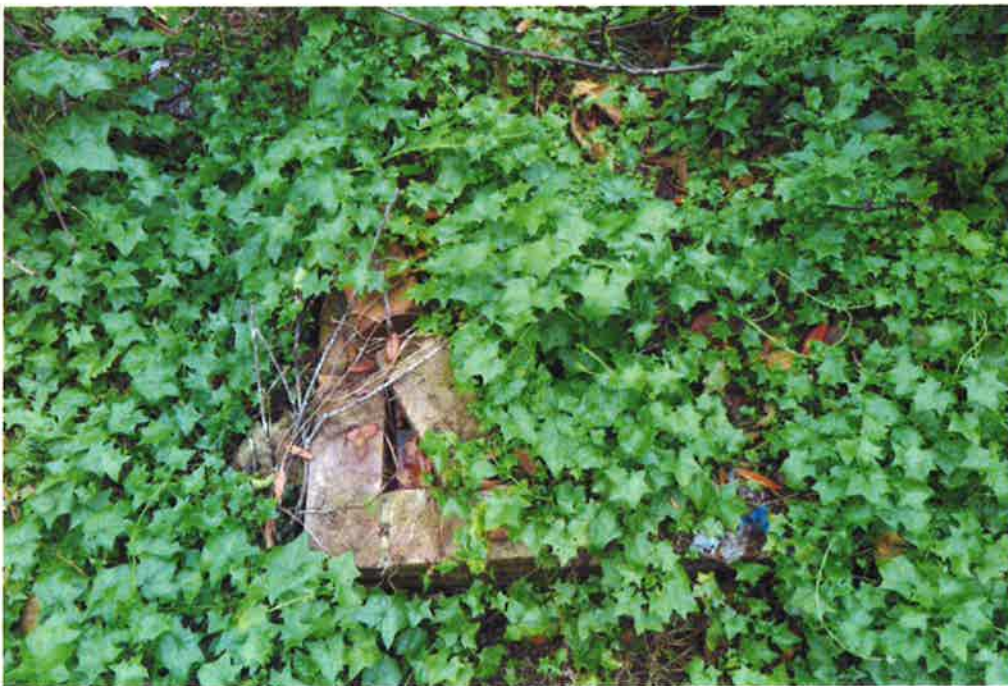
Figure 64: Machine- pressed brick feature, probably a garden bed. Located in the rear yard (former kitchen garden area), approximately 10m west of the shed in Figure 2.4.4. C&L, dated 2017.

There was evidence of a continuum of land use and the constant building of new structures throughout the 20th century (Figure 64), however, most of the structures observed during the visit would have had a fairly minor impact on any potential remains below (Figure 65). It was also apparent that the level of the land had been built up and levelled out throughout parts of the site (Figure 66). It is likely that areas have also been cut down in the course of levelling works, although no specific examples of this were seen.

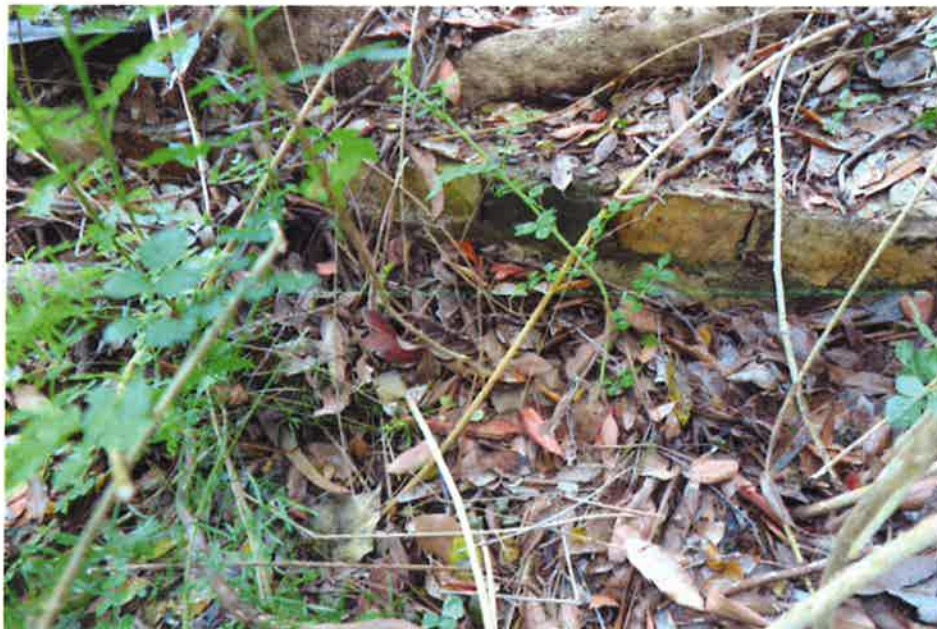
Figure 66: Brick footings in the southeast corner of the yard. View to the north. Source, C&L, dated 2017.

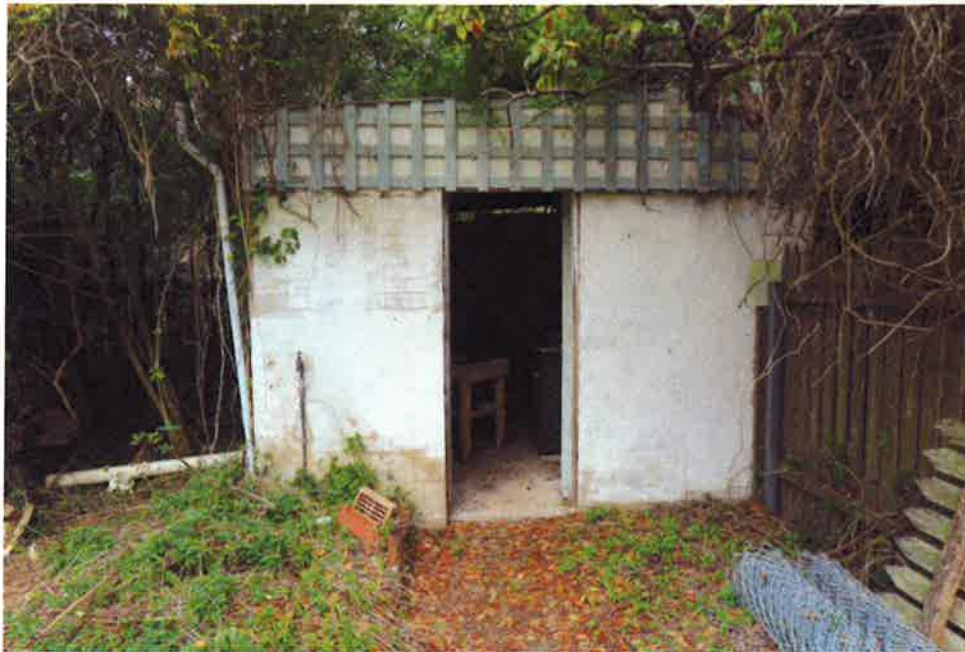
Figure 67: Laundry pre-dating 1943. View to the south. Source, C&L, dated 2017.

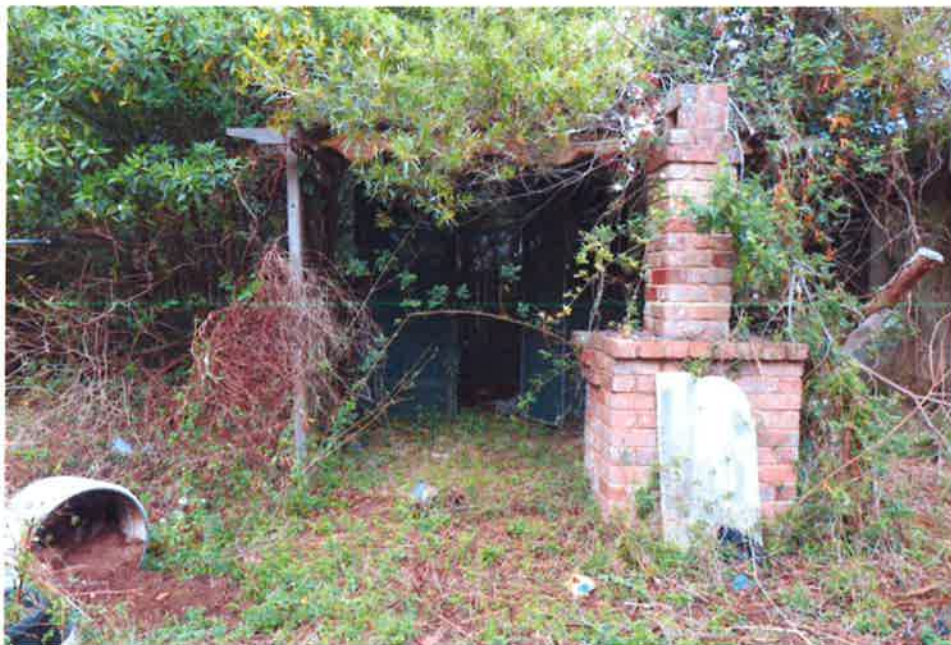
Figure 68: The fireplace of an outbuilding to the immediate west of the laundry.
This structure first appeared in the 1955 aerial photograph. Source, C&L (Figure 2.4.08), dated 2017.

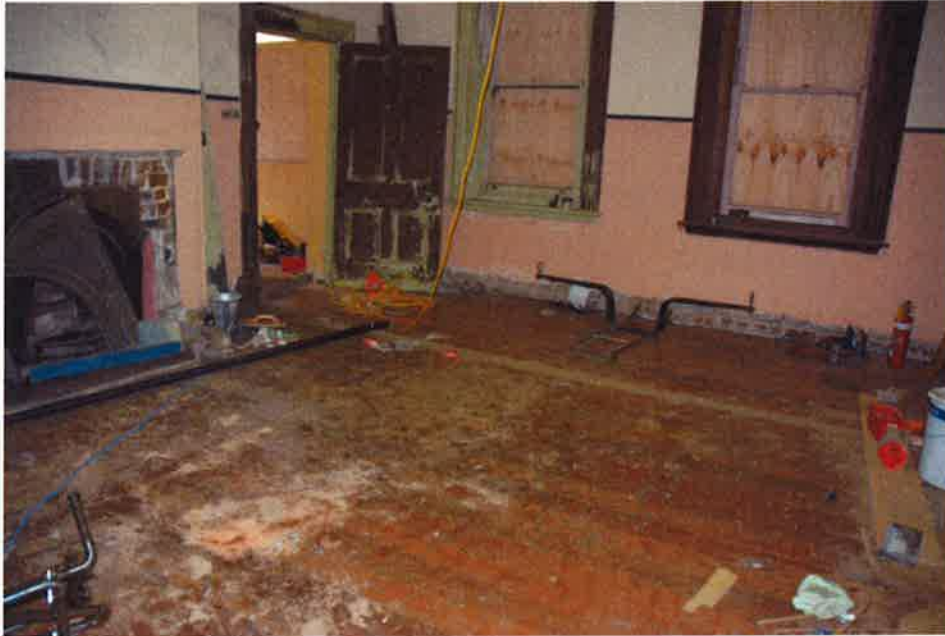
Figure 71: 'Ballroom' showing recently replaced flooring. Source, C&L, dated 2017.

The house was found to have tongue and groove flooring, some of which has been replaced recently (Figure 71). The main ground floor hallway is a combination of tiling and floorboards. Many of the building's ceilings have been replaced or false ceilings had been introduced.

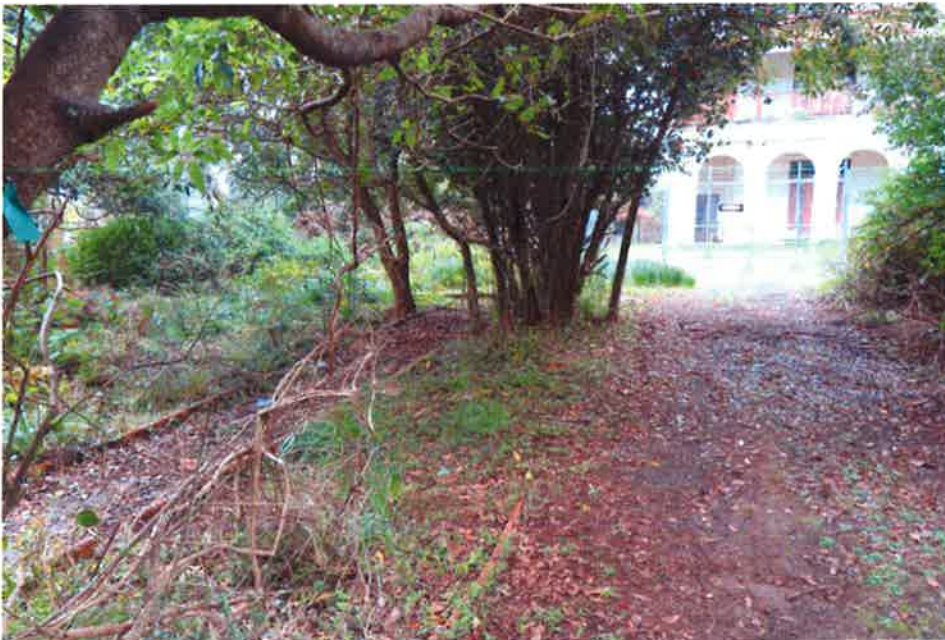
Figure 72: Rows of garden edging tiles demarcating the former garden path and part of the carriage loop. View to the east. Source, C&L, dated 2017.

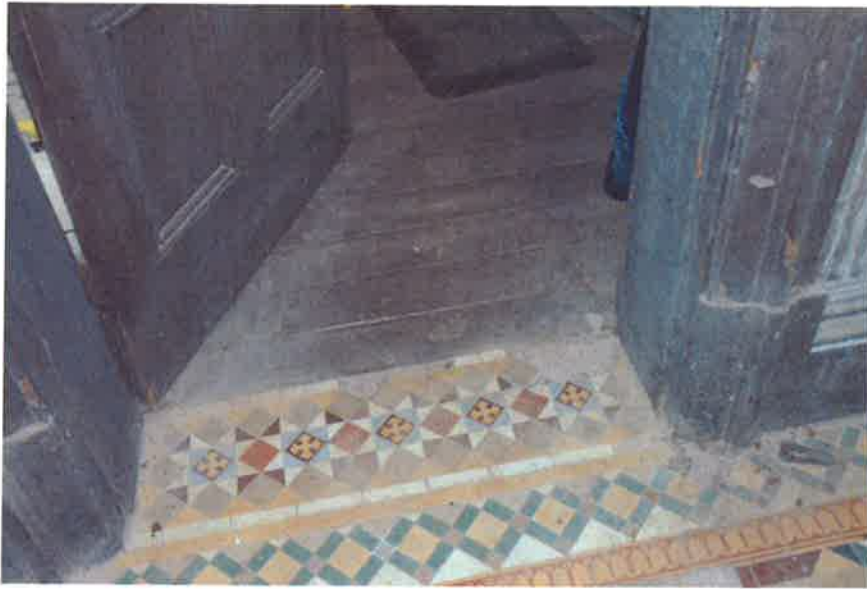
Figure 73: Threshold between hallway tiles and timber flooring. C&L, dated 2017.

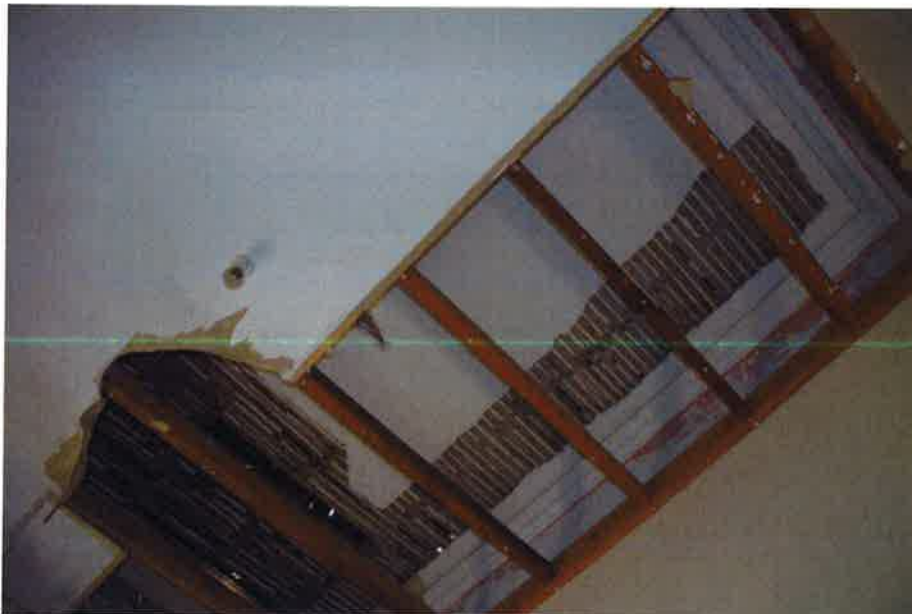
Figure 74: False ceiling below original lathe and plaster ceiling. Source, C&L, dated 2017.

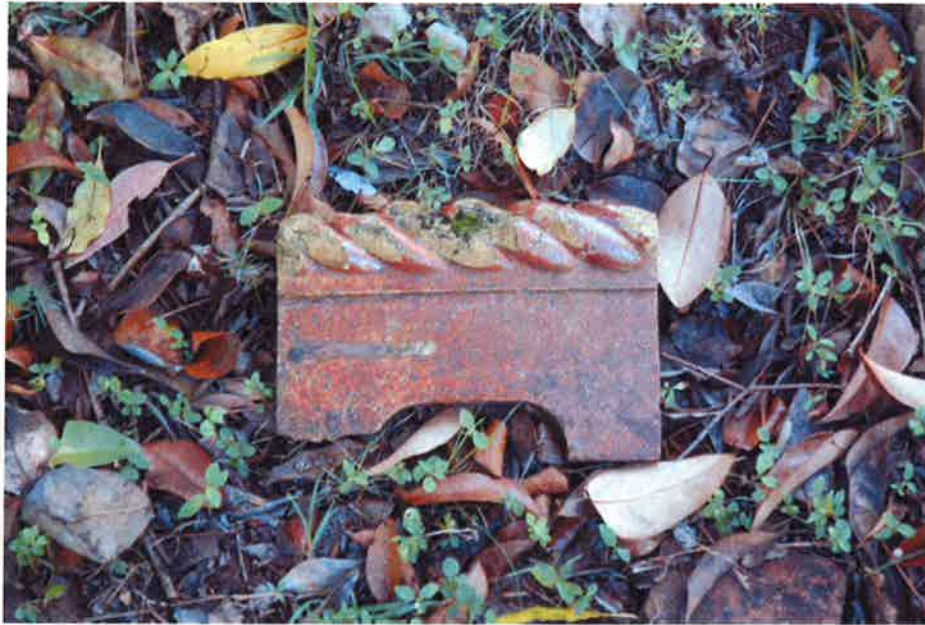
Figure 75: Ceramic tile garden edging. Source, C&L, dated 2017.

Traces of the formalised gardens were evident in the front yard area of the house. These mostly consisted of glazed cable pattern tiles which edged the garden paths and remnant carriage loop (Figure 68).

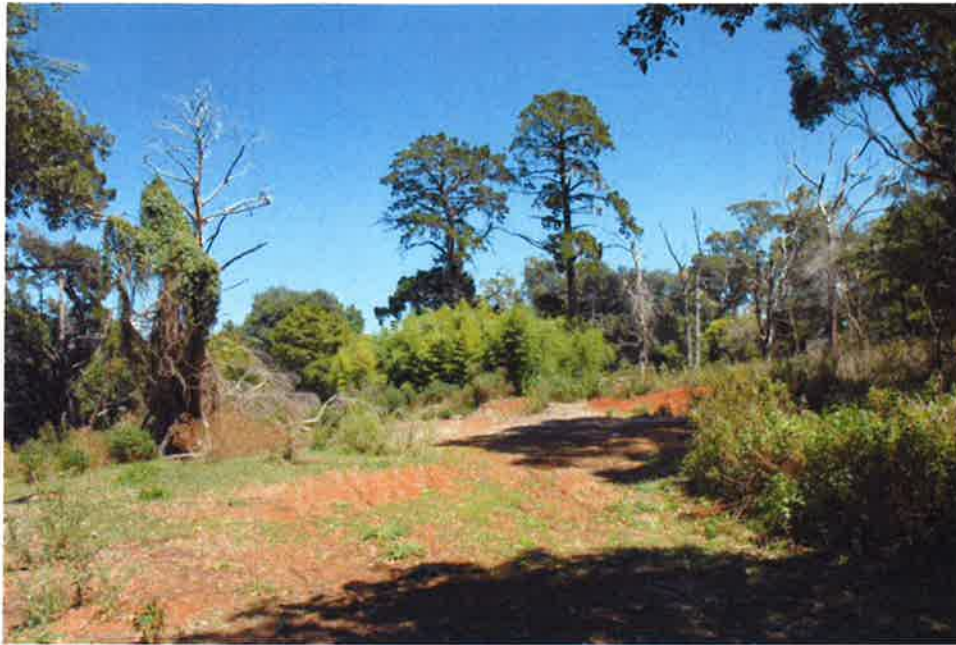
Figure 77: Filled ground along line of earlier drive, looking west. Source, C&L 2017.

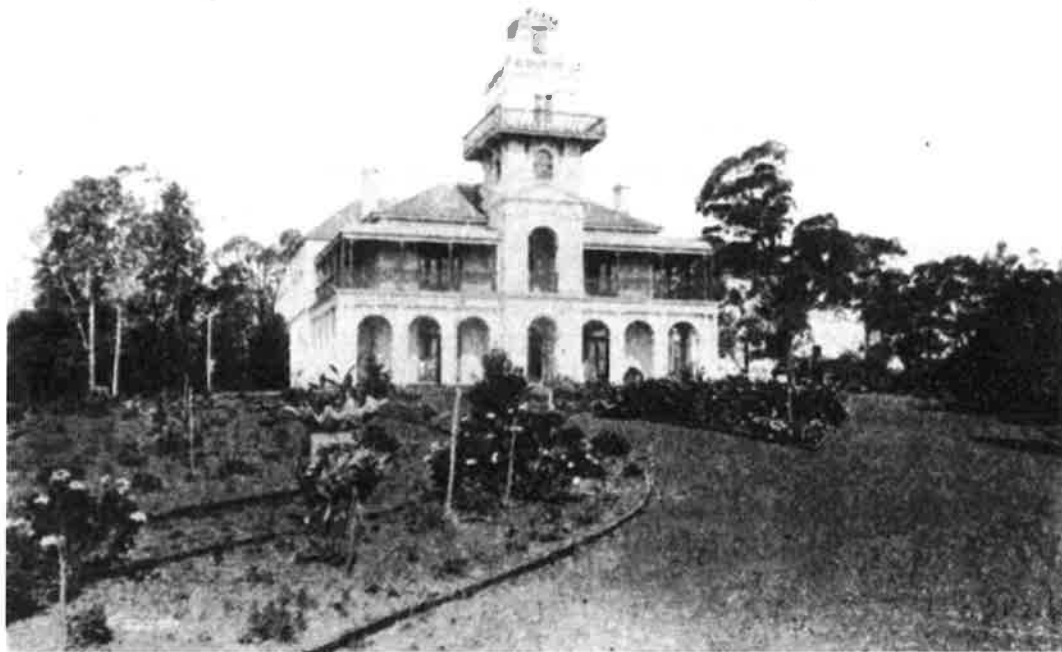
Figure 78: ER Brown, *Homes and haunts*, NSW, Heathcote, c. 1900s, Sutherland Shire Council, Local Studies Library, MF003\MF003118, n.d.

The earliest photograph, Figure 78, – from the ER Brown collection and noted tentatively as c. 1900s but possibly from the late 19th century – is one of the most revealing as it shows much of

the ornamental layout to the front of the house and enables the reconciliation of the existing glazed edging tiles with those in the image.¹⁵¹ The elegant overall carriage loop configuration is legible along with a network of subsidiary pedestrian paths, set out with great precision, that form part of the pleasure grounds of Heathcote Hall. The tile-edged paths enclose numerous bedding areas that are shown to be recently planted out with various ornamentals. To the left of the carriage drive is a pedestal with a giant clam shell (both now missing) – a typical 19th century garden ornament. (Although not seen in this image, it is likely that there would have been a matching half of the clam shell on a similar pedestal on the southern side of the front grounds.) Beyond the house are the familiar forms of large locally indigenous trees that have remained a characteristic landscape feature of the place ever since.

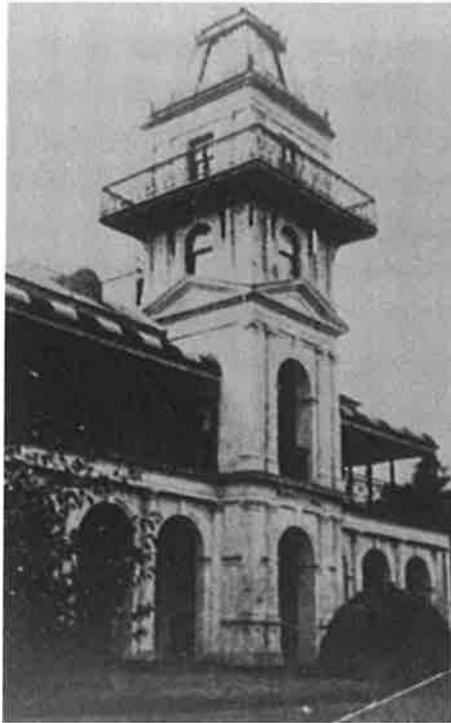
Figure 79: (2.62) Heathcote Hall, Heathcote, c. early 1900s, Sutherland Shire Council, Local Studies Library, MF000MF000118, n.d.

Two close up photographs of the front of Heathcote Hall, featuring the tower, also reveal some details of the grounds at the front of the house. One, Figure 79, shows a shrub clipped into a dome framing the main path into the porch off the carriage loop along with another (unclipped) shrub to the left. Part of the carriage drive is visible at the bottom showing the raised grass beyond that forms an apron to the verandahs.¹⁵² This original modulation of levels is still apparent at the front and sides of the house.

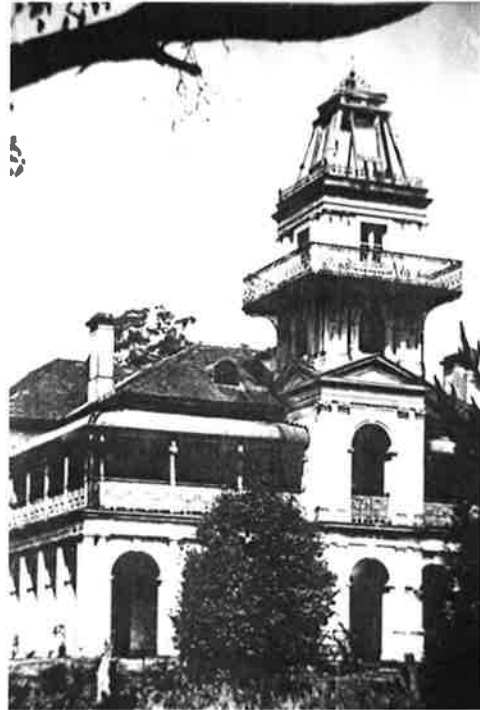
Figure 80: (2.63) ER Brown, *Homes and haunts*, NSW, Heathcote, between 1900 and 1920, Sutherland Shire Council, Local Studies Library, MF004MF004640, n.d.

The other photograph, Figure 80, shows a shrub (presumably one of the existing *Camellias*¹⁵³) along with the foliage of a pine (probably Monterey Pine) to the right and the bough of a locally indigenous tree at the top.¹⁵⁴ These reference points suggest that the photograph may have been taken under the existing large Turpentine at the corner of the former tennis court bench (near the old gatepost) with the pine planted somewhere near the carriage loop. The upper canopy foliage of an indigenous tree (possibly another Turpentine) is visible above the house roof.

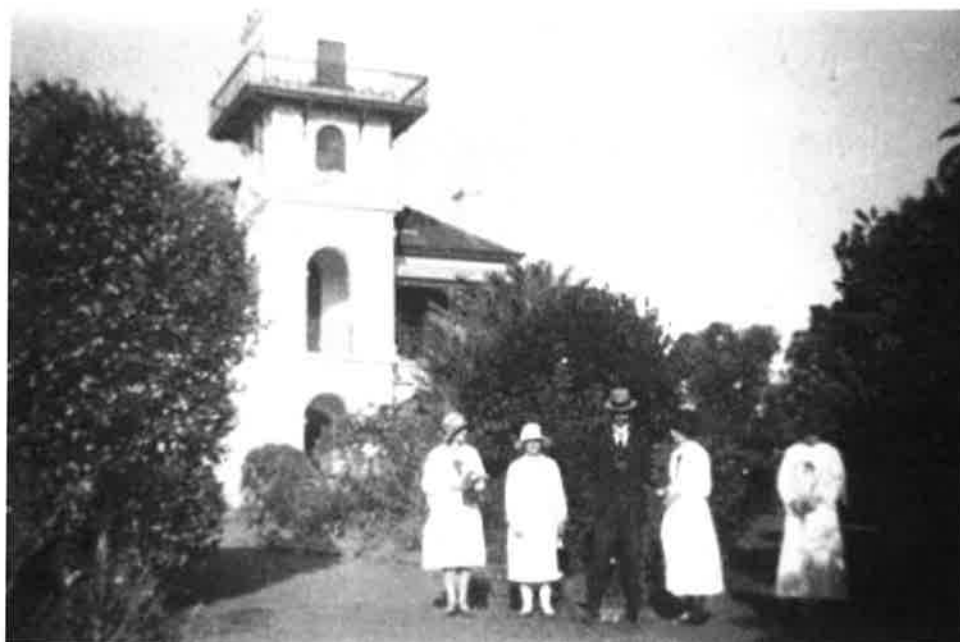
Figure 82: Will, Edith and Clarrie Nelson at Heathcote Hall, Source, Sutherland Shire Council, Local Studies Library; MF004/MF004515, dated 1928.

A 1928 photograph, Figure 82, from within the carriage drive shows five figures posing in front of the house with noticeably developed plantings enclosing them.¹⁵⁵ At left is a Camellia that remains today and the existing date palm is clearly seen within the tile-edged central triangular bed along with various ornamental shrubs. To the right, other tall shrubs define the carriage loop and at the extreme edge there appears to be the fronds of another taller palm (now gone) – possibly a *Washingtonia* sp. that would have been typical of the time. Conspicuously absent in the background are any locally indigenous trees and, in the foreground, any evidence of the earlier pine tree.

Also from Figure 82 and Figure 83 it appears that there was a cleared space (maintained as an open paddock?) to the west of the mansion. The latter photograph suggests that some taller vegetation was used to deliberately frame views of Heathcote Hall from this western space to accentuate the dramatic compositional qualities of its principal elevation – a clearly intended consequence of the mansion's planning and siting as indicated in the earliest photography Figure 32.

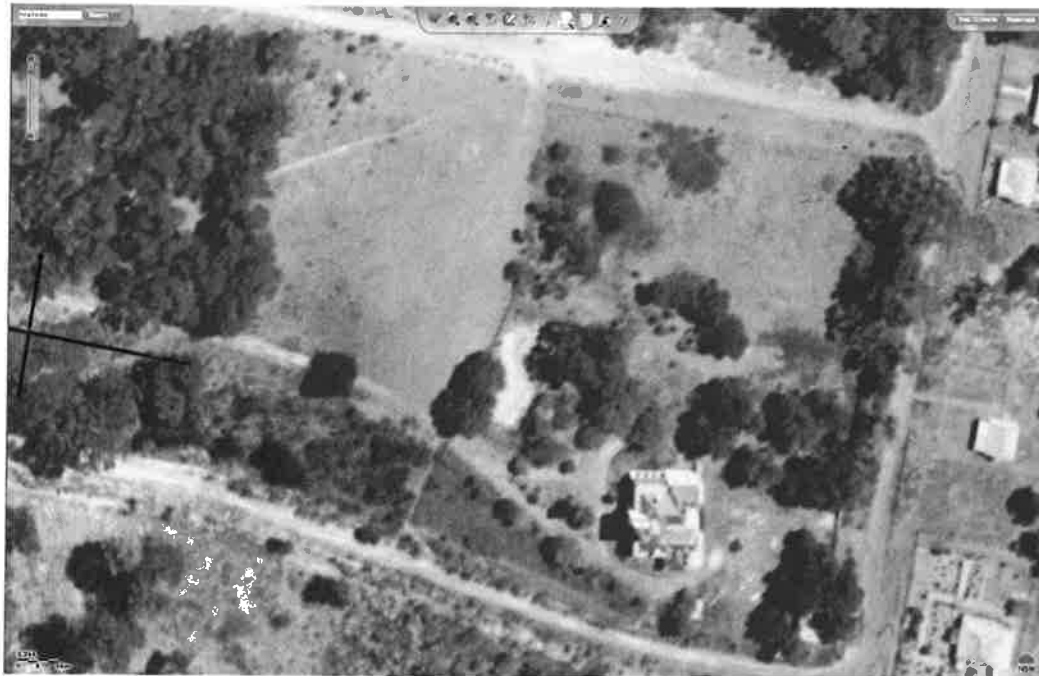
Figure 83: Aerial photograph. Source, Sutherland Shire Council, dated 1943.

Even though the overall site area was subdivided from 1927, the 1943 aerial photography, Figure 83, shows the early carriage drive was probably still in use as the access to the front grounds of Heathcote Hall – likely because of the steep bank along Dillwynnia Grove to the south and southwest of the house and because it was a more direct line of access to the house from Heathcote railway station than Boronia Grove as the other route that avoided the steep bank. Other information conveyed by the 1943 photography is that both Dillwynnia Grove and Boronia Grove were planted out with avenue trees (likely the existing Brush Boxes) up to the beginning of the Heathcote Hall grounds and showing an extent of growth to suggest they were planted at least 10 years earlier (than 1943). (On the basis of the historical research in this CMP, they were probably planted in the late 1920s to reinforce and compliment the residential subdivision of that time.)

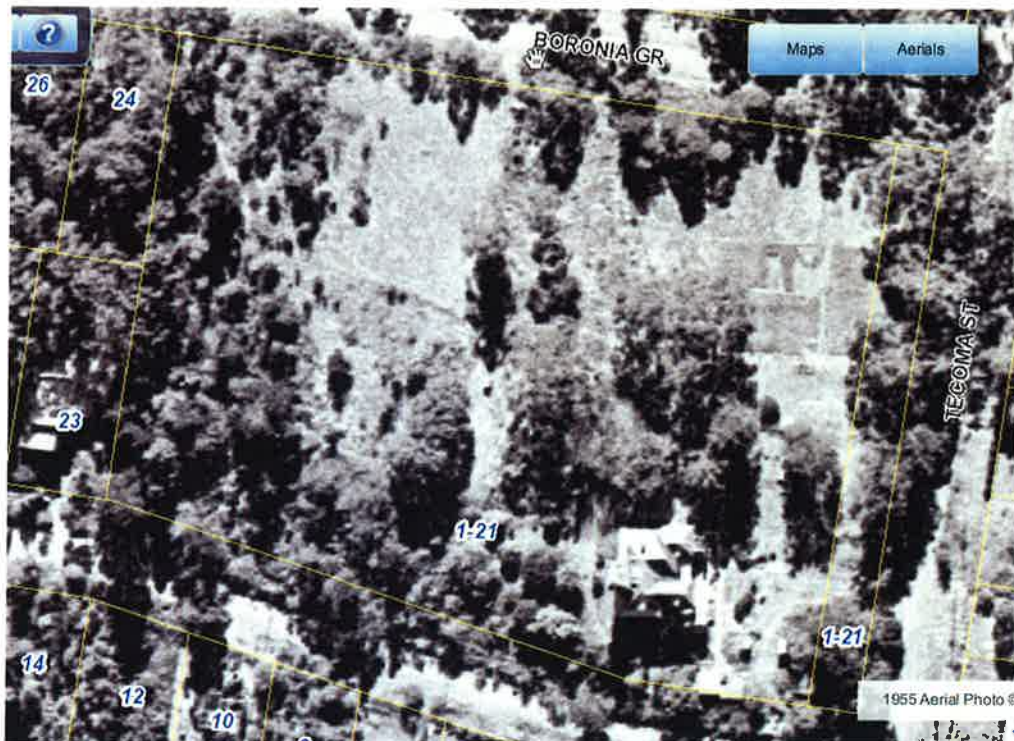
Figure 85: Aerial photograph. Source, Sutherland Shire Council, dated 1955.

By the time of the 1955 aerial photography, Figure 85, a house is shown built in the allotment, with frontage to Dillwynnia Grove, to the immediate west of the Heathcote Hall grounds. This would have curtailed the use up to this point of the carriage drive linking the house with the station. In its place it appears that the main direction of access to the house was from Tecoma Street to the eastern (rear) elevation as there is little evidence in this photography of any access from Boronia Grove to the north. As with the 1943 photography, the grounds are shown divided into discrete compartments (presumably based on function) with the northwest paddock remaining mostly cleared but now showing signs of some patchy regrowth in places, the northeast enclosure showing definite signs of cultivation as if used for kitchen gardens and the front and rear house grounds used for their respective functions. The old carriage drive is also visible to the west of the house.

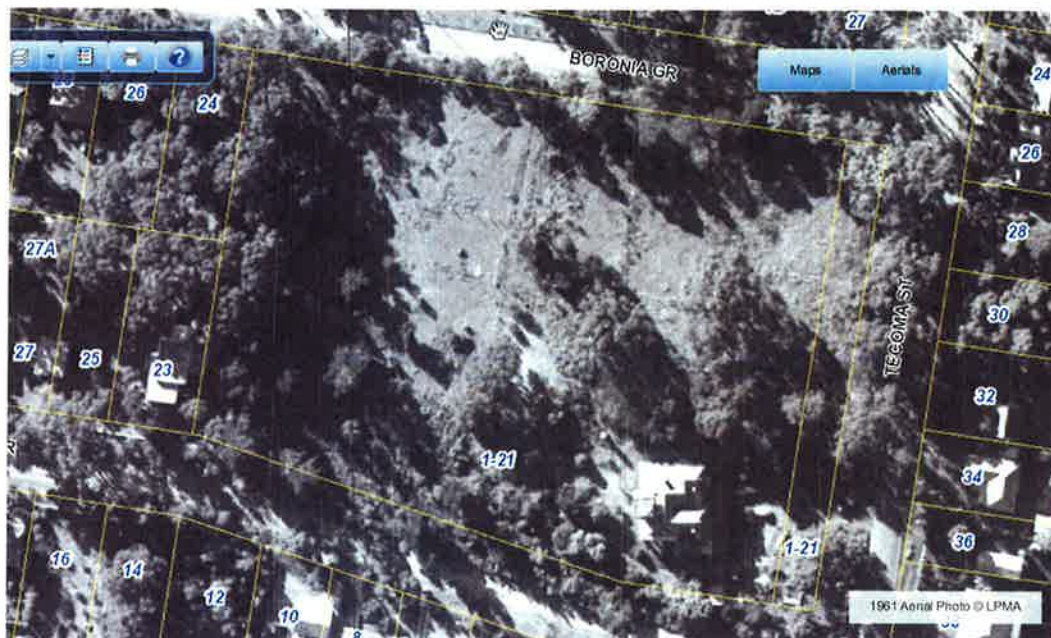
Figure 86: Aerial photograph. Source, Sutherland Shire Council, dated 1961.

Aerial photography from 1961, Figure 86, shows more clearly the fencing lines dividing the grounds into various compartments and also begins to show some evidence of an access from off Boronia Grove running perpendicular to the street between fences before passing to the west of the tennis court and connecting with the remnant carriage drive in an arrangement that persists to the present. By 1961 the cultivated areas to the northeast have been discontinued and the abandoned part of the carriage drive is only just visible. Ornamental plantings around the house are thrown into high relief from the long shadows cast by the mid-year photography.

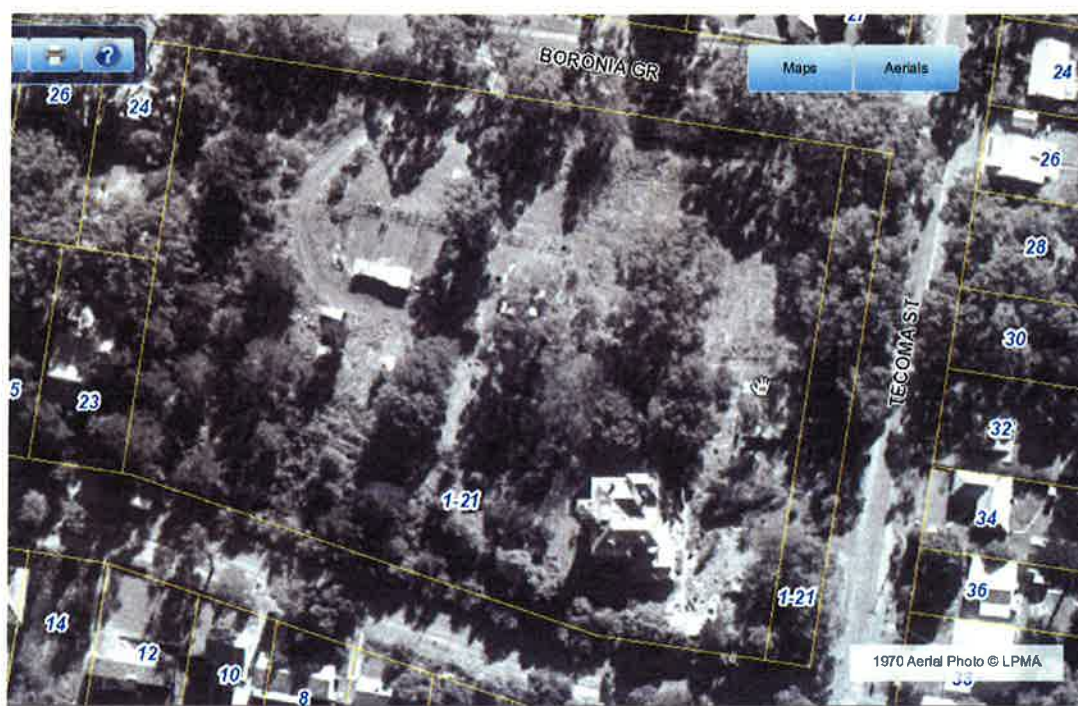
Figure 87: Aerial photograph. Source, Sutherland Shire Council, dated 1970.

The 1970 photography, Figure 87, shows development occurring across the northwestern paddock with a broad track, several structures and shadows indicating heavy rails to the fencing (probably relating to horses) associated with the structures. Earlier vegetation is shown to be maturing considerably such as the various pines along the western boundary and Dillwynnia Grove. Long, large shadows suggest some large indigenous trees have been left within the site. The tennis court is clearly visible as is part of the abandoned early carriage drive while the rear grounds are shown to be largely open with many smaller objects stored there. A substantial building (the northern part of which is gabled) is shown about half way along the Tecoma Street frontage.

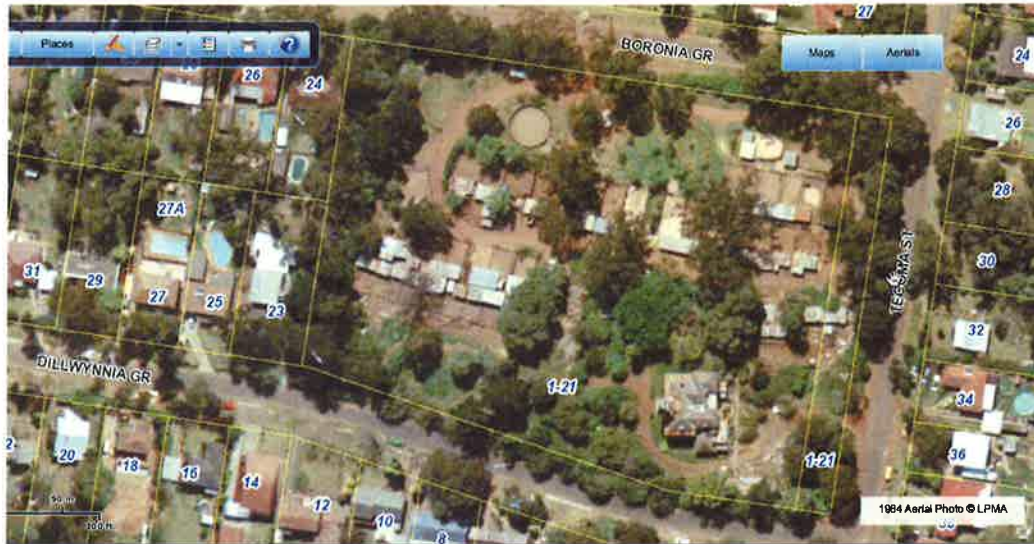
Figure 88: Aerial photograph. Source, Sutherland Shire Council, dated 1984.

By the 1984 photography, Figure 88, the Heathcote Hall grounds are shown almost fully developed with parallel rows of stables and integral fenced yards. There are also two lunging rings – one of which (the western-most) remains. A collection of ancillary structures is shown where the existing chicken runs and pig pen are located and a narrow path is shown running across the entire rear elevation of the house linking with a shed to the south. Yet despite the extensive level of development throughout the site, some key areas remain largely intact. These include the immediate front grounds where the gravelled drive loop is clearly seen; the tennis court area; and the route of the former carriage drive.

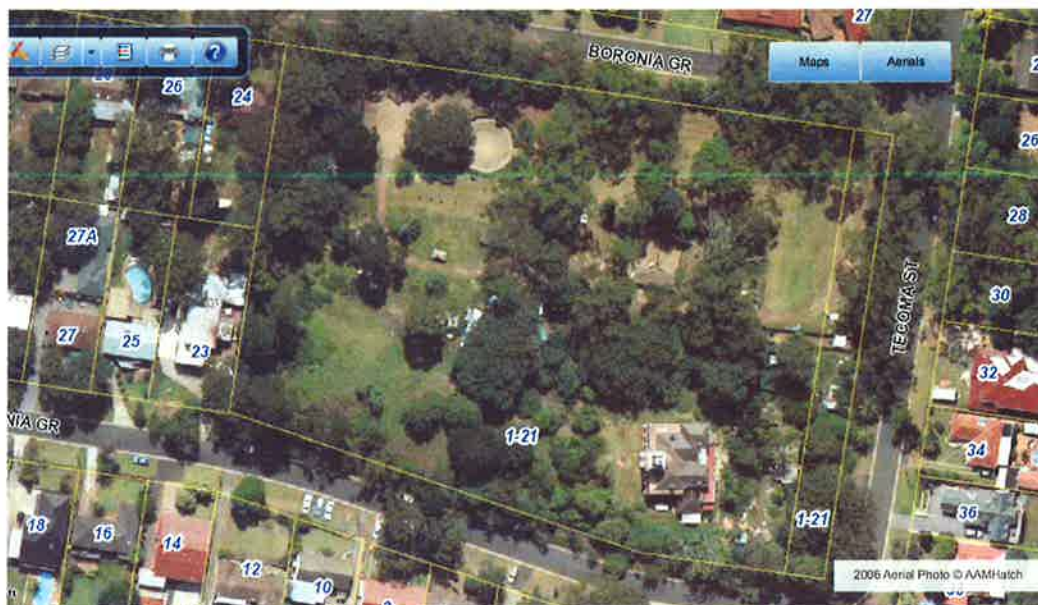
Figure 89: Aerial photograph. Source, Sutherland Shire Council, dated 2006.

Photography from 2006, Figure 89, reveals a dramatic contraction of development within the Heathcote Hall grounds with most of the earlier horse yards and stables removed. One lunging ring remains clearly visible along with associated access tracks. However the immediate house grounds are again shown to be largely unchanged although the carriage drive surface in front of the house has now become covered with grass. A faint trace of darker green grass may also indicate the old route of the long abandoned carriage drive west of the tennis court that, by this date, has become overgrown.

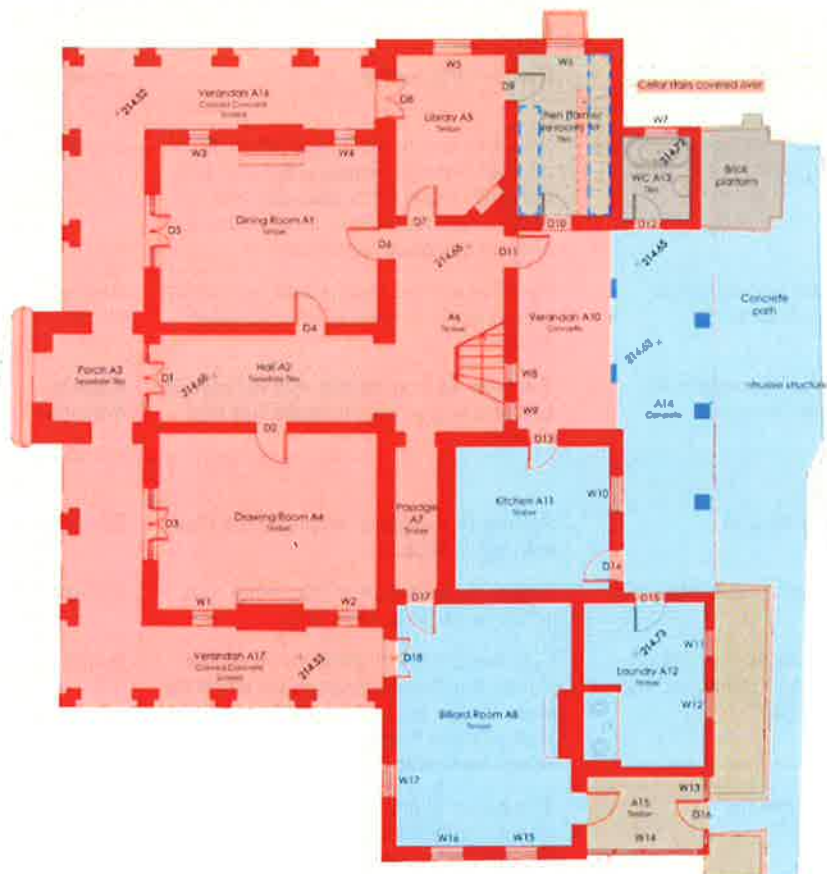
Figure 94: Jenner Ground Floor Plan showing gradings of significance for building elements, n.d.

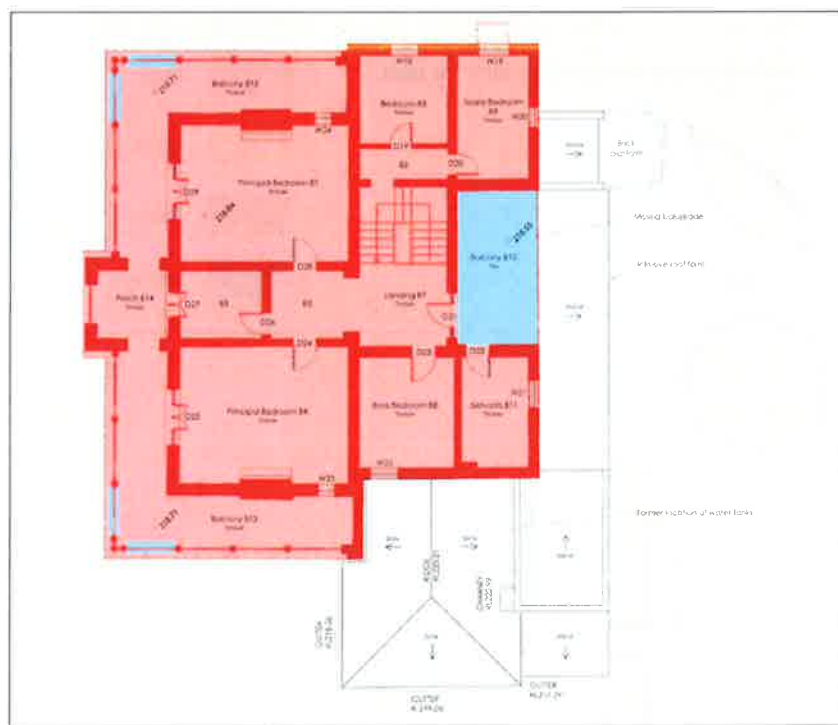
Figure 95: Jenner First Floor Plan showing gradings of significance for building elements, n.d.
