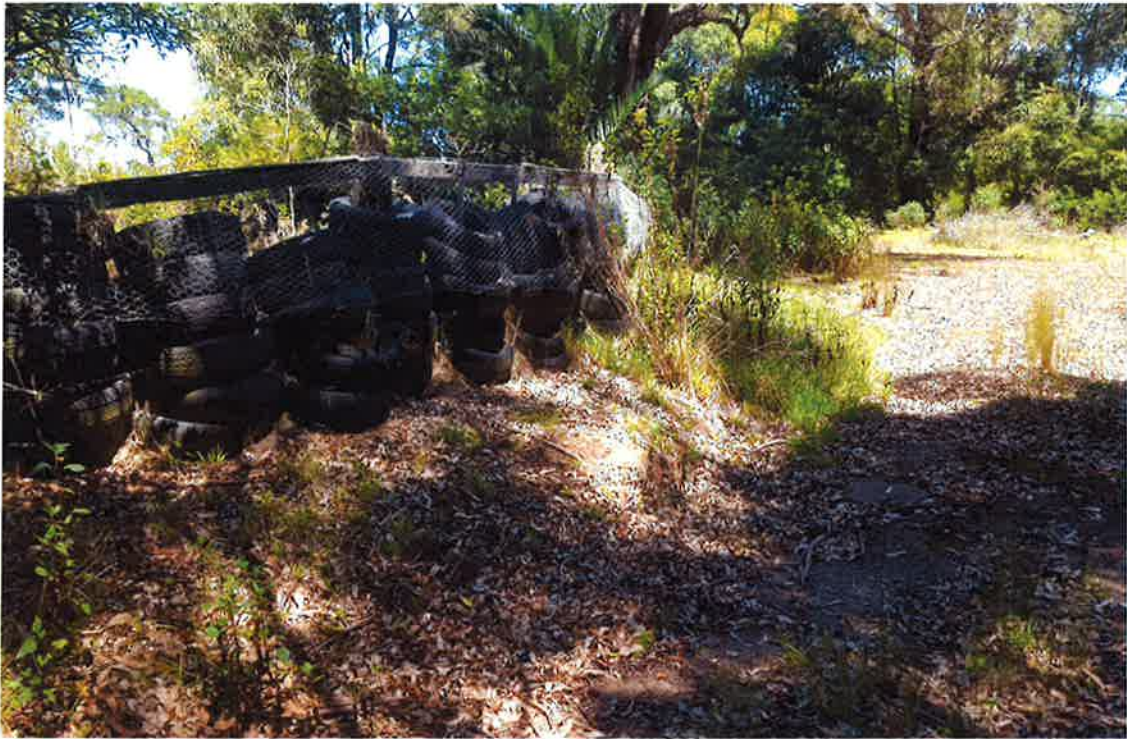
Figure 28: The northern boundary of the corral and part of the oval road viewed west (Source: CRM 2017)

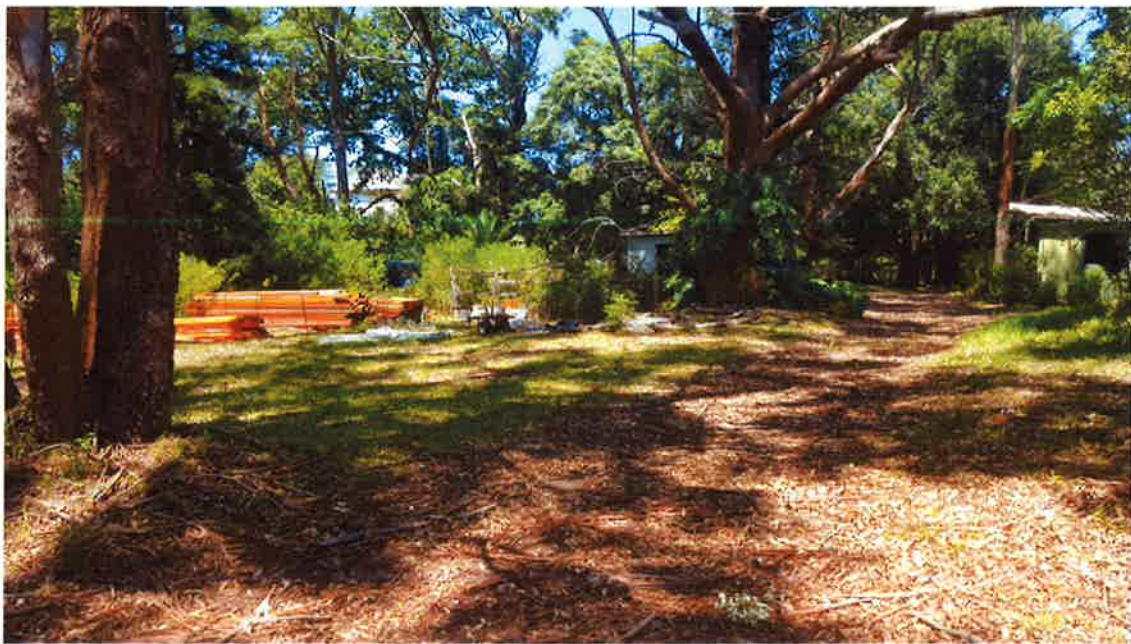
Figure 29: The road runs between two former stables buildings in the north-west quadrant (Source: CRM 2017)

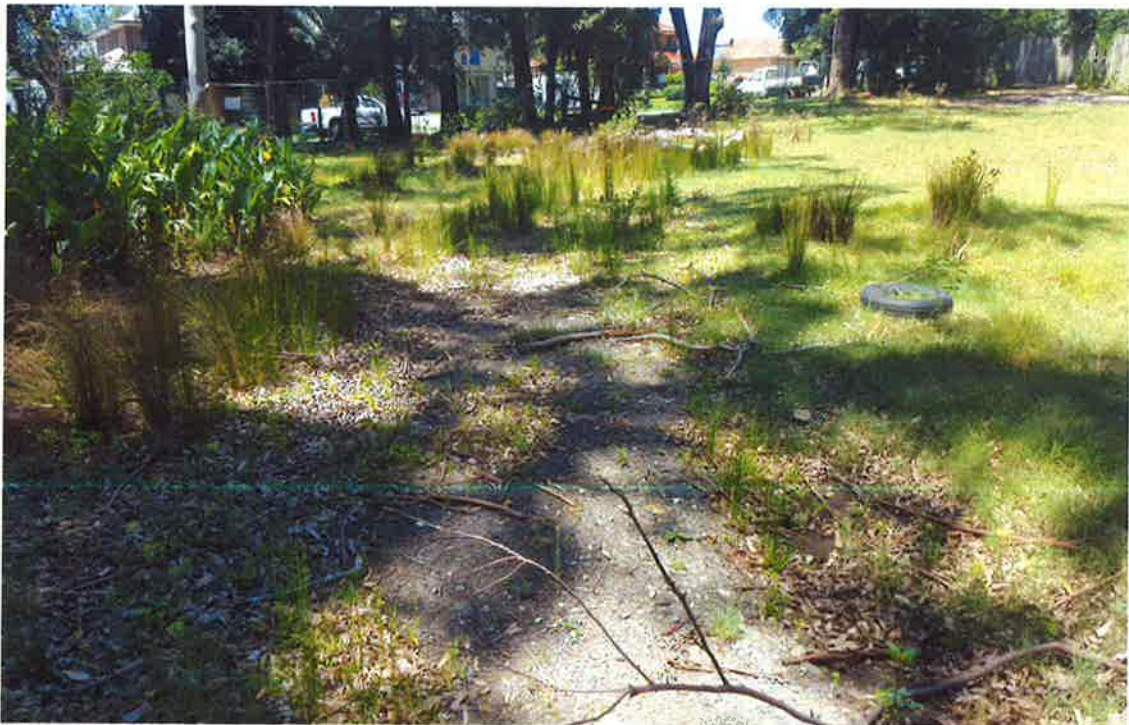
Figure 30: Remnant of the oval road in the north-east quadrant looking east towards the property boundary (Source: CRM 2017)

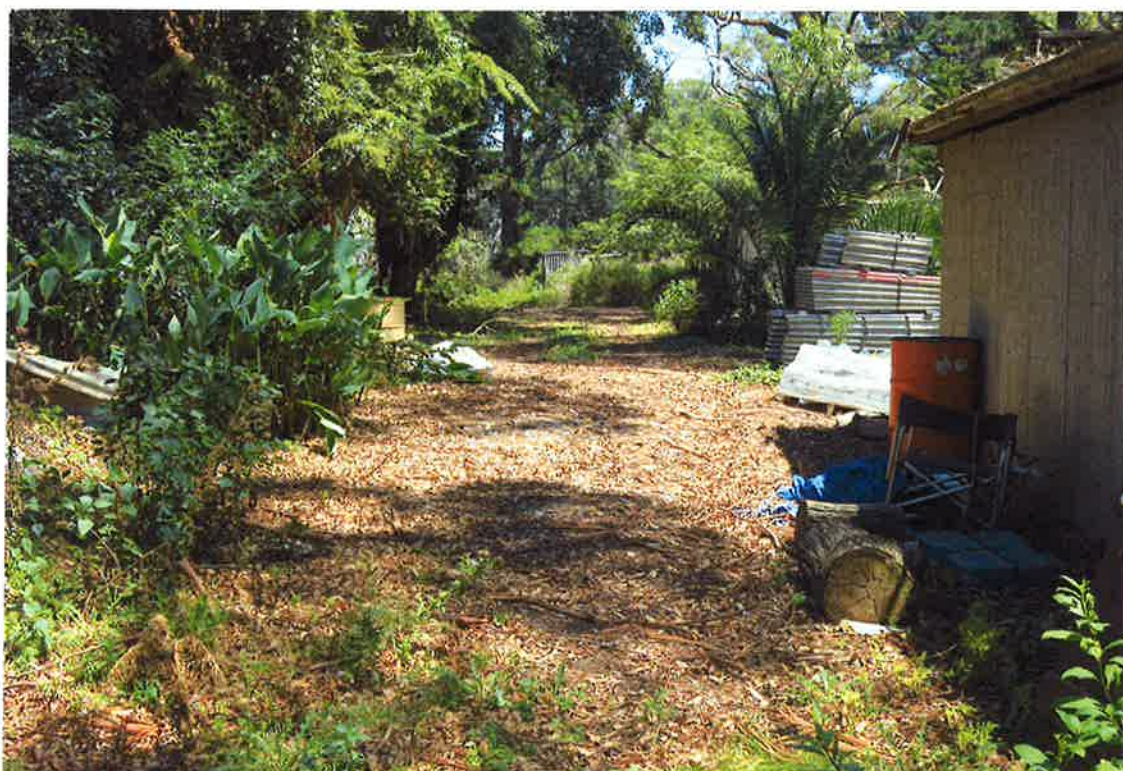
Figure 31: Remnant of the oval road that is behind the stables building in the north-east quadrant looking west (Source: CRM 2017)

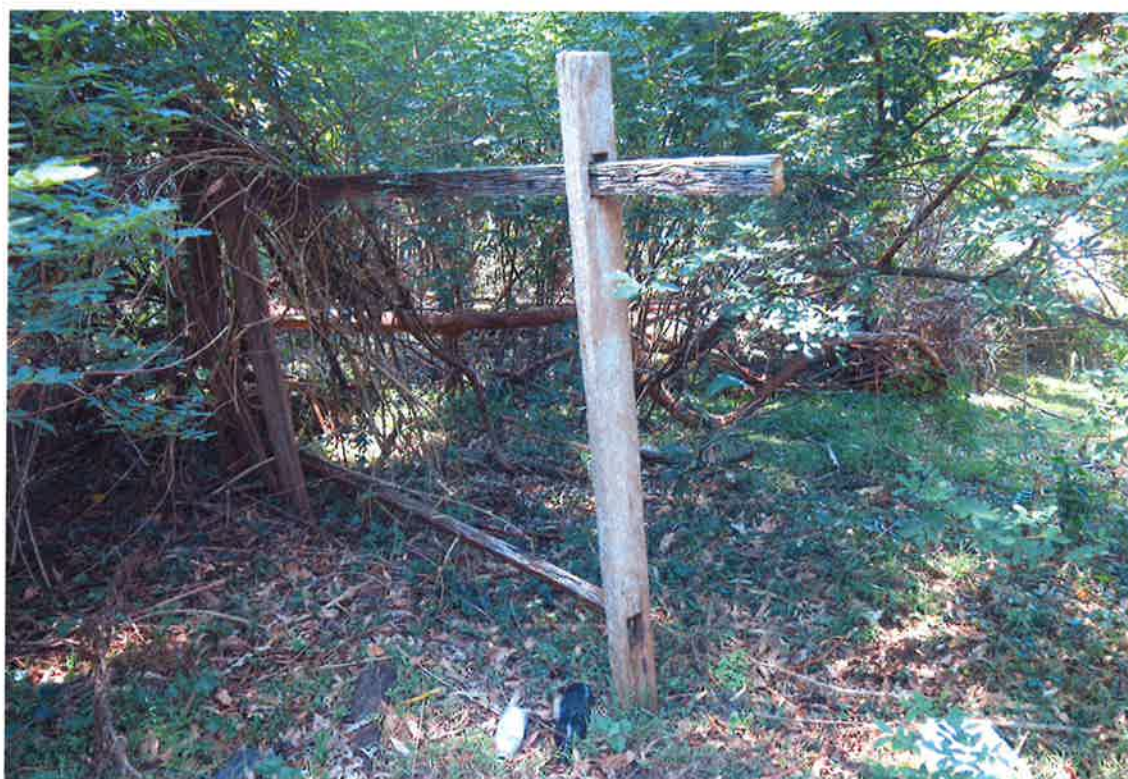
Figure 32: Remnant fence separating the formal gardens surrounding the house from the rest of the property (Source: CRM 2017)
