### 3.2.3 Assessment of Site Landscape

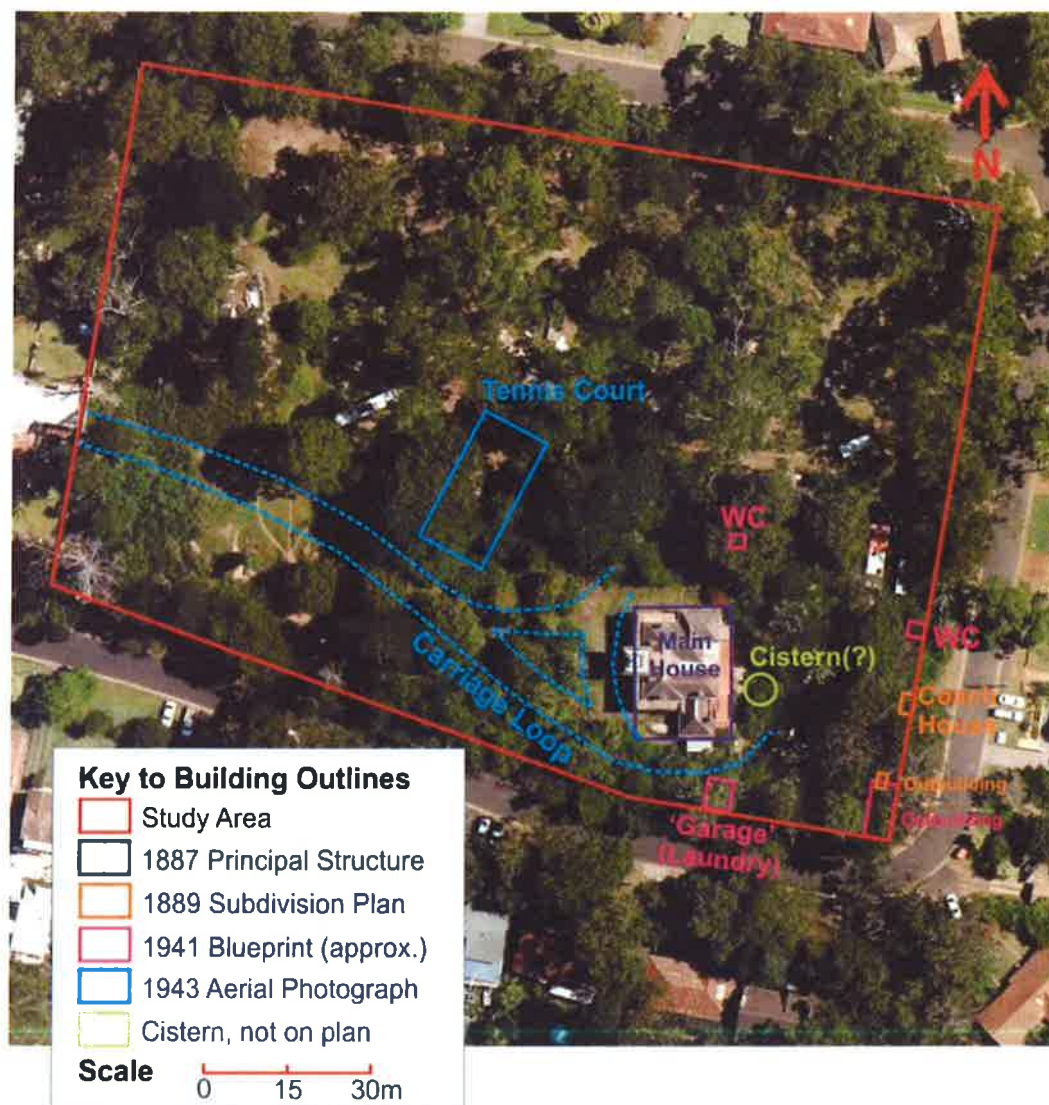
Figure 100: Satellite view of the current state of the study area with outlines showing the location of the outbuildings and other structural features shown on historic plans and aerial photographs of the site. This overlay shows where the expected archaeological remains are located. Source, SIX Maps, LPI, n.d.

The overlay maps show the likely location of remains within the study area (Figure 122). The potential mapping Figure 102) takes into consideration the likely remains and the impact from the existing state of the study area. In addition to the main building, the study area contains a number of outbuildings in various states of repair which indicate the ongoing and changing use of the grounds of the estate over the years. Historical research indicates that there have been no major impacts to the study area, but that various structures, landscaping and infrastructure have been constructed, altered and demolished throughout the last 130 years. The identified levels of archaeological potential are:

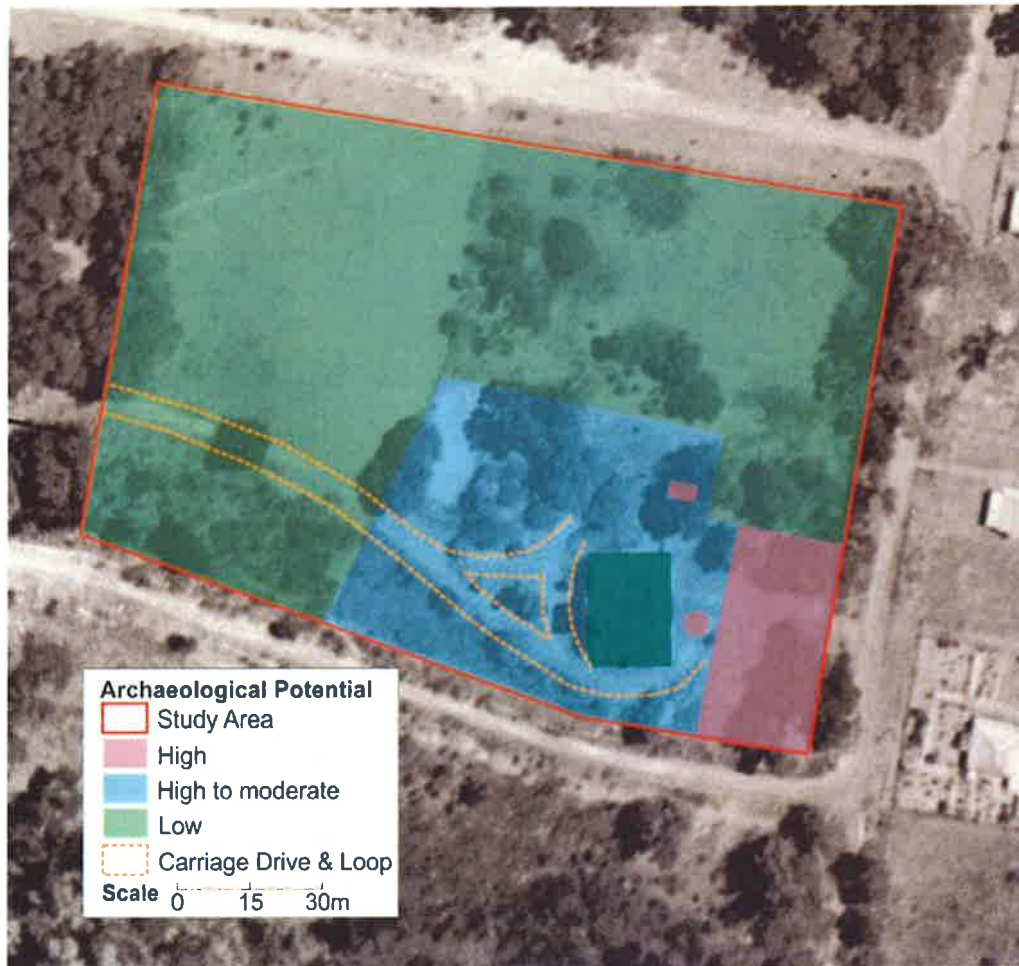
Figure 101: Areas of archaeological potential overlaid onto 1943 aerial photo, n.d.

**Moderate to Low Potential:** The proximity to the house means there may be unrecorded structures including possible early cesspits and other archaeological features such as rubbish dumps, garden features and evidence of land use including the formalised gardens and kitchen garden. The old carriage loop was also located in this area. Substantially intact archaeological remains could survive in these areas.

**Low Potential:** The main house itself is assessed as having only a low potential to contain possible occupation material. The north and west of the site are also assessed as having only low archaeological potential. No structures are recorded in these areas prior to the mid-20th century, however, unrecorded structures are possible. The old line of driveway which led toward the carriage loop was also located in this area. Other archaeological features such as rubbish dumps, garden features and evidence of land use are also possible.
