**RE SITE: 1-21 Dillwynnia Grove, Heathcote NSW 2233**

**DETAILED GEOTECHNICAL SITE INVESTIGATION REPORT  
FOR  
PROPOSED DEVELOPMENT  
AT  
1-21 DILLWYNNIA GROVE HEATHCOTE NSW 2233**

**Project No: SRE/275/HC/17**

# WASTE MANAGEMENT PLAN

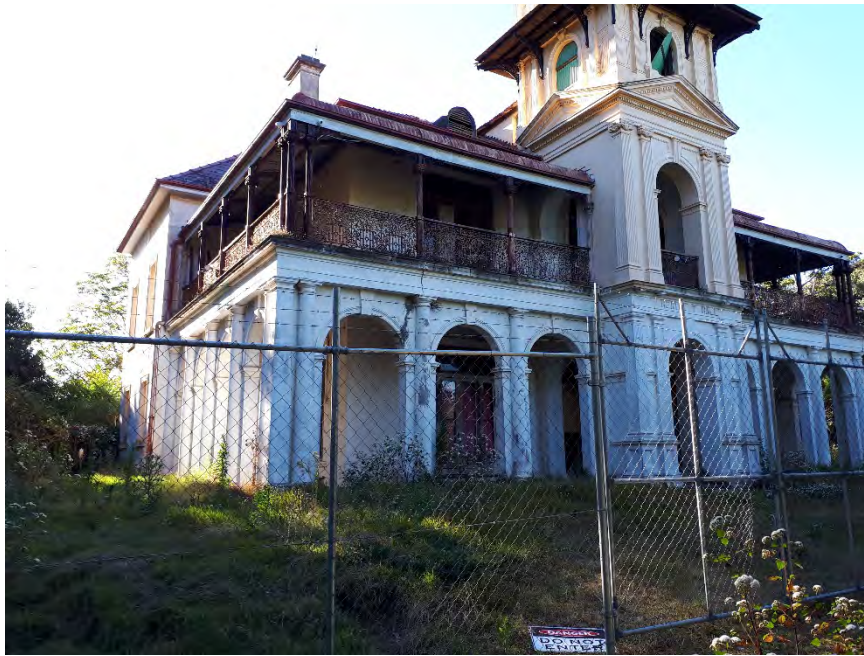
*Photograph 1: Heathcote Hall, seen from north-west*

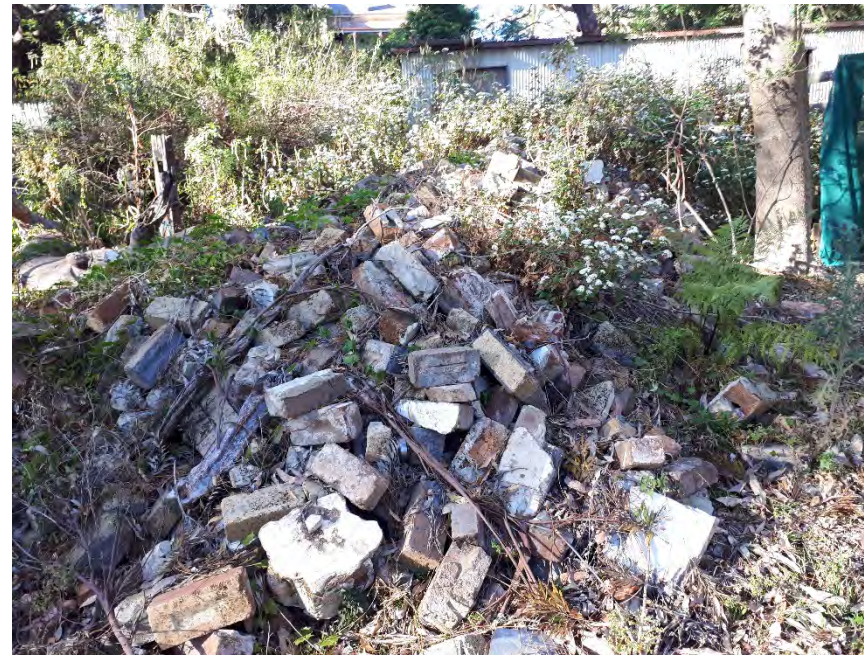
*Photograph 3: Building materials stockpile near central stables*

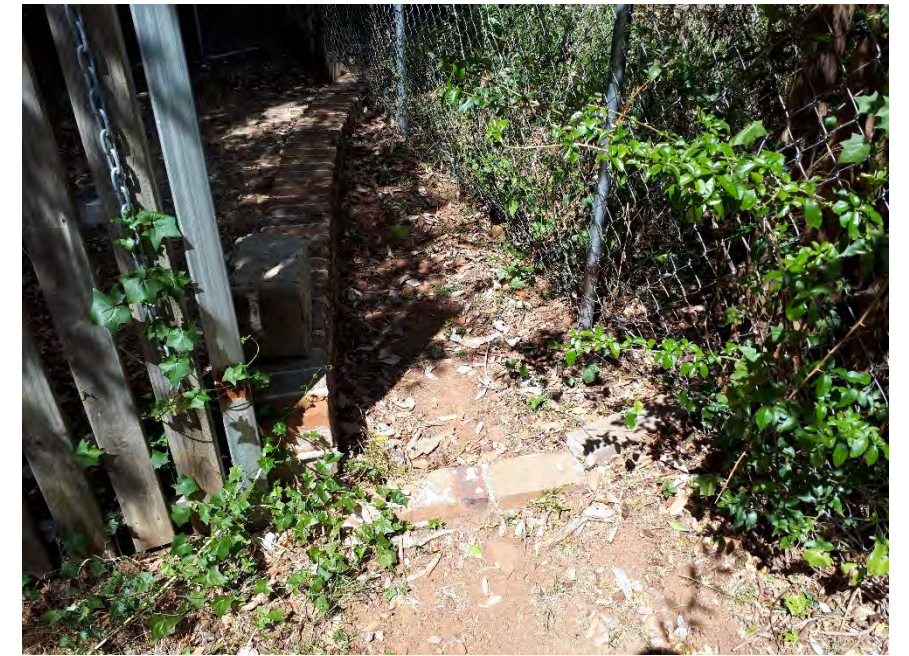
*Photograph 5: Potential asbestos containing material fragments on ground, south-west corner of garden area*

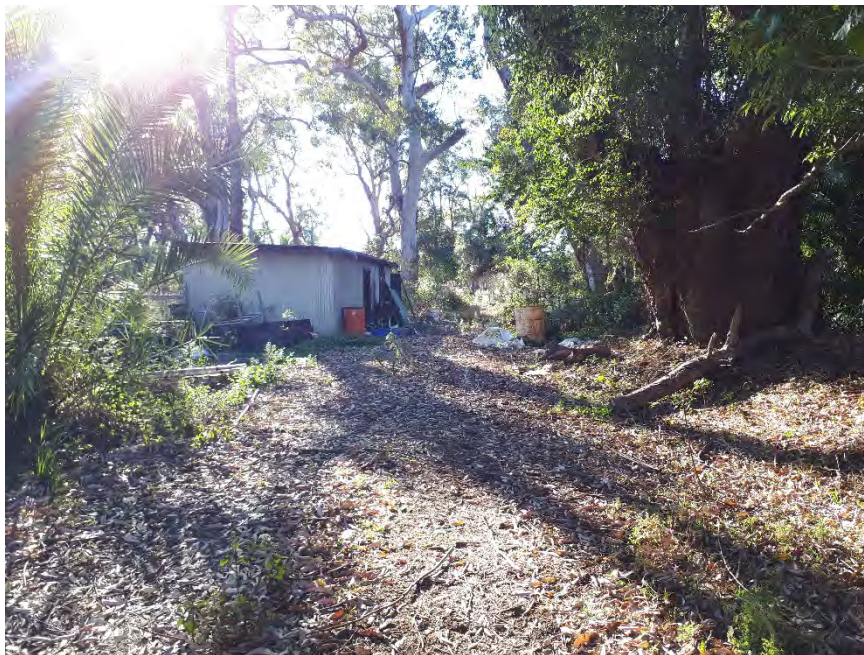
*Photograph 2: Central stables and drums, seen from west*

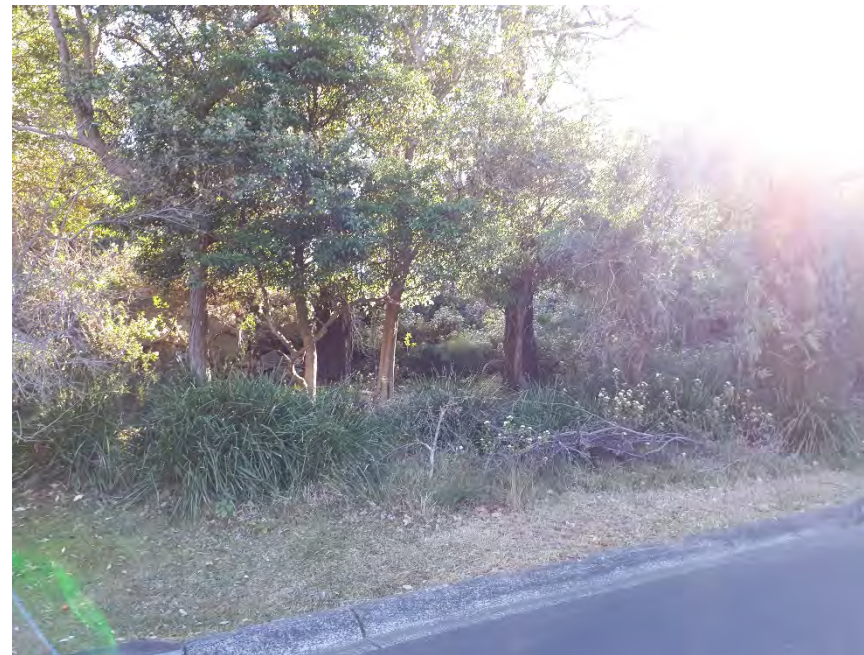
*Photograph 4: Fill embankment, south-west corner, seen from Dillwynnia Grove*

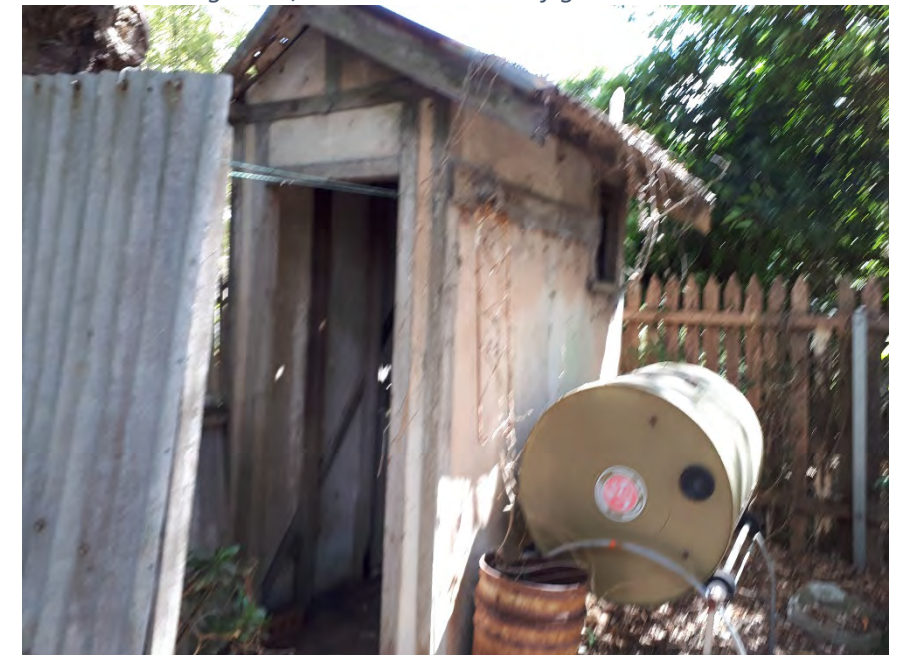
*Photograph 6: Outhouse in garden area*

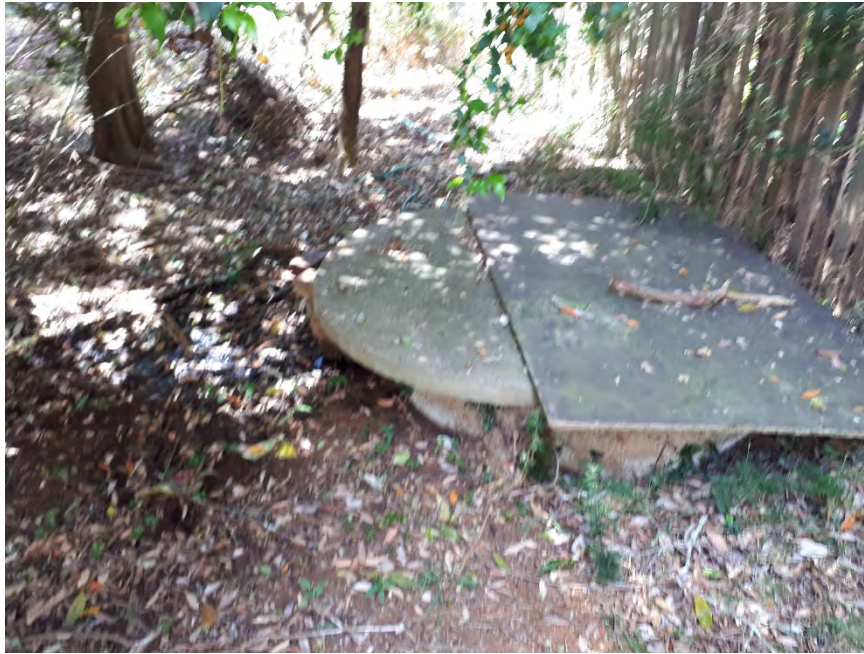
*Photograph 7: Septic tank, adjacent west of outhouse*

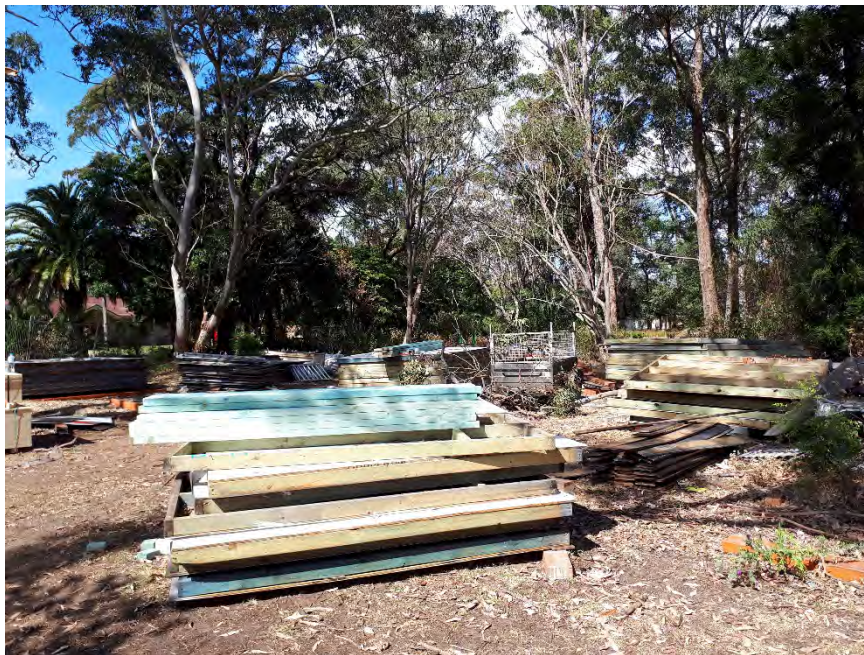
*Photograph 8: Hoarding and materials being stored onsite*

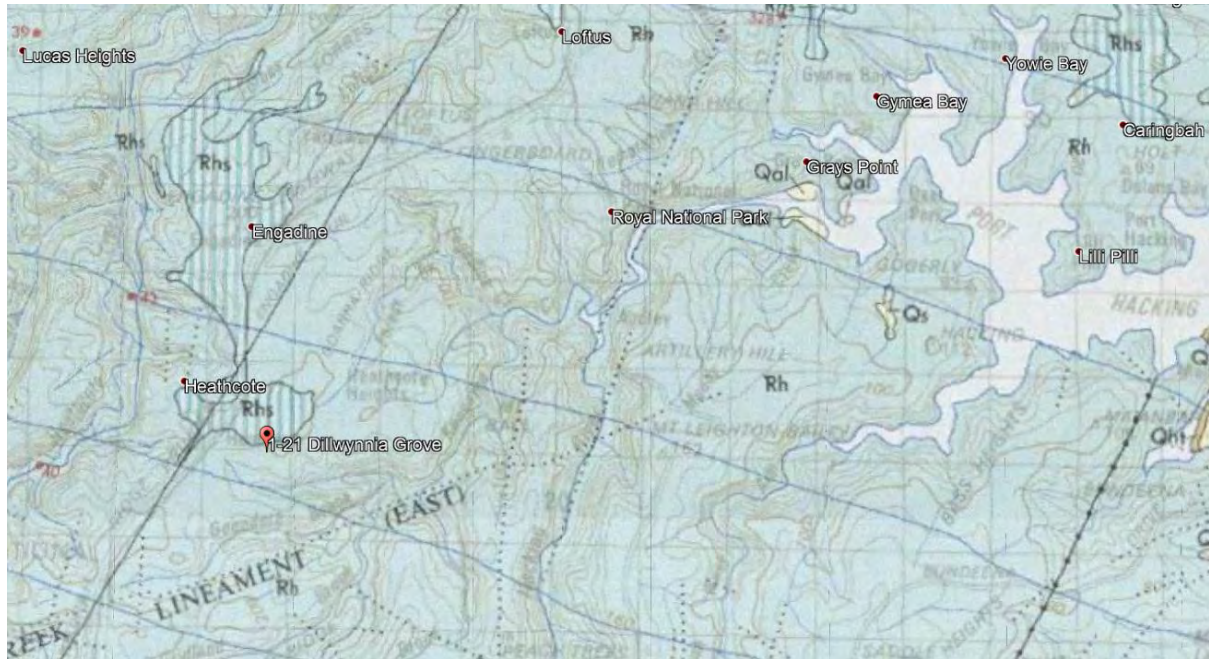
**Figure 1** – Portion of the of Wollongong – Port Hacking 1:100,000 sheet 9029-9129. Site area location highlighted in red/black dot.

Reference to the Geological Map of Wollongong – Port Hacking 1:100,000 sheet 9029-9129, it is indicated that the site is underlain by shale lenses occurring in the Hawkesbury Sandstone classified as “Rhs - claystone, siltstone and laminate shale lenses” from period of Middle Triassic in Mesozoic Era.

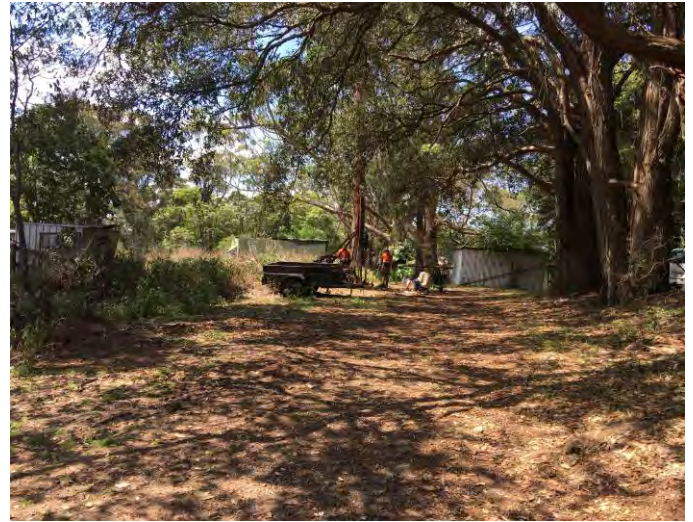
Photo 2 - North view to Borehole BH10 location - area of the proposed apartment building construction.

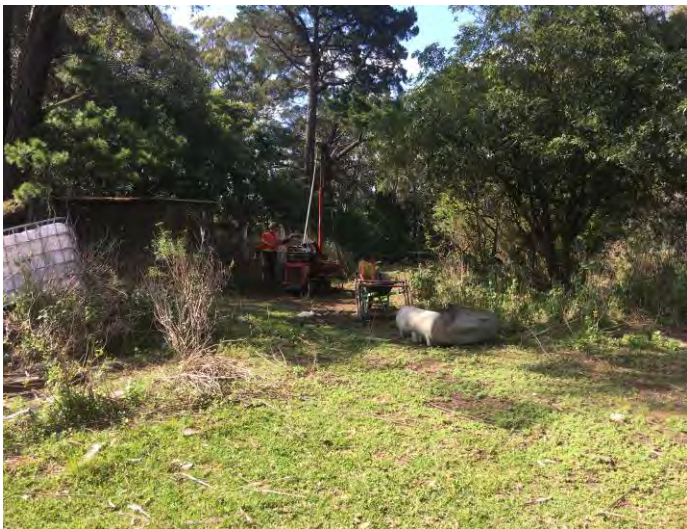
Photo 3 - North view to Borehole BH07 location - area of proposed townhouses construction located at west of the site.

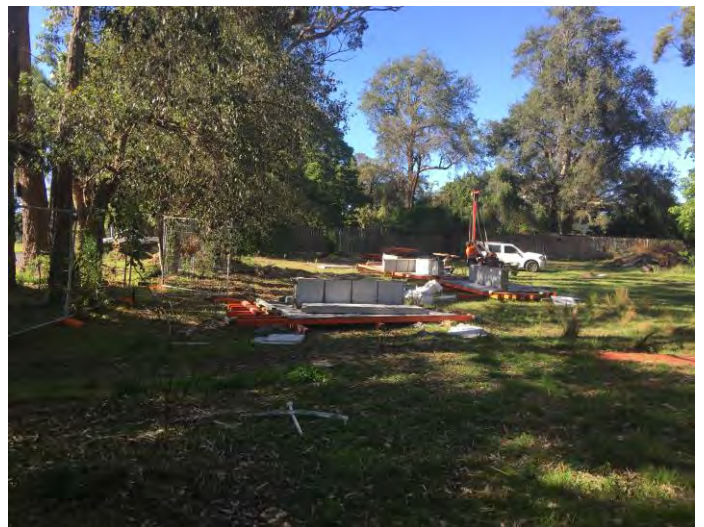
Photo 4 - South view to the Borehole BH12 location - area of the proposed townhouses construction located a East of the site.

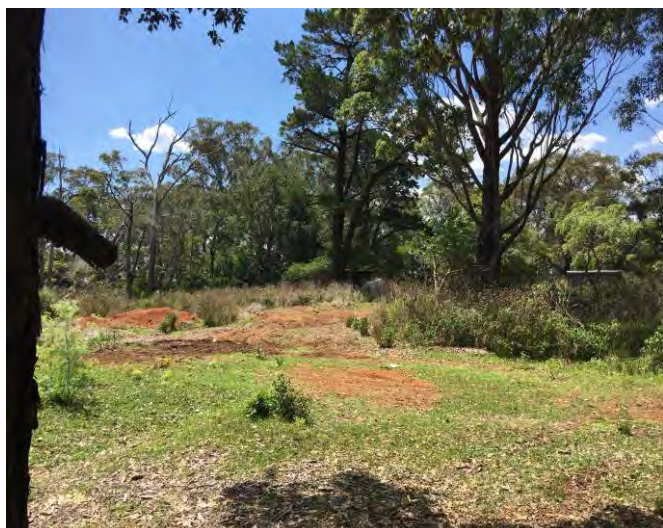
Photo 5 - South view to site boundary adjacent to Dillwynnia Grove, a small hill slopes down from site to road.

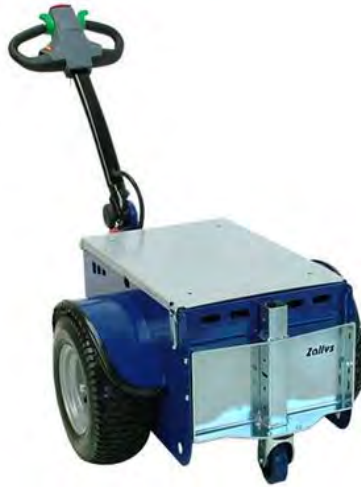
- Move trolleys, waste bin trailers and 660litre/1100 litre bins up and down a ramp incline. Ideal for Apartment Buildings (to move waste bins located at a basement level to road level).
- Quiet, smooth operation with zero emissions and simple to use, no driver's licence required

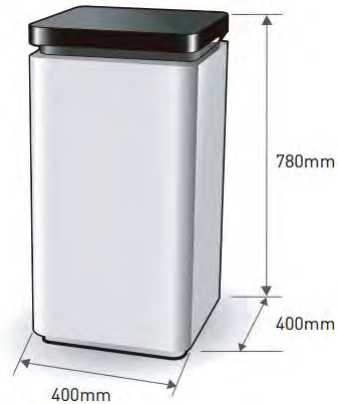
### Product Specifications

| Decomposition Method | Fermentation by microorganisms |
