CONSERVATION MANAGEMENT PLAN

North Cronulla Surf Club

62 Prince Street, Cronulla

FINAL 2 MAY 2018

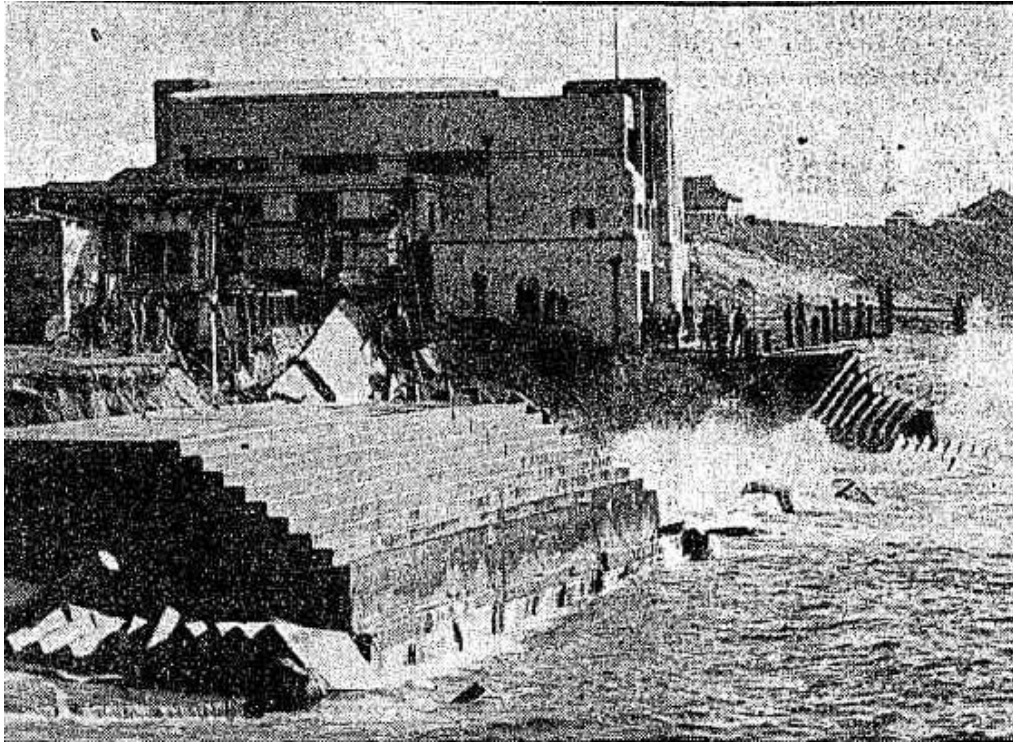
Figure 16 — Collapsed seawall, kiosk and surf pavilion at North Cronulla. (Source: 'Council will Abandon Clubhouse to the Sea', *The Sun*, 27 August 1946, p.3.)

Sutherland Shire Council alleged that the collapse was because of the removal of sand for the tank trap that had been dug in front of the wall. The army, on the other hand, maintained that this had only 'accelerated by a few hours' the inevitable collapse of the wall 'due to its defective design'. The case eventually went to arbitration.

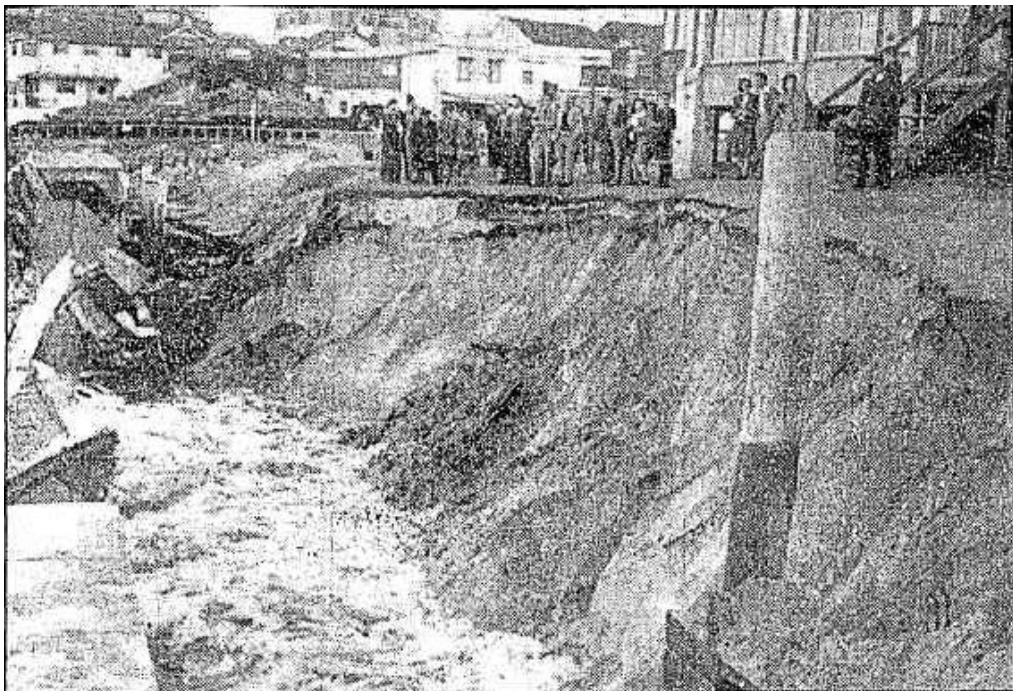
Figure 17 — Collapsed seawall, kiosk and surf pavilion at North Cronulla. (Source: 'Council will Abandon Clubhouse to the Sea', *The Sun*, 25 August 1946, p.1.)

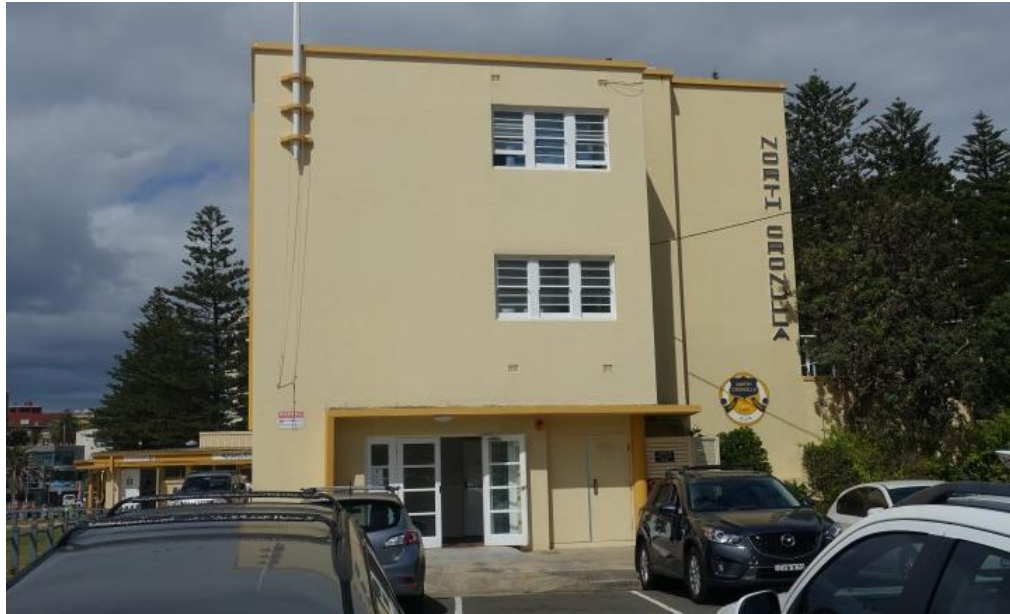
Figure 43 – Front (north) elevation. (Source NBRsArchitecture, March 2018)

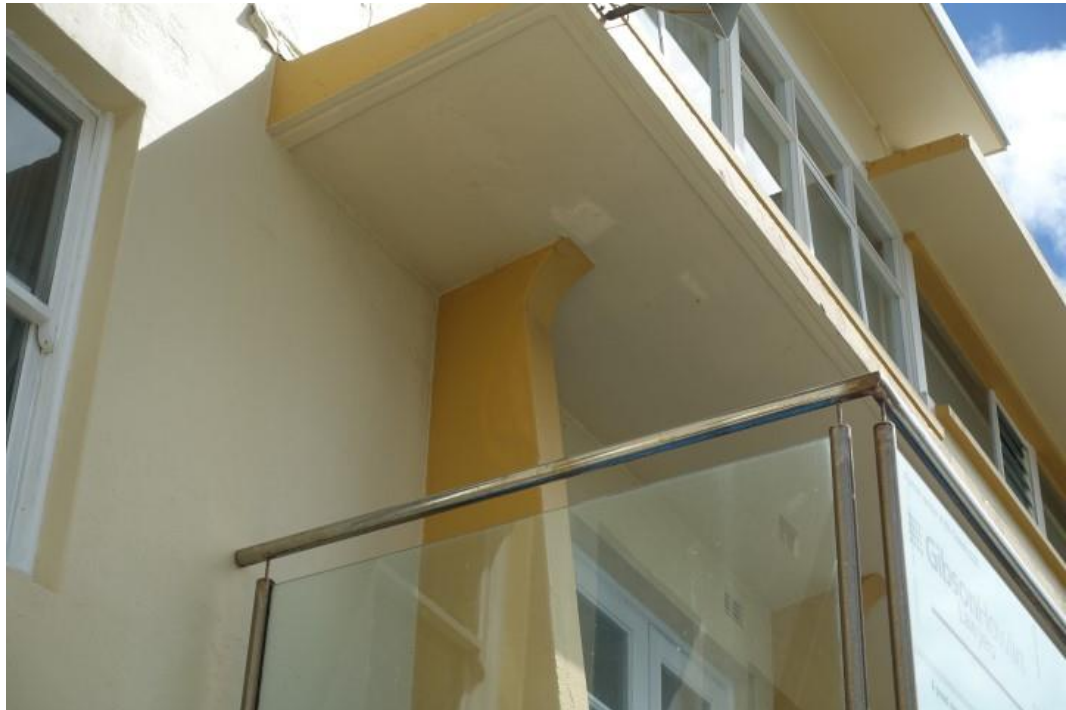
Figure 47 – Detail of reinforced concrete balcony and sunshade on east elevation. (Source NBRSArchitecture, March 2018)

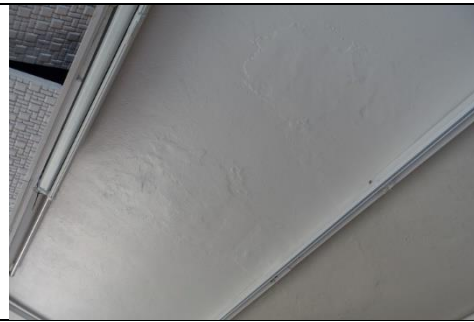
Figure 58 – Damp damage to plaster ceiling over stage in function room. (Source NBRSArchitecture, March 2018)

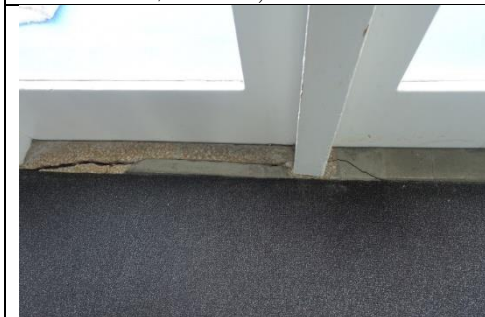
Figure 59 – Cracking in terrazzo door sill to balcony on first floor. (Source NBRSArchitecture, March 2018)

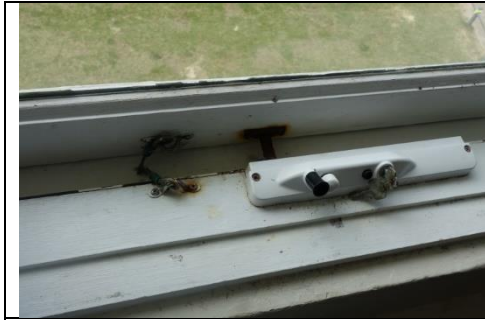
Figure 65 – Corrosion to window winders on second floor. (Source NBRSArchitecture, March 2018)

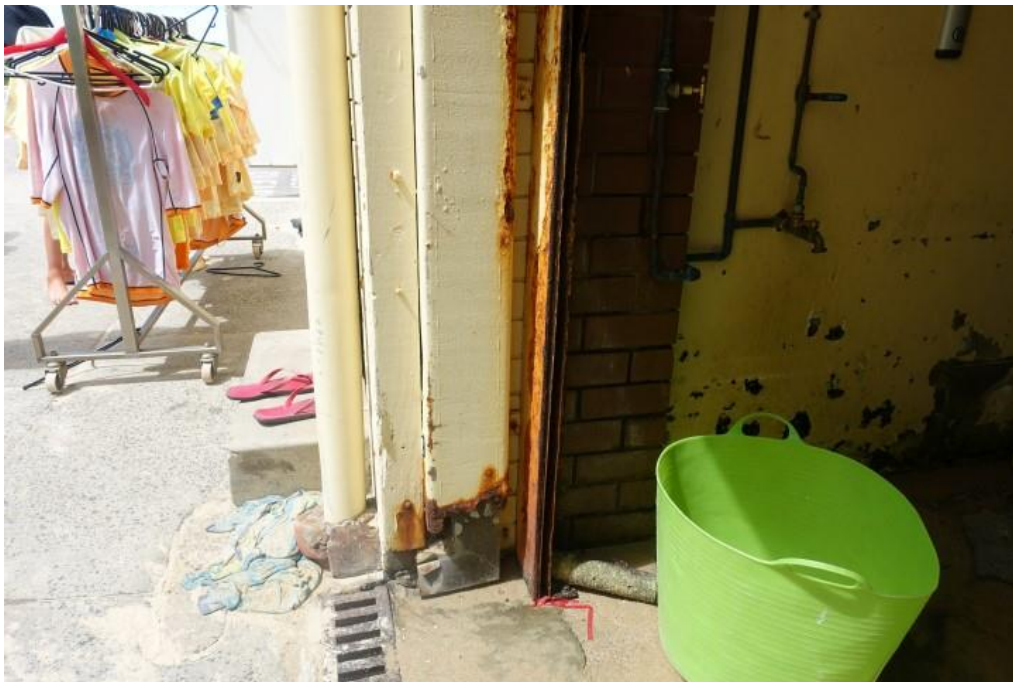
Figure 74 – Corroded door frame to boat shed. (Source NBRSArchitecture, March 2018)

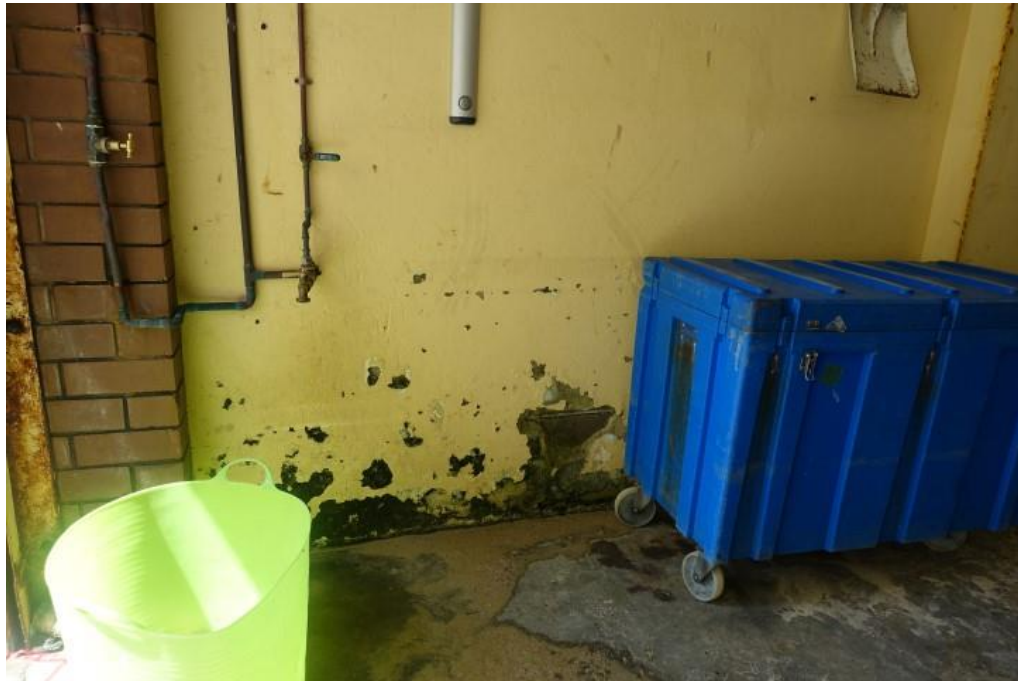
Figure 75 – Damp damage to walls in boat shed. (Source NBRArchitecture, March 2018)

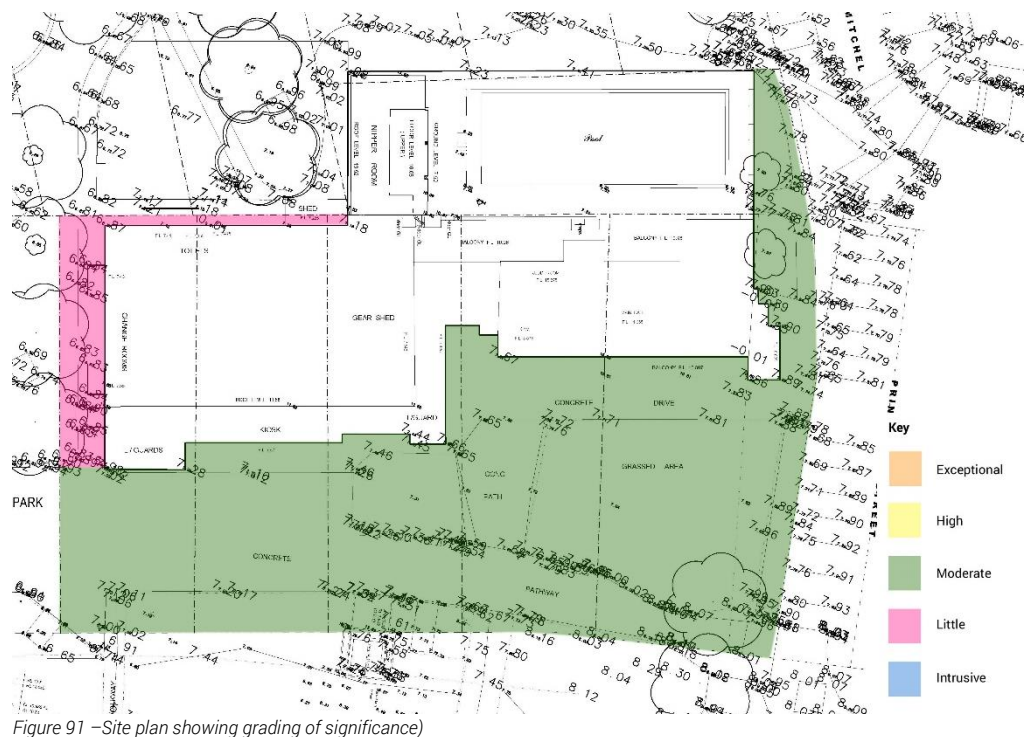
Figure 91 –Site plan showing grading of significance)

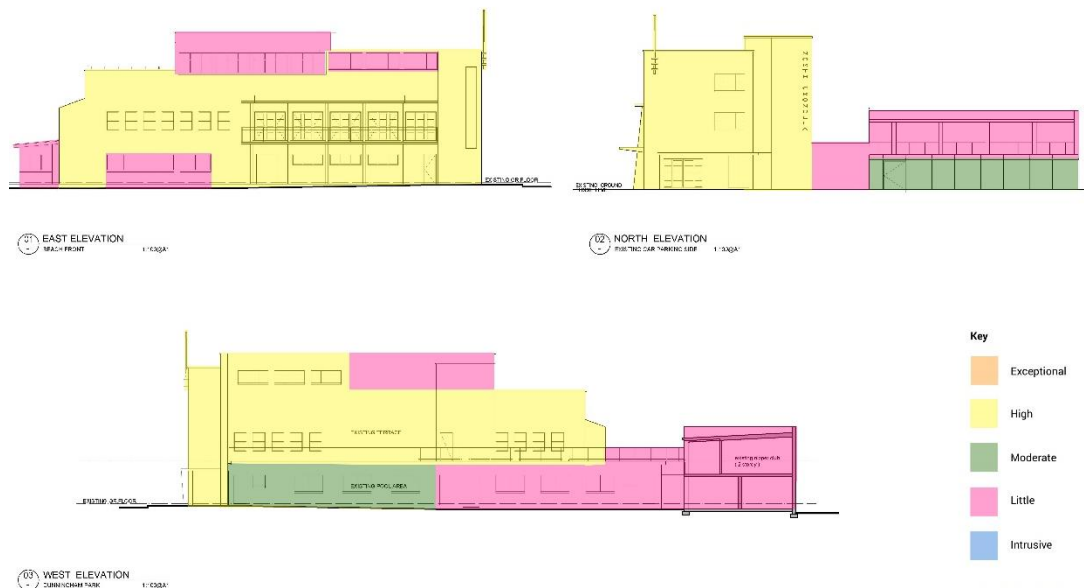
Figure 95 –Elevations showing grading of significance
