PRELIMINARY SITE INVESTIGATION

**449 Victoria Street,
Wetherill Park NSW**

JS Architects Pty Ltd

30th November 2016

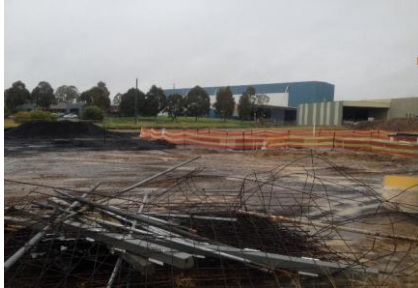
Photograph N° 1

View of: excavation area and road base stockpile
Looking south west
Inspected on 01.09.2016

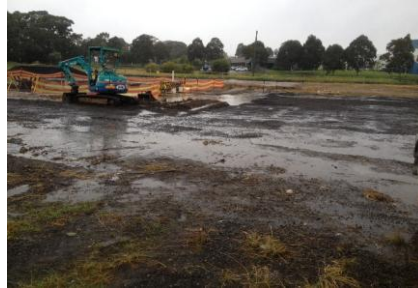
Photograph N° 2

View of: excavation area
Looking south
Inspected on 01.09.2016

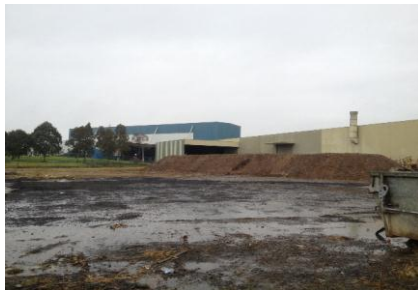
Photograph N° 3

View of: excavated stockpile
Looking south west
Inspected on 01.09.2016

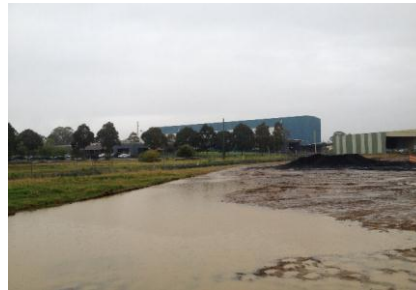
Photograph N° 4

View of: southern portion of site
Looking west
Inspected on 01.09.2016

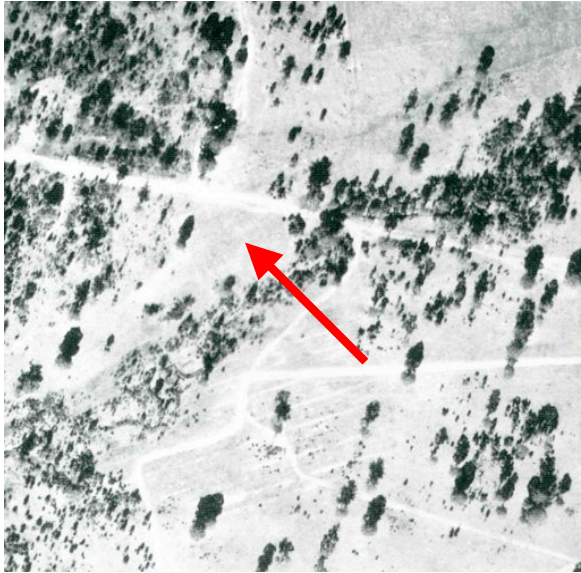
<p>1951 Closeup – Block of land part of a larger property and appears to be used as pasture land (fences, tracks). The line of trees marks the creek bed (Wetherill Park Drain / Canal)</p> <p>Further afield to the east and south (approx.1 km) are complexes of cropland and orchards.</p>

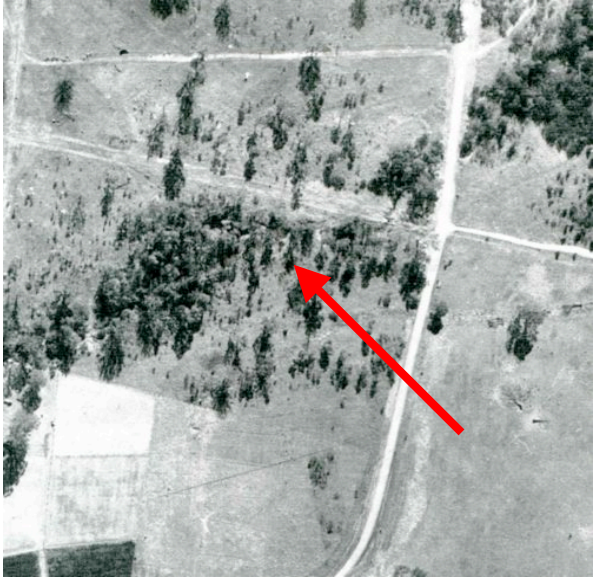
<p>1970 Closeup - Block of land part of a larger property and appears to be used as pasture land (fences, tracks). The line of trees marks the creek bed (Wetherill Park Drain / Canal).</p> <p>Larger blocks to the north and east have been sub-divided into residential farmlets.</p>

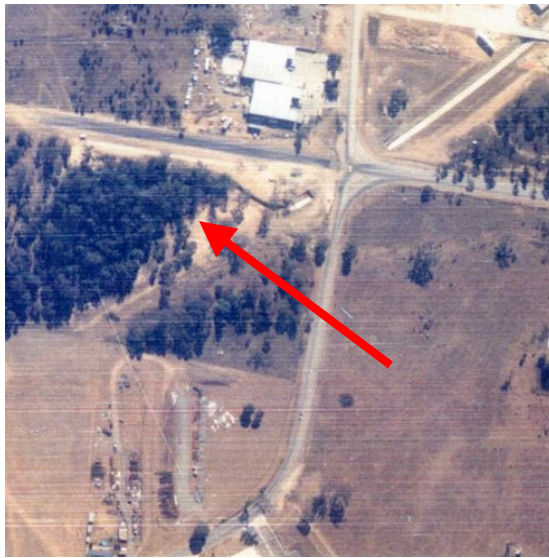
1986 Closeup Trees and scrubs are still in situ on the block which appears undeveloped. Industrial activity and warehouses are located to the northeast, east and southeast of the block – though there are many empty areas.

The Wetherill Park Drain is being constructed and the underground bypass under the convergence of Victoria Street and Newton Road was being undertaken at the time of the shot.

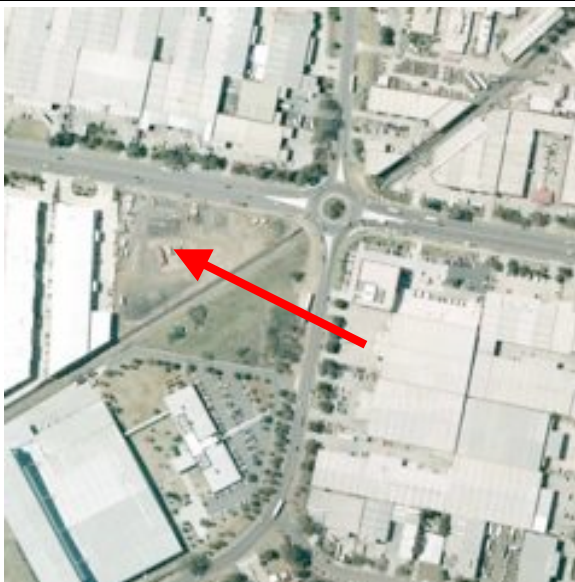
Recent – The block is being used to store machinery. Major warehouse construction has occurred on all surrounding blocks except that directly on the southern side of the concrete drain.

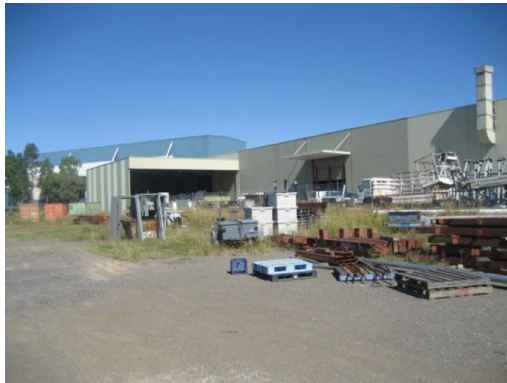
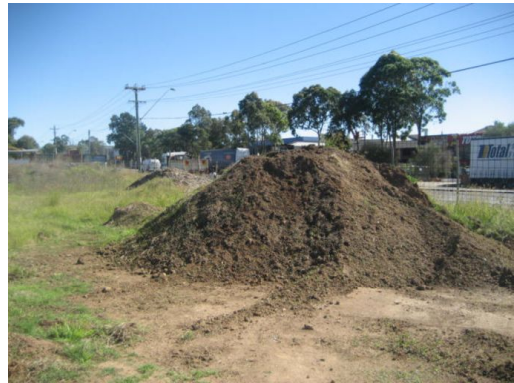
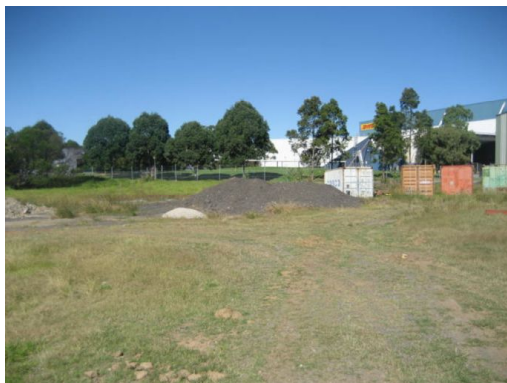
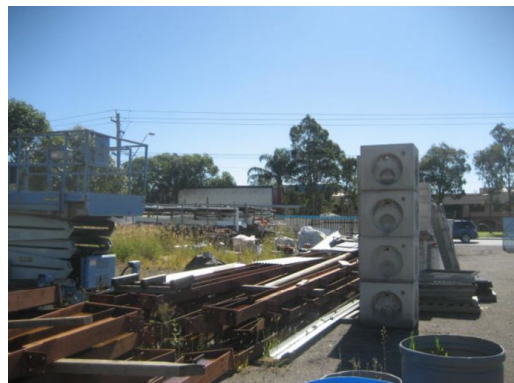
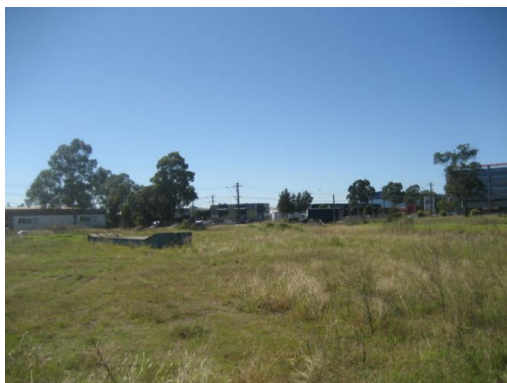
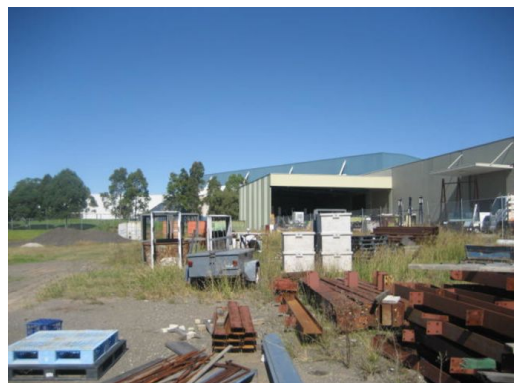
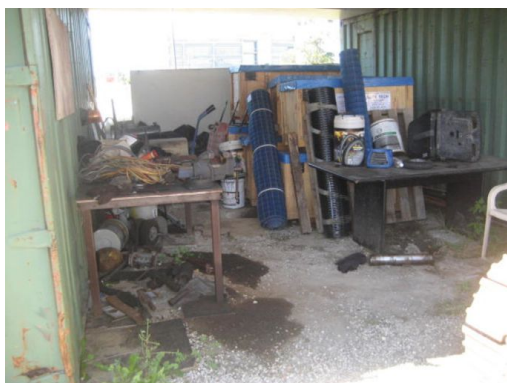
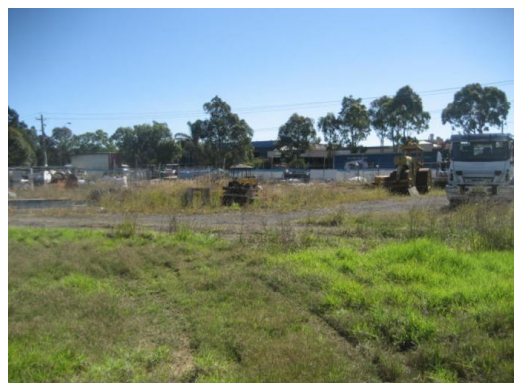
*Appendix A - PHOTOGRAPHS : Stage 1 ESA : 449 Victoria St, Wetherill Park NSW
(EBG-02295.Stage1.ESA)*

The block is vacant. The site is being used to store some machinery and building materials. The property has been cleared. The surface is covered with low scrubs, weeds and grasses. The vegetation appears to be in good condition. A number of stockpiles of suspected imported fill material were located in two isolated areas.

A small machinery shed is located facing Victoria Street. This has been used to house and work on machinery and vehicles. There are a number of shallow oil stains on the ground around this area.

R3. Oil Stained Soil Around Shed and Compound
