GEOTECHNICAL INVESTIGATION REPORT

26-28 Shepherd Street, Liverpool, NSW

El Report No. E23125 GA Rev2

Date: 21 December 2016

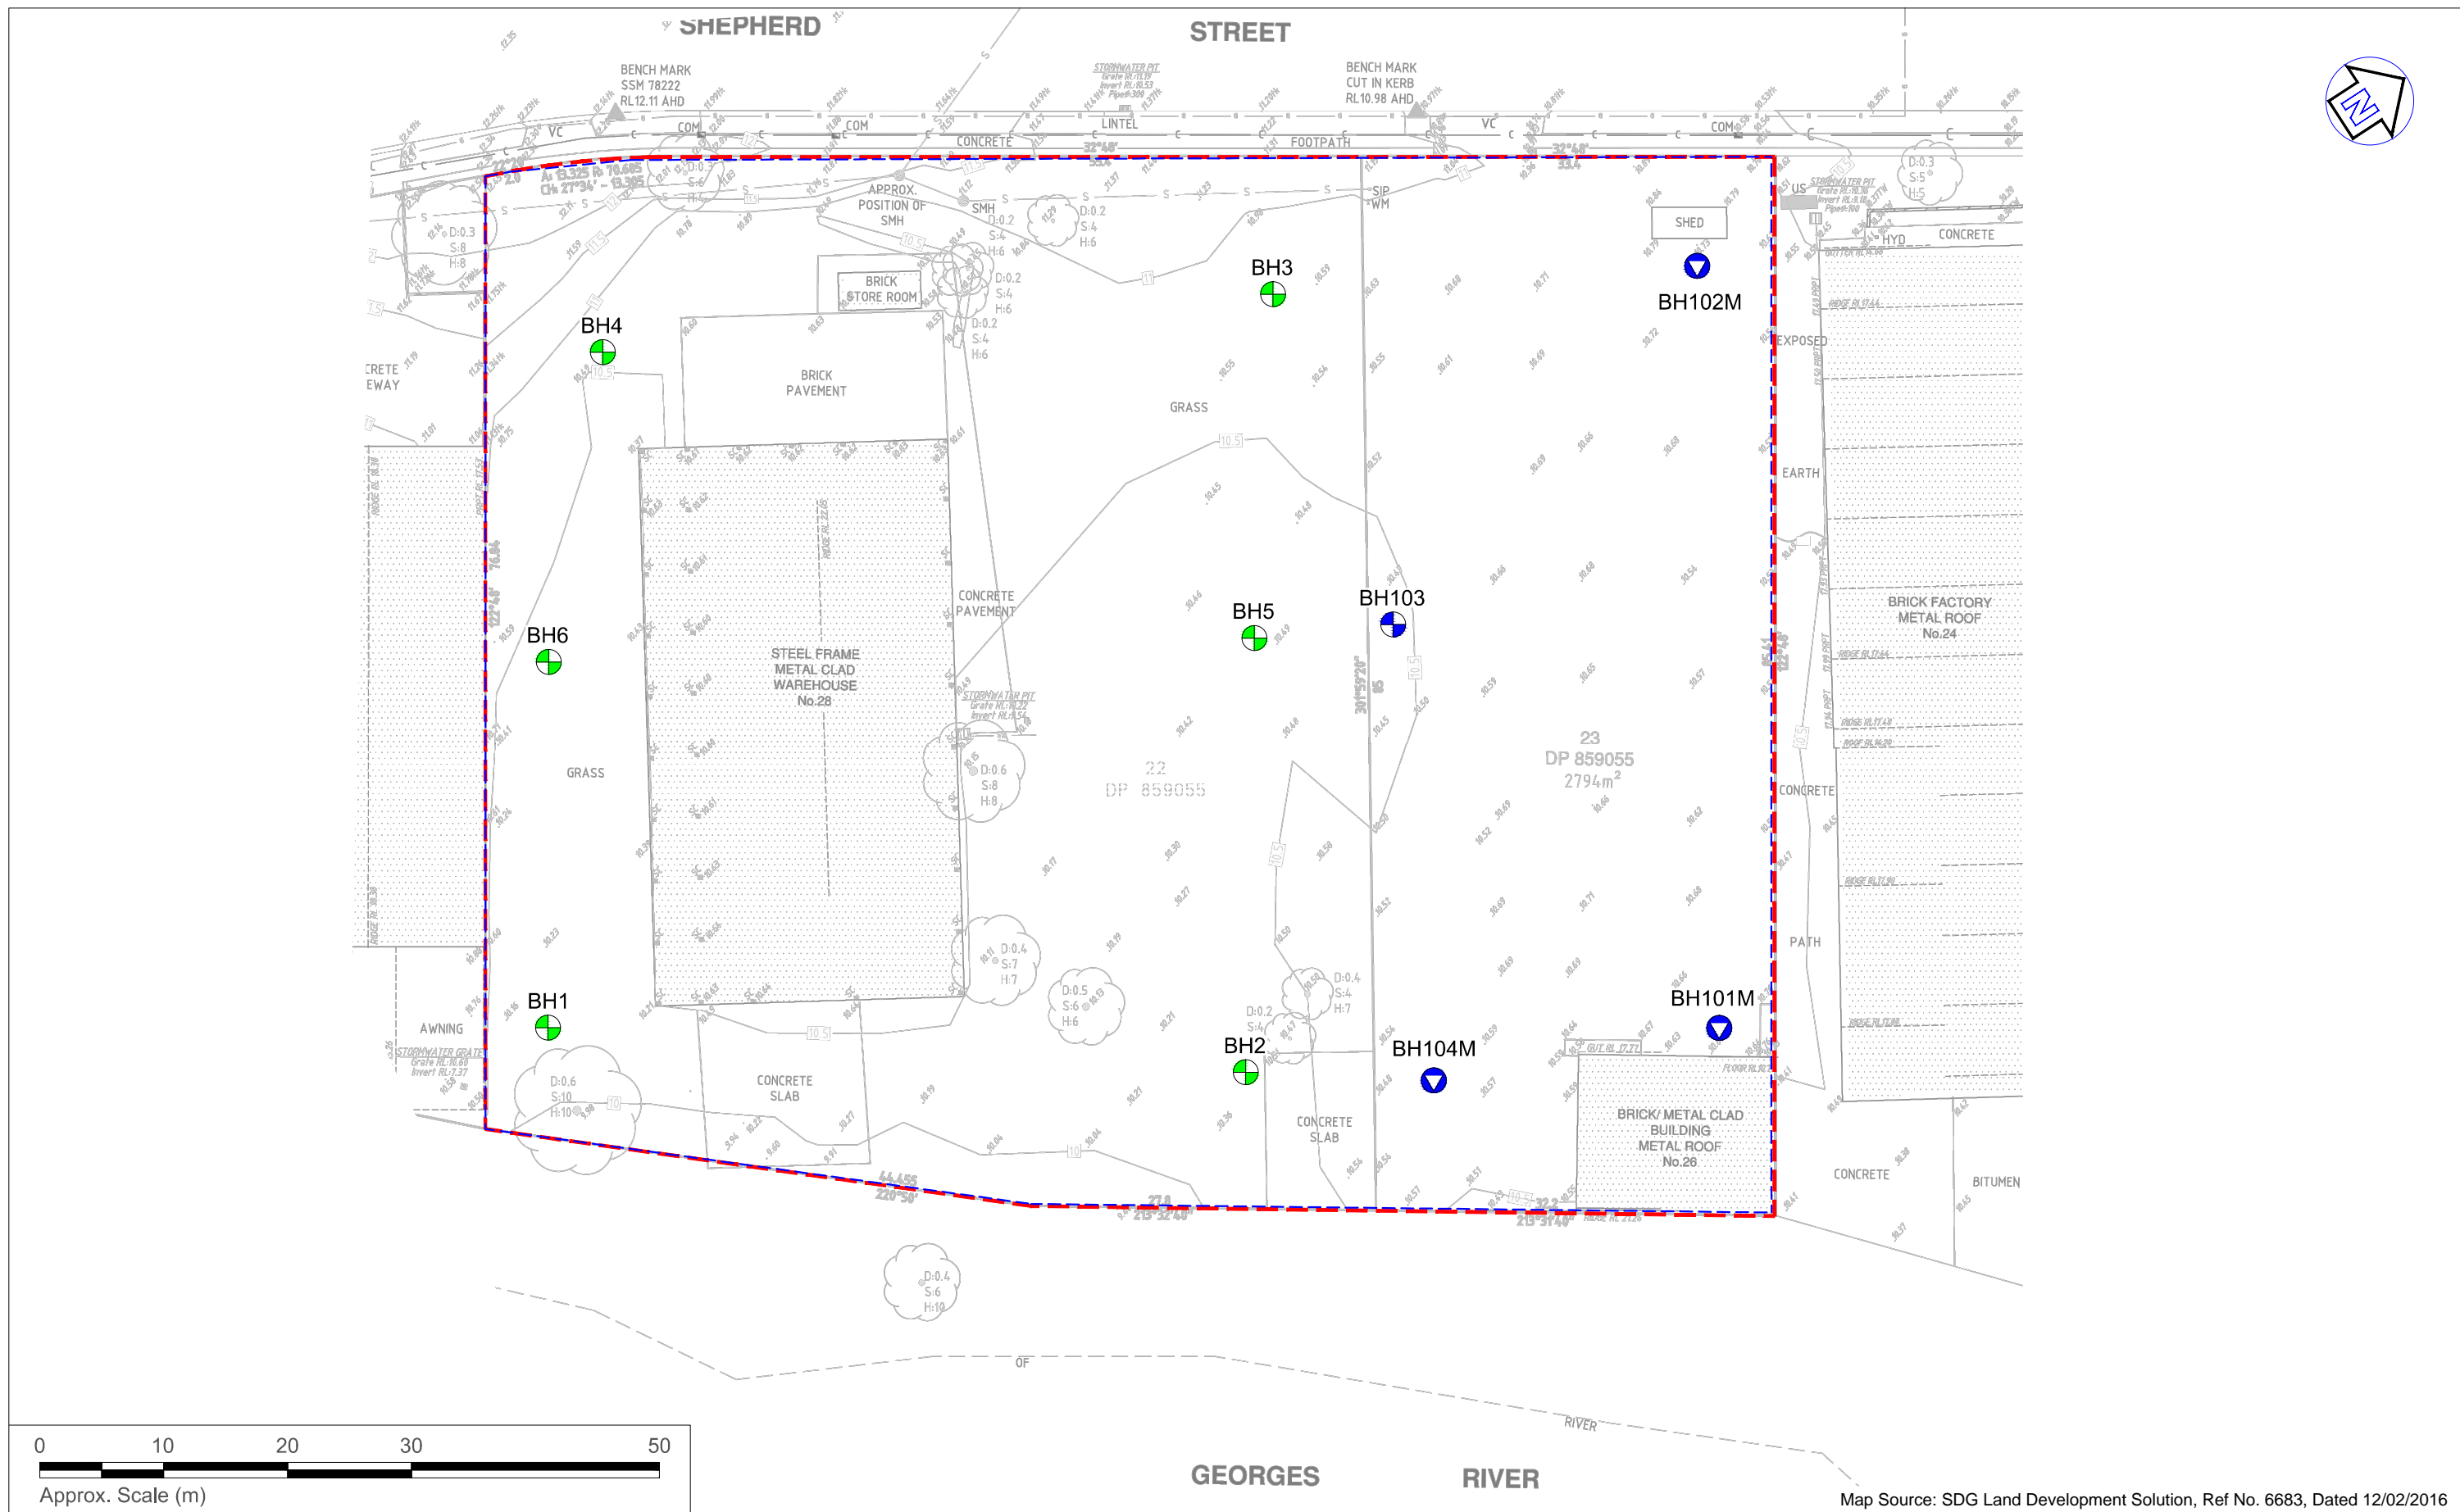
LEGEND <ul style="list-style-type: none">Approximate Site BoundaryApproximate basement outlineApproximate borehole locationApproximate borehole/ monitoring well locationApproximate previous borehole location (Asset, Ref. 2936-R1, dated 15 April 2015)	  <p>Contamination Remediation Geotechnical</p> <p>Suite 6.01, 55 Miller Street, PYRMONT 2009 Ph (02) 9516 0722 Fax (02) 9518 5088</p>	Coronation (26 Shepherd Street) Pty Ltd Geotechnical Investigation 26-28 Shepherd Street, Liverpool NSW Borehole Location Plan	Figure: 2 Project: E23125 GA
	Drawn:	S.K.	
	Approved:	J.P.	
	Date:	16/11/16

- 1 Site Locality Plan
- 2 Borehole Location Plan

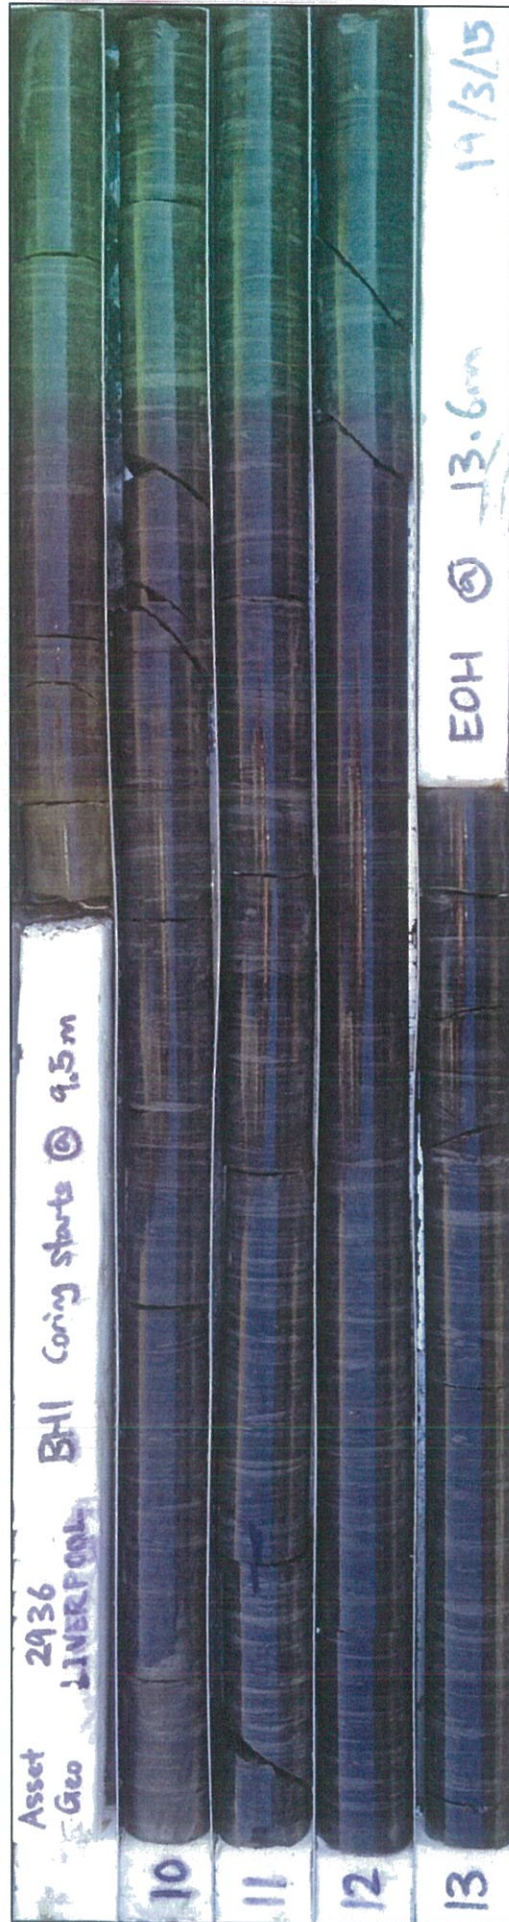
NMLC				9.5		SHALE, dark grey, well developed, thinly laminated to medium bedded	SW		D=0.35 A=0.34		JT 20° cu sm cl
				10

ASSET GEOTECHNICAL geotechnical engineering consultants info@assetgeotechnical.com.au SYDNEY 2.05/56 Delhi Rd North Ryde NSW 2113 Ph: 02 9878 6005 Fax: 02 8282 5011		PROPOSED RESIDENTIAL DEVELOPMENT 28 SHEPHERD STREET, LIVERPOOL for CORONATION PROPERTY CO. PTY LTD		drawn: JZ date: 27.03.15	job no.: 2936
		CORE PHOTOS - BH1		checked: MAB scale: 1:4 A4	fig: — issue: A

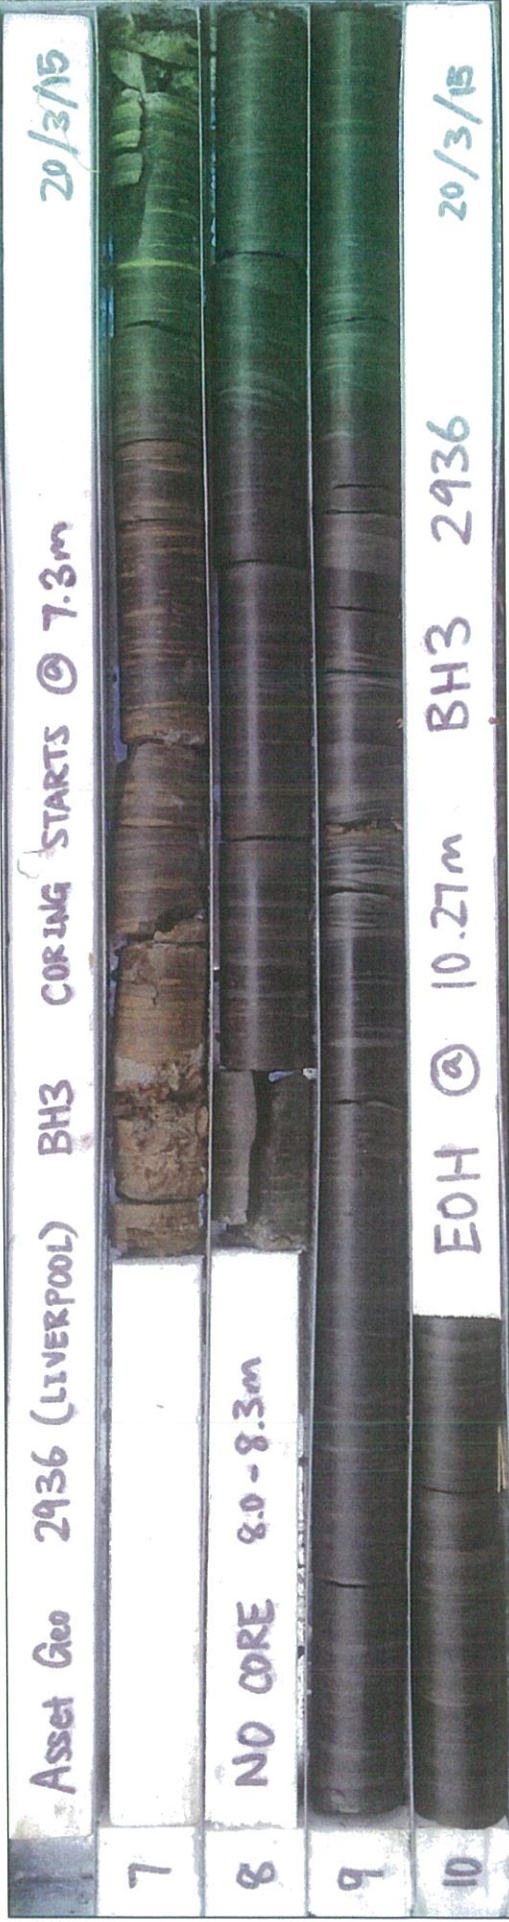
8.3	SHALE, dark grey, well developed, thinly laminated to medium bedded
		9	
		10	
		10.27	BH3 terminated at 10.27m
		11	
		12	
		13	
		14	
		15	
		16	
		17

ASSET GEOTECHNICAL geotechnical engineering consultants info@assetgeotechnical.com.au SYDNEY 2.05/56 Delhi Rd North Ryde NSW 2113 Ph: 02 9878 6005 Fax: 02 8282 5011		PROPOSED RESIDENTIAL DEVELOPMENT 28 SHEPHERD STREET, LIVERPOOL for CORONATION PROPERTY CO. PTY LTD CORE PHOTOS - BH3		drawn: JZ date: 27.03.15 checked: MAB scale: 1:4 A4	job no.: 2936 fig: — issue: A
--	--	---	--	--	-------------------------------------
