STATEMENT OF HERITAGE IMPACT

263 Queen Street Campbelltown NSW 2560

MARCH 2017

STATEMENT OF HERITAGE IMPACT FOR 263 QUEEN STREET, CAMPBELLTOWN

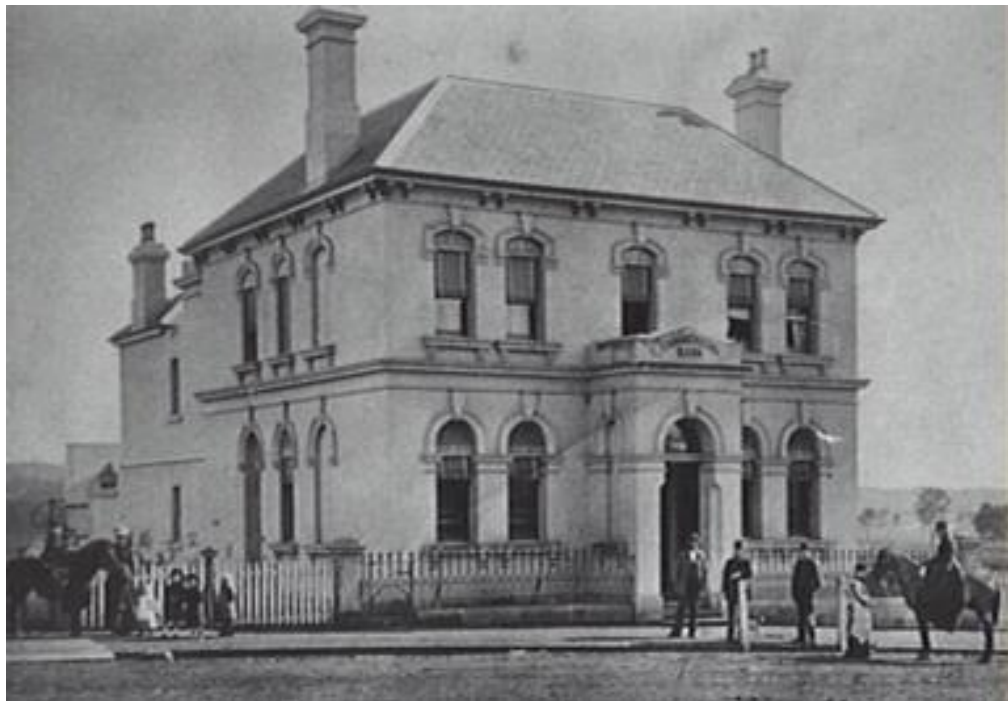
Figure 3 – Commercial Bank, 1881. (Source: CBC Officers' Club Inc www.cbcbank.com.au)

- The early colour schemes have been investigated. The 1880s building will be repainted in a scheme that references the original and likely second colour schemes, see in Figure 3 and Figure 6.

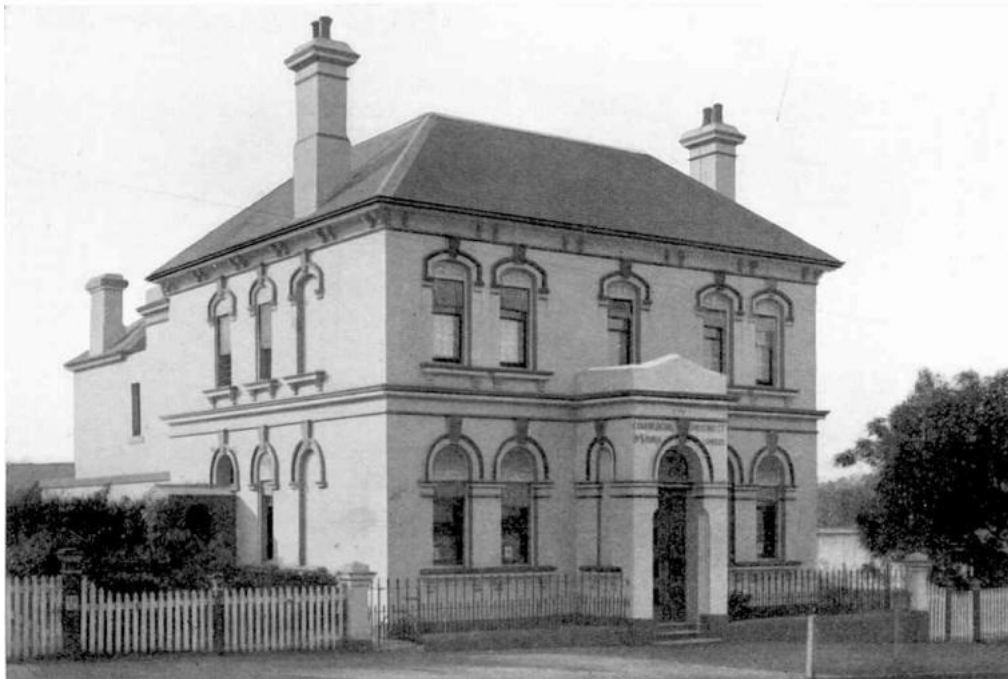
Figure 6 – CBC, 1934? (Source: A Century of Banking: The Commercial Banking Company of Sydney 1834-1934)

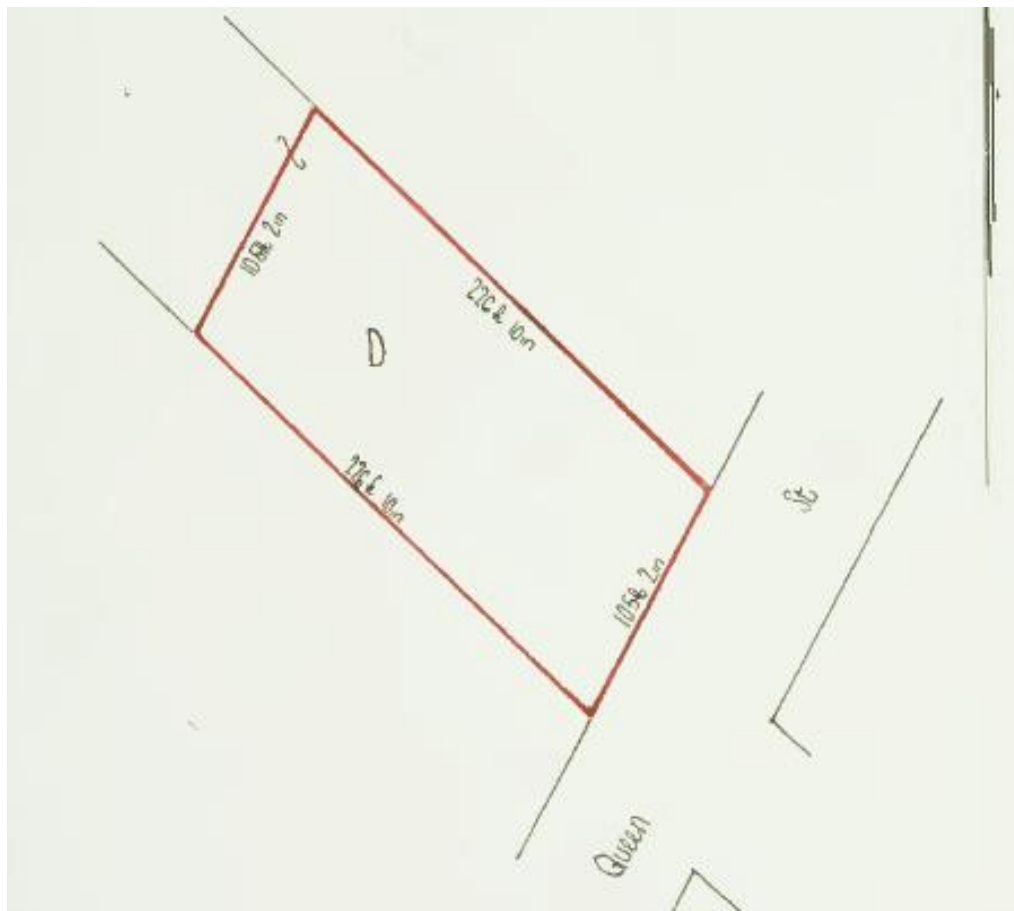
Figure 8 – Block plan accompanying Certificate of Title Vol 7904 Fol 176, May 1960. (Source: NSW Land & Property Information)

In 1948 and 1949, conveyed part of their land to Keith Charles Smart and Samuel William Bursill⁵ but retained Lot D comprising one acre thirty-five and one quarter perches of land. In 1959, they transferred another portion of their land (Lot C) to the Commonwealth of Australia, leaving a residue of two roods and four 4 perches (Lot D).⁶ In the 1960s, a newer commercial building was built to the rear of the site, however there was no physical connection between the buildings and this 1960s building was demolished for the existing commercial development at the rear.

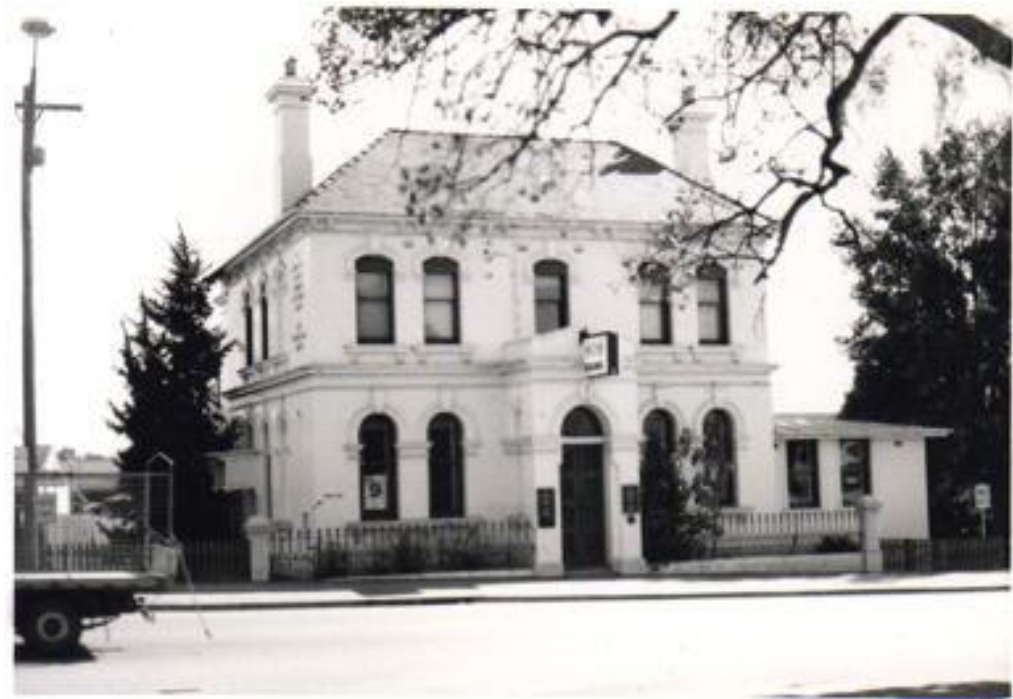
Figure 9 – Street elevation of CBC, c1960-70 / Steven Roach. (Source: Steven Roach Collection - Campbelltown City Library Local Studies Collection)

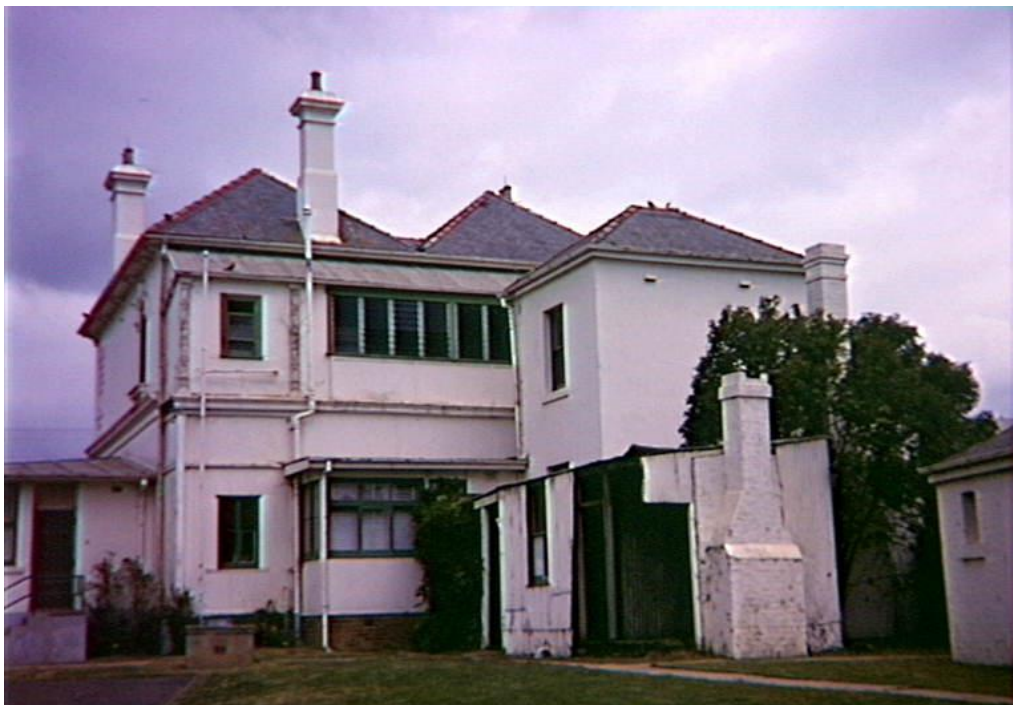
Figure 10 – Rear elevation of CBC, October 1981 / Verlie Fowler. (Source: Campbelltown City Library Local Studies Collection)

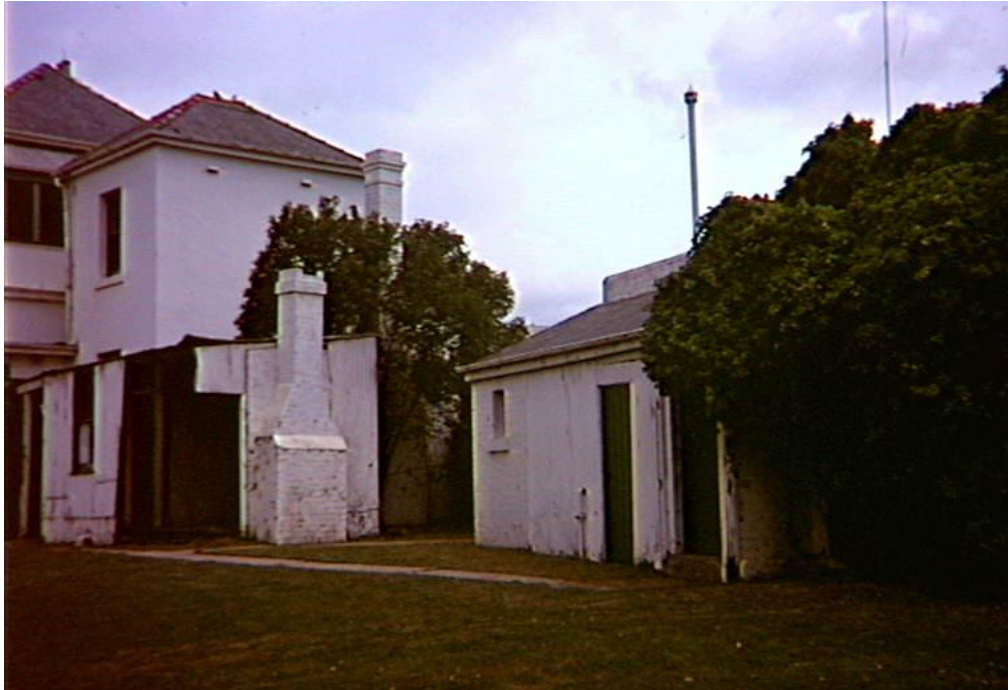
Figure 11 – Shed at rear of CBC, October 1981 / Verlie Fowler. (Source: Campbelltown City Library Local Studies Collection)

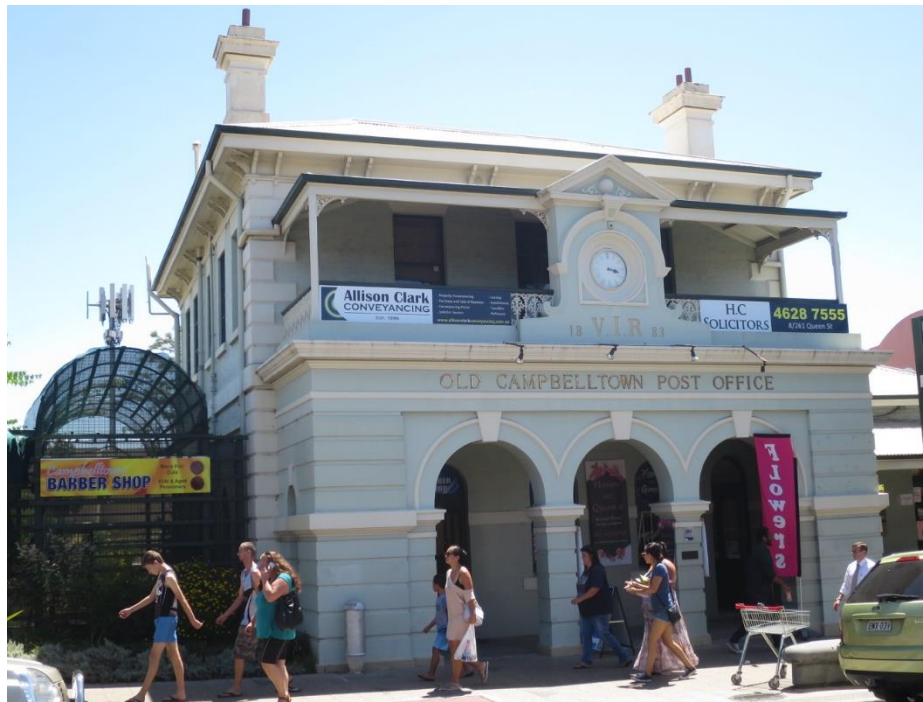
Figure 13 – the former Campbelltown Post Office at 261 Queen Street has a similar scale, form and Victorian Italianate detail as the subject building next door.

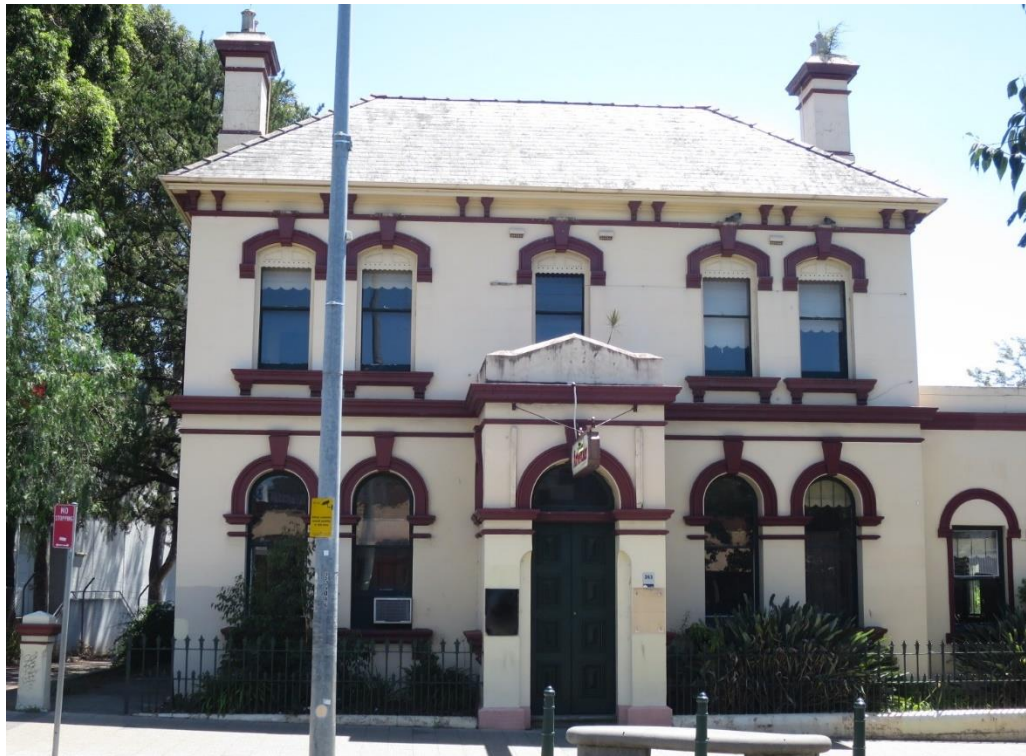
Figure 16 – the front elevation of the subject building. NBRSArchitecture February 2017.

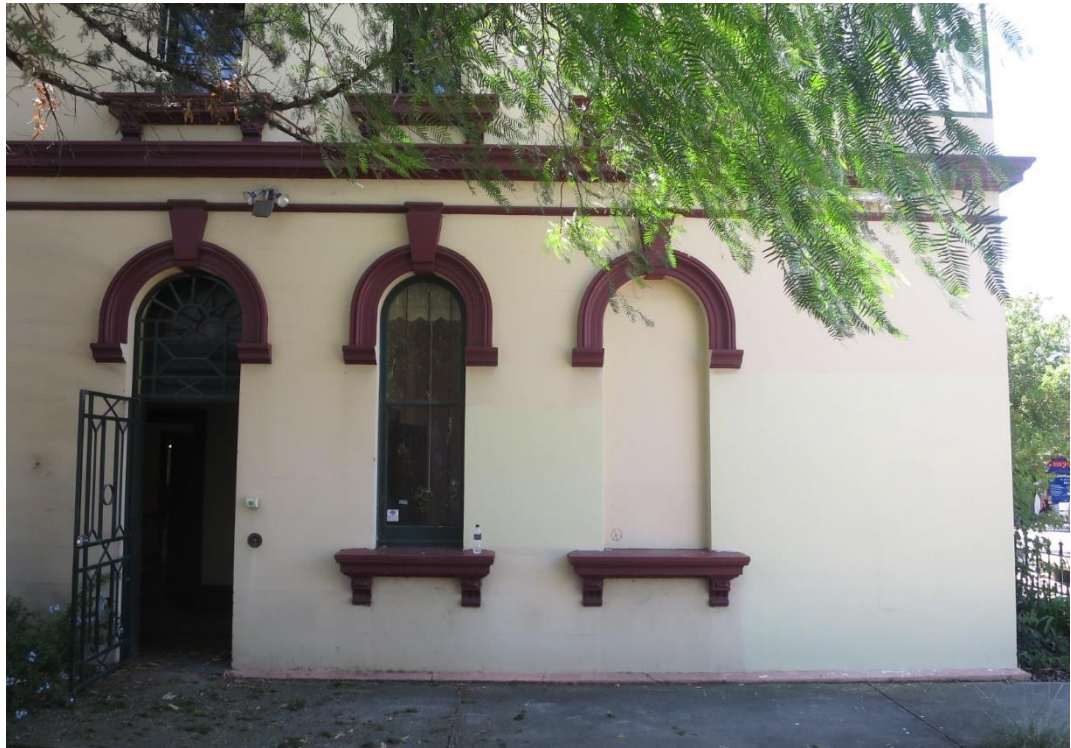
Figure 17 – the entry to the residence and window of the bank manager's study on the south-west elevation. The timber door is original. NBRSArchitecture February 2017.

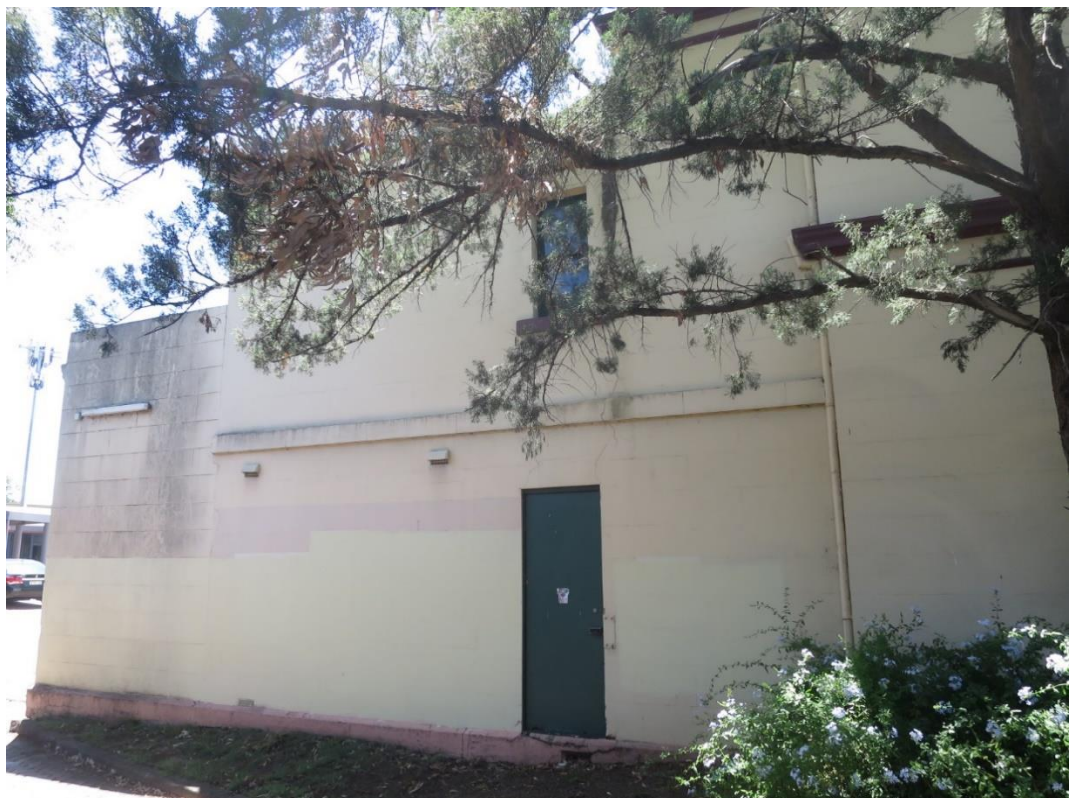
Figure 18 – the south-west elevation of the remains of the service wing. The two-storey section is original, but altered. The single-storey section on the left is 1990s fabric on the site of the much longer single-storey service wing that contained the laundry and coal stores. The tree is a Virginian juniper. NBRSArchitecture February 2017.

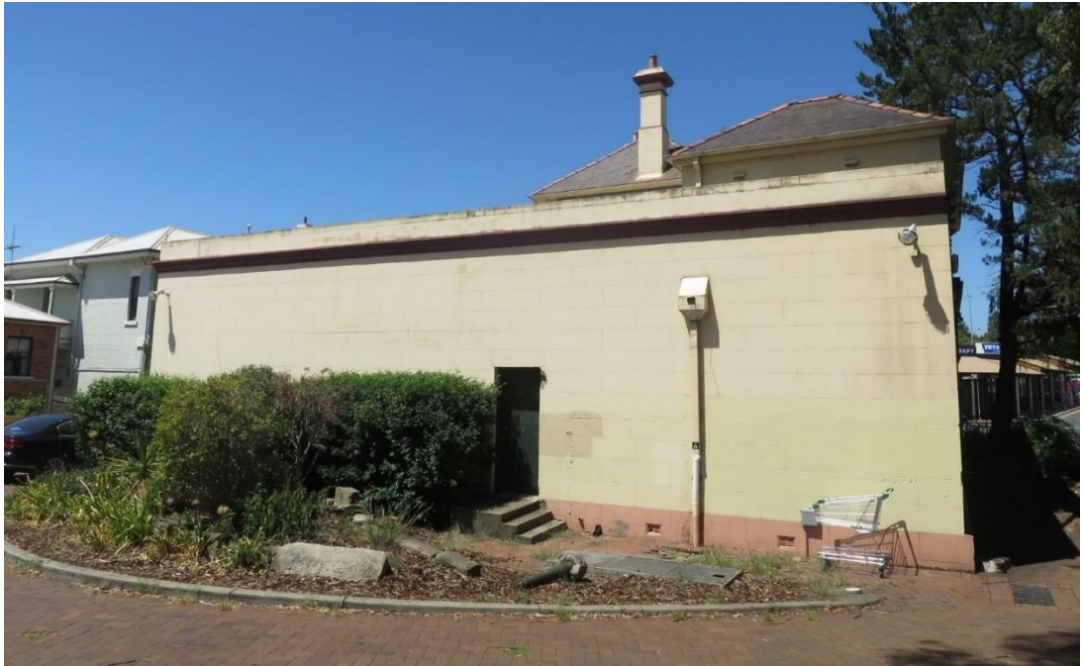
Figure 19 – the rear extension of the former bank was built in the period 1985-95. It is not significant.
NBRSArchitecture February 2017.

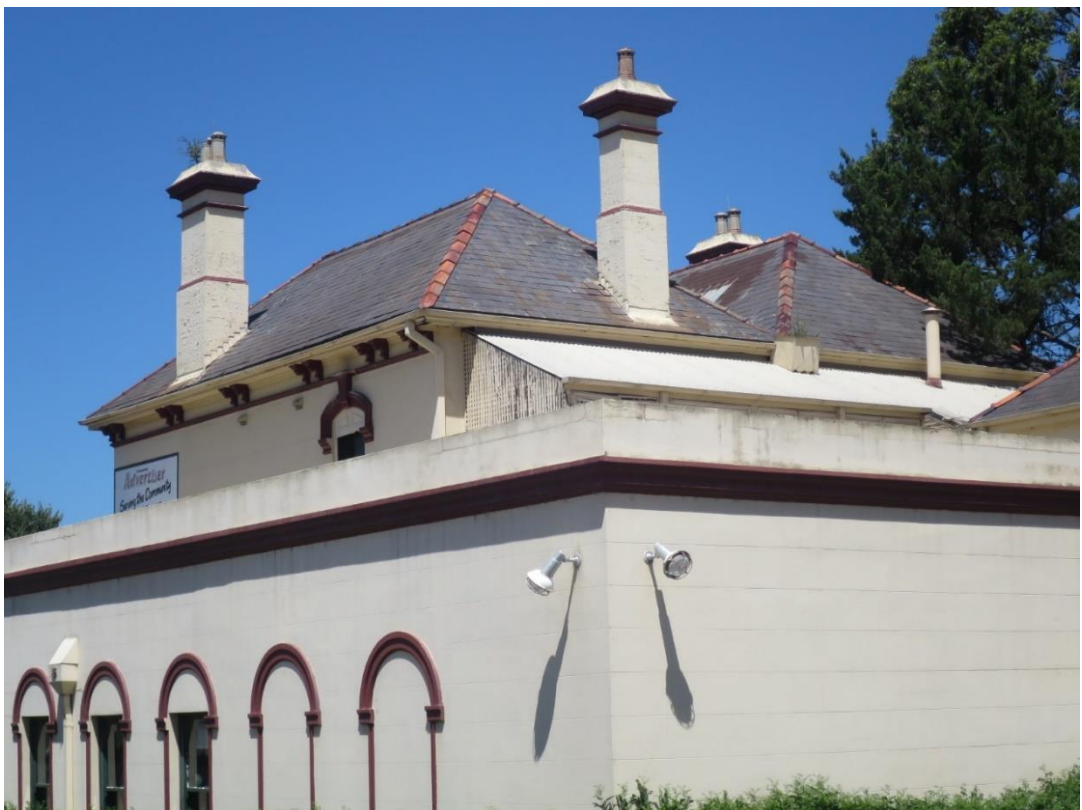
Figure 20 – easterly showing the single-storey rear section, and the two-storey section that is largely original.
NBRSArchitecture February 2017.

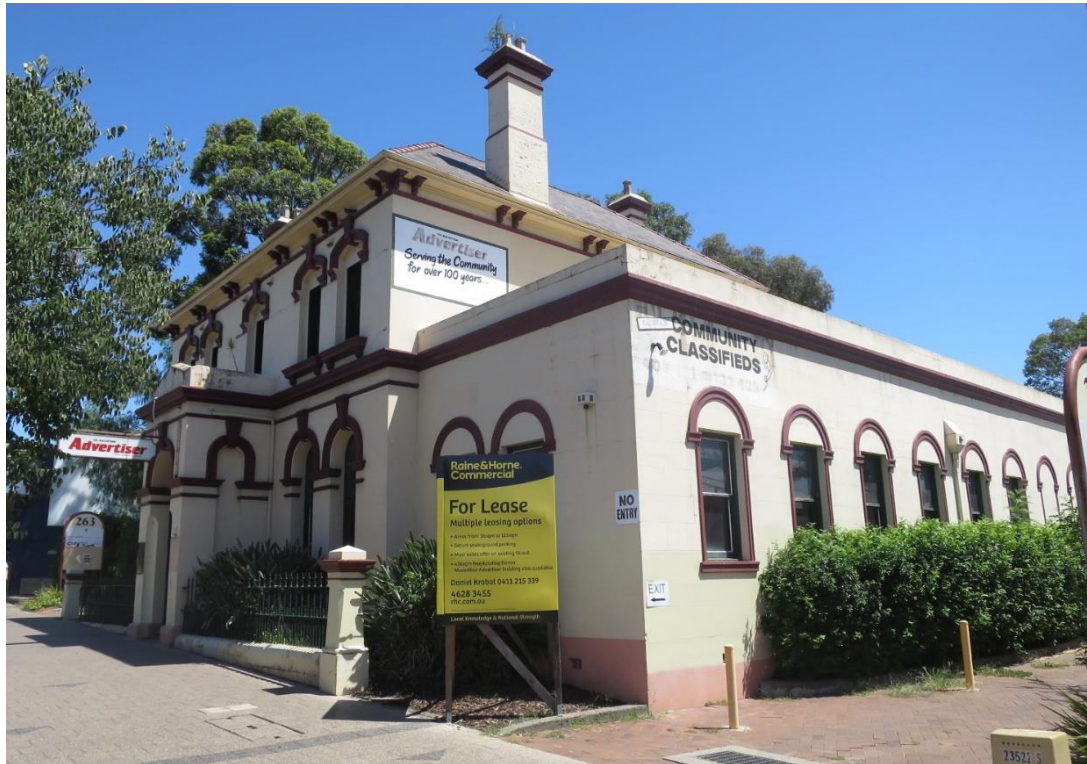
Figure 21 – southerly view showing the single-storey extension in the foreground that should be removed from the original building. NBRSArchitecture February 2017.

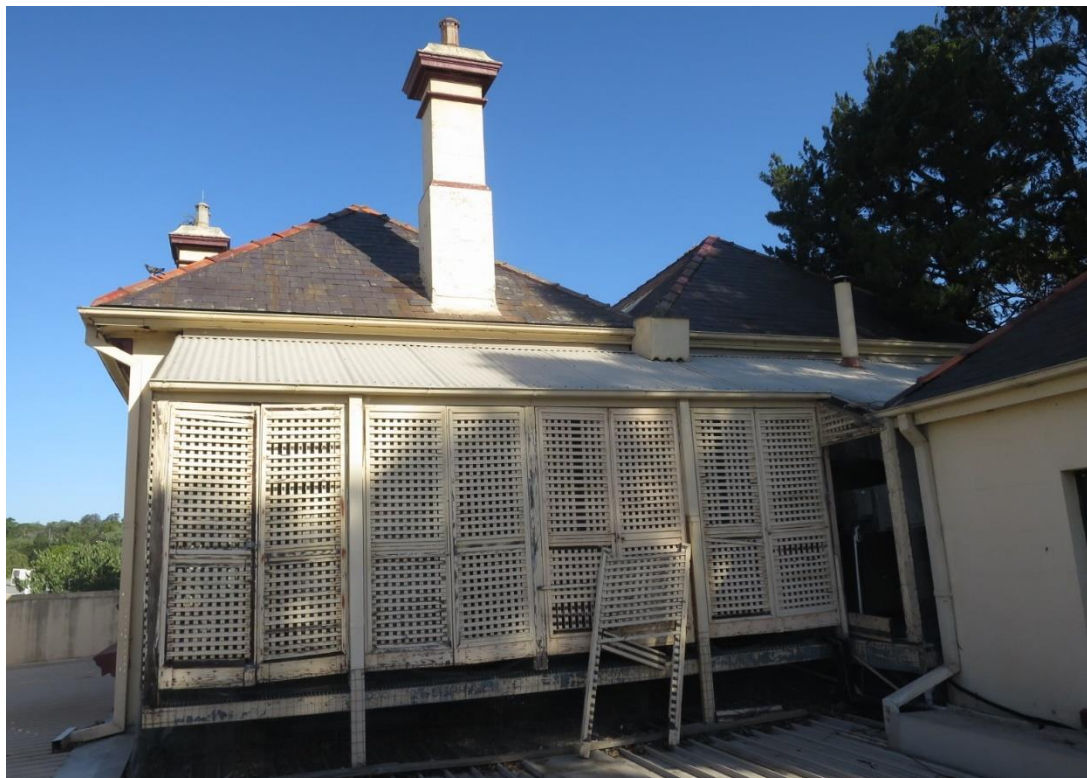
Figure 22 – the rear veranda is from the 1985–95 period. It screens the air-conditioning equipment. NBRSArchitecture February 2017.

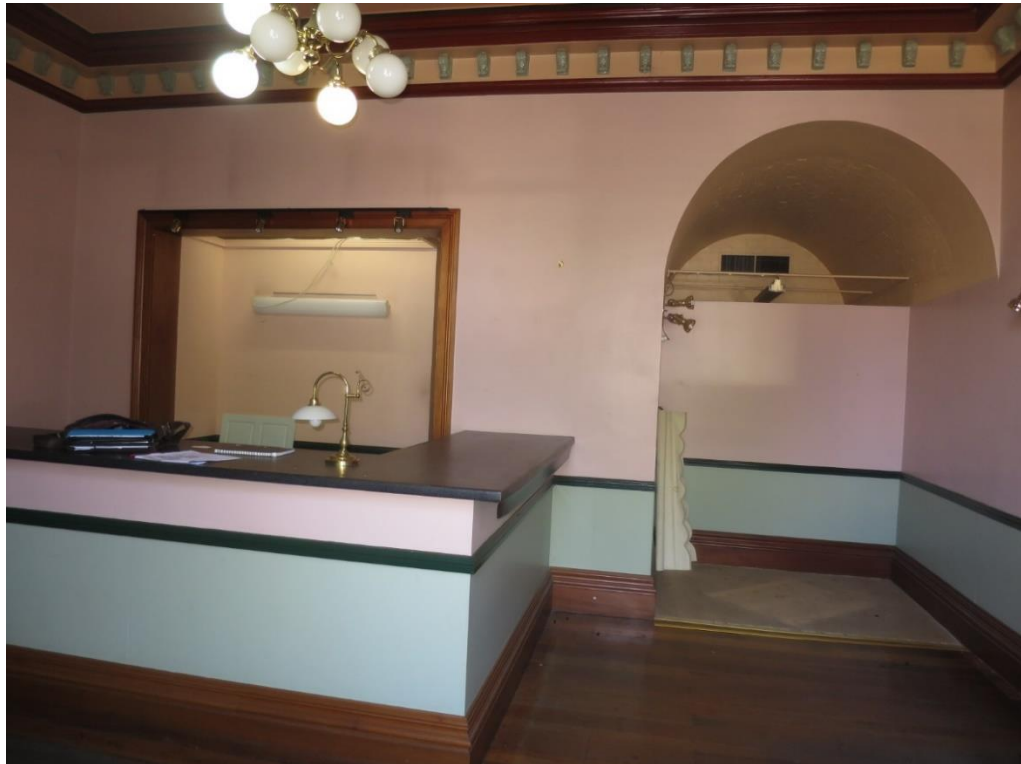
Figure 23 – the banking chamber G.02 showing the recent desk, openings to G.05 and G.06 (former strong room on the right). the skirting is reconstructed, but appropriate. NBRSArchitecture February 2017.

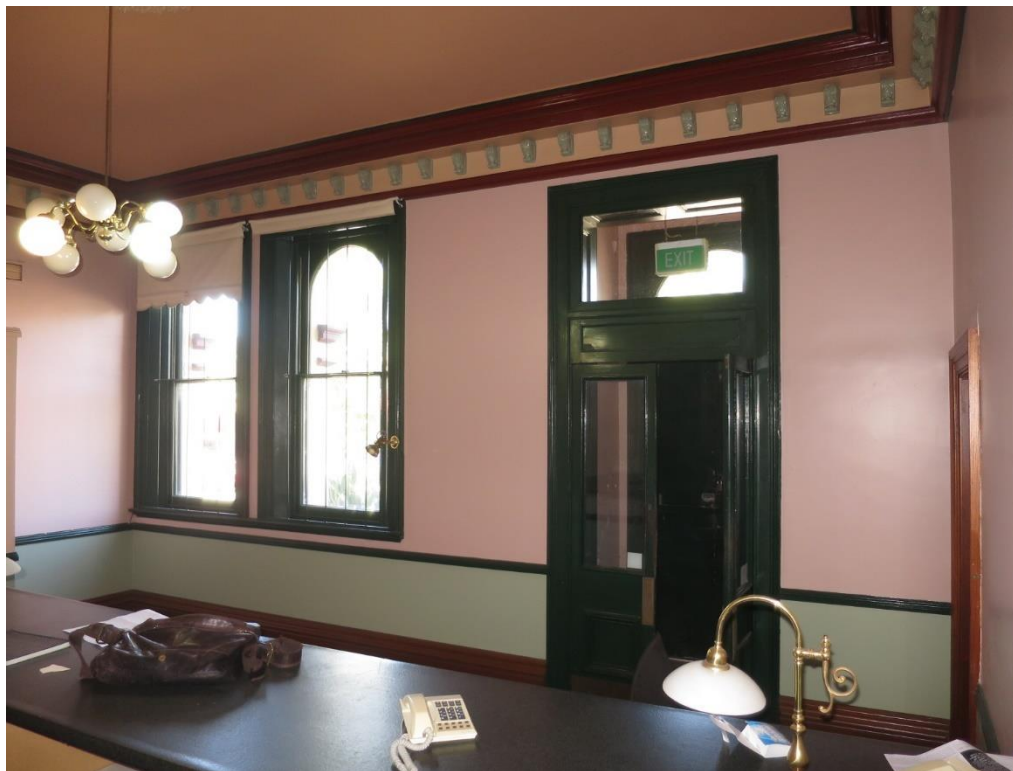
Figure 24 – the banking chamber G.01 showing the original entry doors and windows. NBRSArchitecture February 2017.

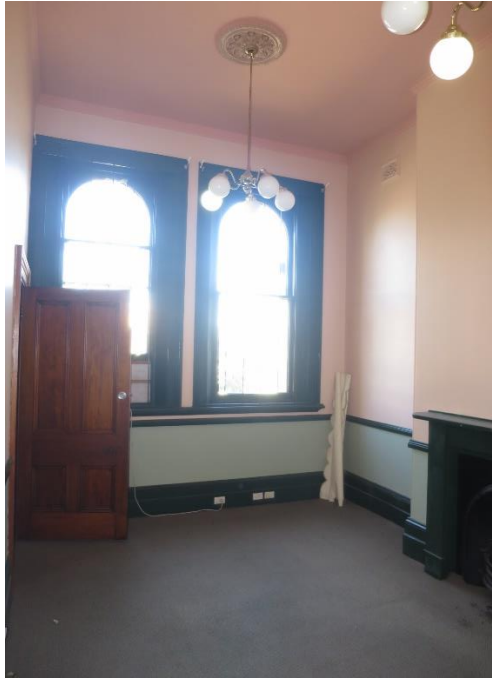
Figure 25 – original windows and skirting in G.03, bank manager's office. NBRSArchitecture February 2017.

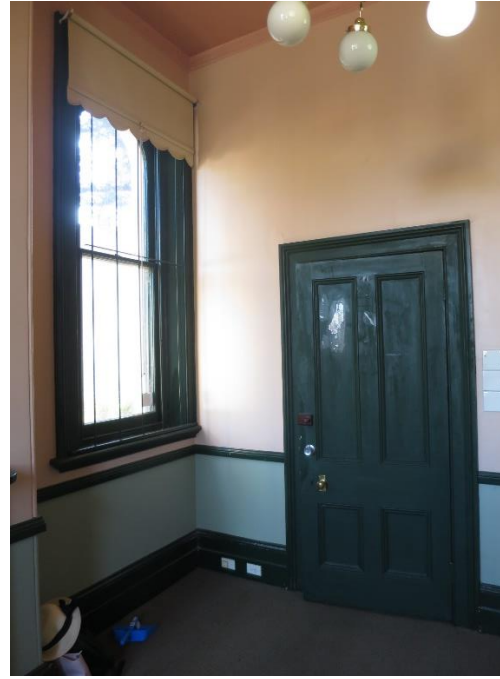
Figure 26 – original door and side elevation window in G.03 to be replicated in the conservation works.

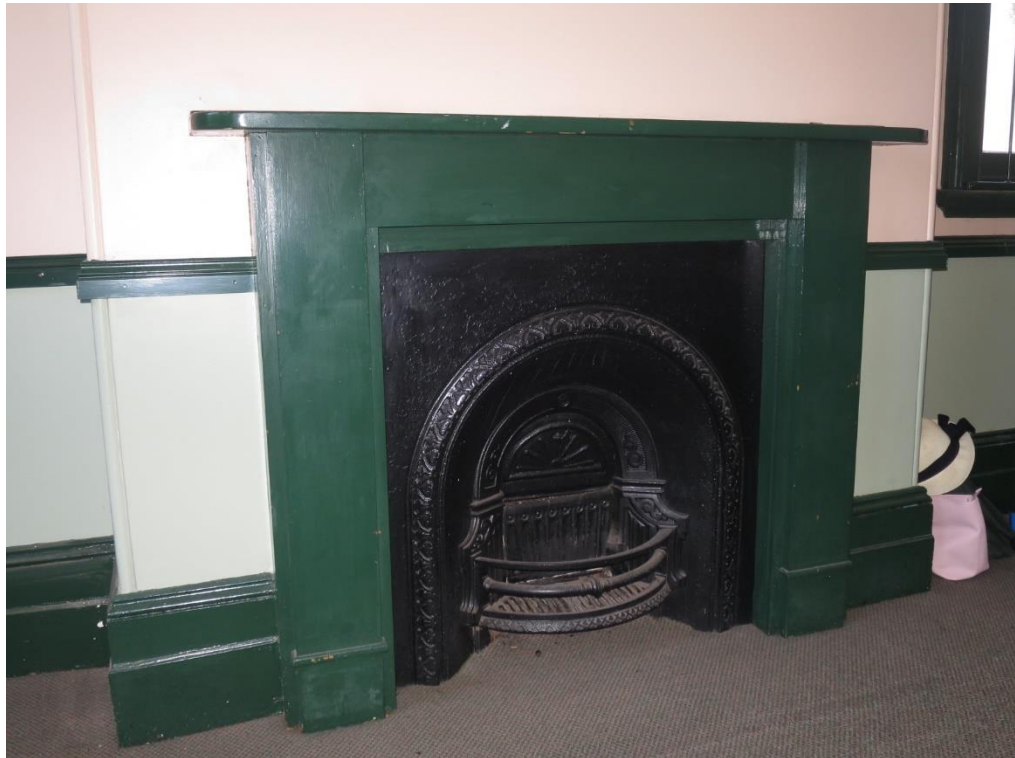
Figure 27 – likely original cast iron coal grate in G.03. the timber mantelpiece is recent and should be replaced with a Victorian design in marble. NBRSArchitecture February 2017.

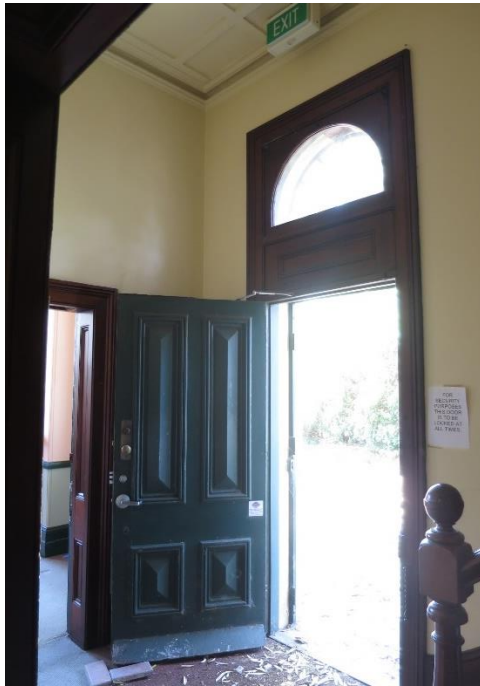
Figure 28 – the original door to the residence on the south-west side, original cornice.

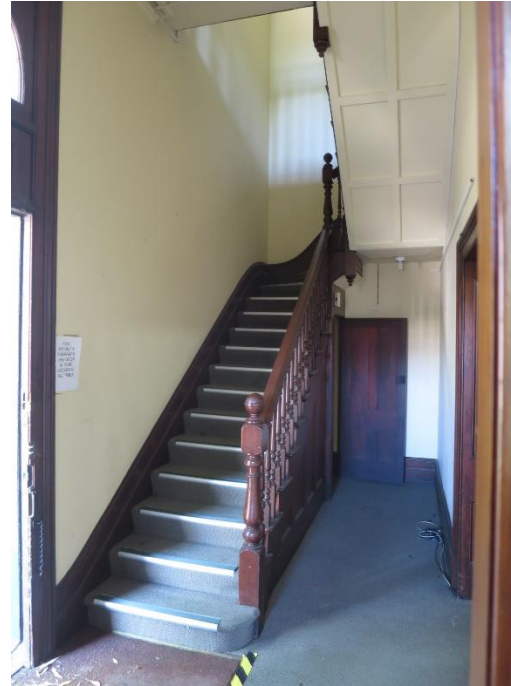
Figure 29 – the original stair, with more recent carpet and stays, in G.04. NBRsArchitecture February 2017.

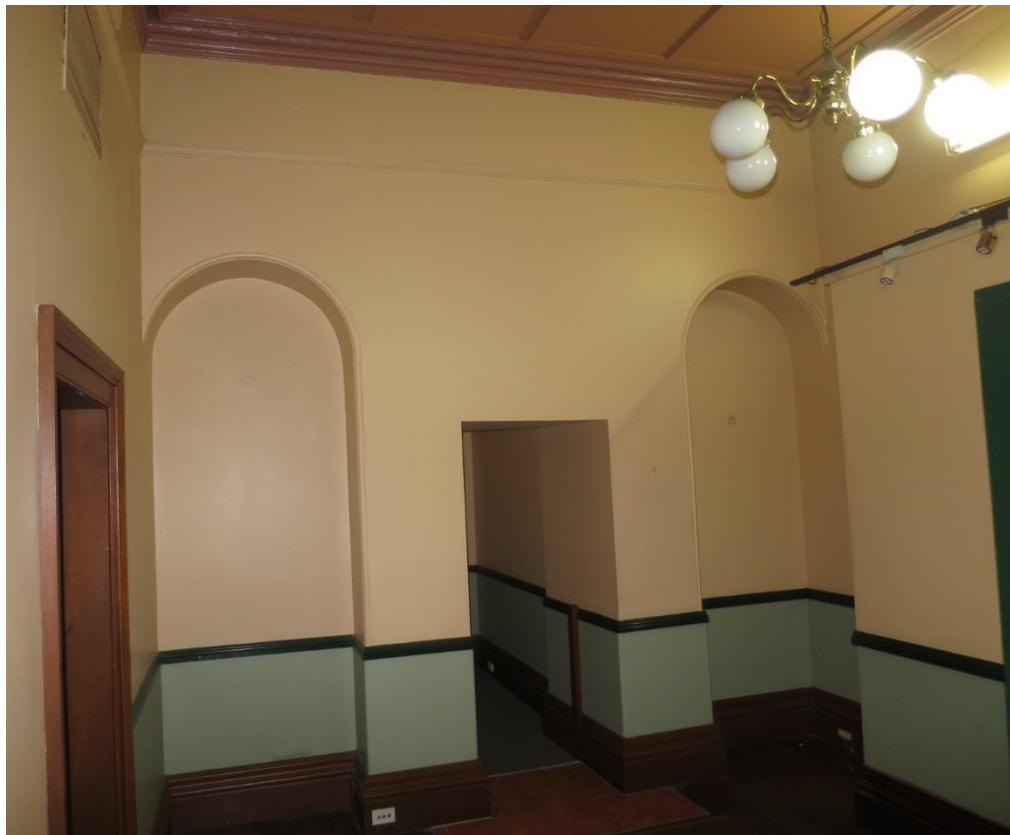
Figure 30 – the original dining room G.05 on the ground floor. The niches, skirting and cornice are original, but the central fireplace has been turned into a doorway to the former strong room. The chimney rises over the left niche.

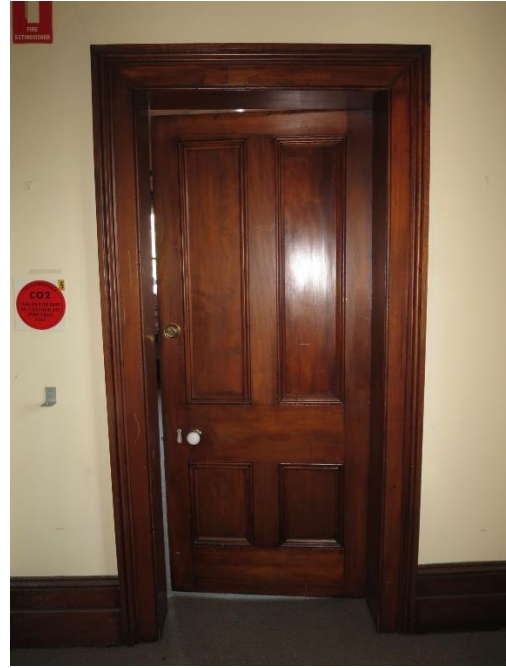
Figure 32 – the intact original door to the former drawing room 1.02. NBRSArchitecture February 2017.

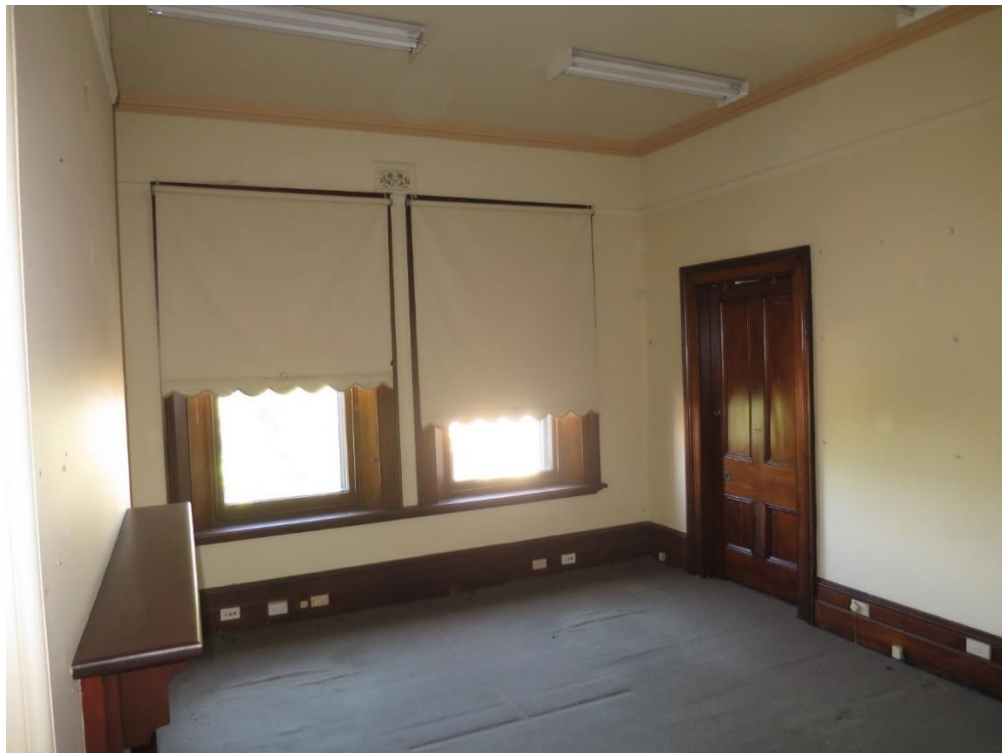
Figure 33 – Rom F.04 has original skirting, window, door and cornice. NBRSArchitecture February 2017.

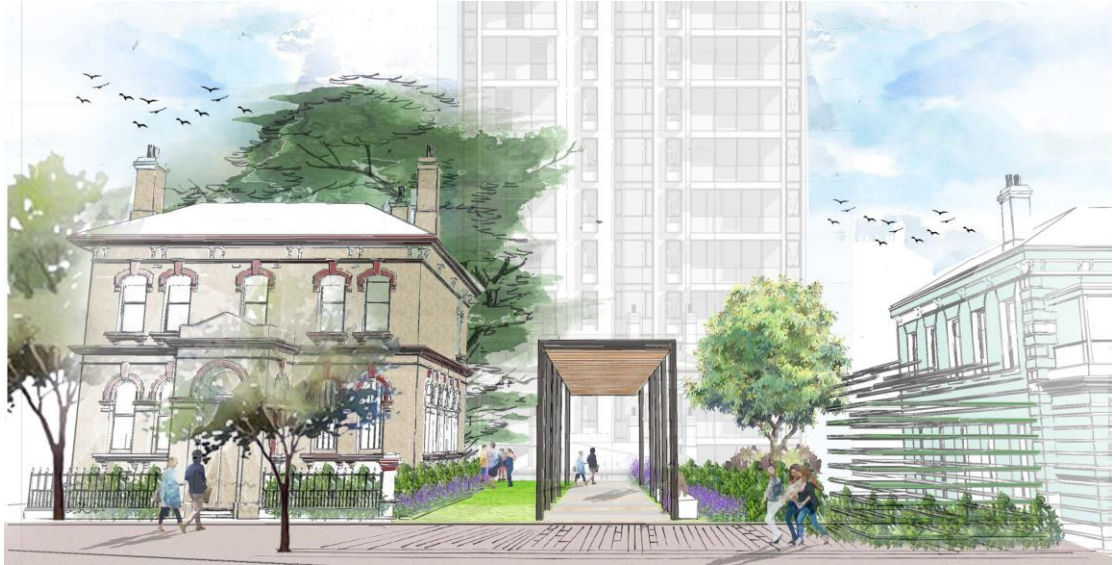
Figure 34 – perspective of the proposed landscape works by Taylor Brammer, March 2017.

The landscape works would keep the subject heritage item exposed to the street, and also well exposed in views from most parts of the front half of the site. The landscape concept provides for a covered walkway leading pedestrians to the tower at the rear of the site. This structure would have a diminutive scale relative to the heritage items on either side. The path, lawn areas and garden in the vicinity of the former bank building would follow the rectilinear geometry of the bank (rather than be parallel with the side boundaries of the site). The front and north-east sides of the building would be planted formally with low-height planting to provide an appropriate garden setting.
