Raith House

Conservation Management Plan

Final Draft

Government Property NSW

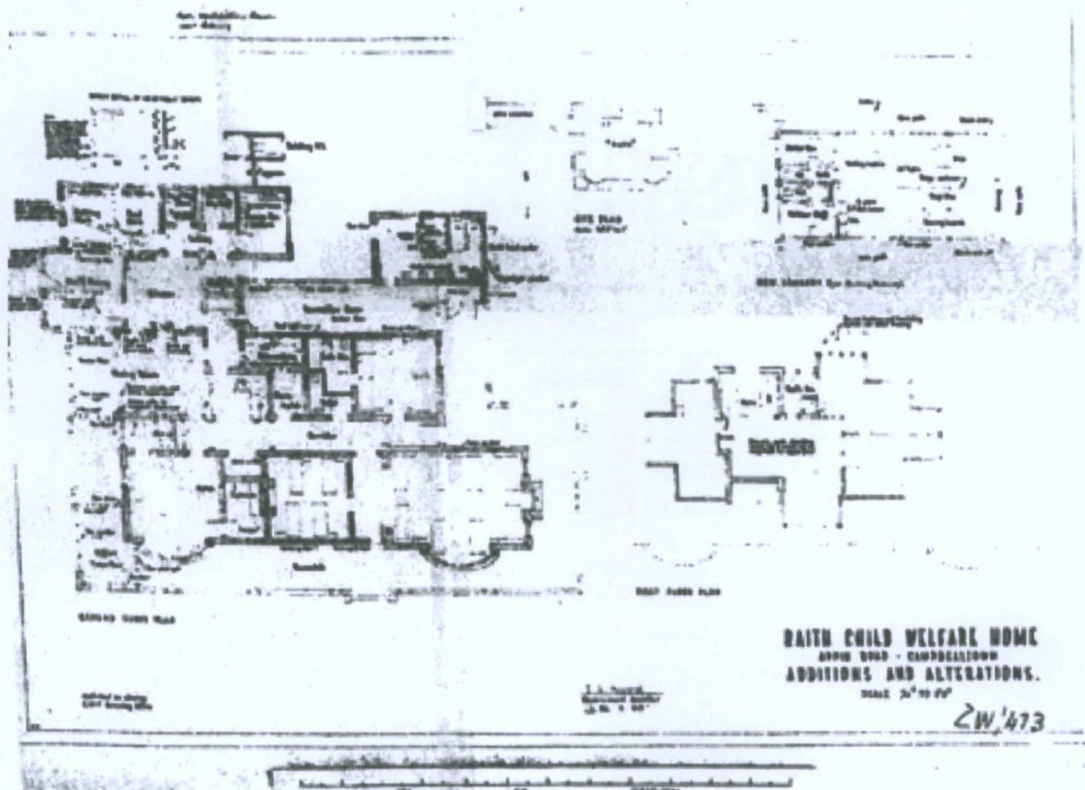
Figure 5 Alterations to "Raith" documented by the Government Architect's Office in 1965 in preparation for its use as a home for children. (Public Works and Services CW/473)

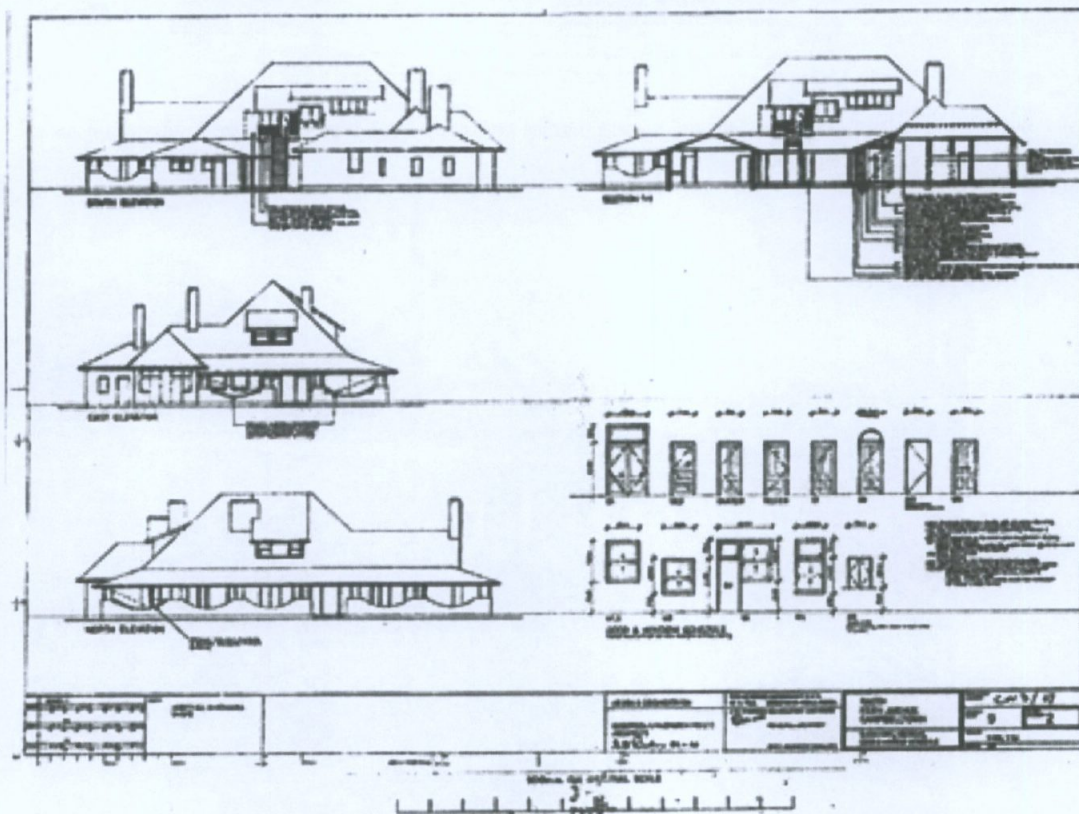
Figure 8 Alterations and additions to "Raith" documented by Robertson and Hindmarsh in 1986. (Public Works and Services CW3/27)

Further modifications were documented by the architectural firm of Robertson and Hindmarsh in 1985 and these are essentially what comprise the present configuration of the house. The verandah enclosures were removed, the kitchen relocated and storage and bathrooms revised and upgraded. Ceilings throughout the building (with the exception of the

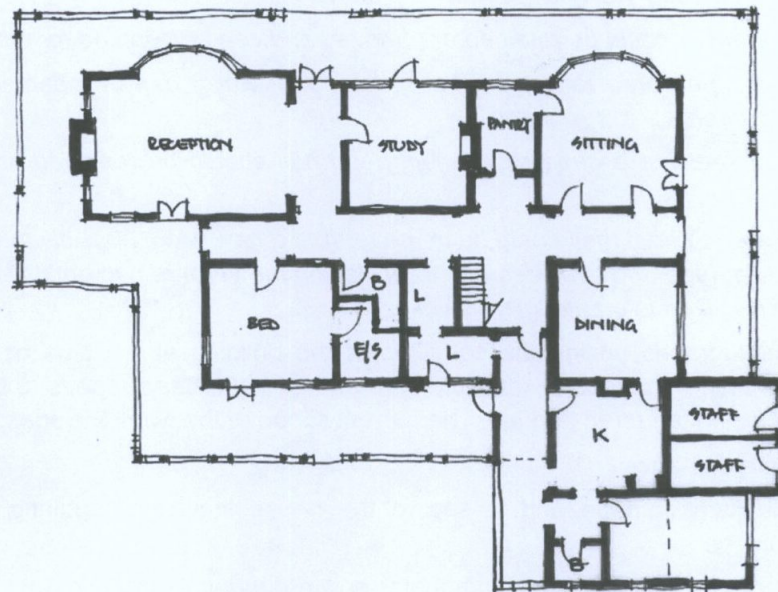
Figure 9 Conjectural original layout of the building. Paul Davies 2014.

Generally the changes to the fabric should be removed and reversed, however in some locations, where original finishes etc. are lost there is potential to make new interventions in to the place to facilitate future use.

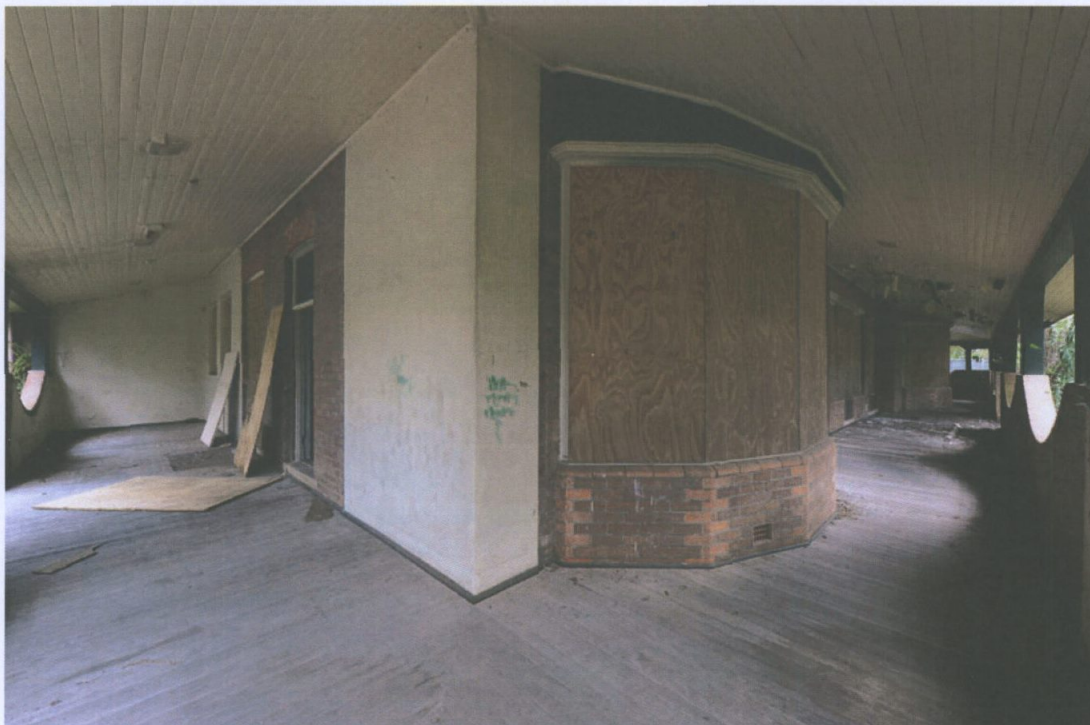
Figure 10 View along the verandah of both the eastern and northern façade. Note the rendered walls where earlier verandah enclosures were created. Paul Davies 2014.

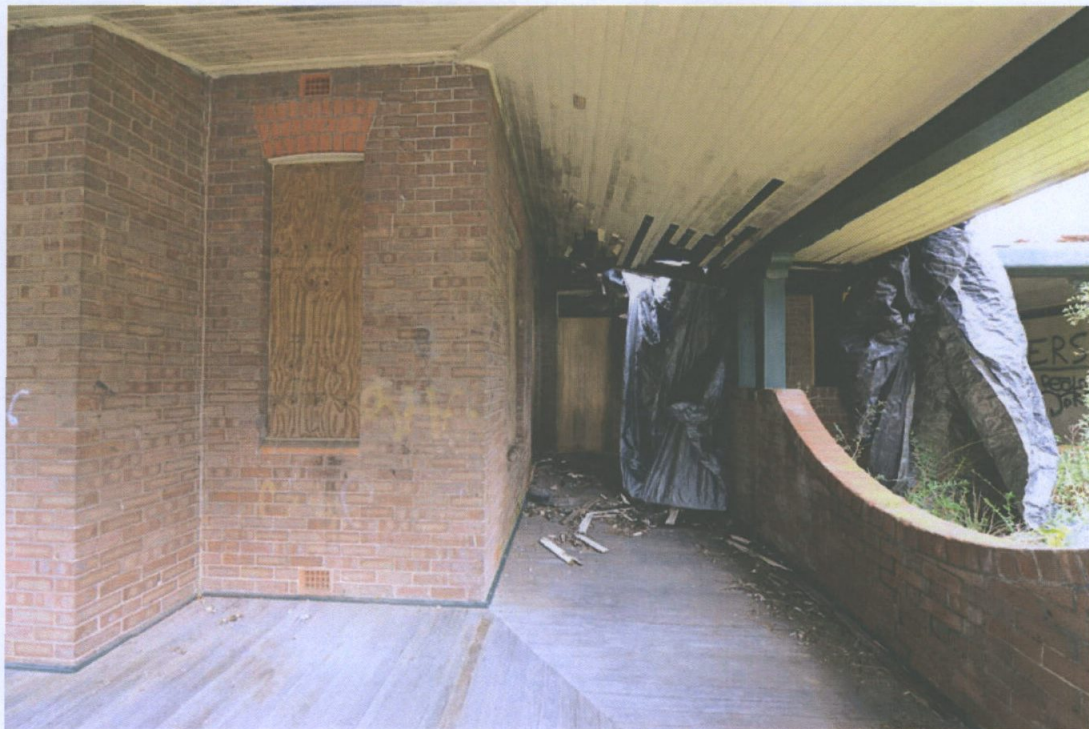
Figure 11 View along the western verandah showing roof damage. Paul Davies 2014.

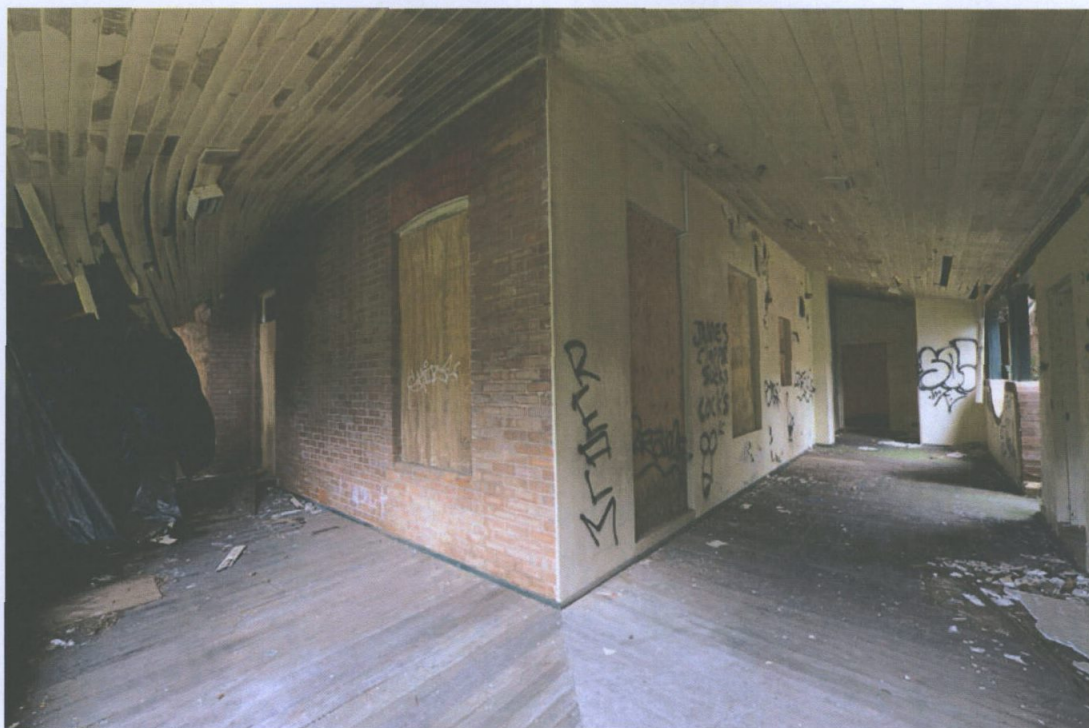
Figure 12 View along west/south verandahs showing verandah roof collapse, vandalism and the remains of rendered walls from the rear verandah enclosure. Paul Davies 2014.

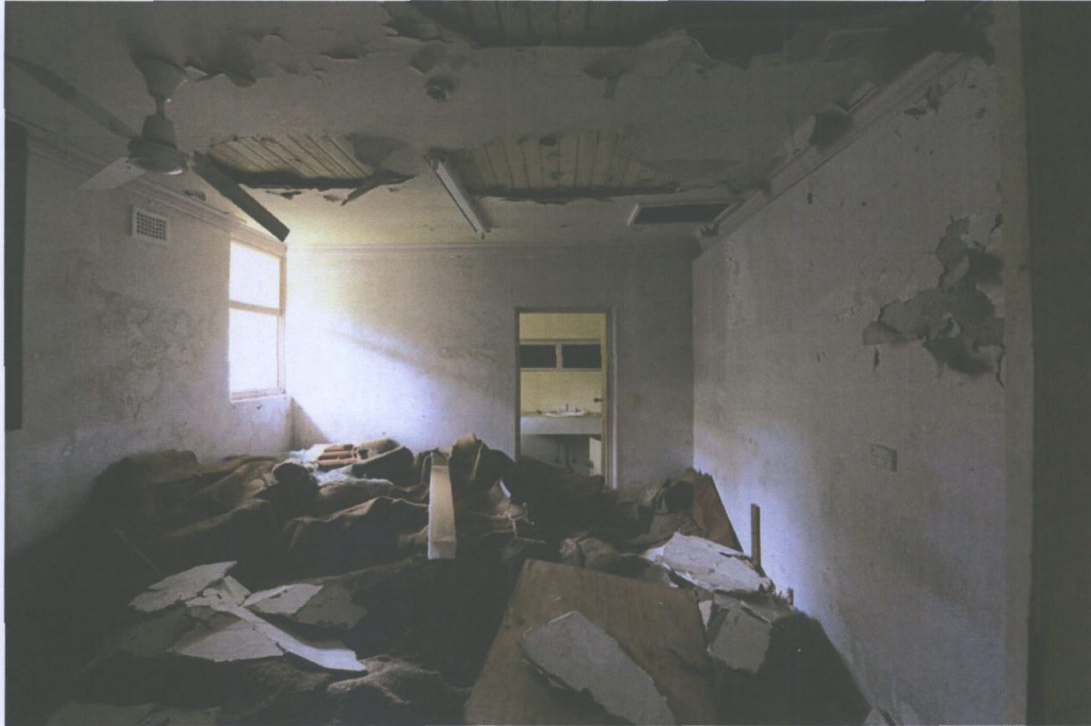
Figure 13 Interior of former garage area, now divided into bathroom and general room. Note the timber boarding above the plaster ceiling and the later joinery from one of the adaptations of this wing for institutional use. Paul Davies 2014.

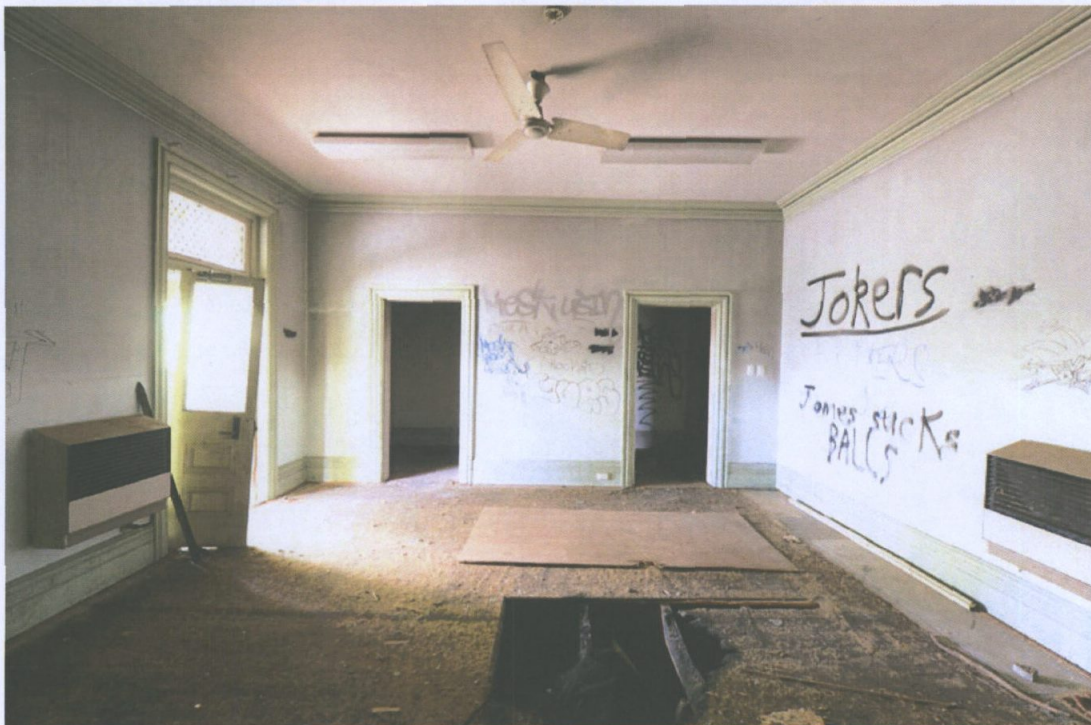
Figure 14 Main Living Room with vandalism damage, fire damage and the later fitout of plaster ceiling, heaters and fans. Paul Davies 2014.

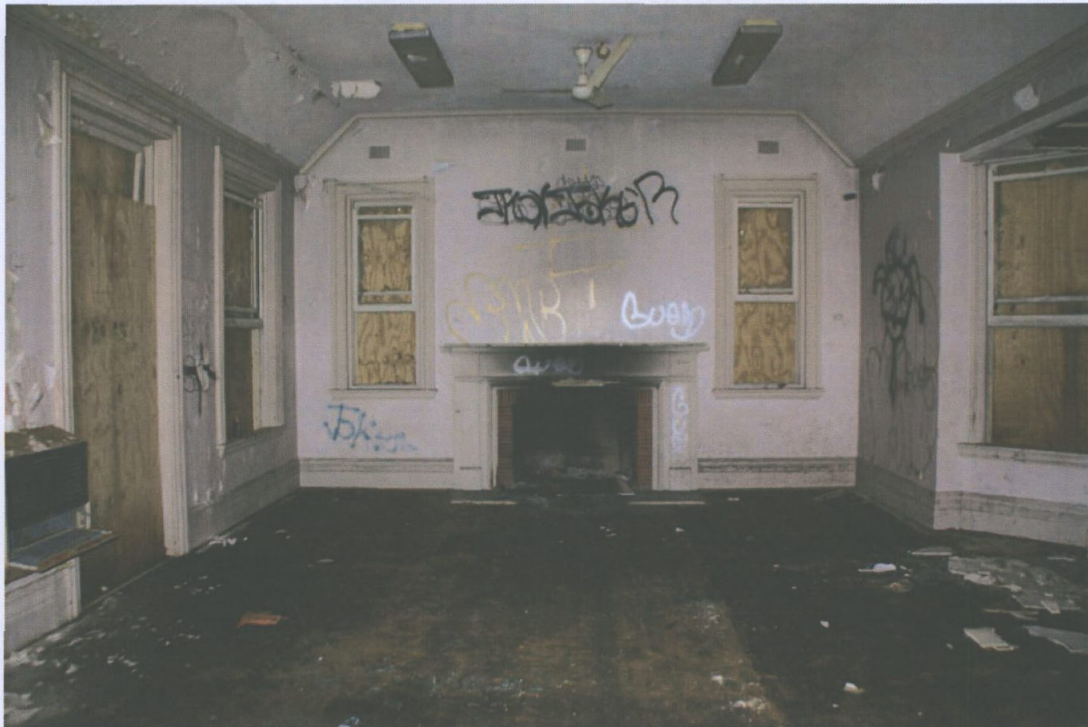
Figure 15 View of room 1 displaying significant vandal damage including evidence of fires and graffiti. The ceiling has been clad in plasterboard. Paul Davies 2014.

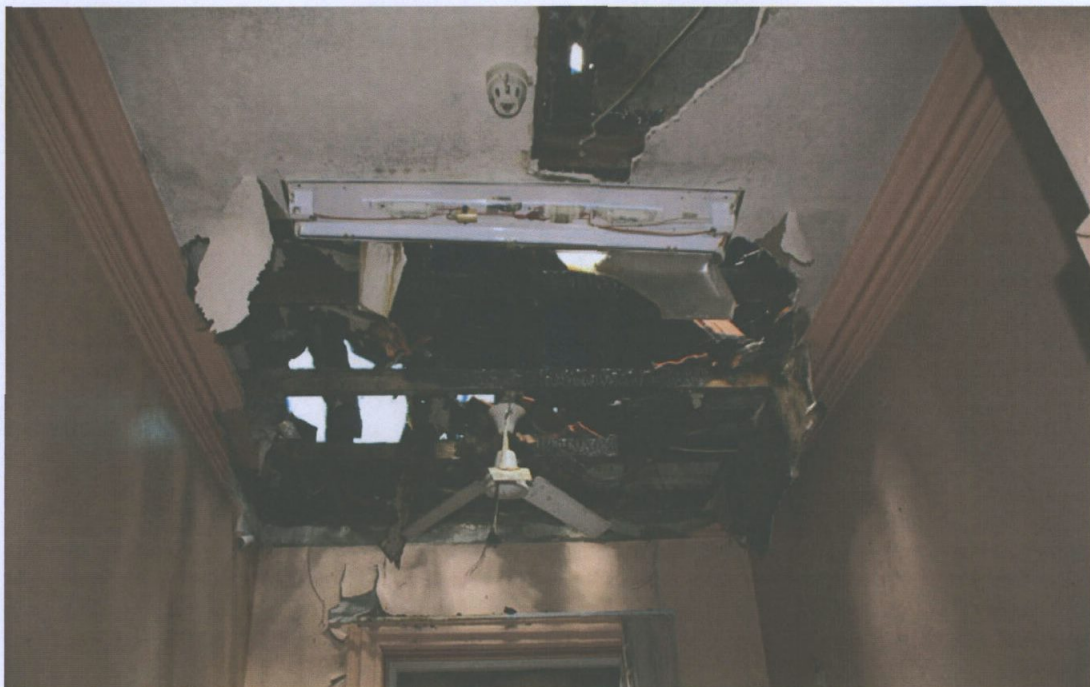
Figure 16 Damage to the ceiling of Room 6 from the fire revealing the pressed metal ceiling above the lowered plaster ceiling. Paul Davies 2014.

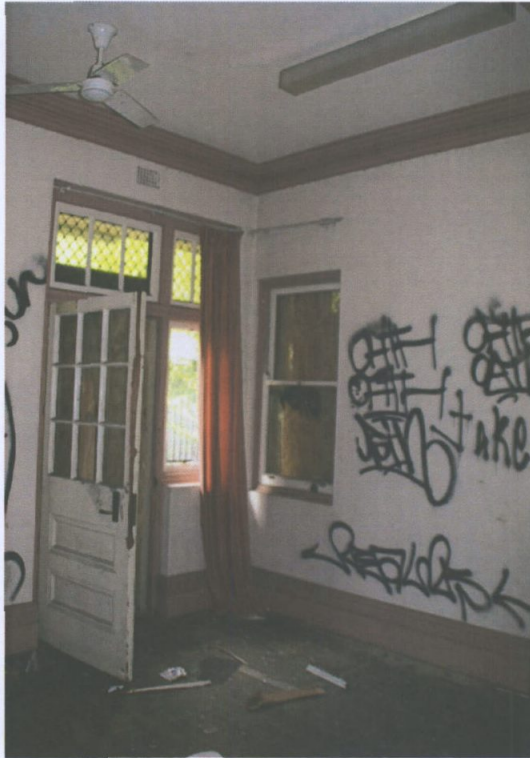
Figure 17 Room 11 facing southeast. This room was originally two small staff bedrooms accessed only from the exterior doors. The window to the right is a later addition. Paul Davies 2014.

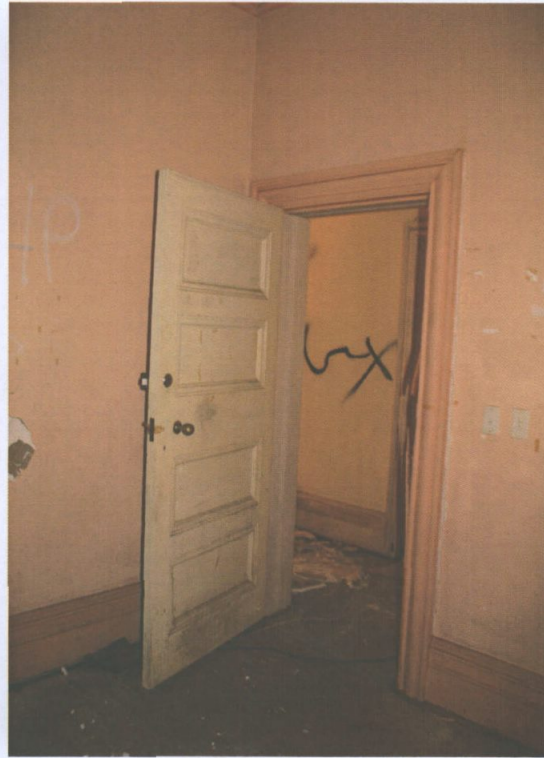
Figure 18 Room 14 facing northwest. Note the early door. Paul Davies 2014.

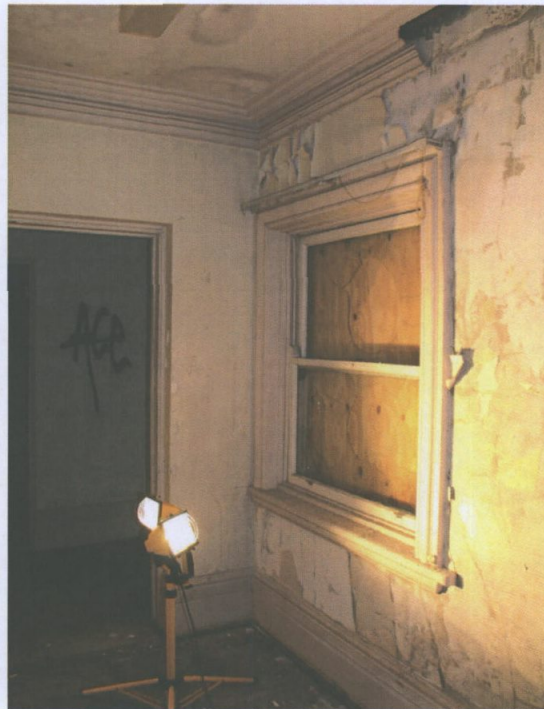
Figure 20 Hall 3 with severe water damage. Paul Davies 2014.

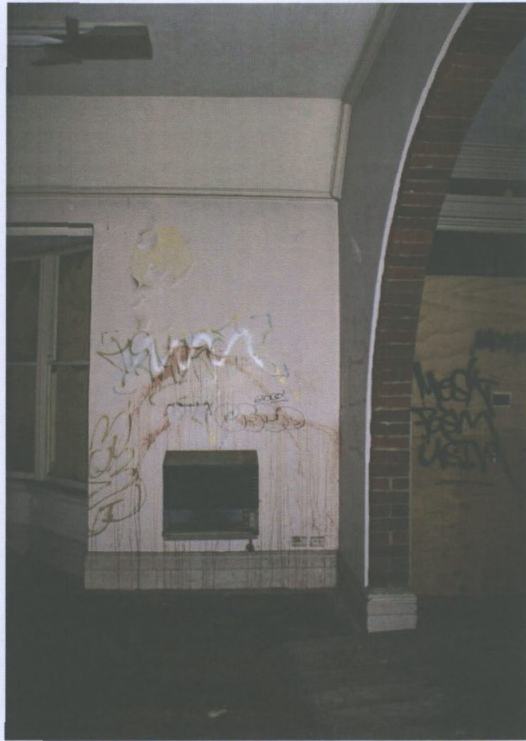
Figure 21 The main entrance (Hall 1) and reception room facing north, note loss of render to archway. Paul Davies 2014.

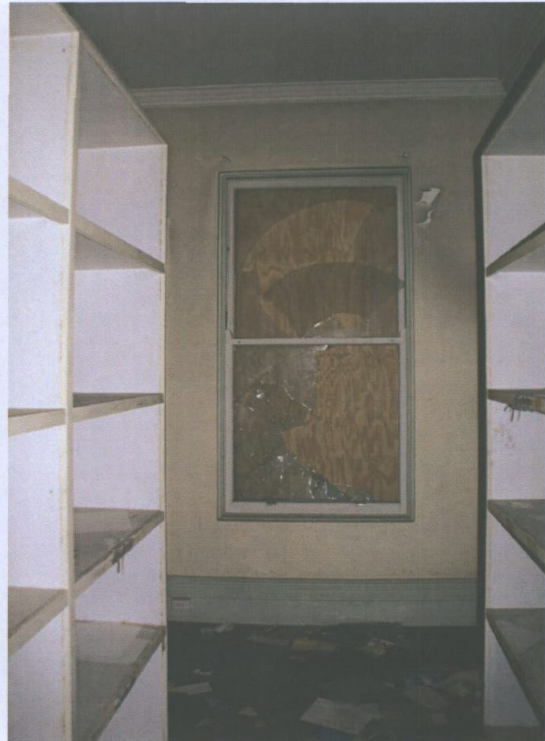
Figure 22 Butlers Pantry with recent shelves and recent plastering ceiling. Paul Davies 2014.

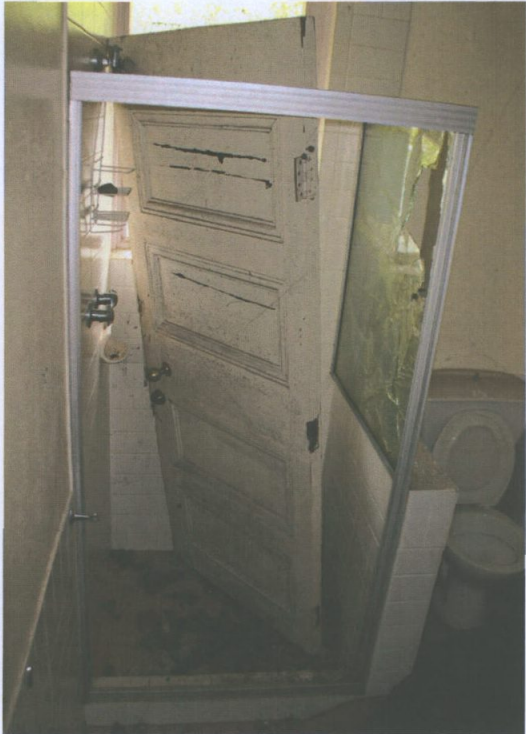
Figure 23 Bathroom in former garage with vandalised original door. Paul Davies 2014.

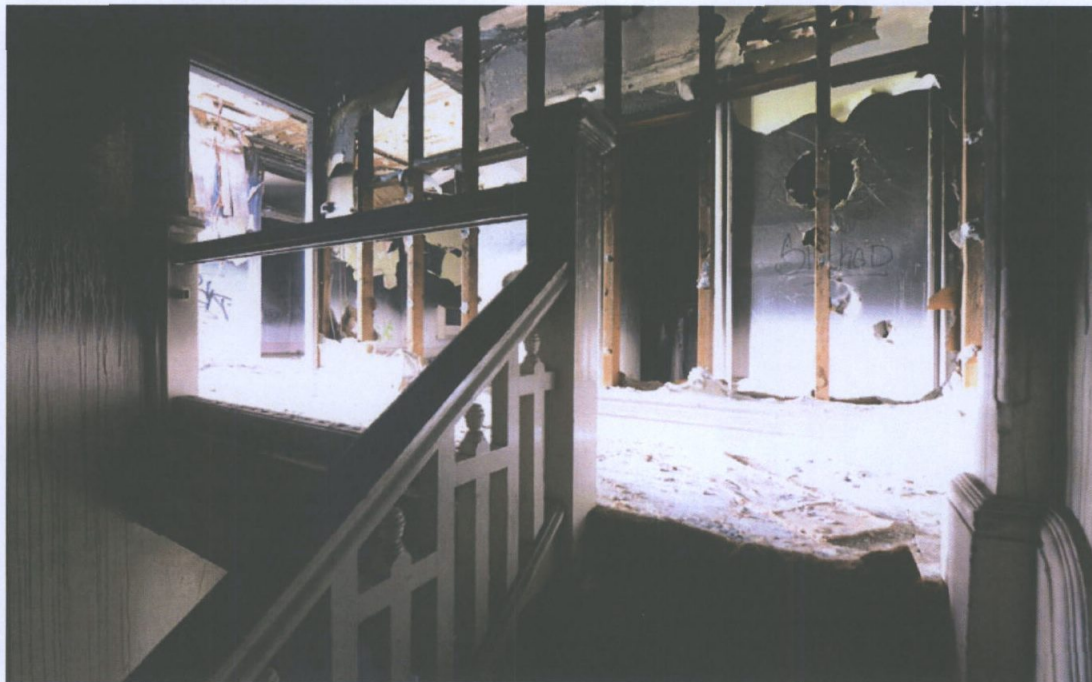
Figure 25 Stairway to second floor facing northwest. Note later timber framed walls that have been burnt and vandalised. Most of the immediate fire damage is superficial with the stair and its enclosure remaining structurally sound. The stair has undergone substantial vandalism. Paul Davies 2014.

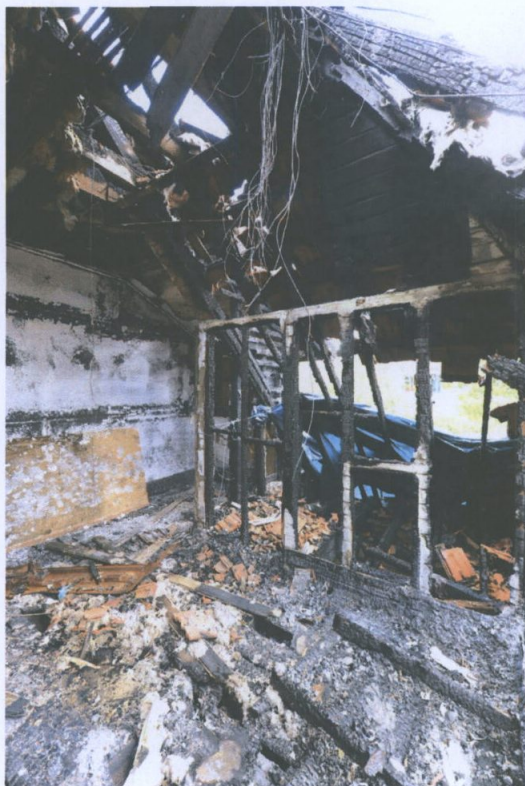
Figure 26 Room 17, including overview of fire damage. Paul Davies 2014.

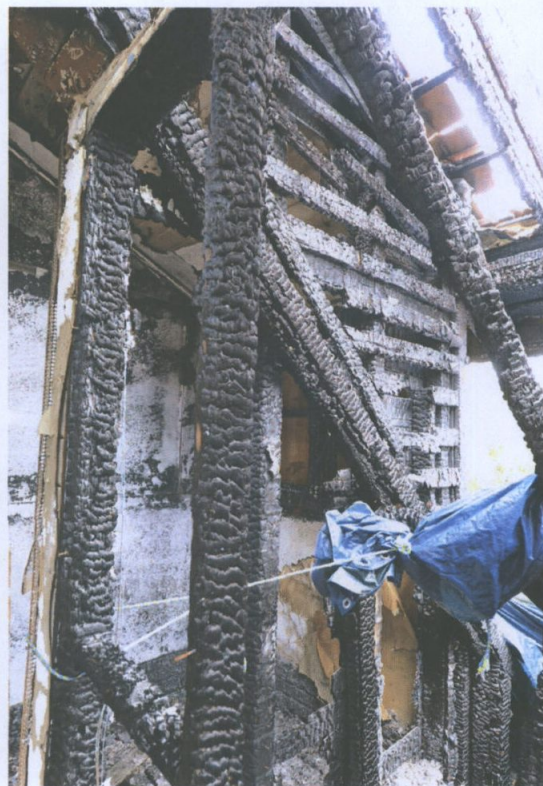
Figure 27 Room 17, including detail of fire damage. Paul Davies 2014.

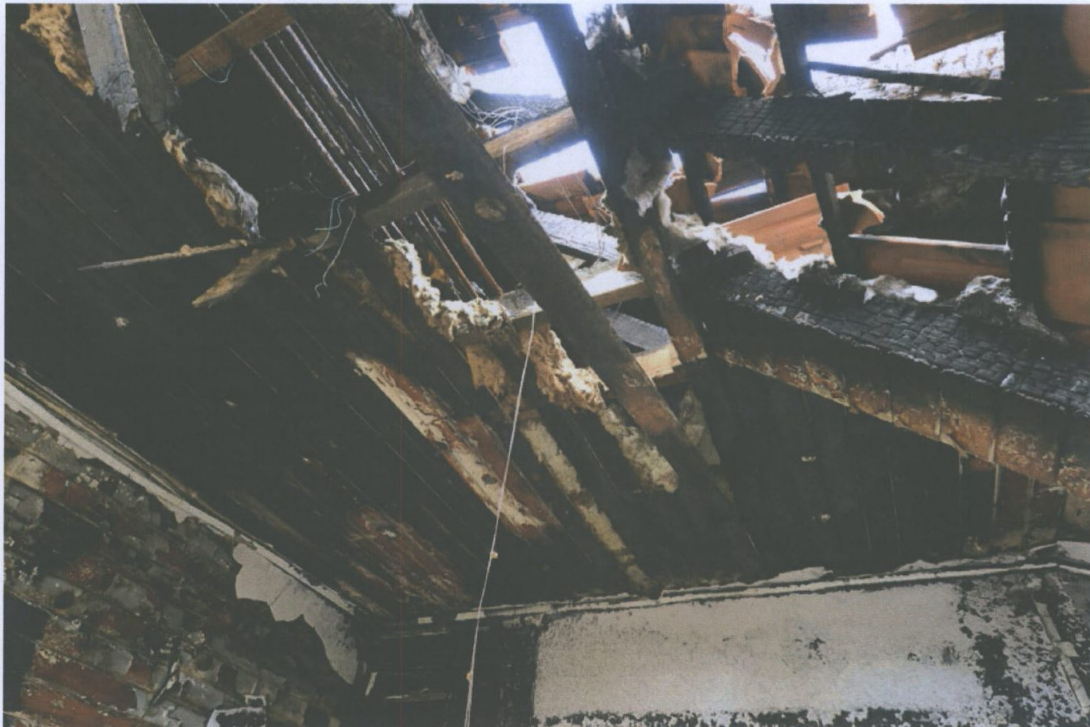
Figure 28 Room 17 roof area showing fire damage. Paul Davies 2014.

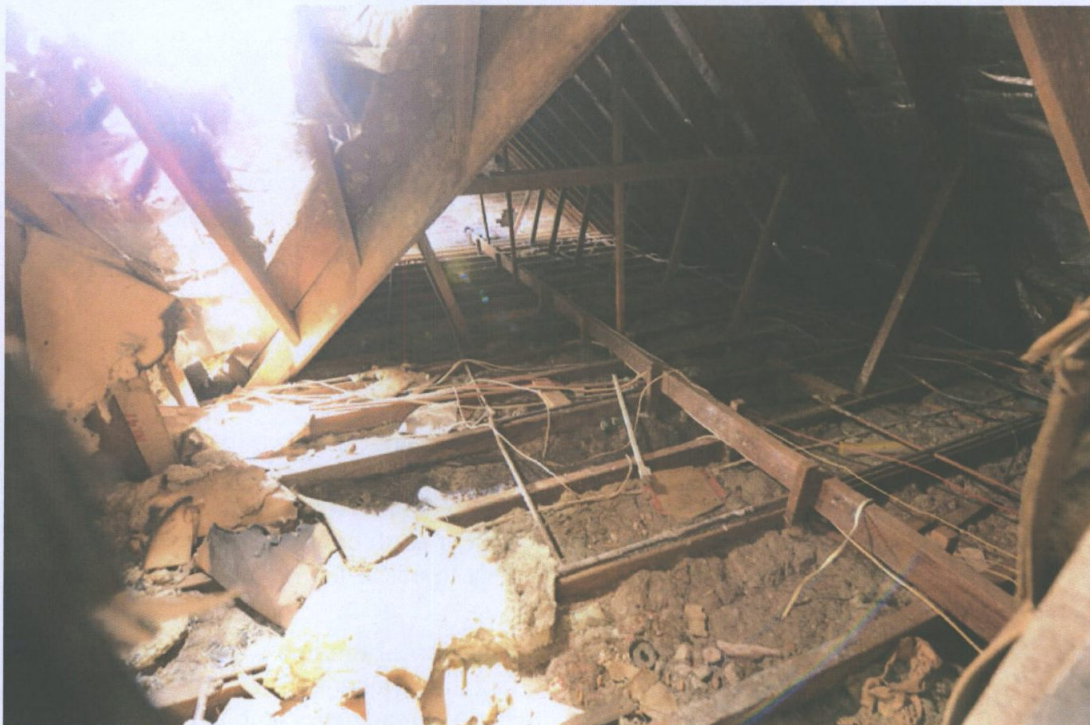
Figure 29 Interior of roof void over main reception room, generally the roof in this area has remained without damage, however it requires cleaning and tile repair above. Paul Davies 2014.

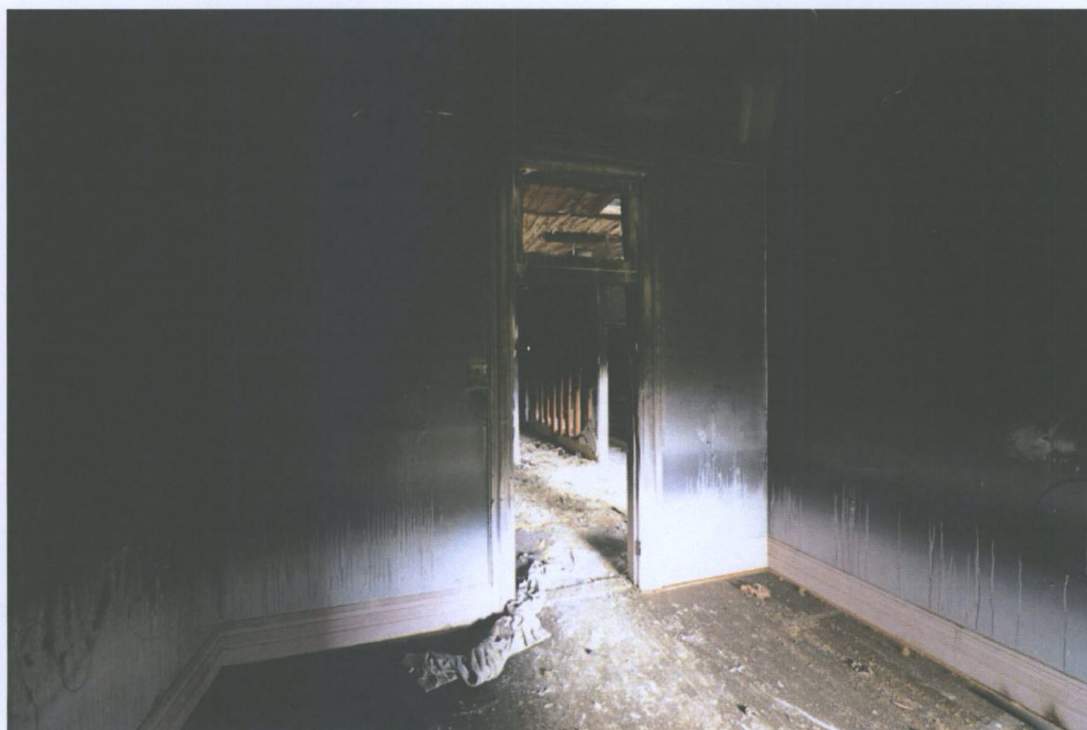
Figure 30 Room xxx showing impact of smoke and heat damage. It is likely that the wall finish to the right and ceiling will be fire damaged behind the plaster linings and will require replacement. Paul Davies 2014.

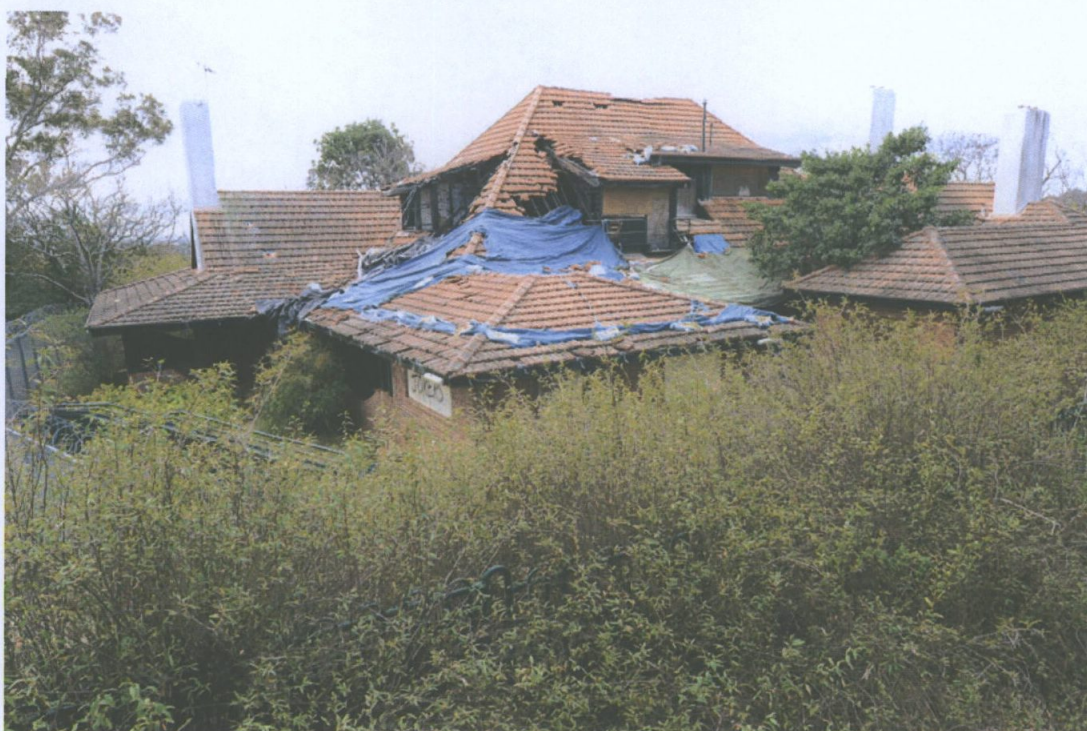
Figure 31 Overview of house from west of rear embankment. Apart from fire damage the photo shows the poor quality of planting on the bank and the need to consider a landscape treatment for the area that provides separation between adjacent uses and enhances the setting of the house. The child-care facility will retain overviews as it is elevated even with significant landscape treatment. The boundary fence can also be discerned in the foreground as a green metal fence. Paul Davies 2014.

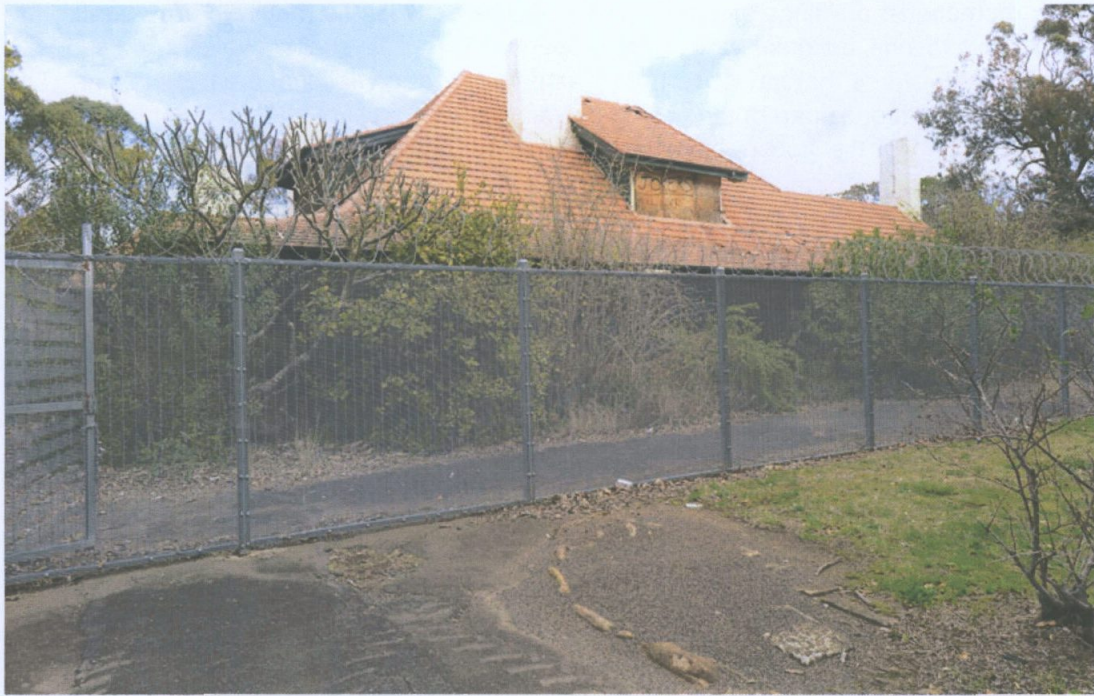
Figure 32 View of house from frontage. While the fence is necessary to provide some security, the generally degraded character of the frontage can be seen with failed pavements. It is noted that the planting around the house has been largely removed in recent maintenance works. Paul Davies 2014.

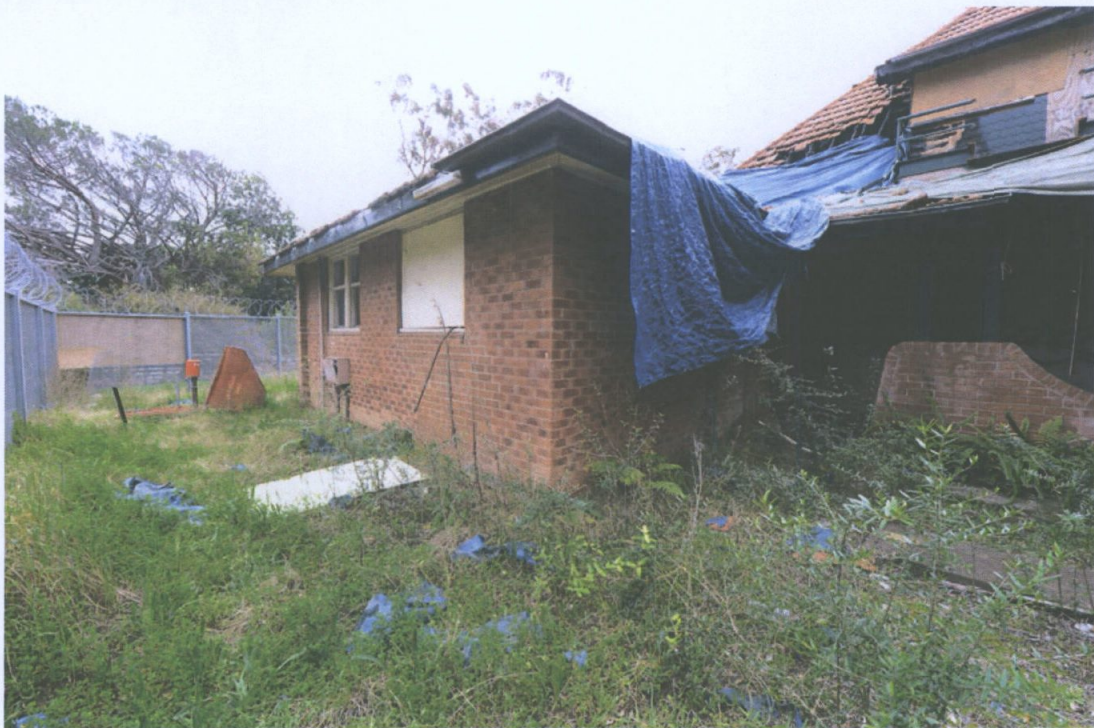
Figure 33 The rear of the former garage building with fire damage in the background. This building has been reworked and was an addition. There is considerable scope to redevelop this part of the site including replacing the current wing to allow discrete new development on the site. Such a wing could accommodate additional rooms and garaging. Removing part of the far embankment could also be considered without compromising the heritage values of the place. Paul Davies 2014.

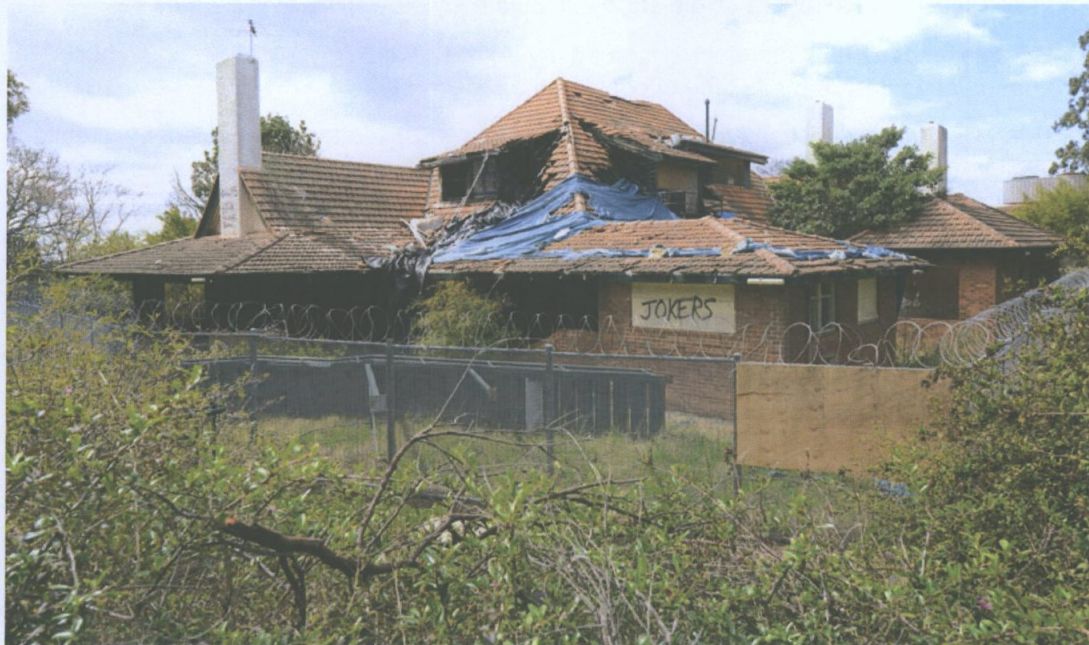
Figure 34 View from the west. This further demonstrates the potential to add some discrete additions to the rear of the building. Paul Davies 2014.

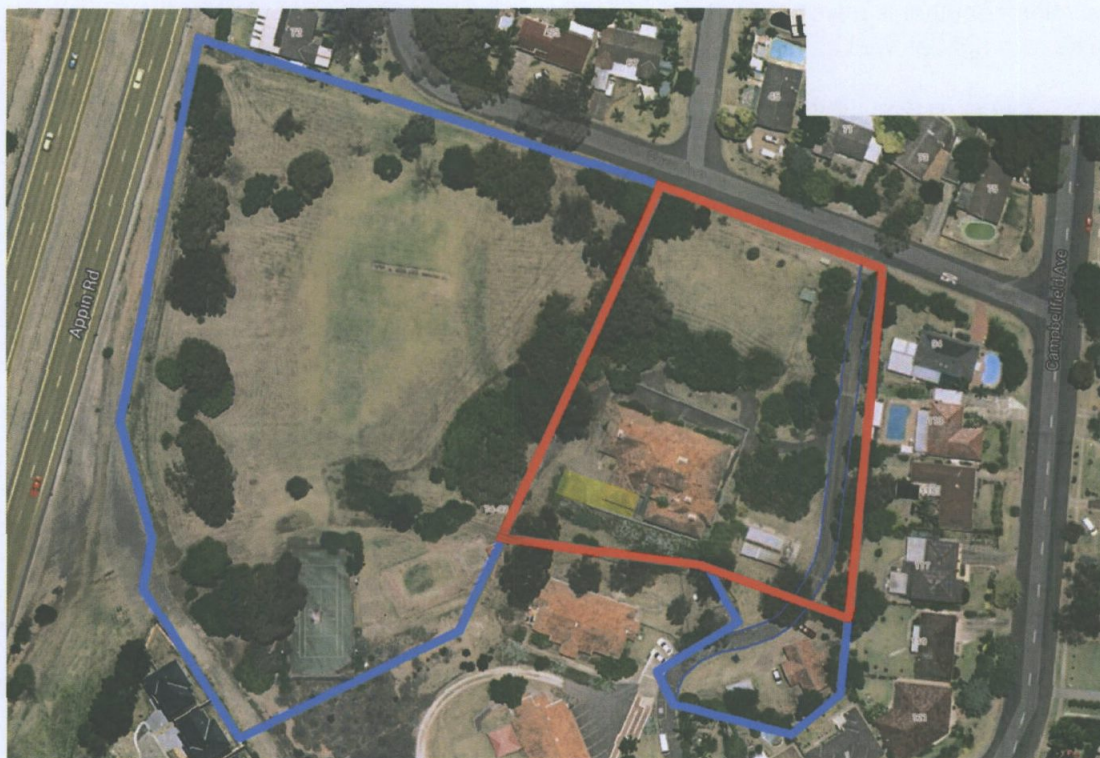
Figure 42 Recommended setting for Raith House. The western boundary follows the base of the embankment to the raised platform around the house. The area to the south between the driveway and the rear boundaries of residences to the east, does not form part of the essential setting of the house and could be separate from the land provided suitable controls on future development were put in place. The driveway is likely to be subject to an easement or right-of way for access. The area marked red is the setting for the house that should not contain development other than directly related to the house (such as additions). An indication of the preferred location for additions (if they are required) is shaded green.

The setting as drawn in figure 41 is the minimum setting to be retained around the house and is to be retained as a single lot.
