GTE1223 – Stage 1 Contamination Assessment  
23 May 2017

**RE: STAGE 1 CONTAMINATION ASSESSMENT at Nos.207-211 Hoxton Park Road, Cartwright**

This letter presents a Stage 1 Contamination report on the inspection and testing services associated with the contamination assessment undertaken at the above project.

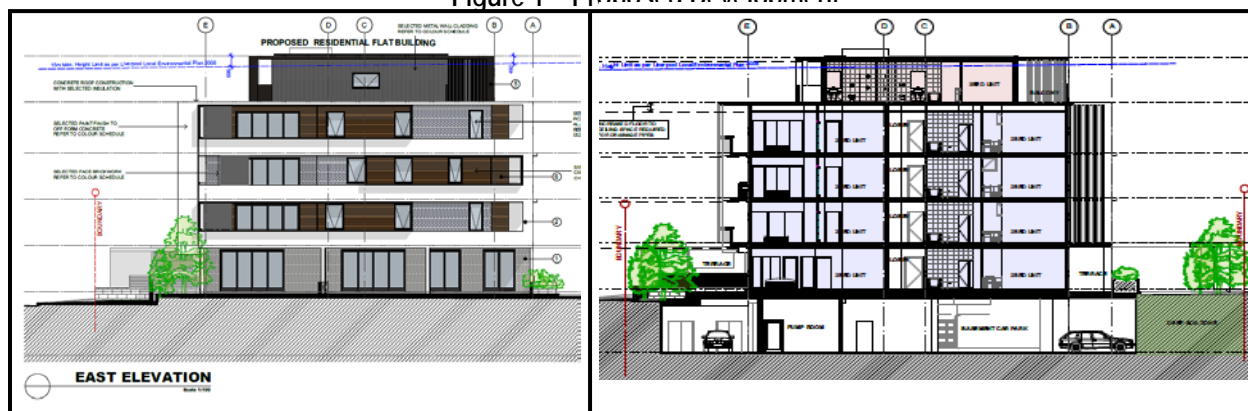
Figure 1 – Proposed Development

Ground Technologies Pty Ltd have undertaken a Stage 1 Contamination Report as requested on Nos.207-211 Hoxton Park Road, Cartwright. It is understood that the proposed works will comprise the construction of a five storey apartment building with one level of basement level car parking. The basement level car park will extend across the majority of the building envelope to a depth of approximately 3.0m below existing ground surface levels.

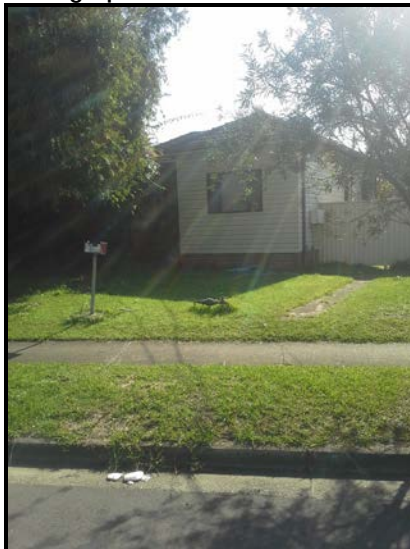
Photograph 1 – No.211

No.211 Hoxton Park Road contains a single storey weatherboard house located centrally within the property. The front and rear yards are predominately grass covered with a fibro shed in the north-western portion of the site. No.209 Hoxton Park Road contains a single storey weatherboard house located centrally within the property. The front and rear yards are predominately grass covered. No.207 Hoxton Park Road contains a single storey fibro house located centrally within the property. The front and rear yards are predominately grass covered with a fibro shed in the north-eastern portion of the site. The surrounding sites contain residential houses of similar construction and a commercial precinct is located on the opposite side of Hoxton Park Road.

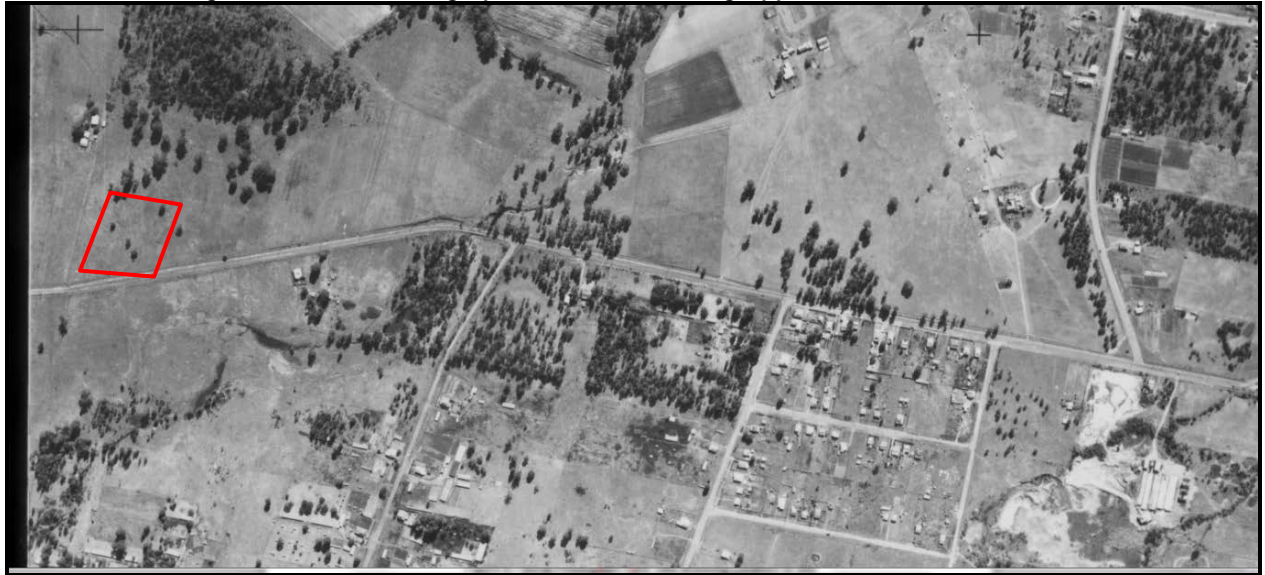
**Figure 3 – Aerial Photograph from 1947 showing Approximate Location of Site**

1947 – In 1947 the site appears to be undeveloped land. The surrounding properties appear to be vacant. No commercial or industrial properties could be observed within the region. The subject site is highlighted in figure 3.

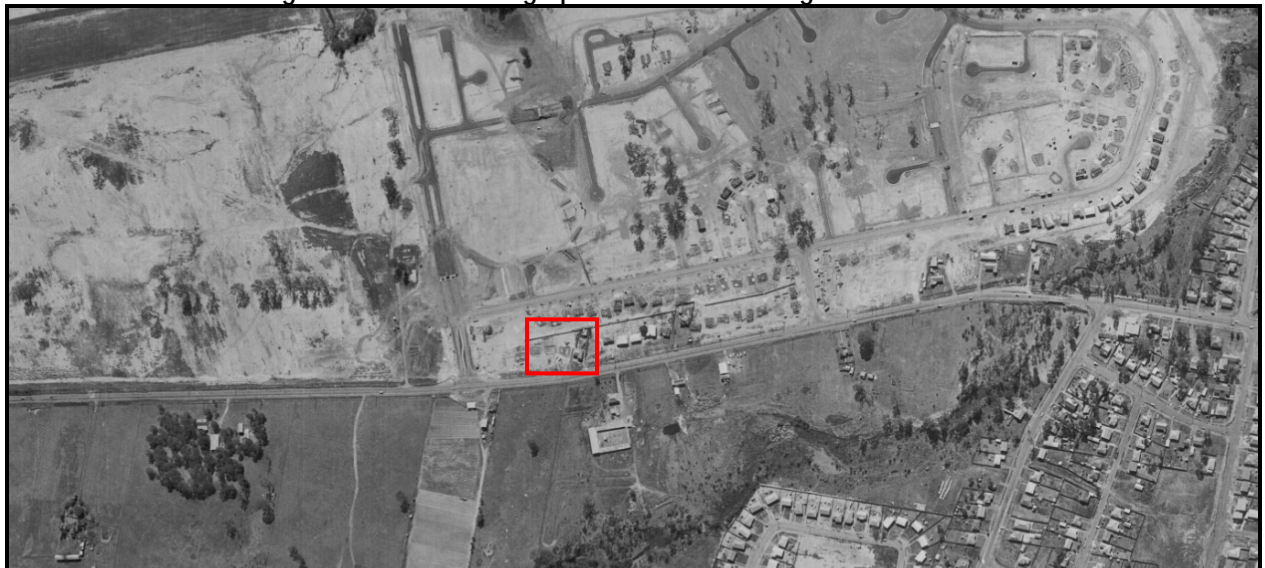
**Figure 4 – Aerial Photograph from 1965 showing Location of Site**

1965 – In 1965 the cartwright subdivision is being created and the subject sites being developed. No commercial or industrial properties could be observed within the region. The subject site is highlighted in figure 4.

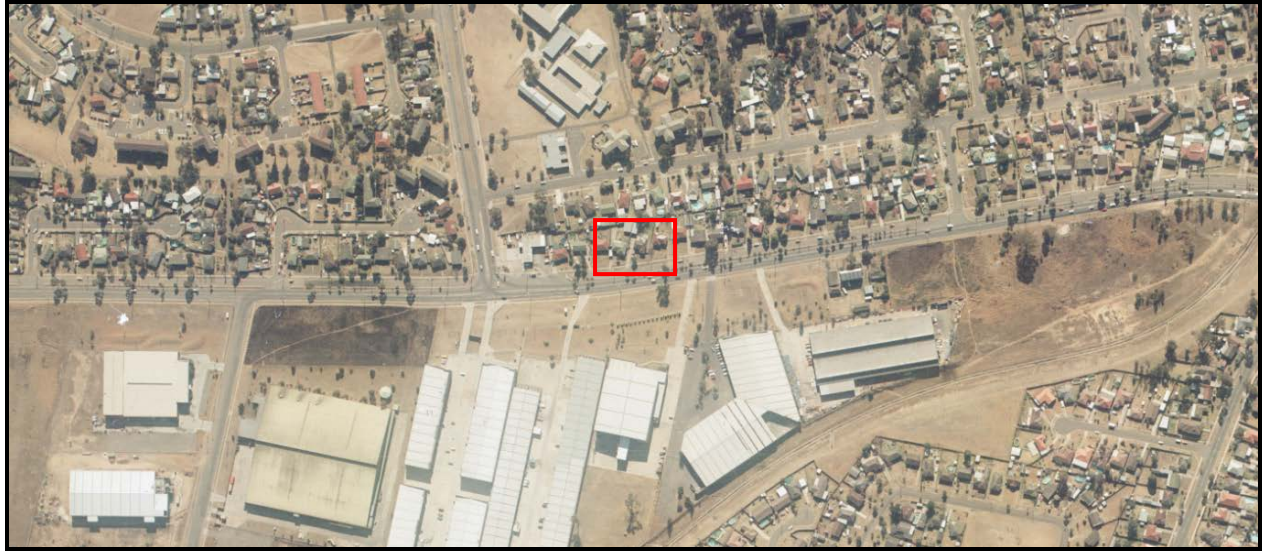
Figure 5 – Aerial Photograph from 1985 showing Location of Site

1985 – In 1985, the cartwright subdivision is completed and in use for residential purposes. The commercial precinct has commenced construction on the southern side of Hoxton Park Road. The subject site is highlighted in figure 5.

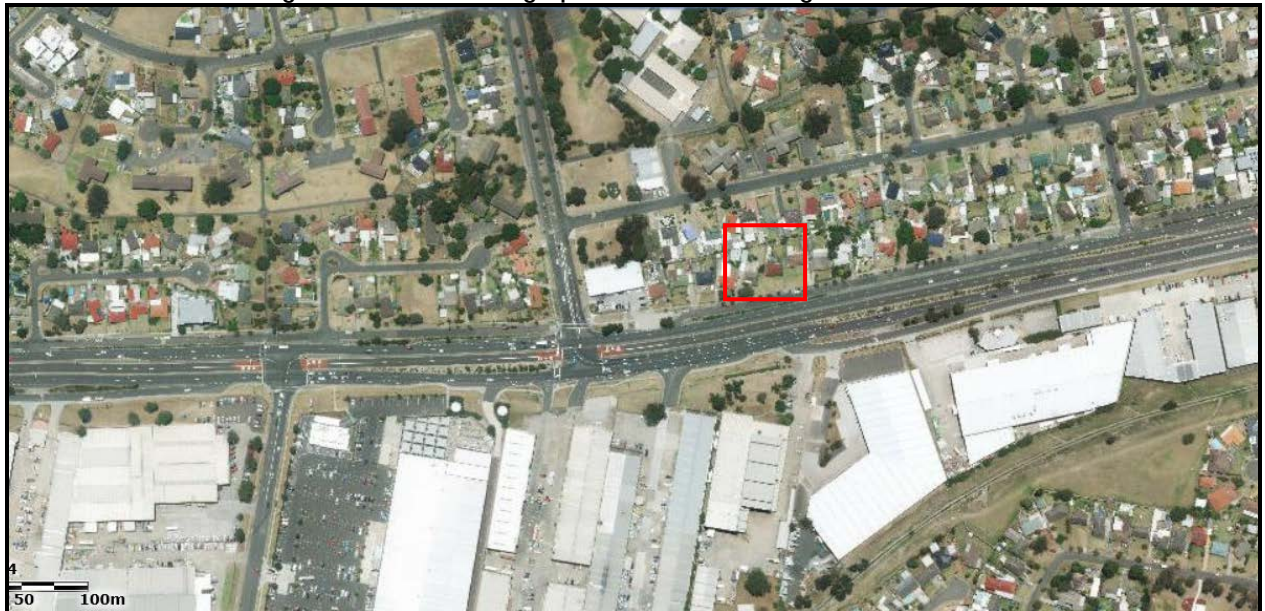
Figure 6 – Aerial Photograph from 2016 showing Location of Site

2016 – In 2016, no significant changes can be observed within the cartwright subdivision and it is still in use for residential purposes. The commercial precinct has been finished on the southern side of Hoxton Park Road. The subject site is highlighted in figure 6.
