## TAB J Heritage Impact Statement

## STATEMENT OF HERITAGE IMPACT

Goulburn Performing Arts Centre 163 Auburn Street, Goulburn

December 2016

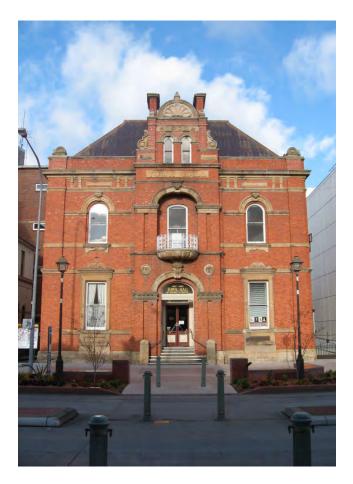
Figure 3.1 (Left) The primary elevation of the former Town Hall building viewed from the western side of Auburn Street

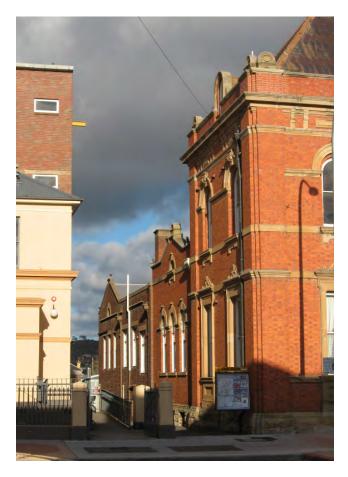
Figure 3.2 (Bottom Left) The northern (side) facade of the subject building viewed from Auburn Street. The 1936 rear addition is clearly discernible due to the change in brickwork colour

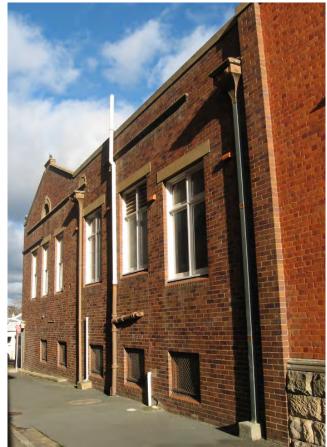
Figure 3.3 (Bottom Right) Northern (side) facade detail of the 1936 addition, of a simpler design than the original 1887 structure

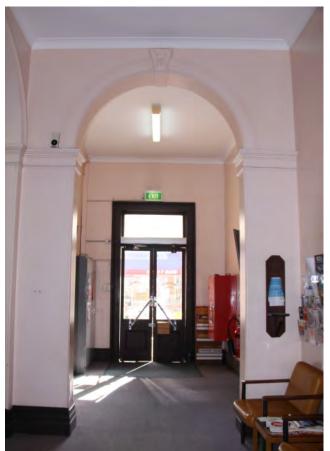
Figure 3.8 Looking west through the foyer towards the front door/main entrance to the building

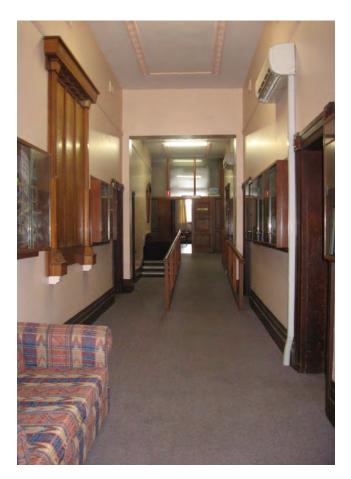
#### Figure 3.9 (Left)

Looking east along the ground floor hallway towards the ramp. Timber memorial nameboard visible affixed to the hallway wall on the left

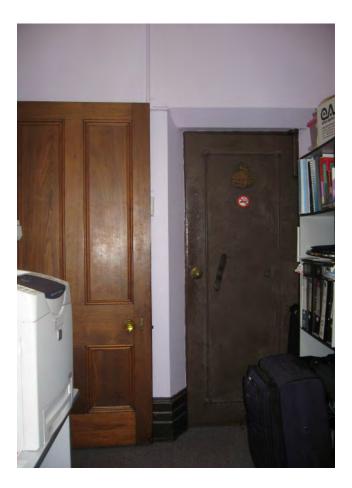
## Figure 3.10 (Bottom Left) The Strong Room door

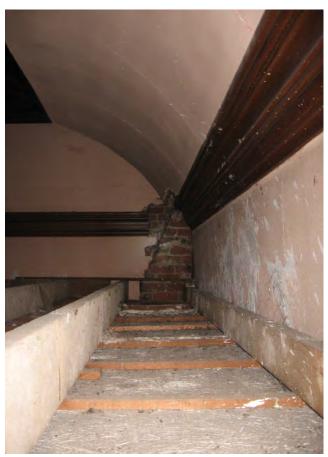
Figure 3.11 (Bottom Right) Coved plaster and timber ceiling of the original 1887 council chamber, above the existing false ceilings in the rooms located within the original chamber space partitioned in 1936. Note the 1936 brick chimney flue in the corner

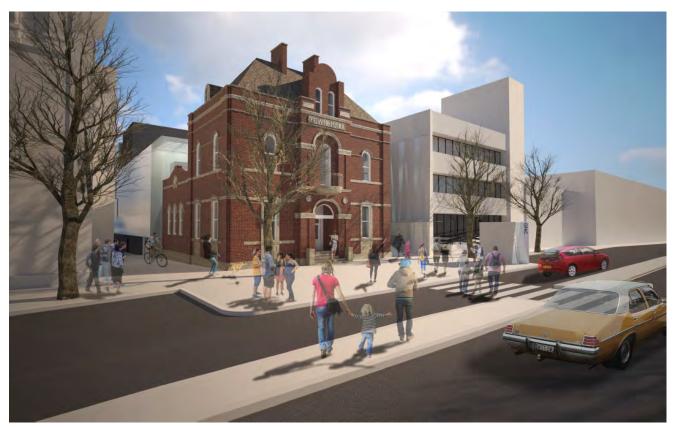
#### Figure 5.2

The Proposed Development - Perspective from Auburn Street (A300). Note the proposed glazed PAC behind the original 1887 building Source: *Brewster Hjorth Architects*

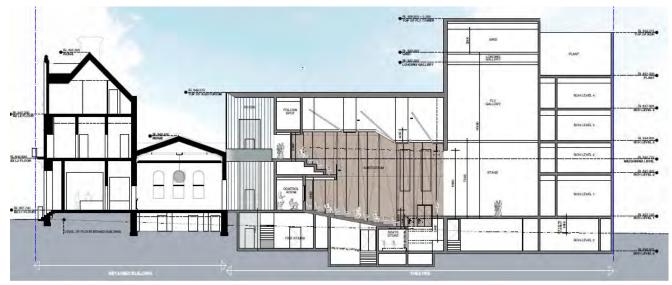
#### Figure 5.7

The Proposed Development - Section 1 (A210) Source: *Brewster Hjorth Architects*

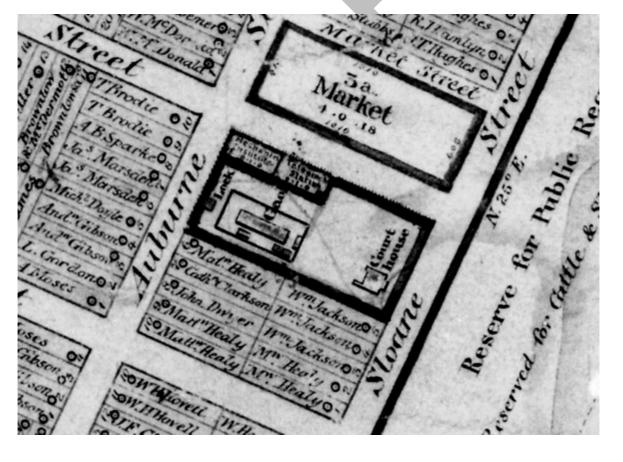
Figure 2.12. The Goulburn Town Map of 1849 showed the Gaol buildings. Source: SR Map 2807

their children.<sup>21</sup> A specification for cookhouses was drawn up on 9 December 1848. The 1849 plan the Town of Goulburn showed the gaol buildings (Figure 2.12).<sup>22</sup>

The general plans of the Gaol from the 1840s to the 1880s tend to be somewhat formulaic, showing the same Gaol and three buildings within the Gaol Walls (Figures 2.12, 2.14, 2.19, 2.20, 2.21, 2.23 and 2.26). This tends to make the identification of individual buildings within the gaol more difficult, apart of course from the Gaol Building itself.

The Lock-up in 1840 was located on the Auburn Street frontage (Figures 2.12 to 2.15, 2.19 to 2.23). The site of the Lock-up is located on the adjacent property (165 Auburn Street), but the burial may not have been directly or precisely behind the building, even though it was reported as "immediately in the rear of the lock-up" (Figure 3.1). There is a possibility that it is located on the subject site.

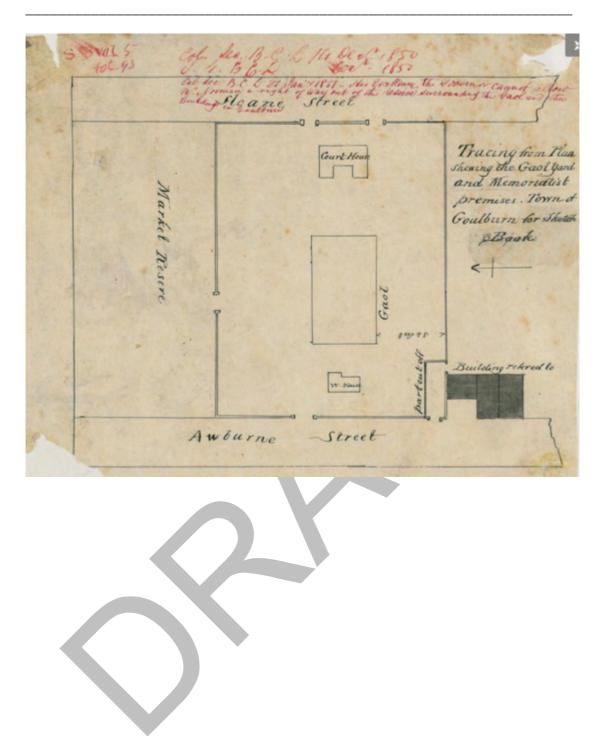
Figure 2.15. Sketch showing access for the adjacent landowner. Source: Surveyor General, Sketch Book 5 f 93

The work was completed by James Sinclair, who presented his bill for fencing the gaol and courthouse on 30 December 1850.<sup>27</sup> A sketch of about December 1850 relating to adjacent land showed a right of way allowed to the adjacent landowner out of the gaol reserve (Figure 2.15).<sup>28</sup>

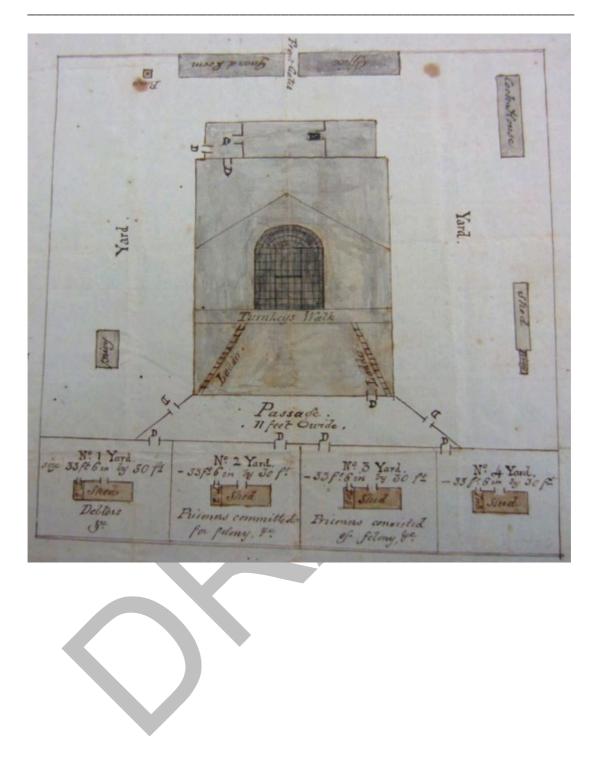
Figure 2.16. Sketch plan of proposed division and layout, 1852. Source: Colonial Architect, Correspondence, Goulburn Gaol, 1844-56, SRNSW 2/8158

A specification for work on the gaol prepared by the Colonial Architect on 22 July 1852 set out the tasks as renewing the floors and repairing the ventilation, replacing rotted cell doors, repairing some gratings, cutting a new door in one end cell at 'the further end of the Gaol', converting two cells into cells for condemned prisoners, and replacing the roof on the turnkey's lodge.<sup>31</sup> On 7 December 1852 a contract was signed with Columbus Fitzpatrick of Goulburn for those repairs.<sup>32</sup> In 1853, the Blue Book showed that additions to the Gaol costing £753/8/0 had been completed.<sup>33</sup> The repairs and additions by Columbus Fitzpatrick in 1852-3 included an additional floor above the cookhouse, a new kitchen for prisoners, re-flooring of the cell wing and the division of the yard into four exercise yards (Figure 2.16).<sup>34</sup>

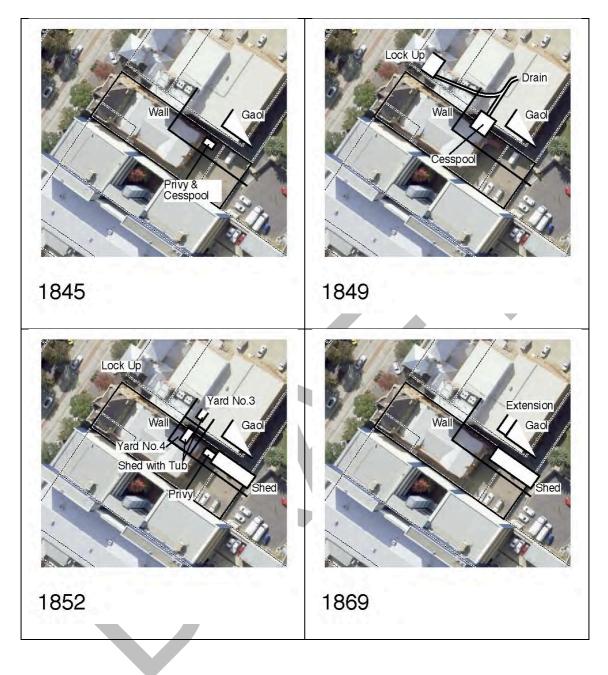
Figure 3.1. Timeline Plans of Goulburn Gaol. Source: Basemap from SIX maps. Overlays of historical plans in Chapter 2.

See Figure 3.1 for Timeline Overlay Plans, 1845, 1849, 1852, 1869, 1882 and 1887.

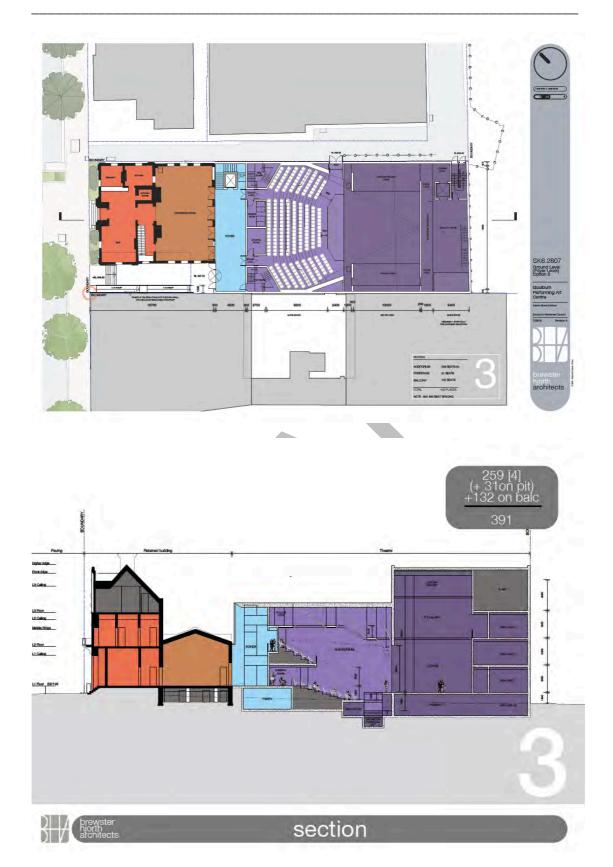
Figures 3.2 and 3.3. Plan and section of proposed development of the Goulburn Performing Arts Centre.

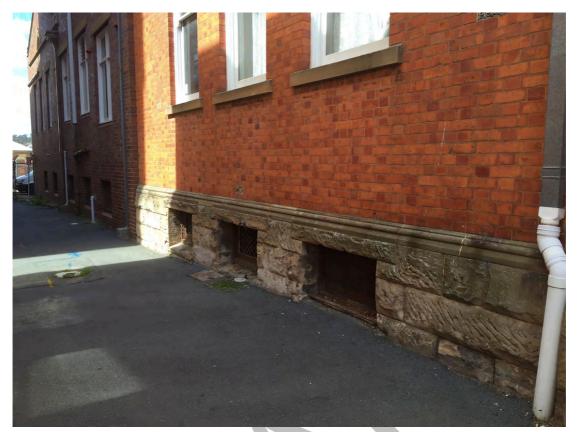
Plate 3.3. Former Town Hall (1887), 163 Auburn Street, Goulburn, NSW 2580. View along roadway on north side of building, with ventilation windows into basement area (?). Photograph by Dr. Edward Higginbotham, 27 September 2016

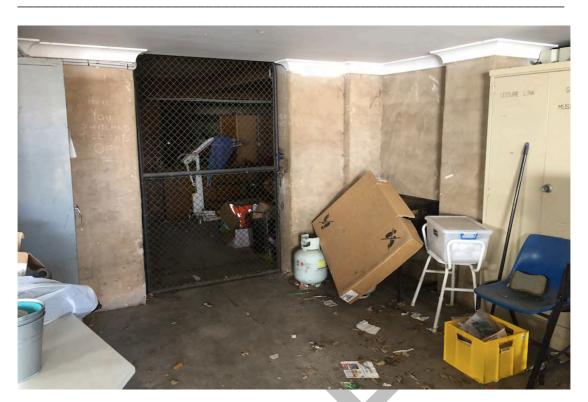
Plate 3.7. Former Town Hall (1887), 163 Auburn Street, Goulburn, NSW 2580. View of store beneath the 1936 extension.

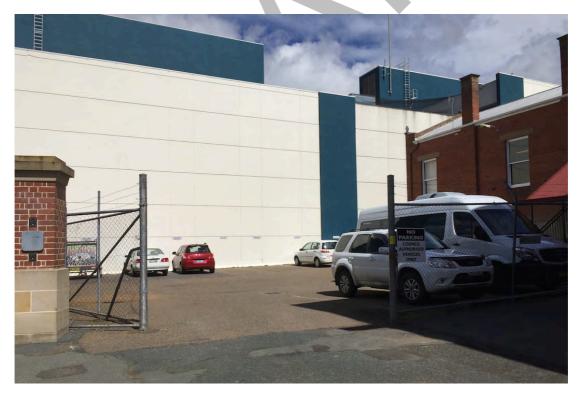
Plate 3.8. Former Town Hall (1887), 163 Auburn Street, Goulburn, NSW 2580. View of rear yard behind the 1936 extension, looking south-west from entrance to car park. Photograph by Dr. Edward Higginbotham, 27 September 2016

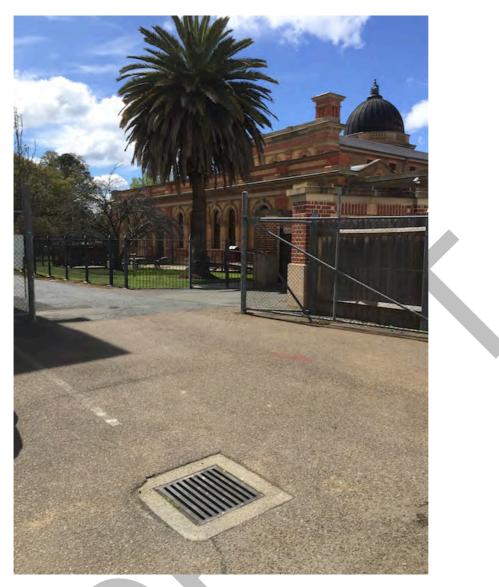
Plate 3.9. Former Town Hall (1887), 163 Auburn Street, Goulburn, NSW 2580. View of rear yard behind the 1936 extension, looking north-east towards entrance to car park and Courthouse Complex. Photograph by Dr. Edward Higginbotham, 27 September 2016.

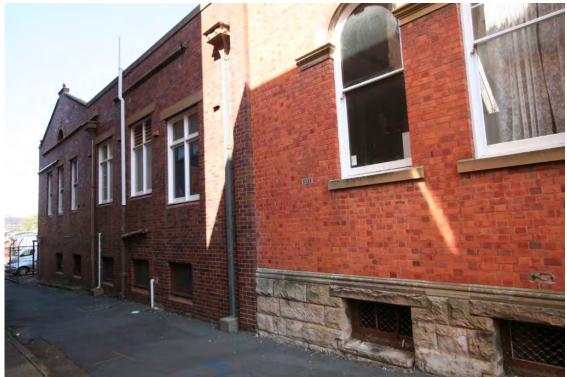
Photograph 9 View of the junction between the original and the addition, looking South noting the replacement offices and relocated Hall at the end.

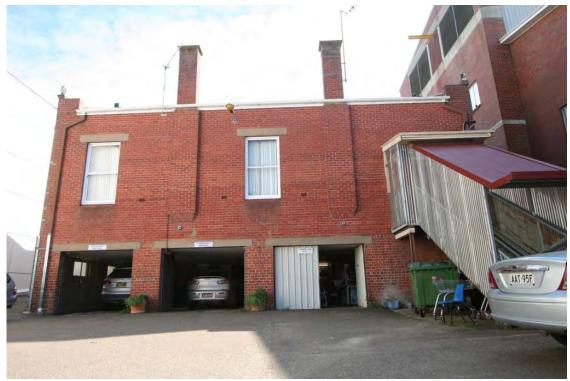
Photograph 12 View of the rear – East Elevation of the replacement Town Hall.

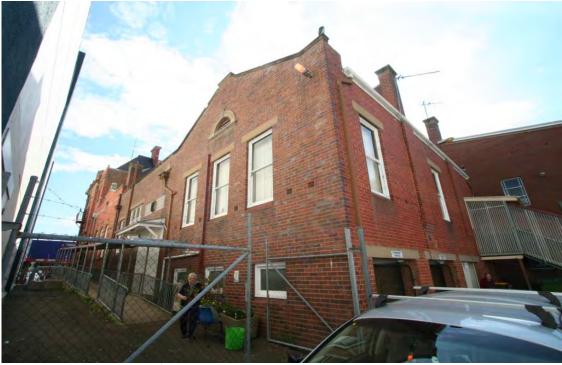
Photograph 13 View of the South Elevation of the Town Hall including the replacement later Hall and the original, noting the access ramps and adjoining State Government Office building.

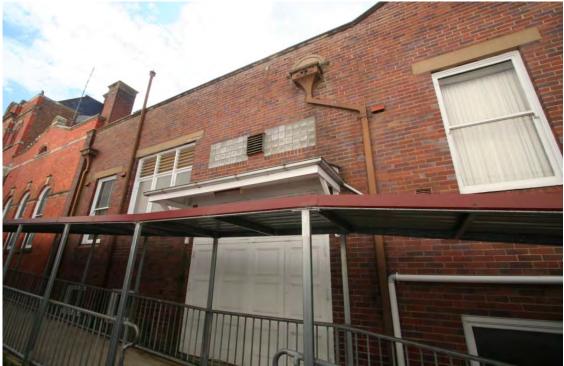
Photograph 14 A detail view of the South Elevation noting the junction between the original the addition with the replacement Town Hall

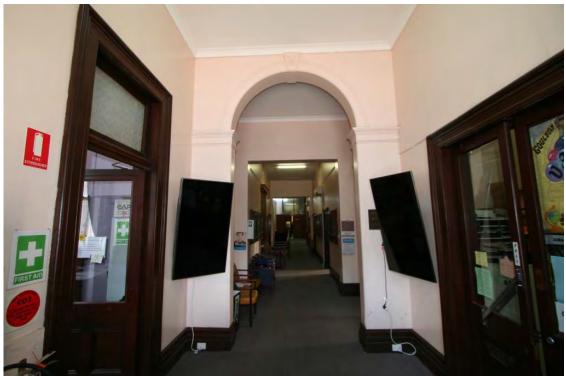
Photograph 17 View from the entry illustrating the original arch separating the lobby from the second opening. The original walls and doors to the left (minor offices) and right (major office) are to be demolished.

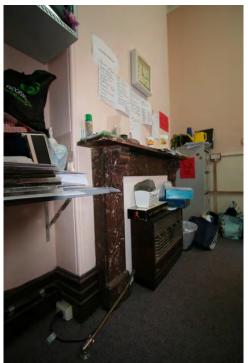
Photograph 19 View of the original fireplace and surround in the minor office – to be retained.

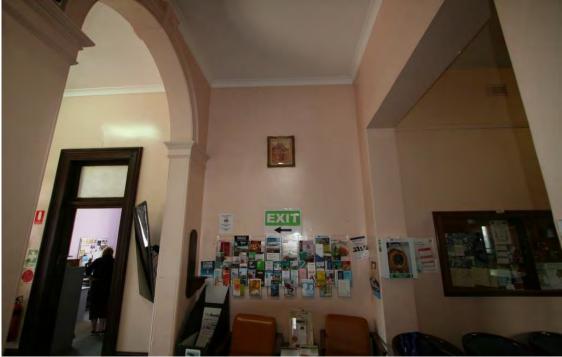
Photograph 20 View of the wall between the arch and opening which backs on to the safe – to be demolished.

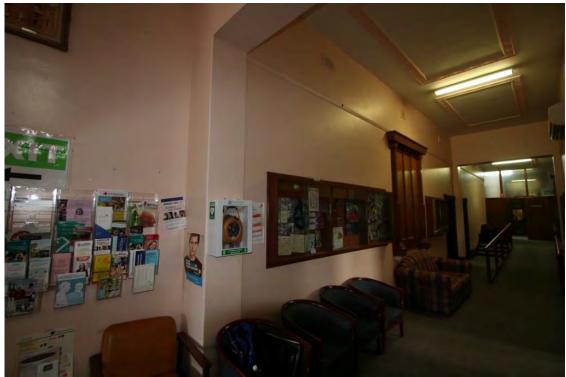
Photograph 21 View of the Northern wall to the main passage from the opening in the original rear wall – the wall to the right of the opening formed part of the extension and replacement Town Hall. The two walls defining the extended passage are to be demolished and the vaulted ceiling restored and reinstated.

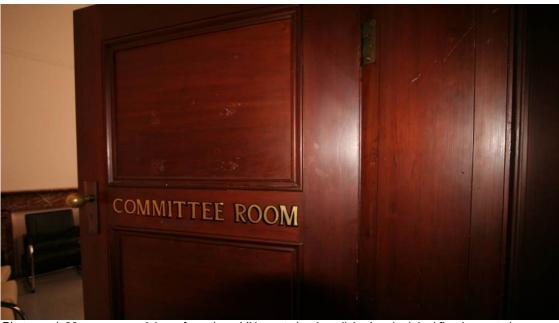
Photograph 22 retained.

Joinery from the addition - to be demolished and original fireplace - to be

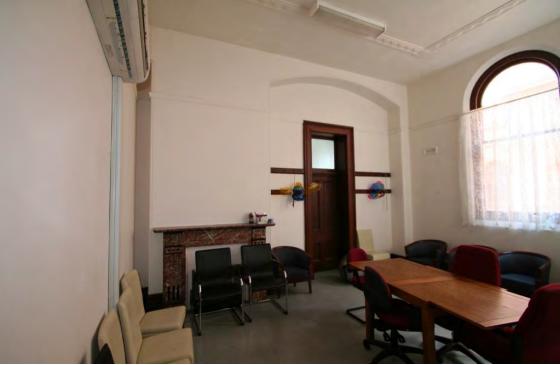
Photograph 23The Committee Room with fireplace and door to the front minor office – to beretained and the wall to the left to be demolished and the ceiling reinstated.

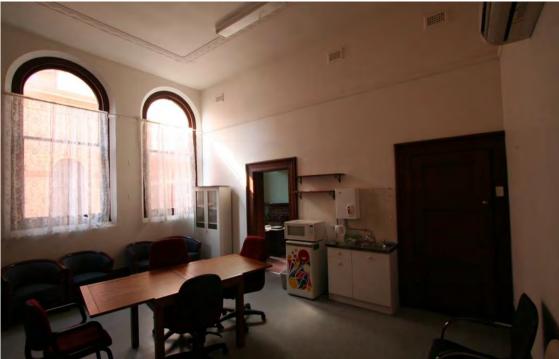
*Photograph 24* Wall and joinery formed for the later Town Hall to be demolished and the vaulted ceiling reinstated.

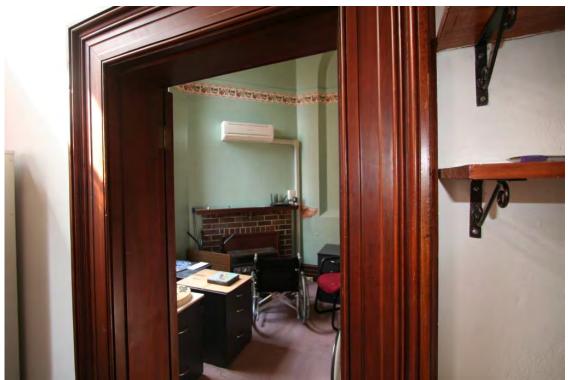
Photograph 25 The fireplace and joinery to be demolished. Photographs of the toilets and kitchen within the later Hall building are omitted from this analysis given their lower level of significance.

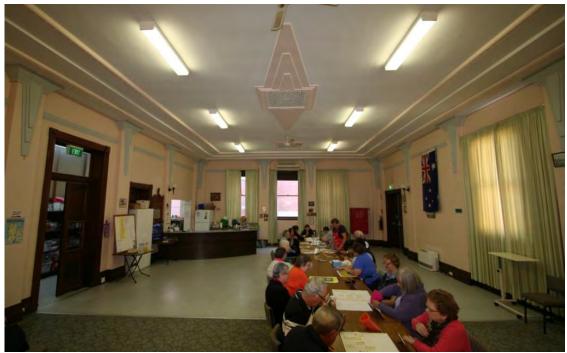
Photograph 26 View of the later Town Hall, noting the decorative plasterwork to the walls and ceiling.

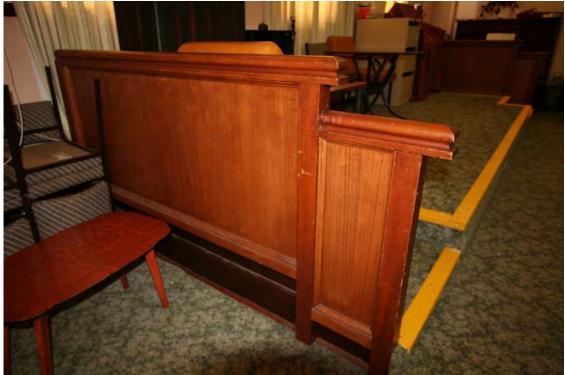
Photograph 27 The raised dais and associated joinery from the later Town Hall – to be demolished.

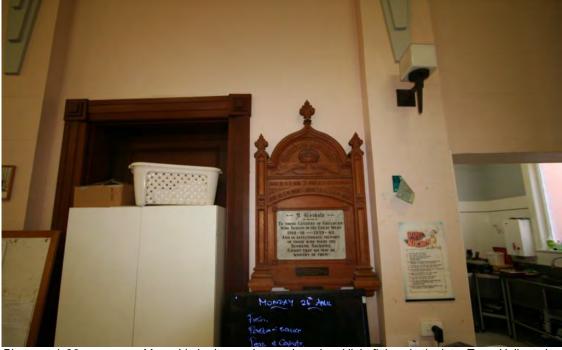
Photograph 28 demolished.

Moveable heritage – honour board and light fittings in the later Town Hall – to be

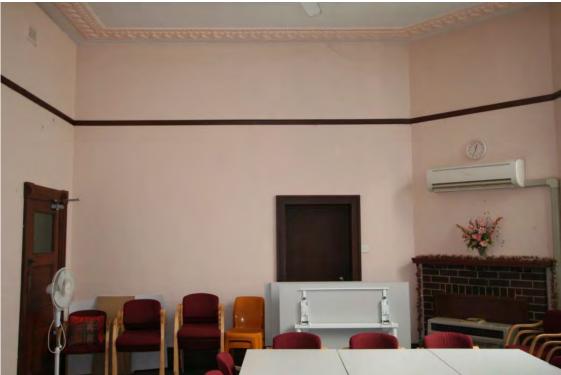
Photograph 29

View of the small meeting room within the extended building – to be demolished.

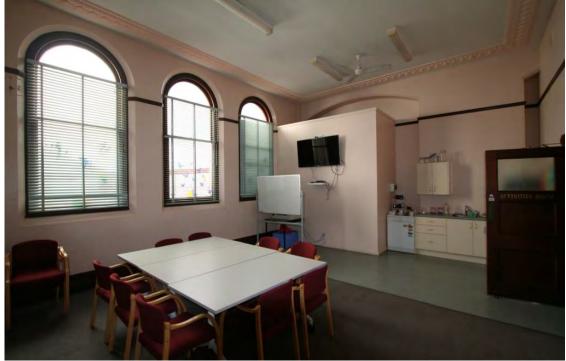
Photograph 30 View of the Activities Room and portion of the former Town Hall – the walls to the rear and right to be demolished and the former Hall ceiling to be reinstated.

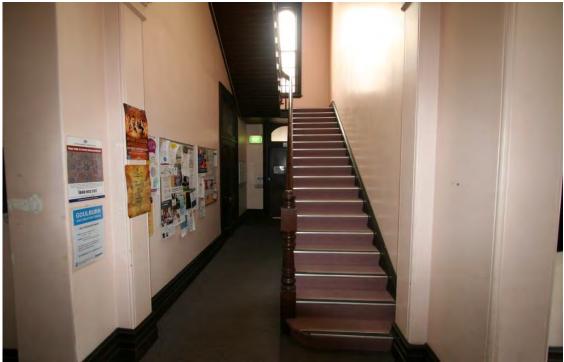
Photograph 31

View of the ground floor stair well – to be retained

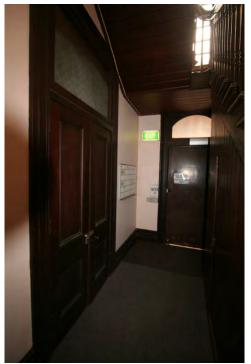
Photograph 32 View of the stairwell space with external door and door to the Activities Room, former Town Hall – to be retained

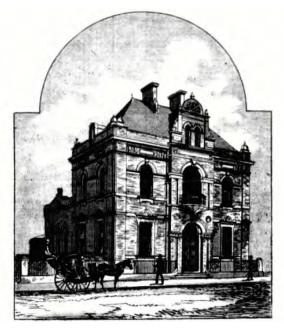
## Figure 2.15

Etching of the new Goulburn Town Hall in 1889 Source: Australian Town and Country Journal, Saturday 16 February 1889, The Goulburn Town Hall, p26

The final design was very decorative with a high pitched hipped roof and tall chimneys (Figure 2.15). The layout of the original building comprised "an under-ground store, a ground floor, a first floor, and an attic"<sup>36</sup> as shown in the original plans which are signed by the contractor W. Wilkie.

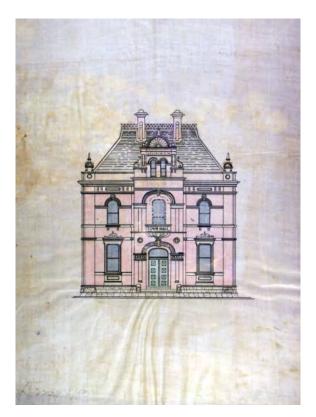
**Figure 2.16** E C Manfred's design No. 9 - Front elevation of the final design chosen for the Goulburn Goulburn Town Hall, signed by the contractor W. Wilkie Source: Goulburn & District Historical Society

The Council selected Manfred's design No. 9 as the final choice for the new building (Figures 2.16 - Figure 2.23).32

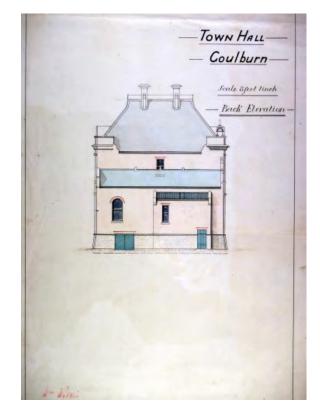
Figure 2.17 Rear elevation drawing Source: Goulburn & District Historical Society

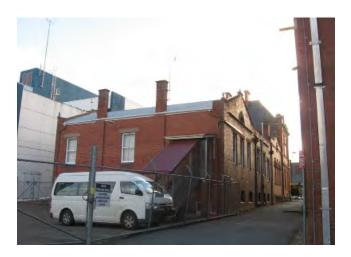
## Figure 3.14

View of the eastern (rear) and northern (side) elevations of the building from the rear access lane. Metal security fence and site carpark visible in the foreground

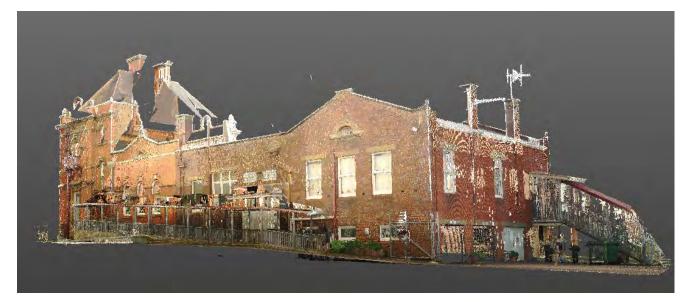
**Figure 3.20** 3D model of the building's southern (side) and eastern (rear) elevations *Source: Brewster Hjorth Architects*

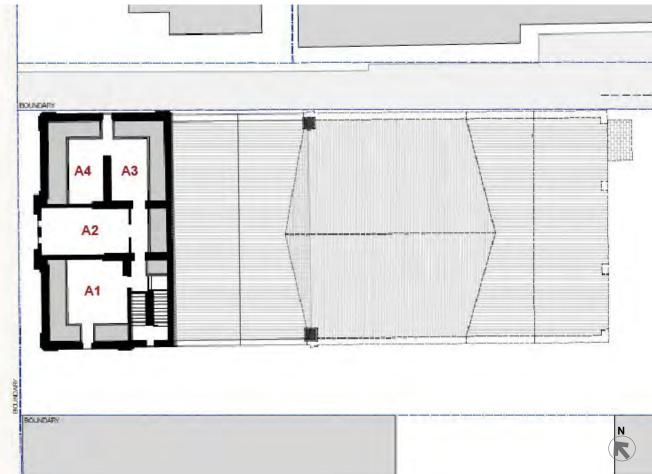
Figure 3.25 The basement level of the building

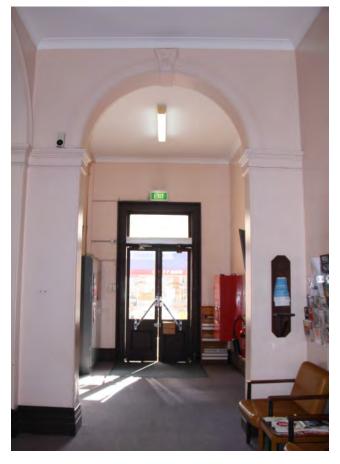
Figure 3.26 Looking west through the foyer (G1) towards the front door/main entrance to the building

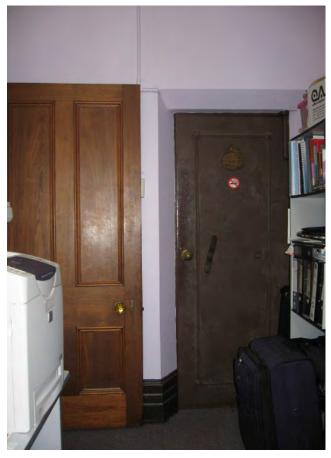
Figure 3.34 The Strong Room (G5) door viewed from within room G3

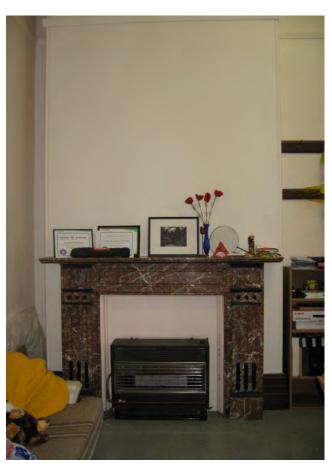
Figure 3.39 Looking north across room G9, located in the 1936 addition to the building

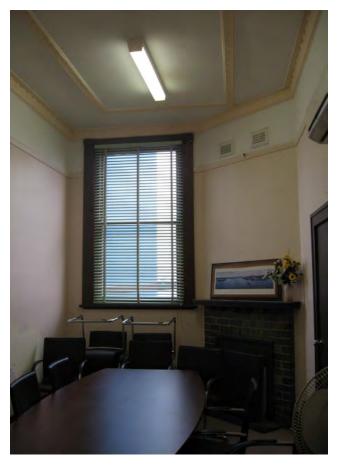
Figure 3.40 Looking south across room G10, located in the 1936 addition to the building

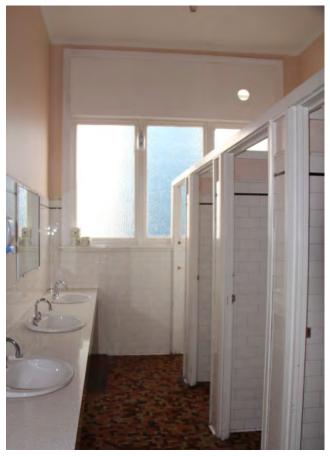
## Figure 3.41

The ladies toilets (G11), located in the 1936 addition to the building, in an area shown to be the mens toilets on the 1936 plans

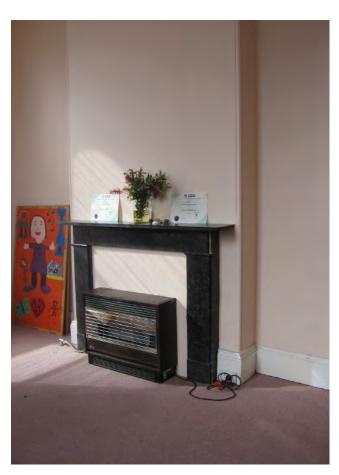
## Figure 3.54

Chimney breast with black stone fireplace surrounds located in room F4. The fireplace has been filled in with a later heater installed

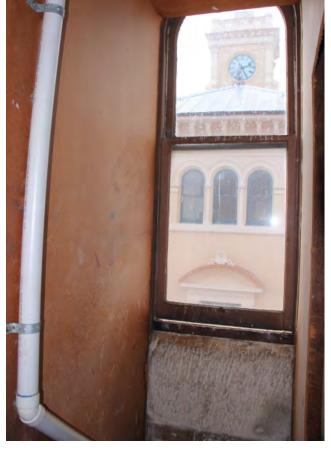
## Figure 3.63

Interior detail of the dormer window in between rooms A3 and A4 which looks out towards the adjacent Post Office building

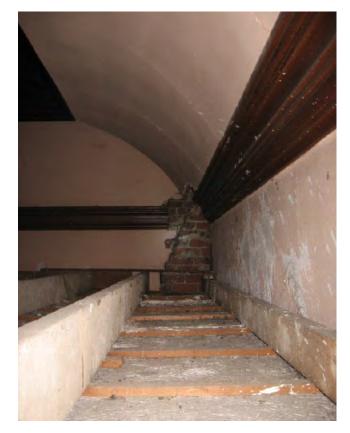
## Figure 3.65

Coved plaster and timber ceiling of the original 1887 council chamber, now located above the existing ceilings in rooms G6, G7 and G8

The ceiling is coved with soffit detailing in the form of diagonally laid alternating pine and cedar boards, and timber mouldings.

The relatively intact original ceiling suggests it should be exposed in a future renovation.

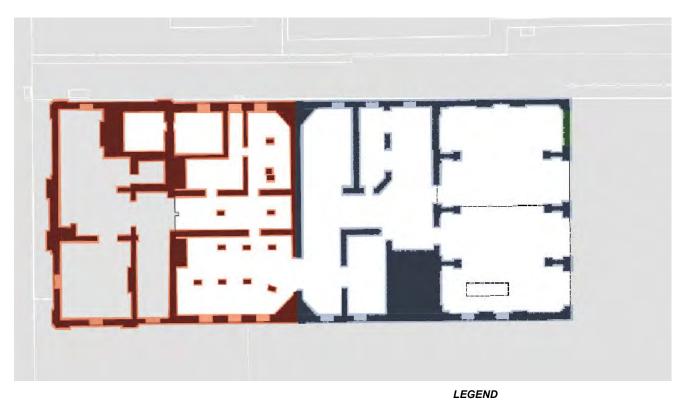
#### Figure 4.10 (Above)

Basement Grading Diagram indicating the significance of individual components, as shown in the key on the right. The Grading Diagram is to be read in conjunction with the Grading Table provided above *Source: Brewster Hjorth Architects*

Any work which affects fabric, spaces or relationships with a High assessed heritage value (see Figures 4.10 - 4.15) should be confined to preservation, restoration, reconstruction and adaptation as defined in *The Burra Charter* and should be carefully maintained.
