# Conservation Management Strategy

## Keira and Thomas Street Development Site

### 131–135 and 137–141 Keira Street, Wollongong

June 2017

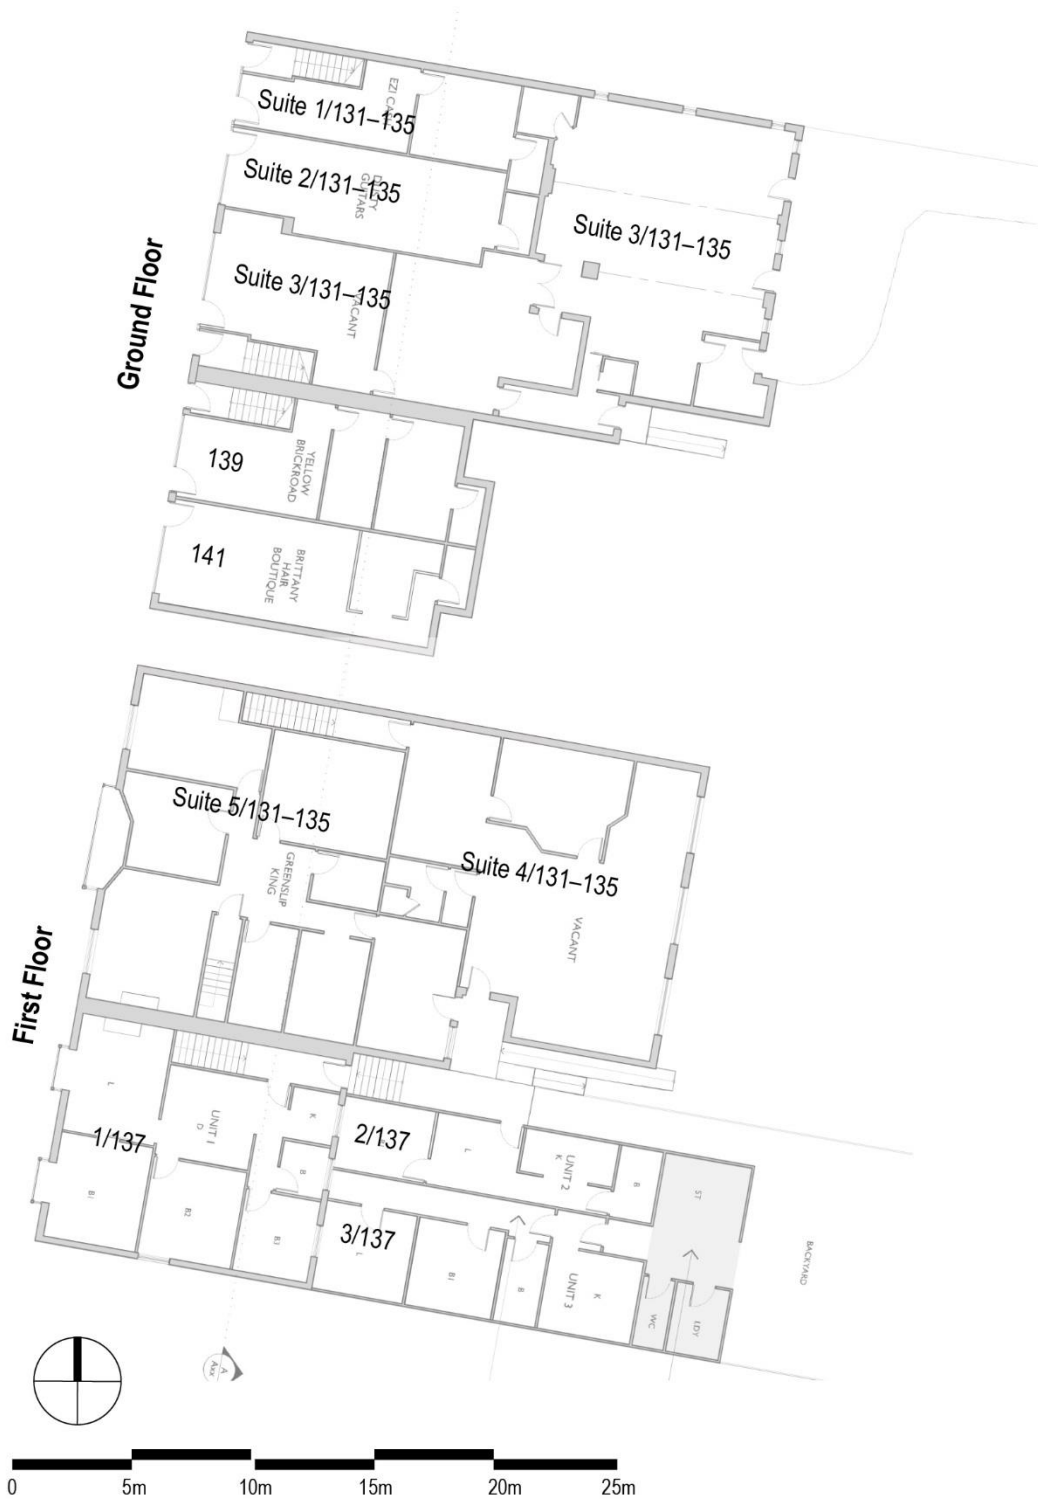
**Figure 1.6** Building identification, 131–135 and 137–141 Keira Street, Wollongong. (Source: ADM, overlay by GML November 2016)

The above property identification is as provided by managing agent, First National (Refer Figure 1.6)

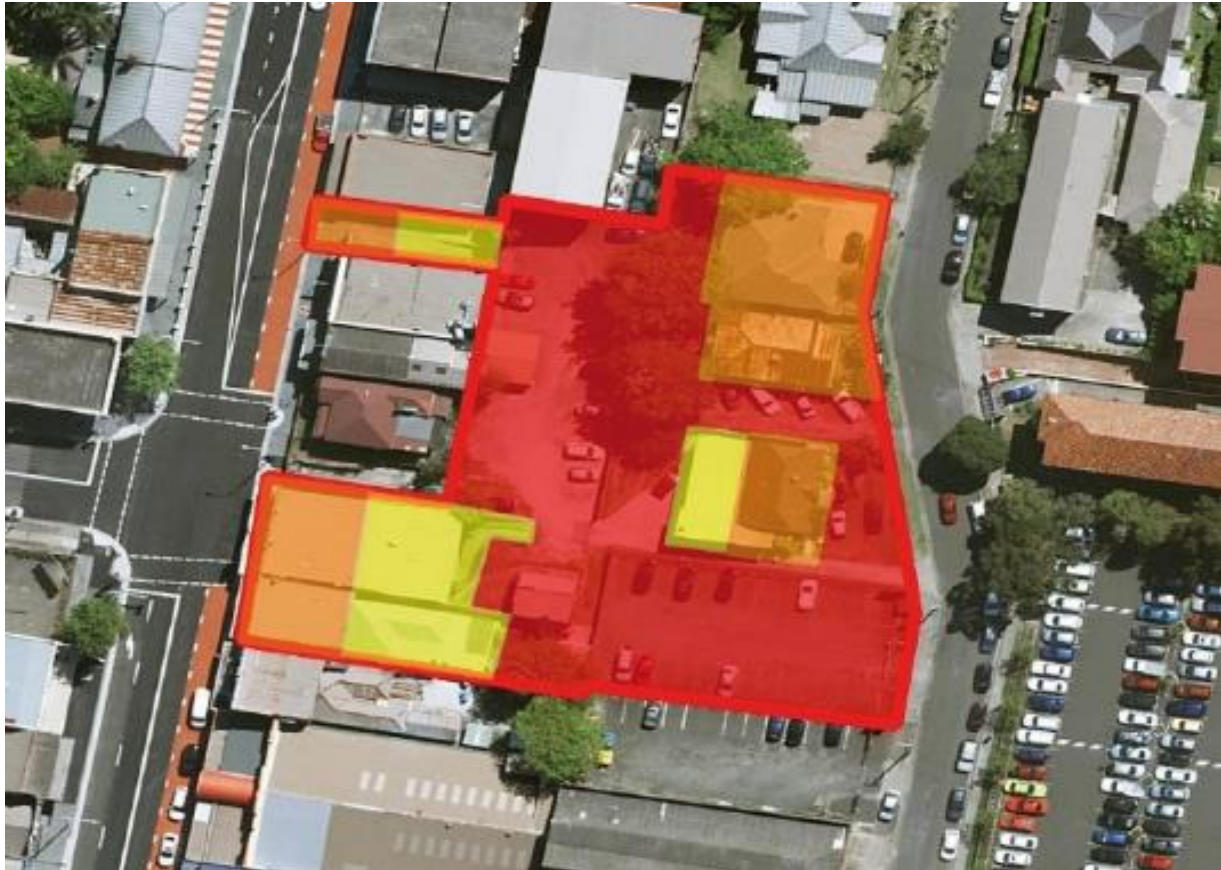
**Figure 2.8** Plan of the subject site showing assessed archaeological potential. (Source: NSW LPI with GML overlay; repeat of Figure 4.2 in the AA)

- The proposed mitigation measures would comprise a program of test excavation to determine the nature and extent of the potential archaeological remains, followed by either archaeological monitoring or open area excavation depending on the results of testing. Interpretative measures could be used to disseminate the results to the wider community.

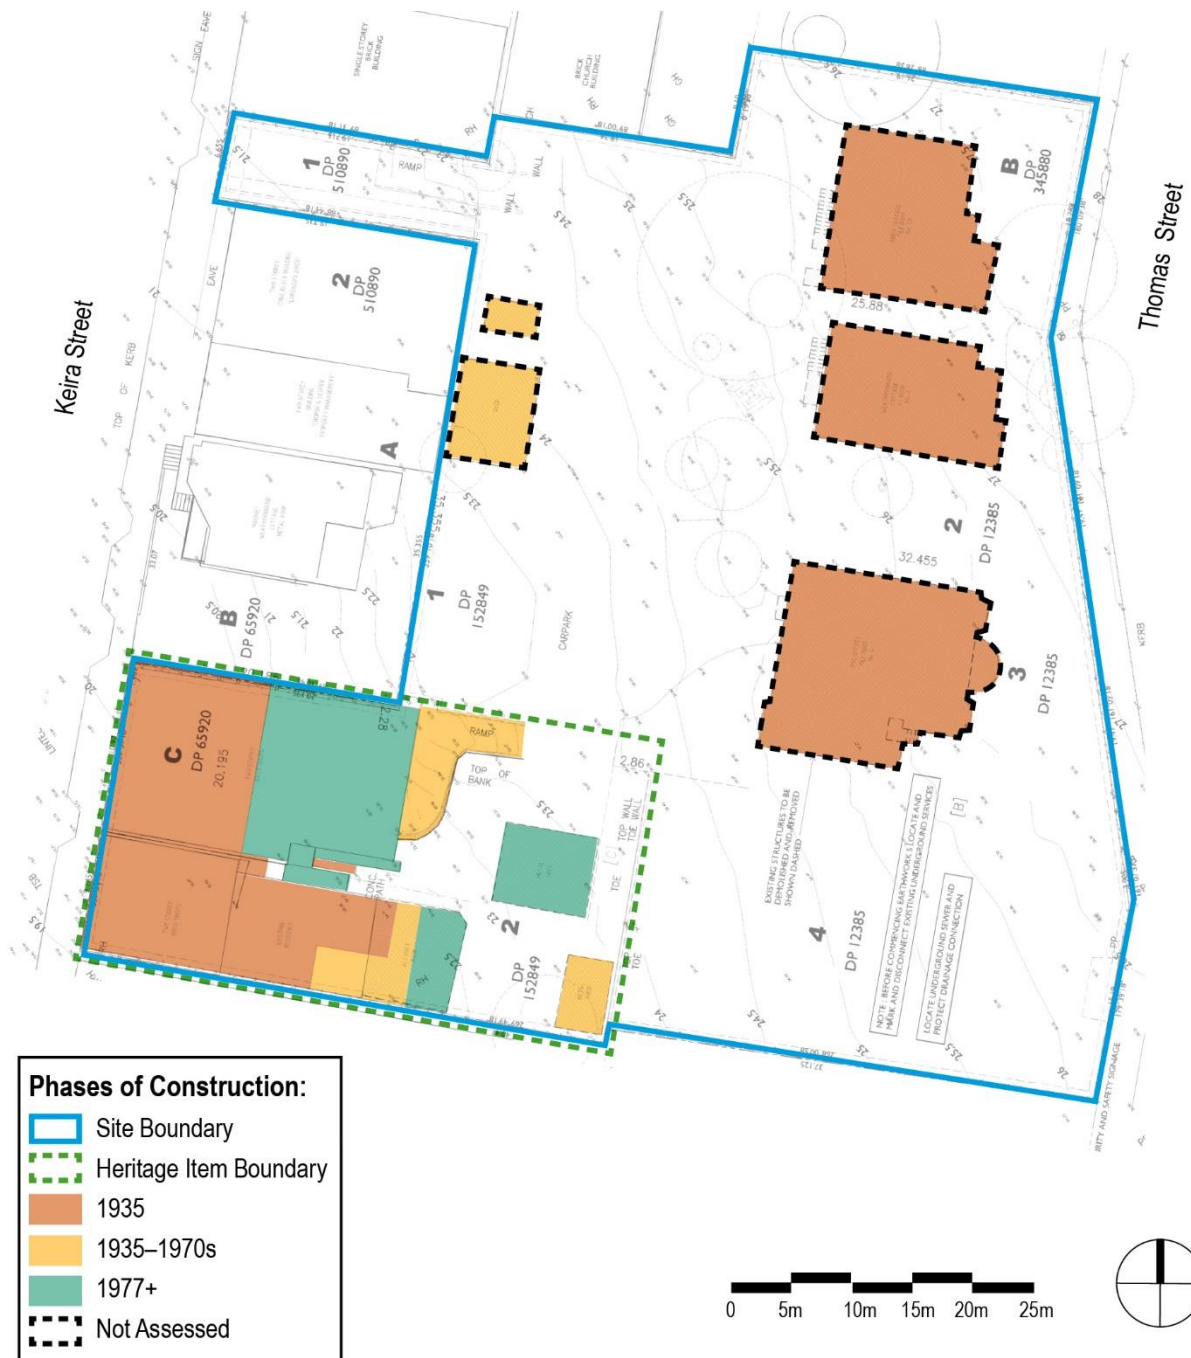
**Figure 2.9** Site plan—phases of construction. (Source: C Robson & Associates Pty Ltd, 29 May 2015, with GML overlays)

The following diagram provides indicative phases of construction for heritage items 131–135 and 137–141 Keira Street.

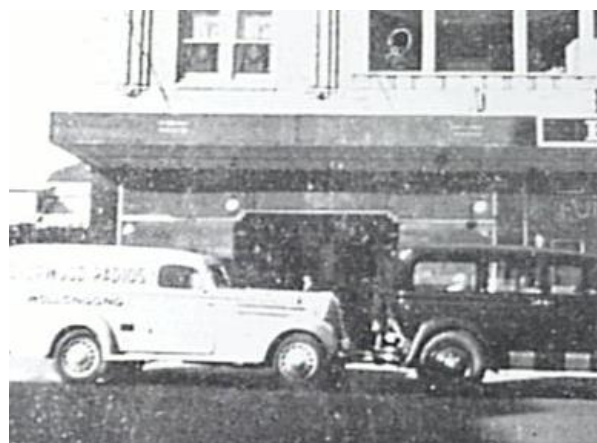
**Figure 2.17** 131–135 Keira Street, shopfront, 1937, providing evidence of original Art Deco detail, since replaced by aluminium framed glazed shopfront windows. (Source: Illawarra Images, No. P14/P14365; refer to Section 2.2.1)

The photograph of the original and largely glazed shopfront with a central entry could provide inspiration for replacement shopfront design (refer to Figure 2.17). Note the original shopfronts still remained in the 1970s.

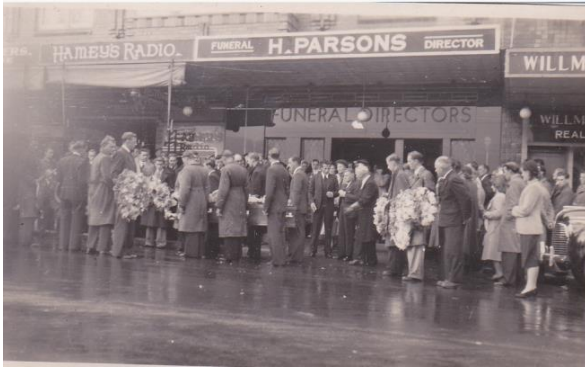
**Figure 2.18** 131–135 Keira Street, H Parsons shopfront (no date), providing evidence of original Art Deco detail, since replaced by aluminium framed glazed shopfront windows. (Source: H Parsons Funeral Directors <<http://hparsons.com.au/services/history/>>)

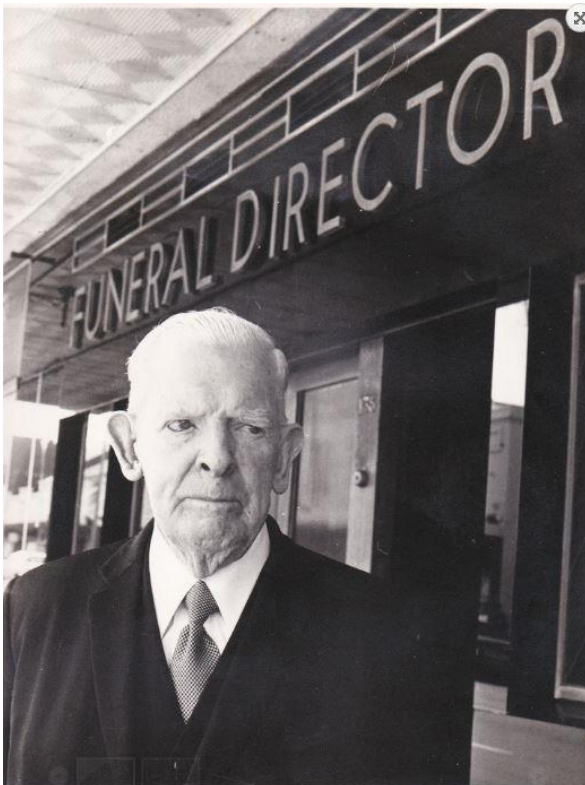
**Figure 2.20** 131–135 Keira Street, H Parsons shopfront (no date, c1970s), providing evidence of original Art Deco detail to shops, signage and awning lining, since replaced by aluminium framed glazed shopfront windows. (Source: H Parsons Funeral Directors <<http://hparsons.com.au/services/history/>>)

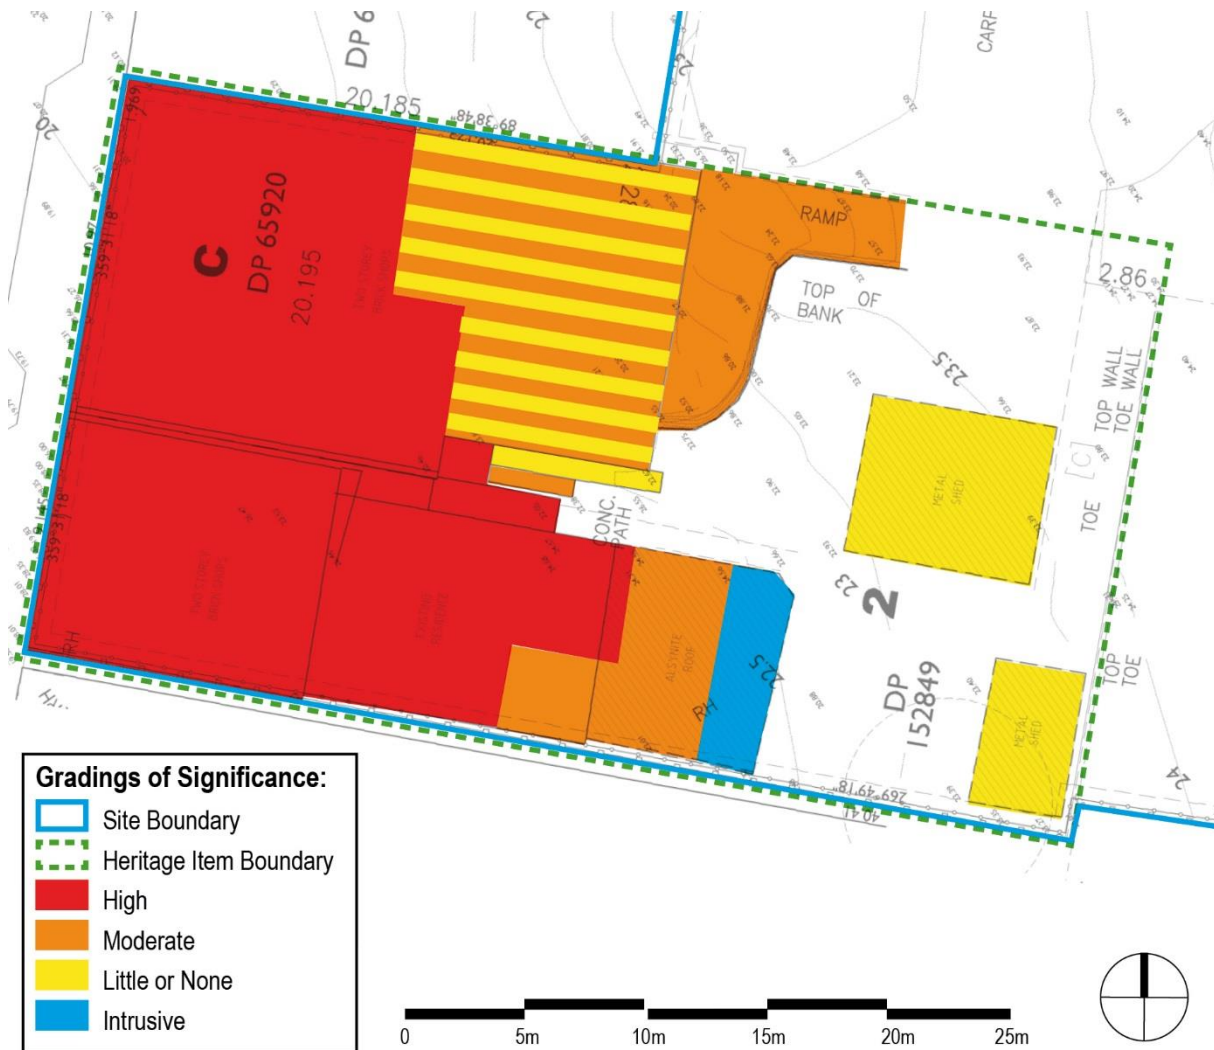
Figure 2.27 Site plan—significance gradings. (Source: ADM Documentation October 2016, with GML overlay)

Figures 2.27–2.30 provide a graphic summary of the gradings of significance for the exterior façade (front only—west) and internal spaces of 131–135 and 137–141 Keira Street, Wollongong. These plans should be read in conjunction with Figures 2.9–2.11 'Periods of Construction' above.

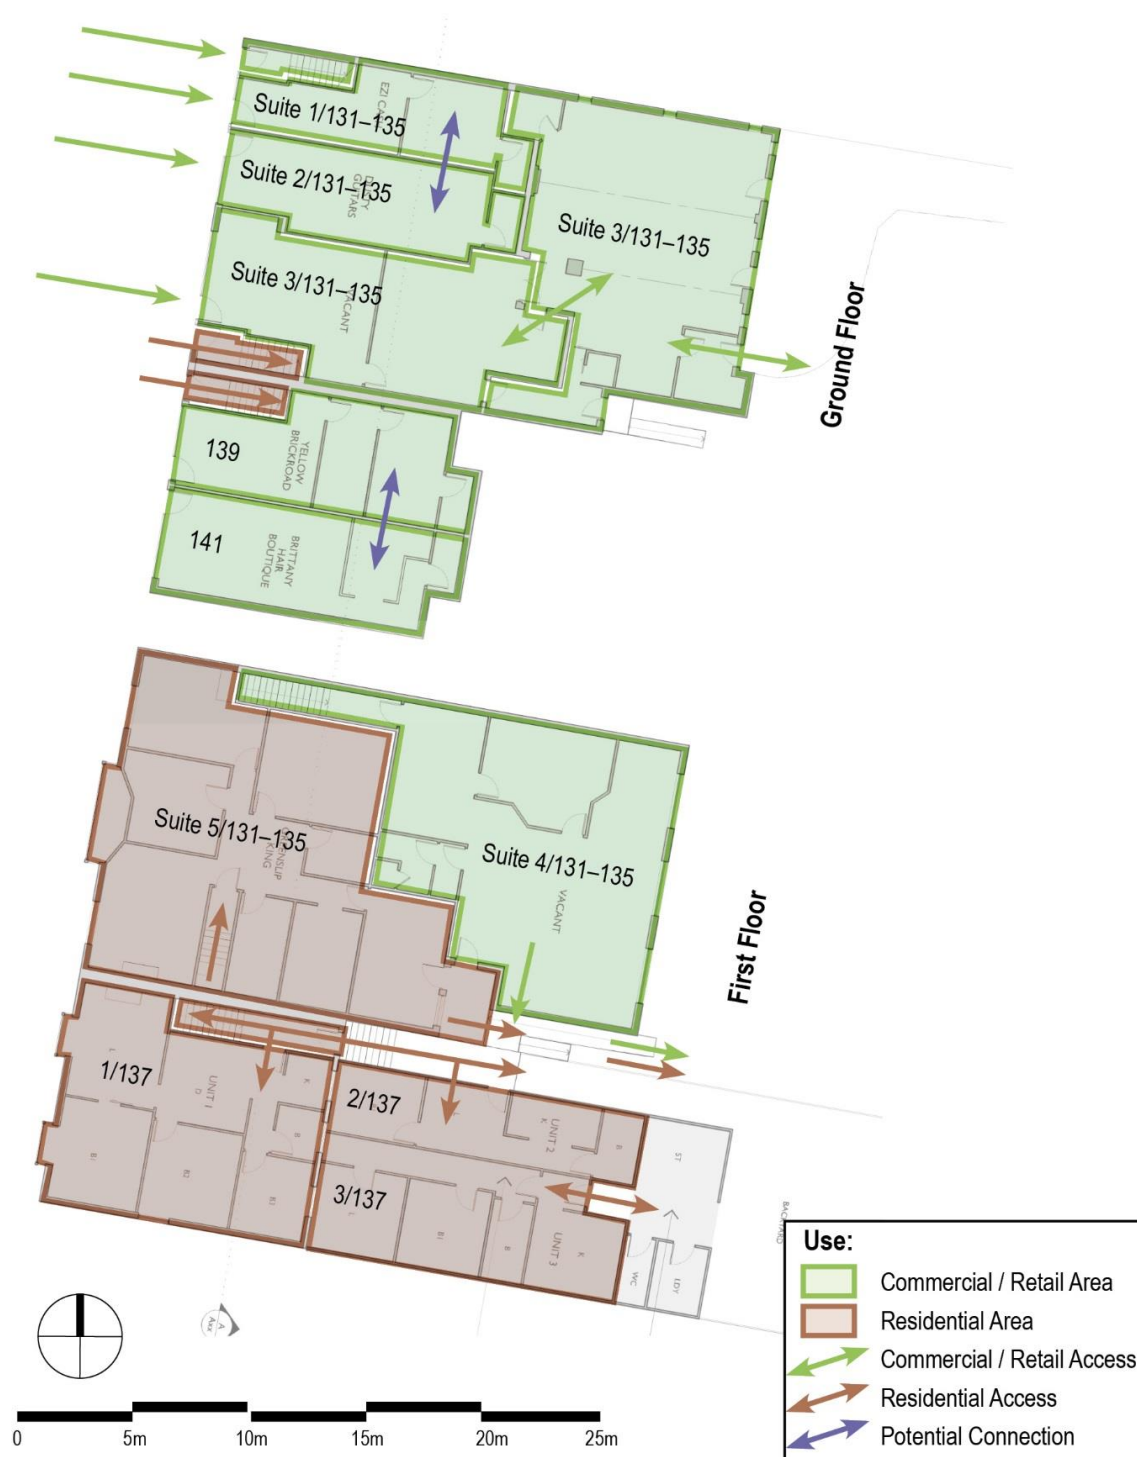
**Figure 3.1** Floor plans—Existing Use. Green and brown arrows show access points required to support the corresponding current use. Blue arrows suggest potential connections that could be made subject to heritage review. (Source: ADM Documentation October 2016, with GML overlay)

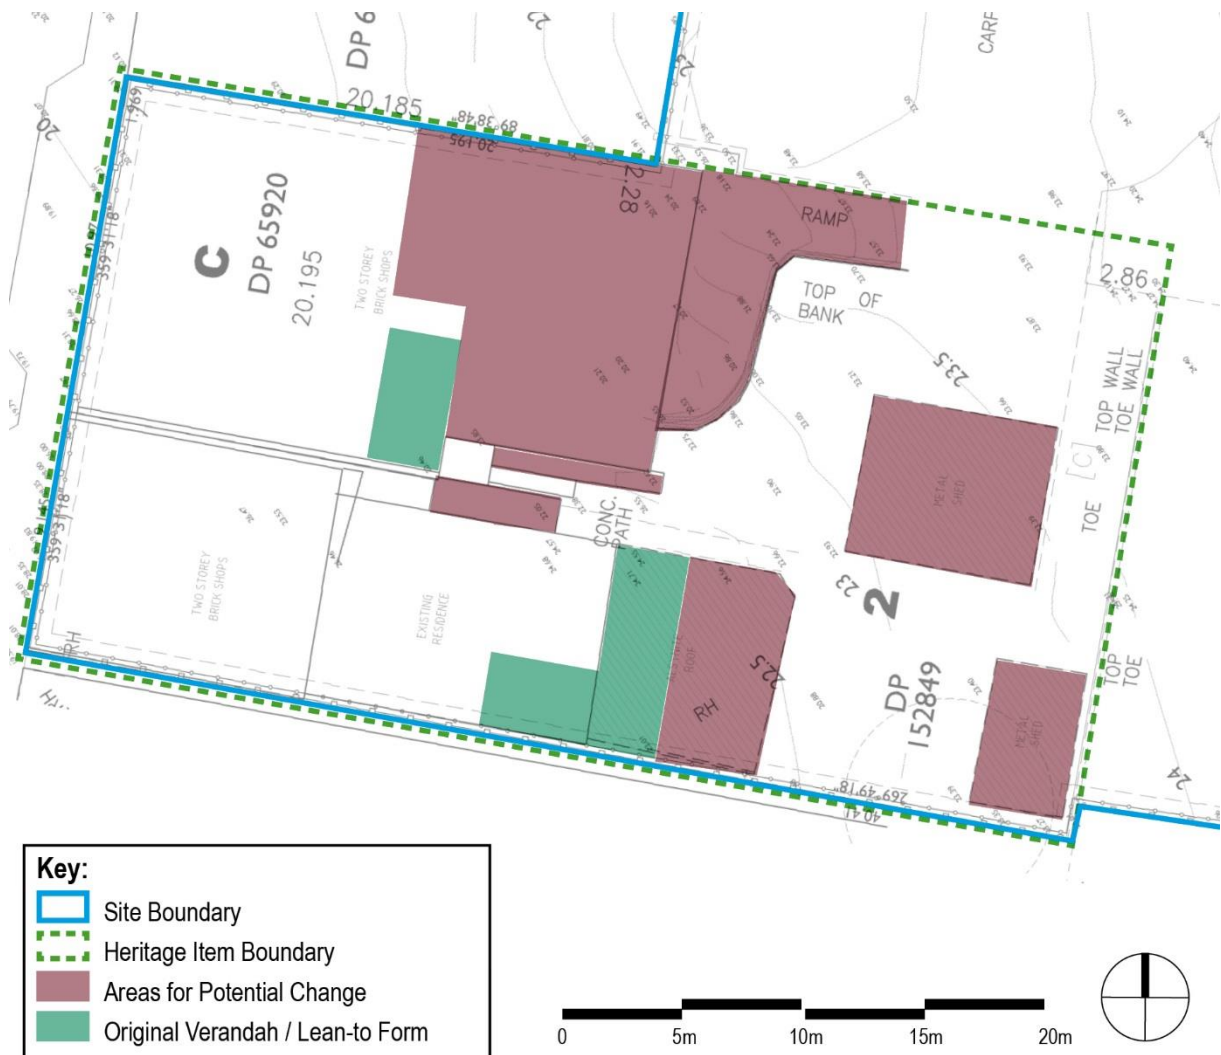
**Figure 3.3** Site plan—areas for potential change. In addition to the standard areas for change, the green area highlights former roof forms or spaces where redesign of altered elements could improve the context of the heritage item. (Source: ADM Documentation October 2016, with GML overlay)

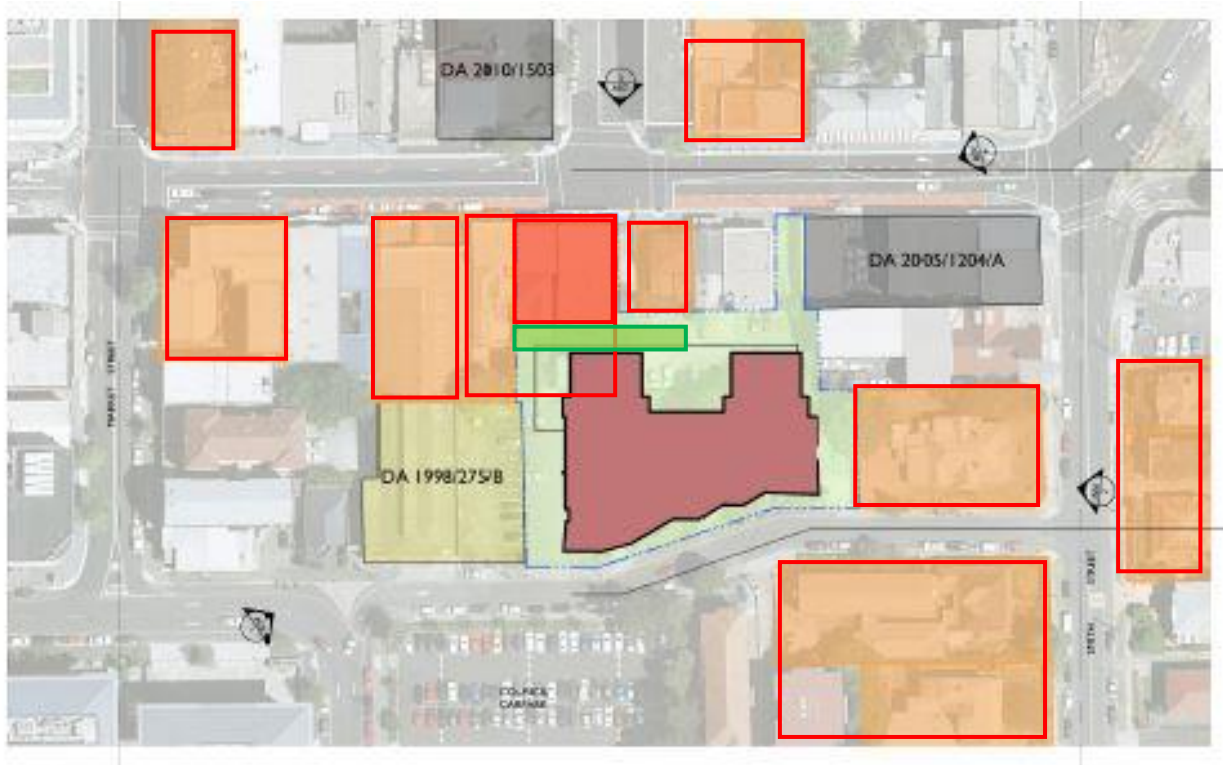
**Figure 3.5** Indicative interface zone (green area) between retained heritage items (red shaded outline, shaded pink) and proposed development (marone), other adjacent heritage items outlined in red (Source: ADM Documentation October 2016, with GML overlay)

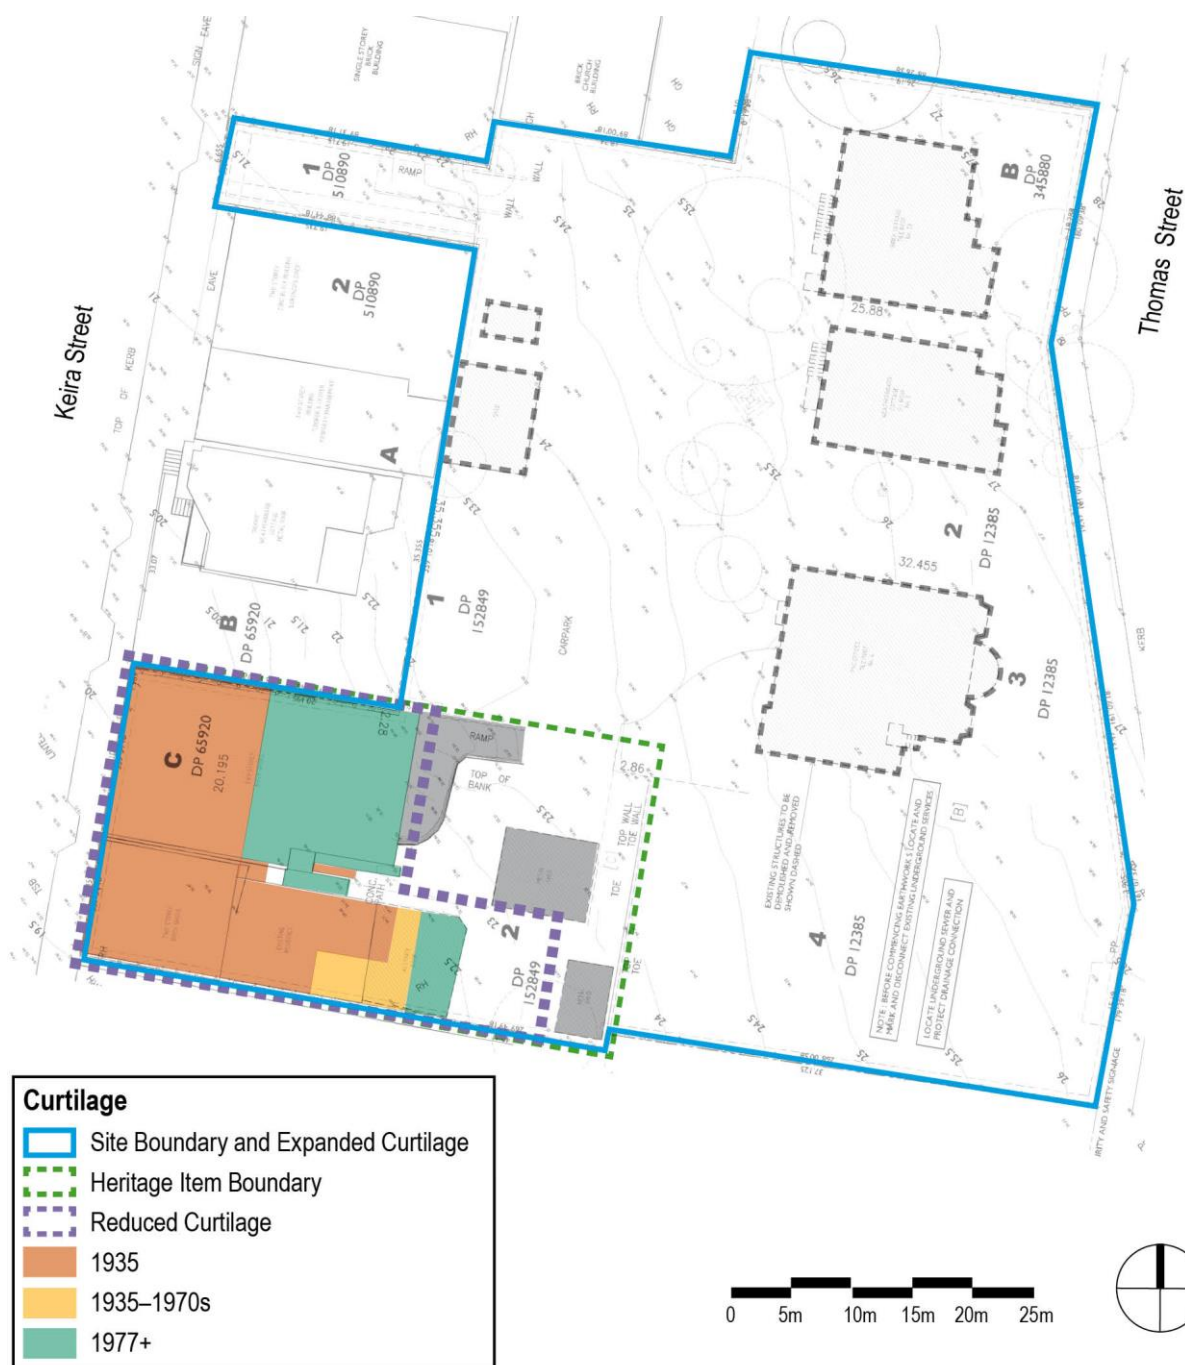
**Figure 3.7** Indicative reduced curtilage (purple outline) behind retained significant structures of current heritage item. The existing heritage item boundary is shown in green and the expanded curtilage is shown in blue outline. (Source: C Robson & Associates Pty Ltd, 29 May 2015, with GML overlays)

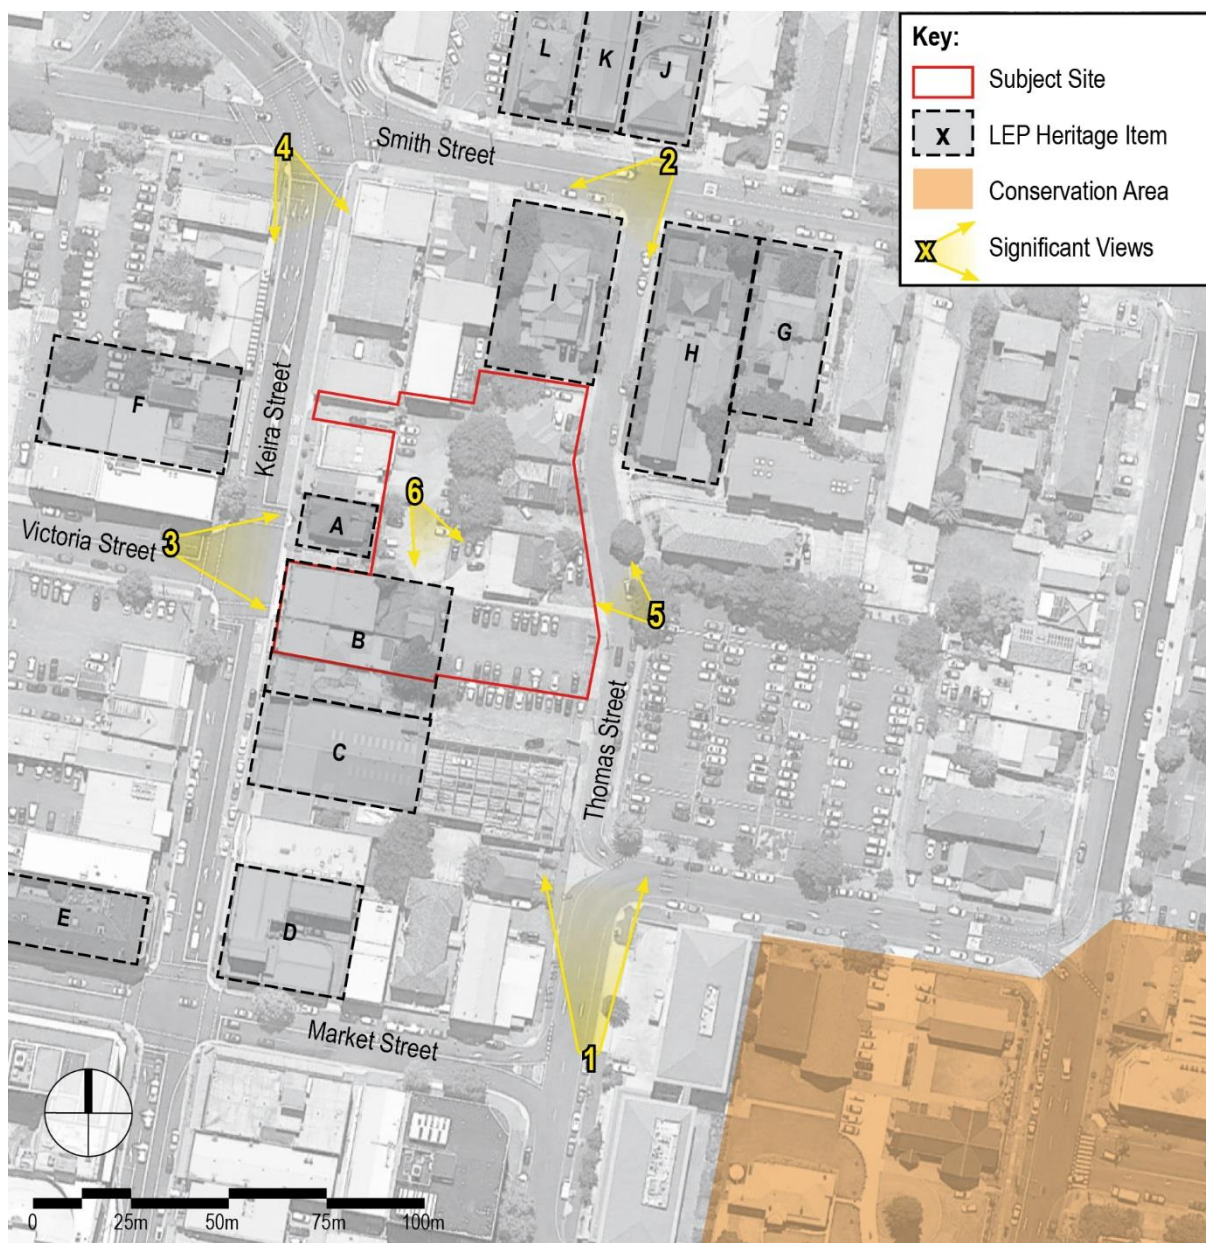
**Figure 3.8** Heritage items in the vicinity and view analysis for heritage items (black outline indicates local significance; black dashed outline indicates state significance) in the vicinity of the proposed development site. (Source: Google Maps, overlay by GML, 2017)

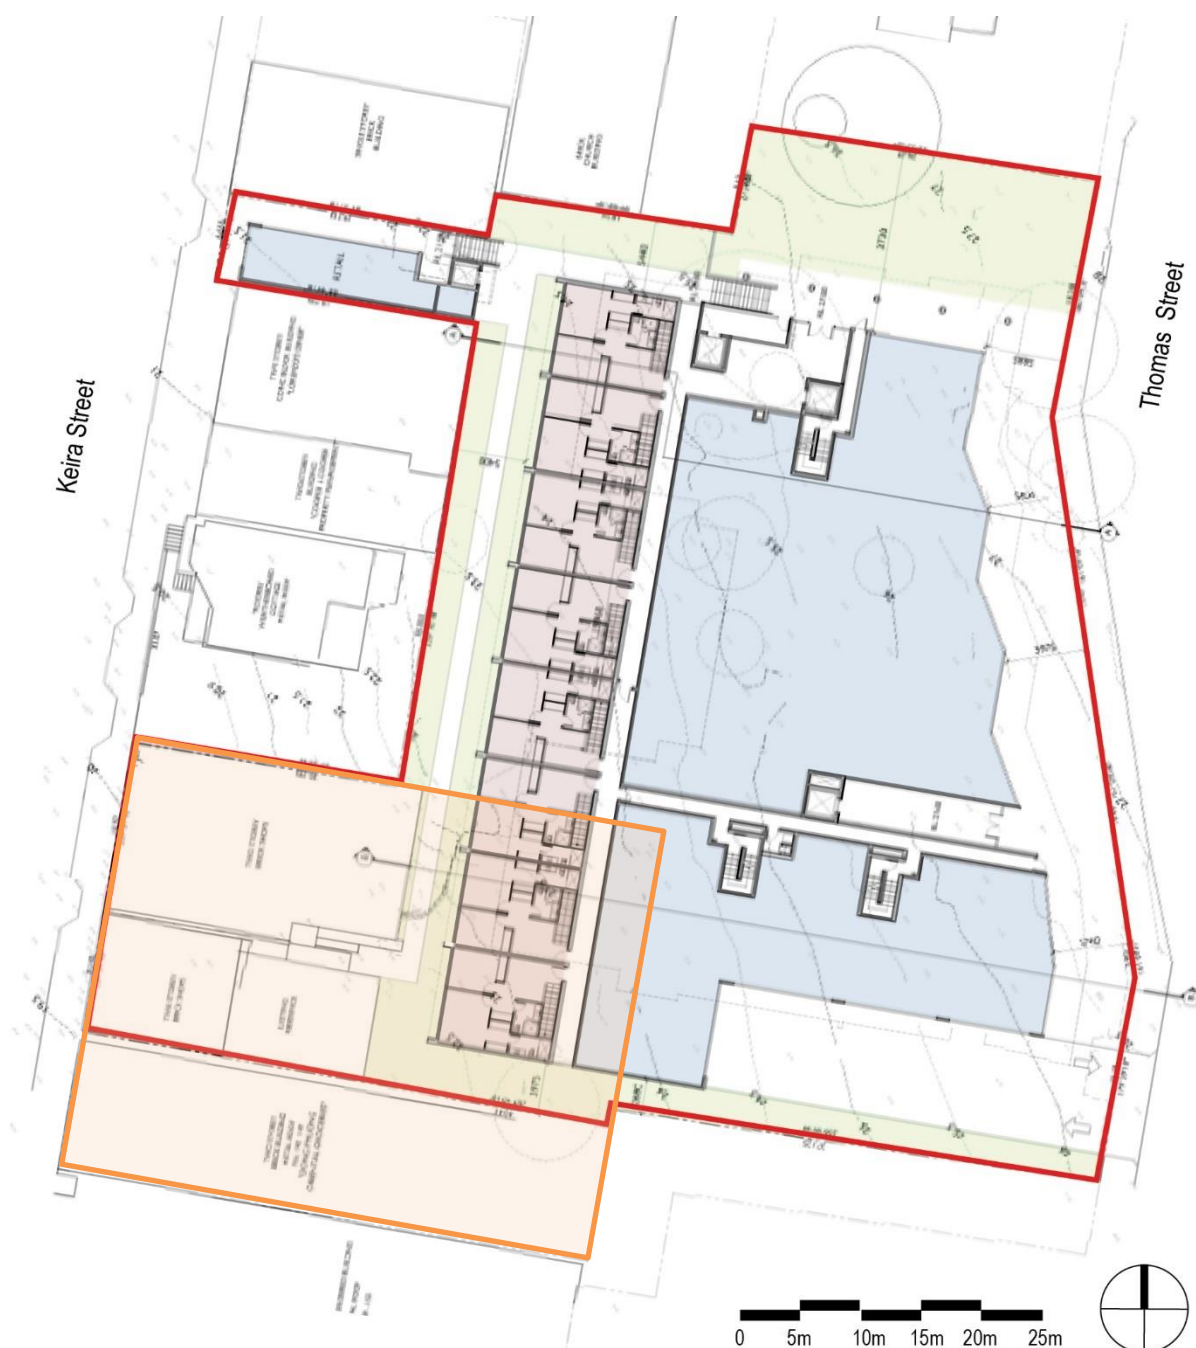
**Figure 1.3** Site plan of proposed development at 131 Keira Street, Wollongong (red outline), with GML overlay showing location of heritage item 131–149 Keira Street (orange outline). The subject of this report, 131–135 and 137–141 Keira Street, is within the proposed development site. (Source: ADM Documentation October 2016, with GML overlay)

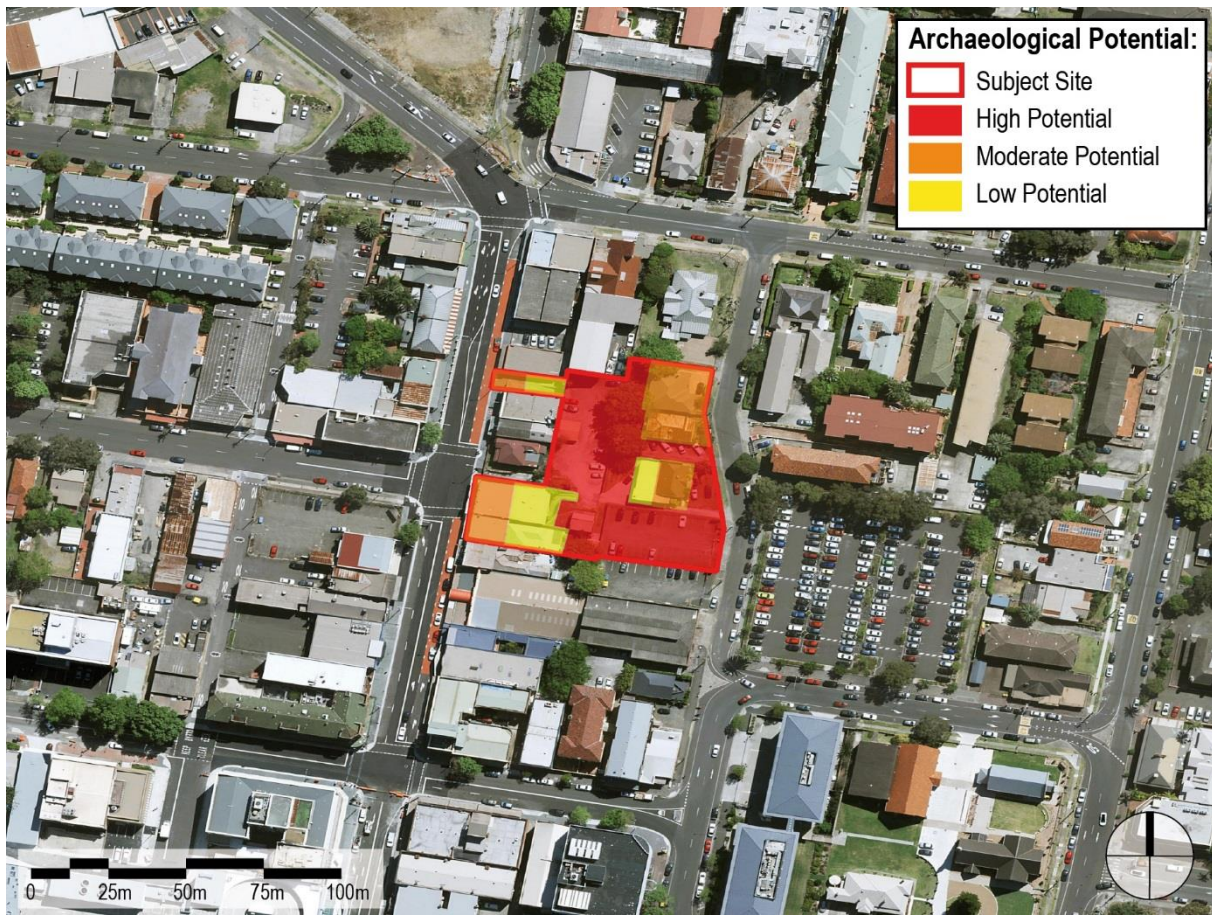
Figure 4.2 Plan of the subject site showing assessed archaeological potential. (Source: NSW LPI with GML overlay)
