STATEMENT OF ENVIRONMENTAL EFFECTS

WOLLONGONG PUBLIC SCHOOL

NOVEMBER 2017
SA6418
FINAL
PREPARED FOR NSW DEPARTMENT OF EDUCATION

Arboricultural Impact Assessment Report.

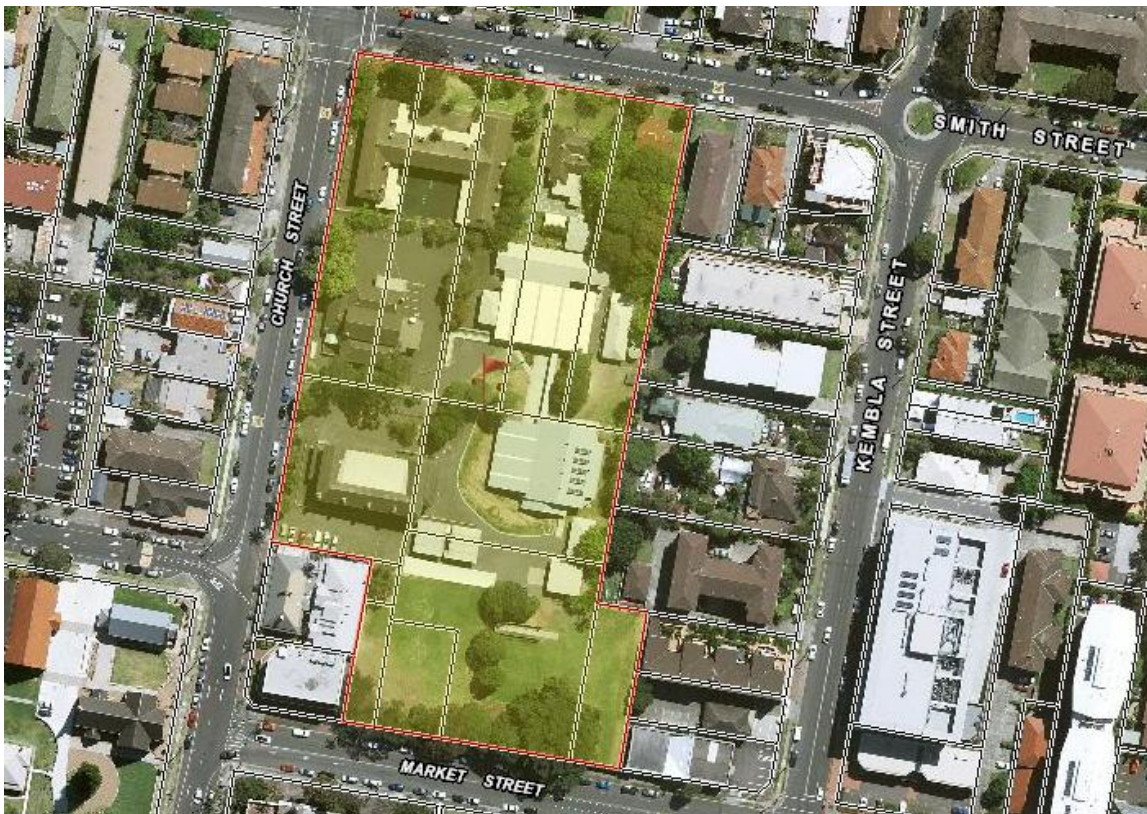
Figure 1 – Site Location

The site is known as Wollongong Public School, located 67A Church Street, Wollongong. The site has an area of 18,410m², with frontages to Church Street to the west, Smith Street to the north and Market Street to the south. Figure 1 highlights the location of the school. The site is legally described as:

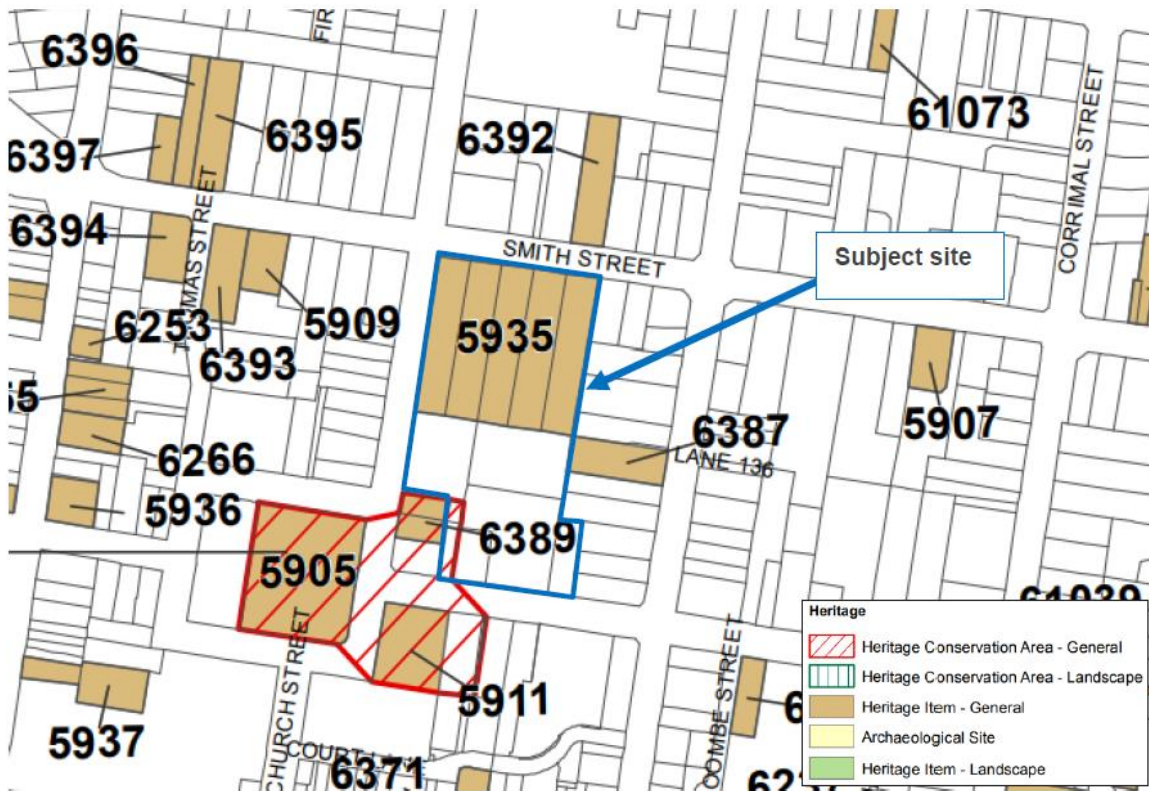
Figure 7 – Heritage Conservation

Figure 7 illustrates the location of the heritage items onsite and in the vicinity to the site, as per WLEP 2009 and **Figure 8** highlights the significant buildings on the site.

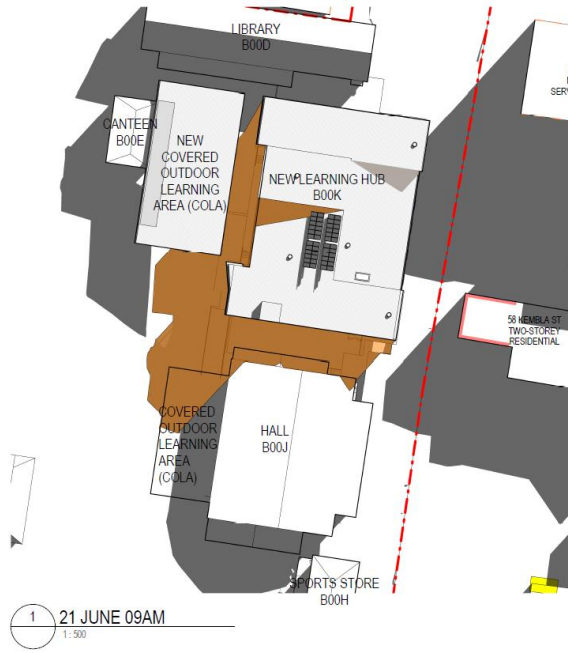
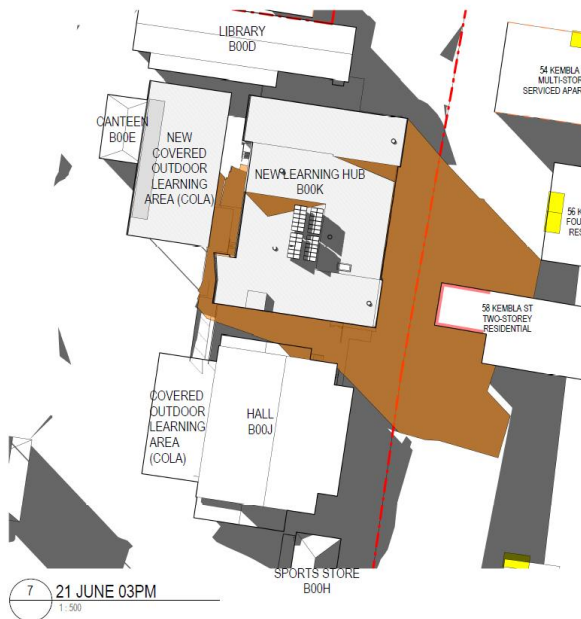
Figure 9 – Shadow Diagrams

Picture 1 – 21 June 9am
Source: Hayball

Picture 2 – 21 June 12pm
Source: Hayball

Picture 3 – 21 June 3pm
Source: Hayball

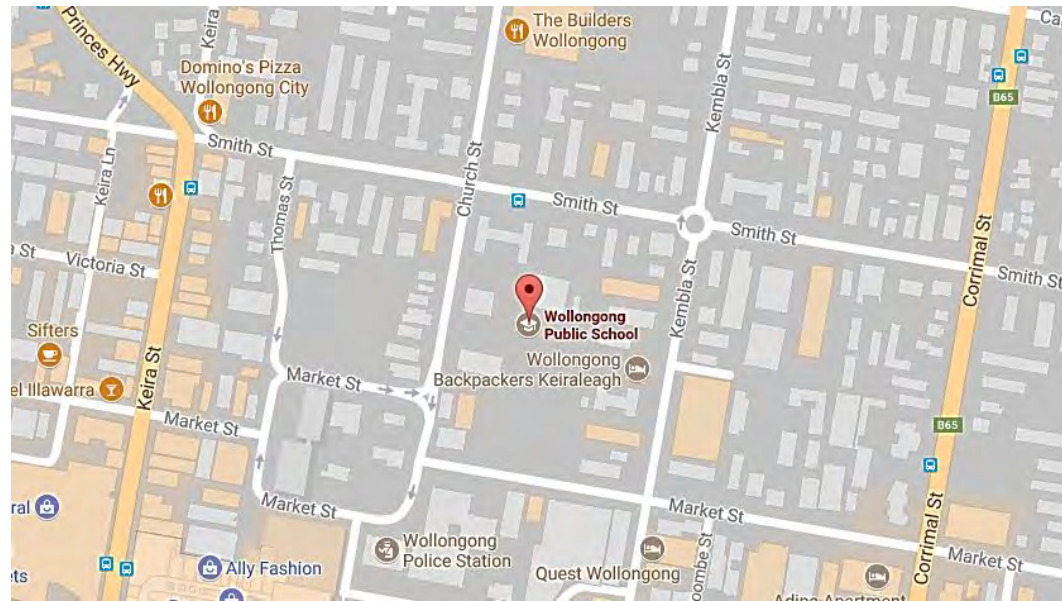
Figure 1. Site Location Map Wollongong Public School, 67A Church Street, Wollongong NSW. (Image Source; Google Maps 2018)

The subject site is located at 67A Church Street, Wollongong NSW. (Figure 1) Site usage is as a Public School, the school was established in 1885. The site is located within the LGA of Wollongong, approximately 0.4 kilometres to the north east of the Wollongong CBD. Figure 3 (following page) is provided to assist with the local site context.

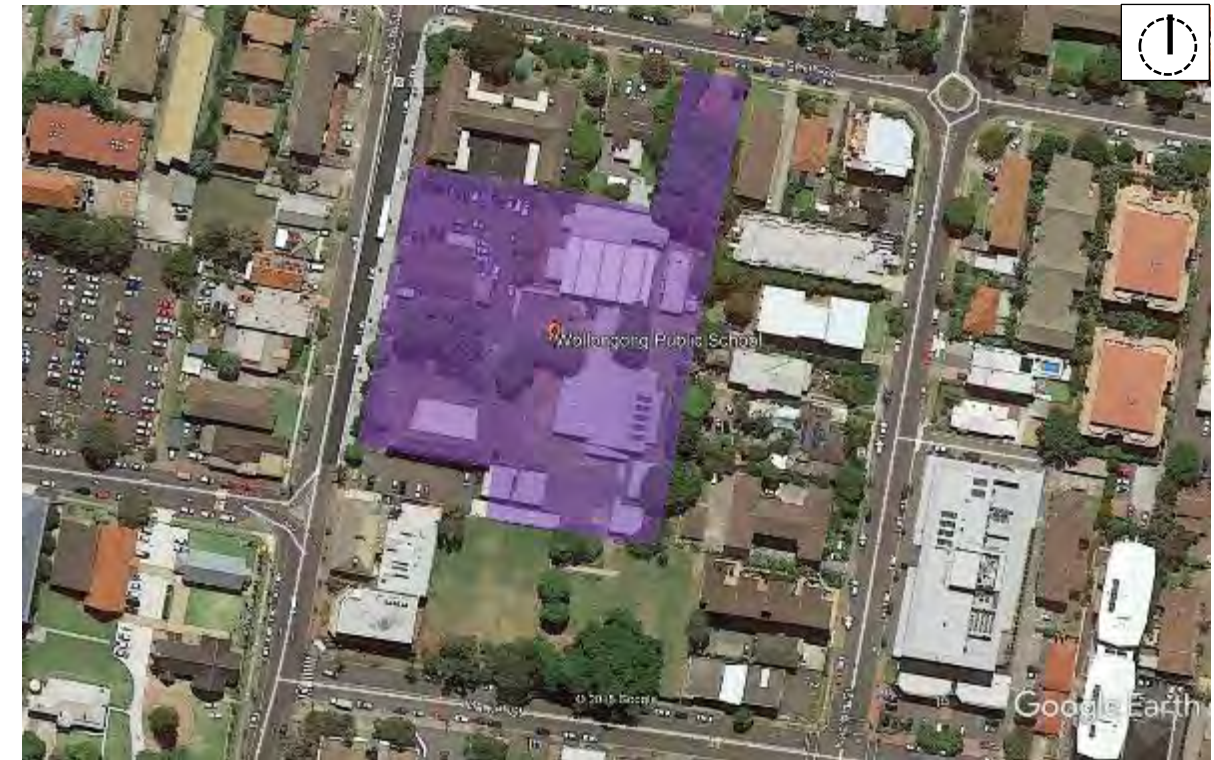
Figure 5. Site Survey Area. (Image Source; Google Maps 2018)

An Impact Assessment Report will identify and comment on the potential for construction impacts on all protected trees located on and within 5m of a site. However due to the physical size of the site and the location of proposed works, only trees located within the works area or within 5m of proposed works have been surveyed. The site works area is illustrated as specified within a site mark-up plan provided by Hayball. (Figure 4) Figure 5 illustrates the site survey area.

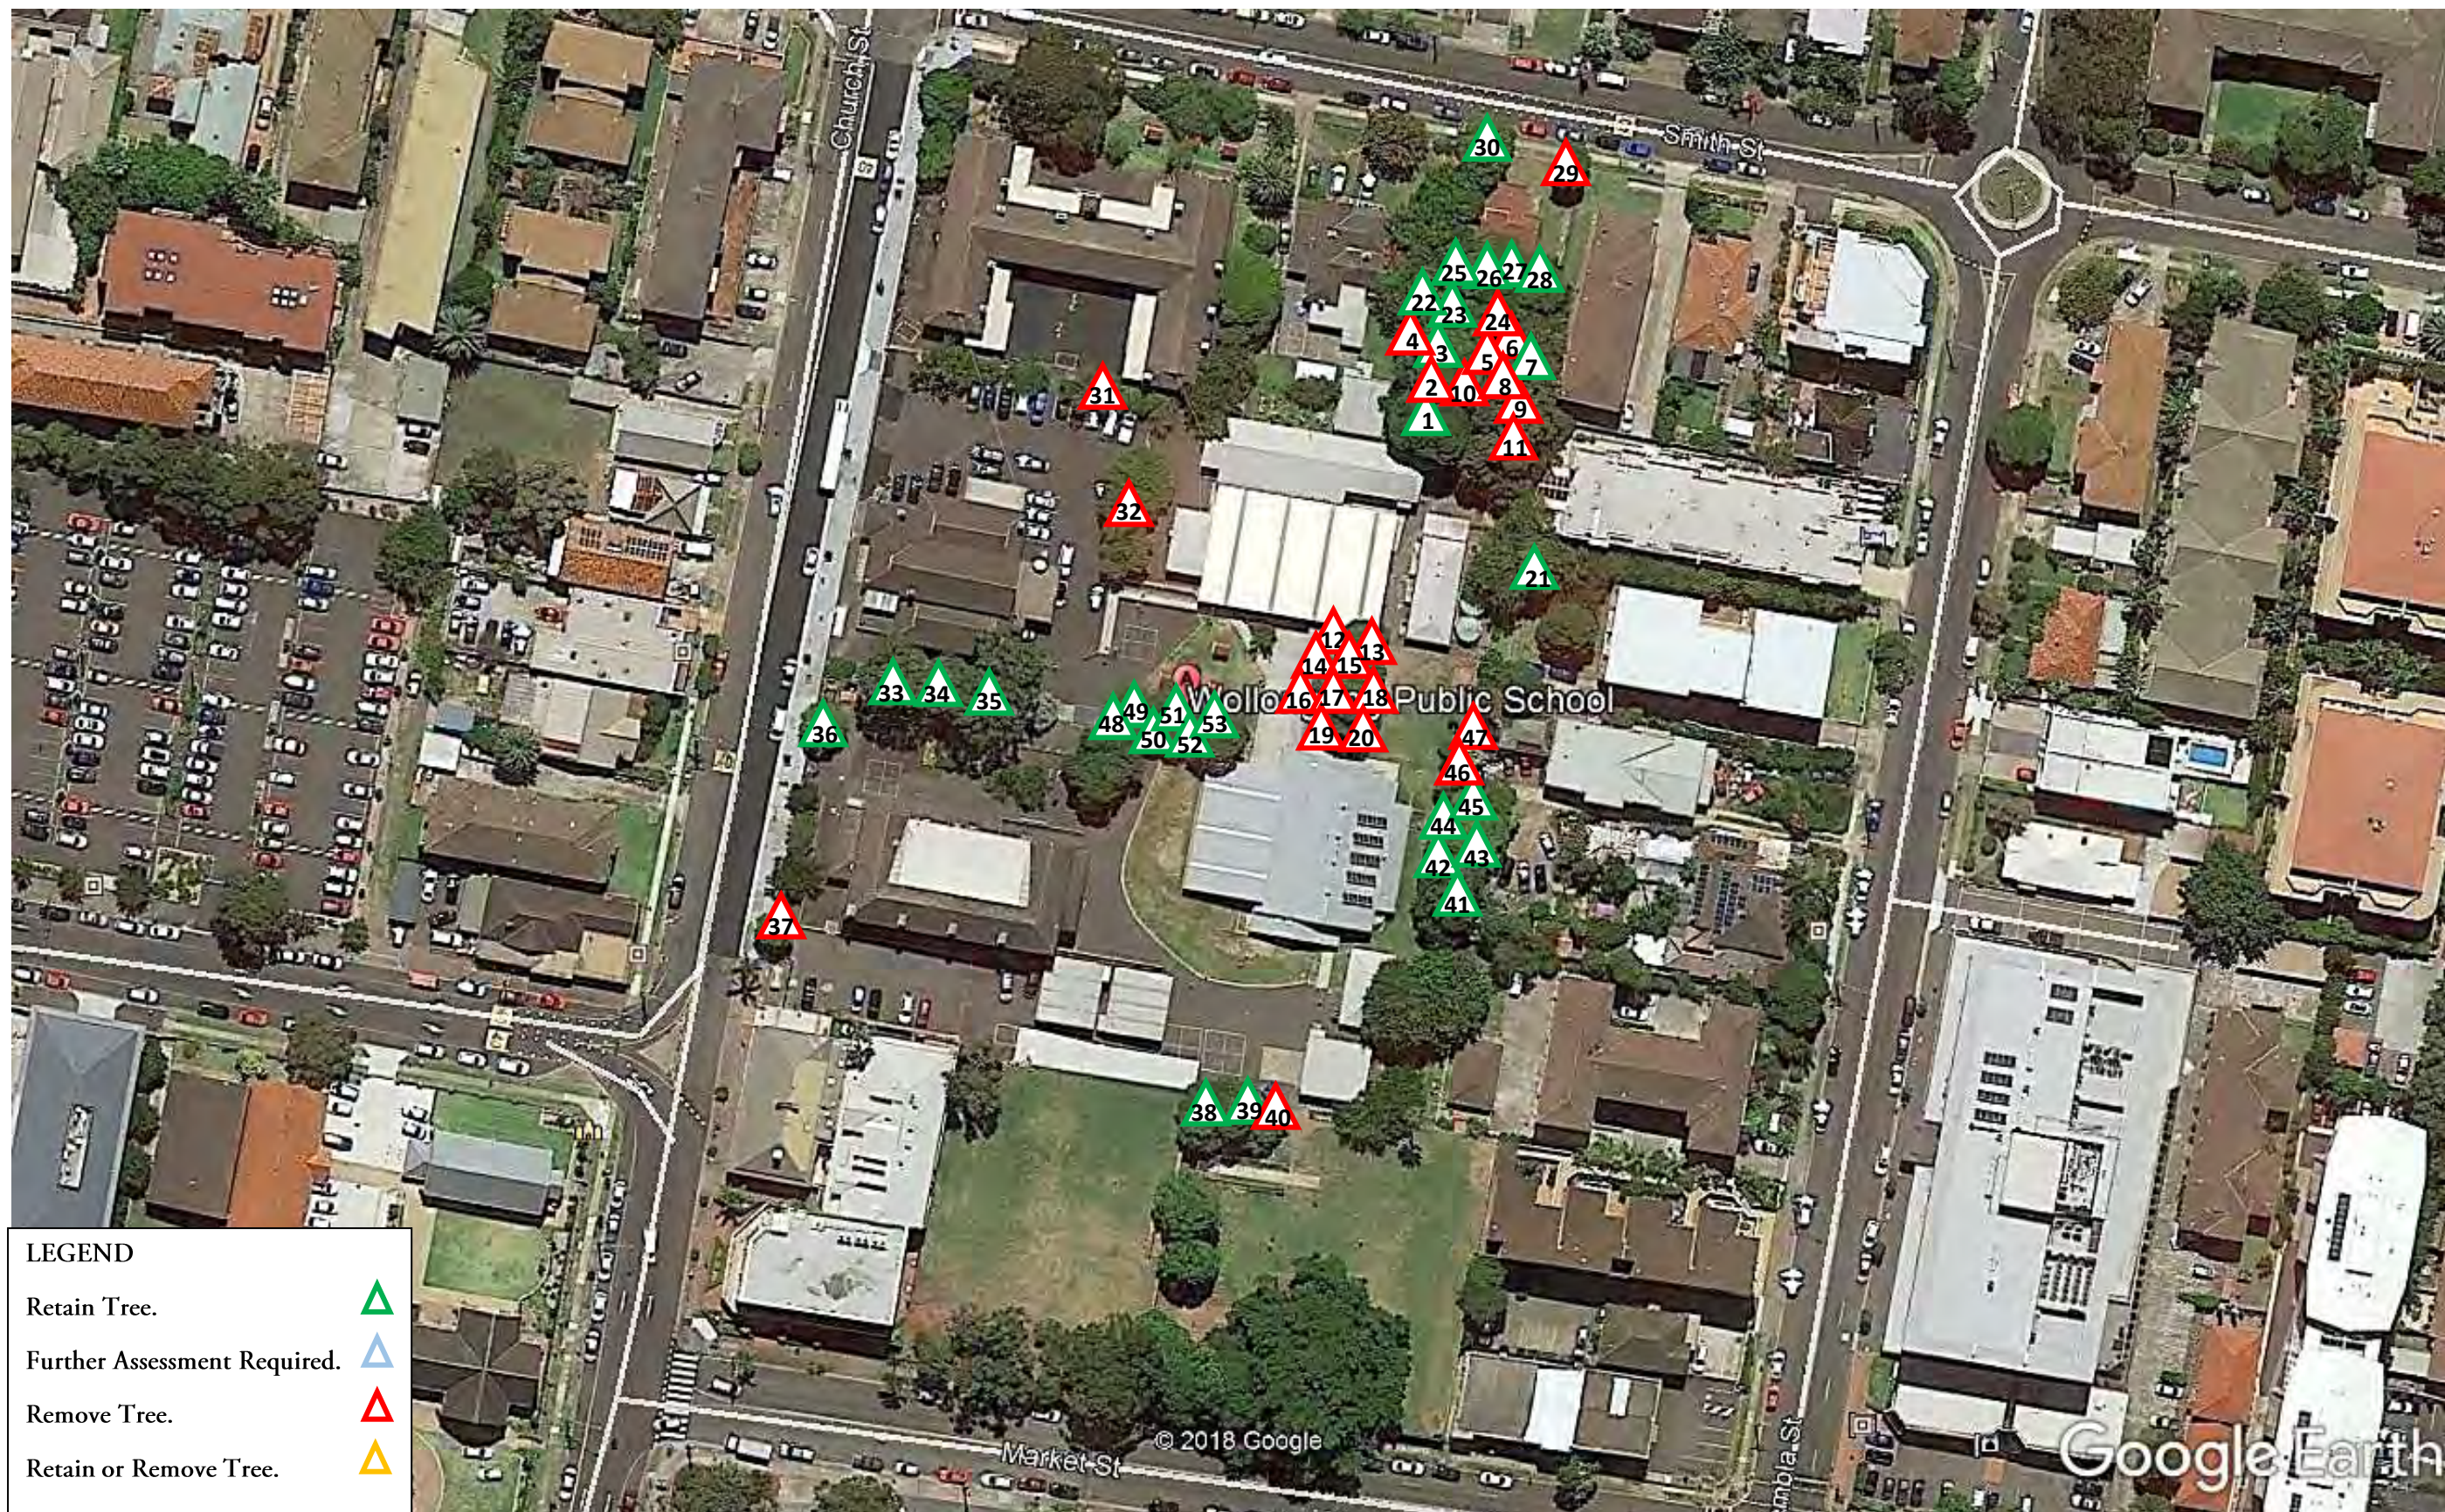
Comments: The subject trees have been tagged and numbered. Tree locations are approximate.

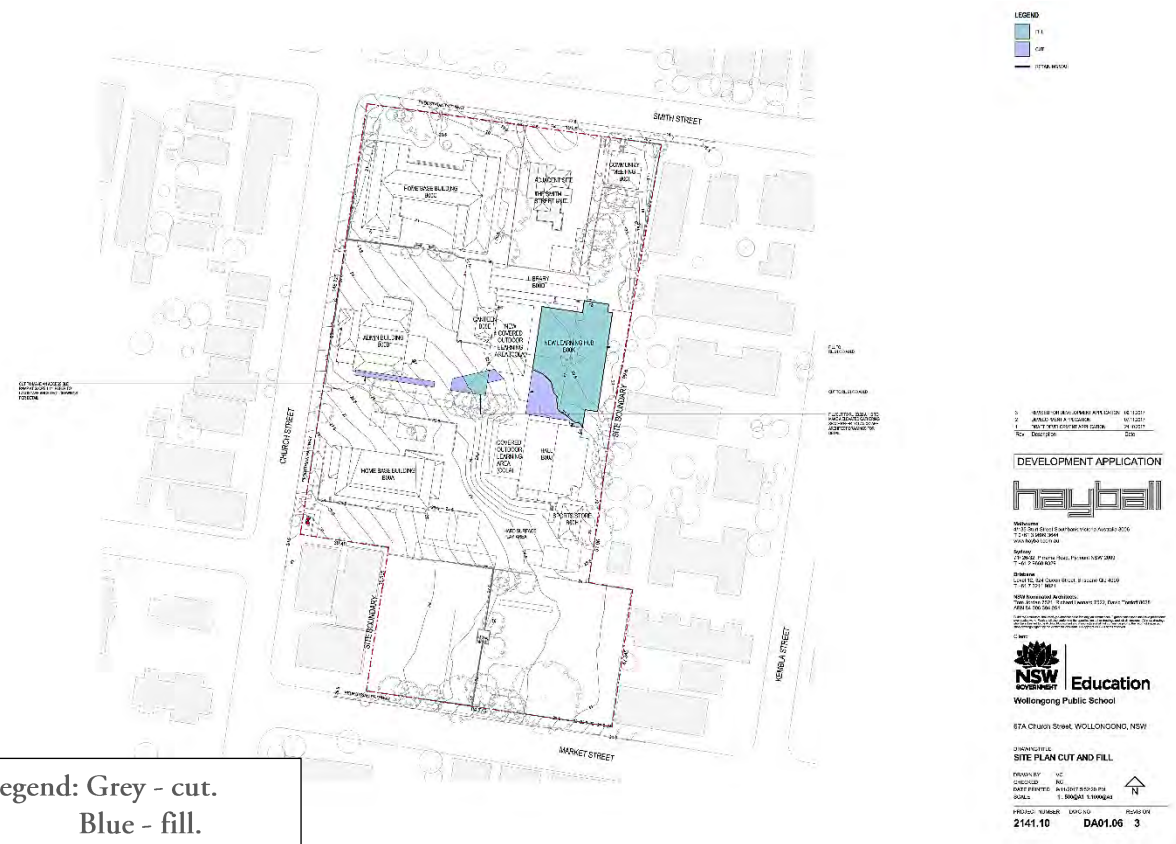
Figure 9. Illustrating Proposed Bulk Earthworks for Buildings. NTS. (Hayball 2018)

Legend: Grey - cut.
Blue - fill.

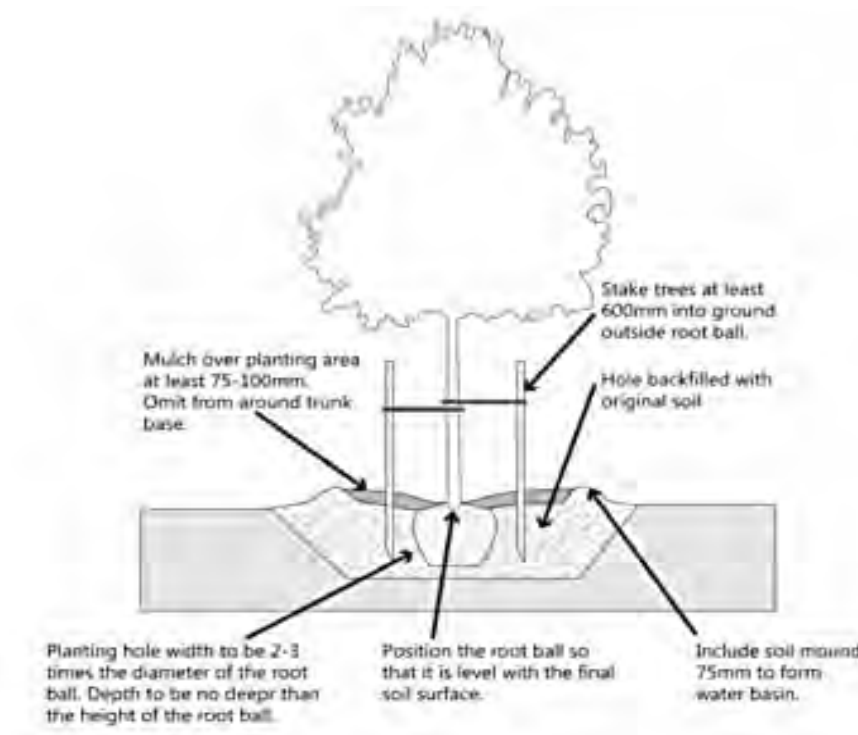
Figure 12. Tree Planting Guide. (Image Source; NUFA).

Plant stock must be grown to the Australian Standard AS 2303-2015 Tree Stock for Landscape Use or NATSPEC and be planted in locations that can accommodate their potential physical dimensions both above and below ground level at maturity. (A planting guide is provided as Figure 9).

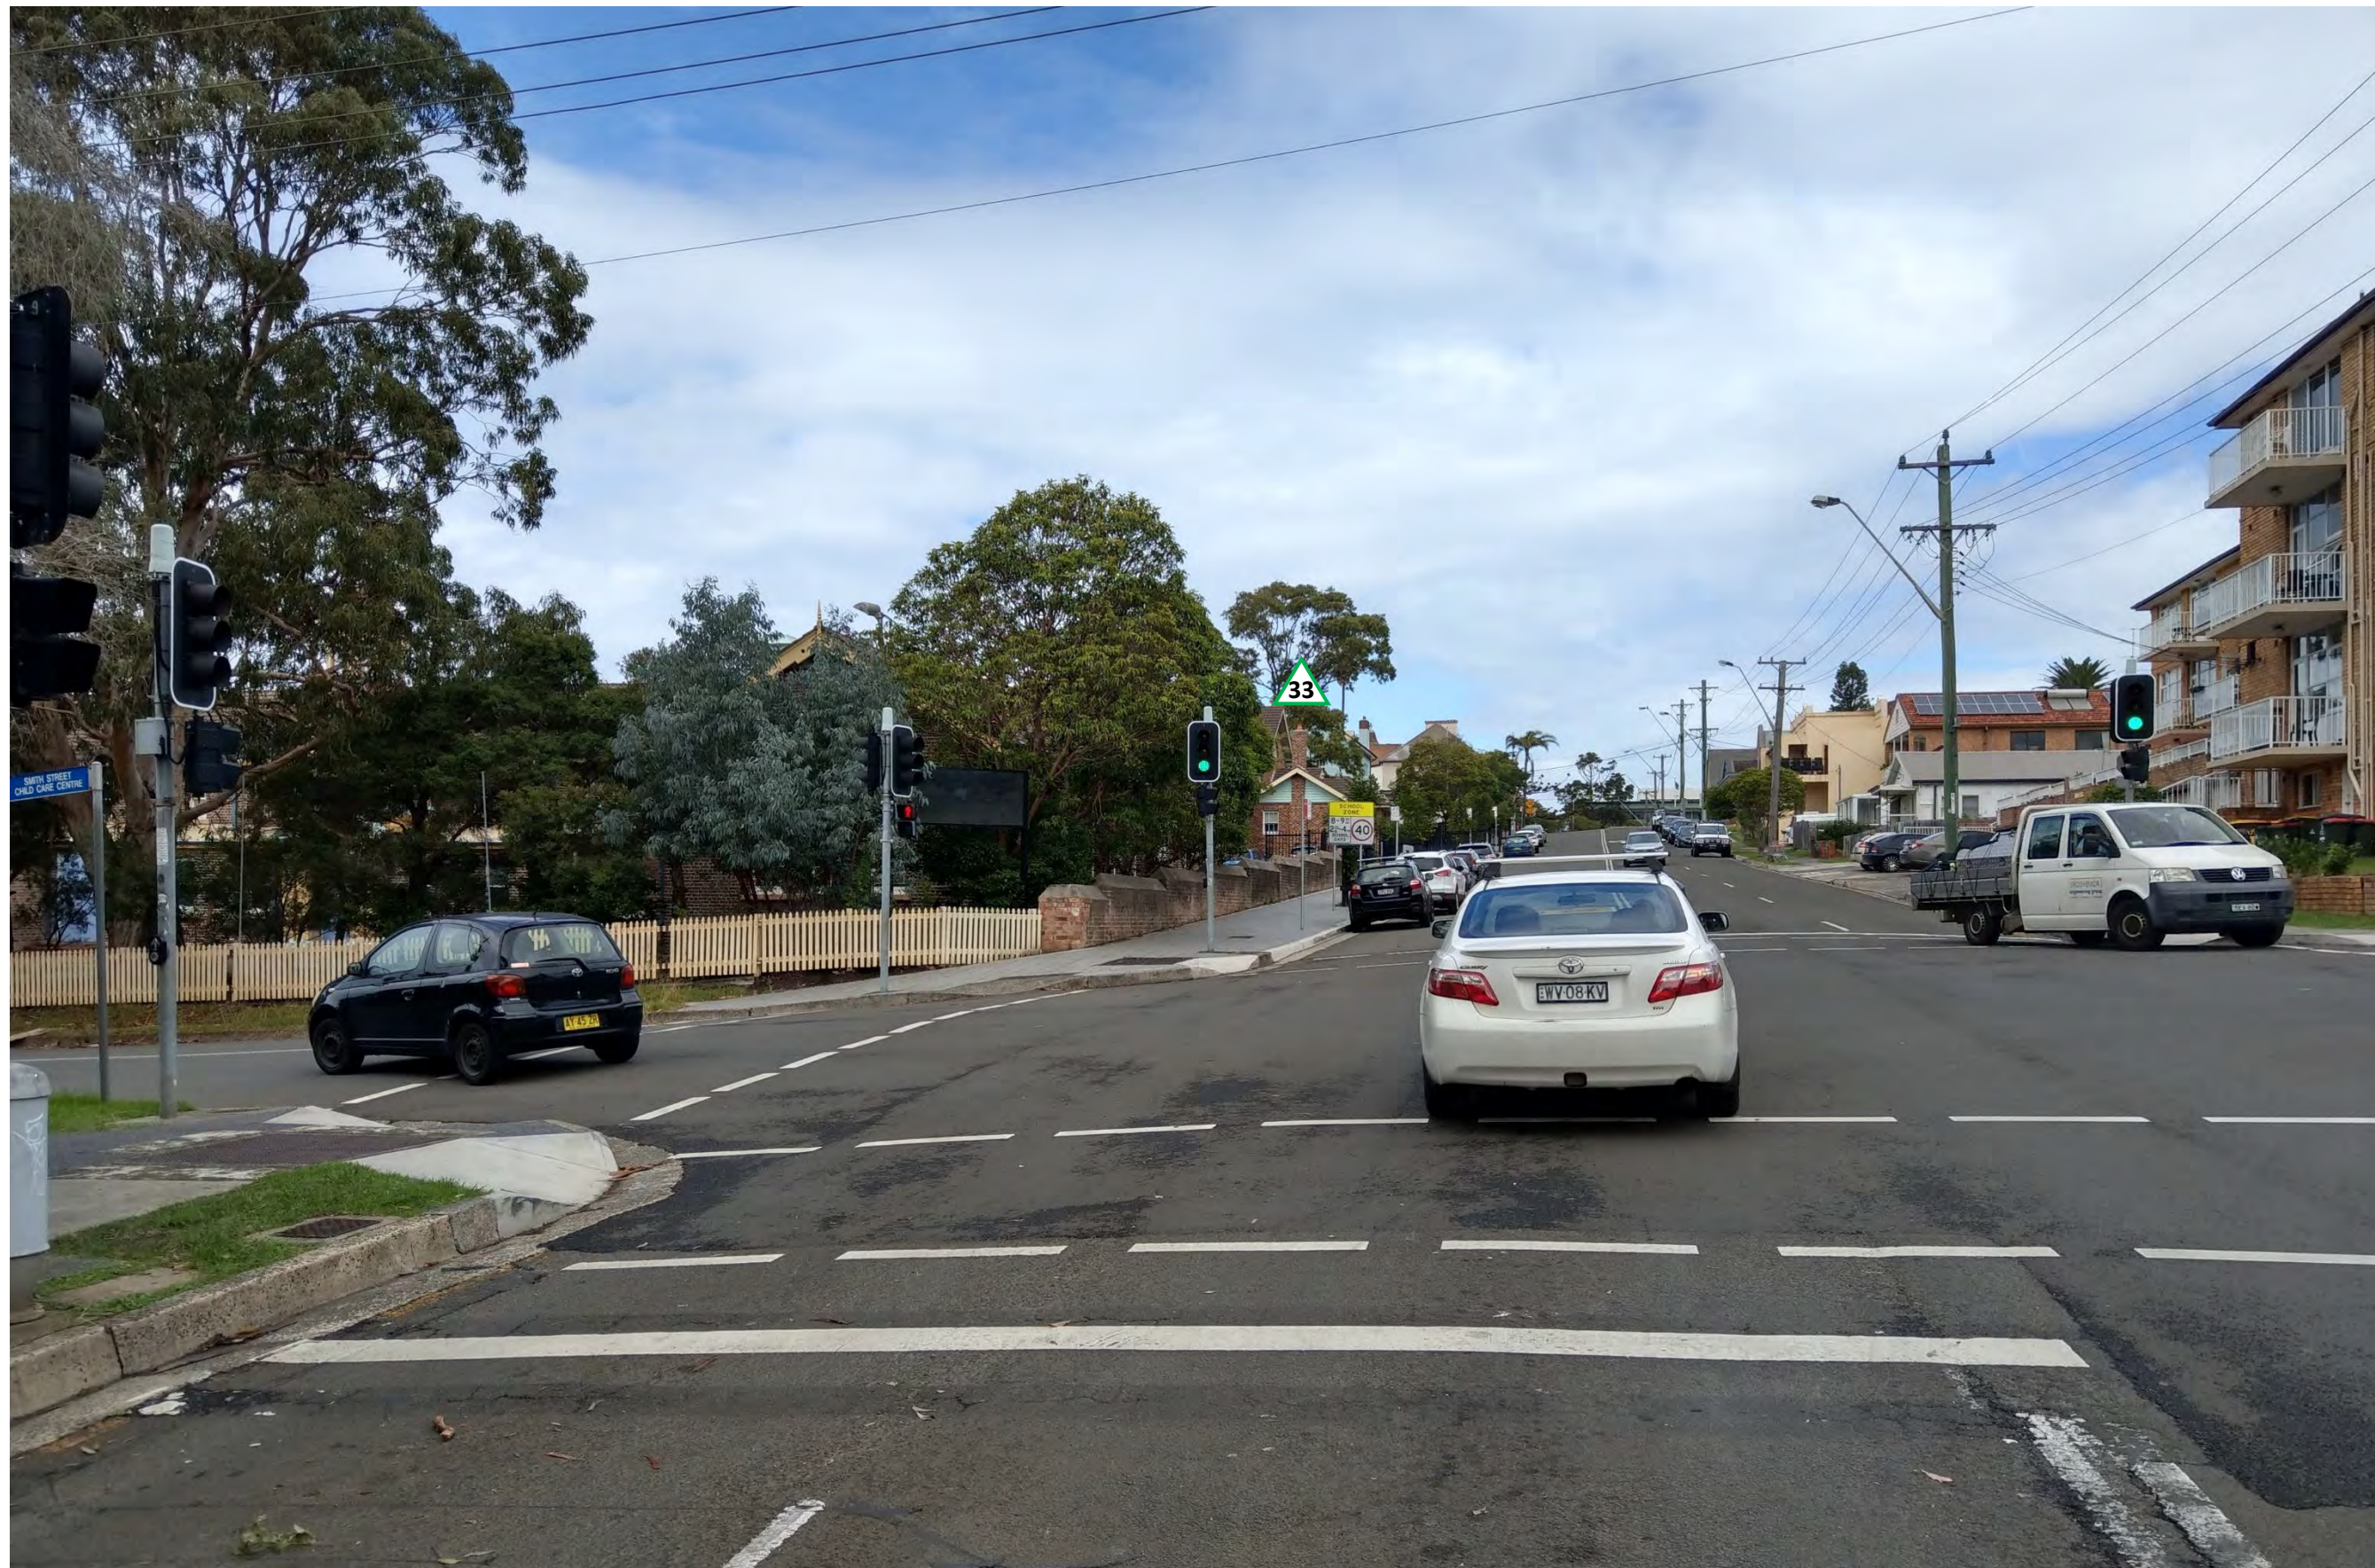
Photograph 1. (North aspect). This photograph illustrates the subject site heading south along Church Street at the intersection of Smith Street. The tree T33 is visible from this aspect.

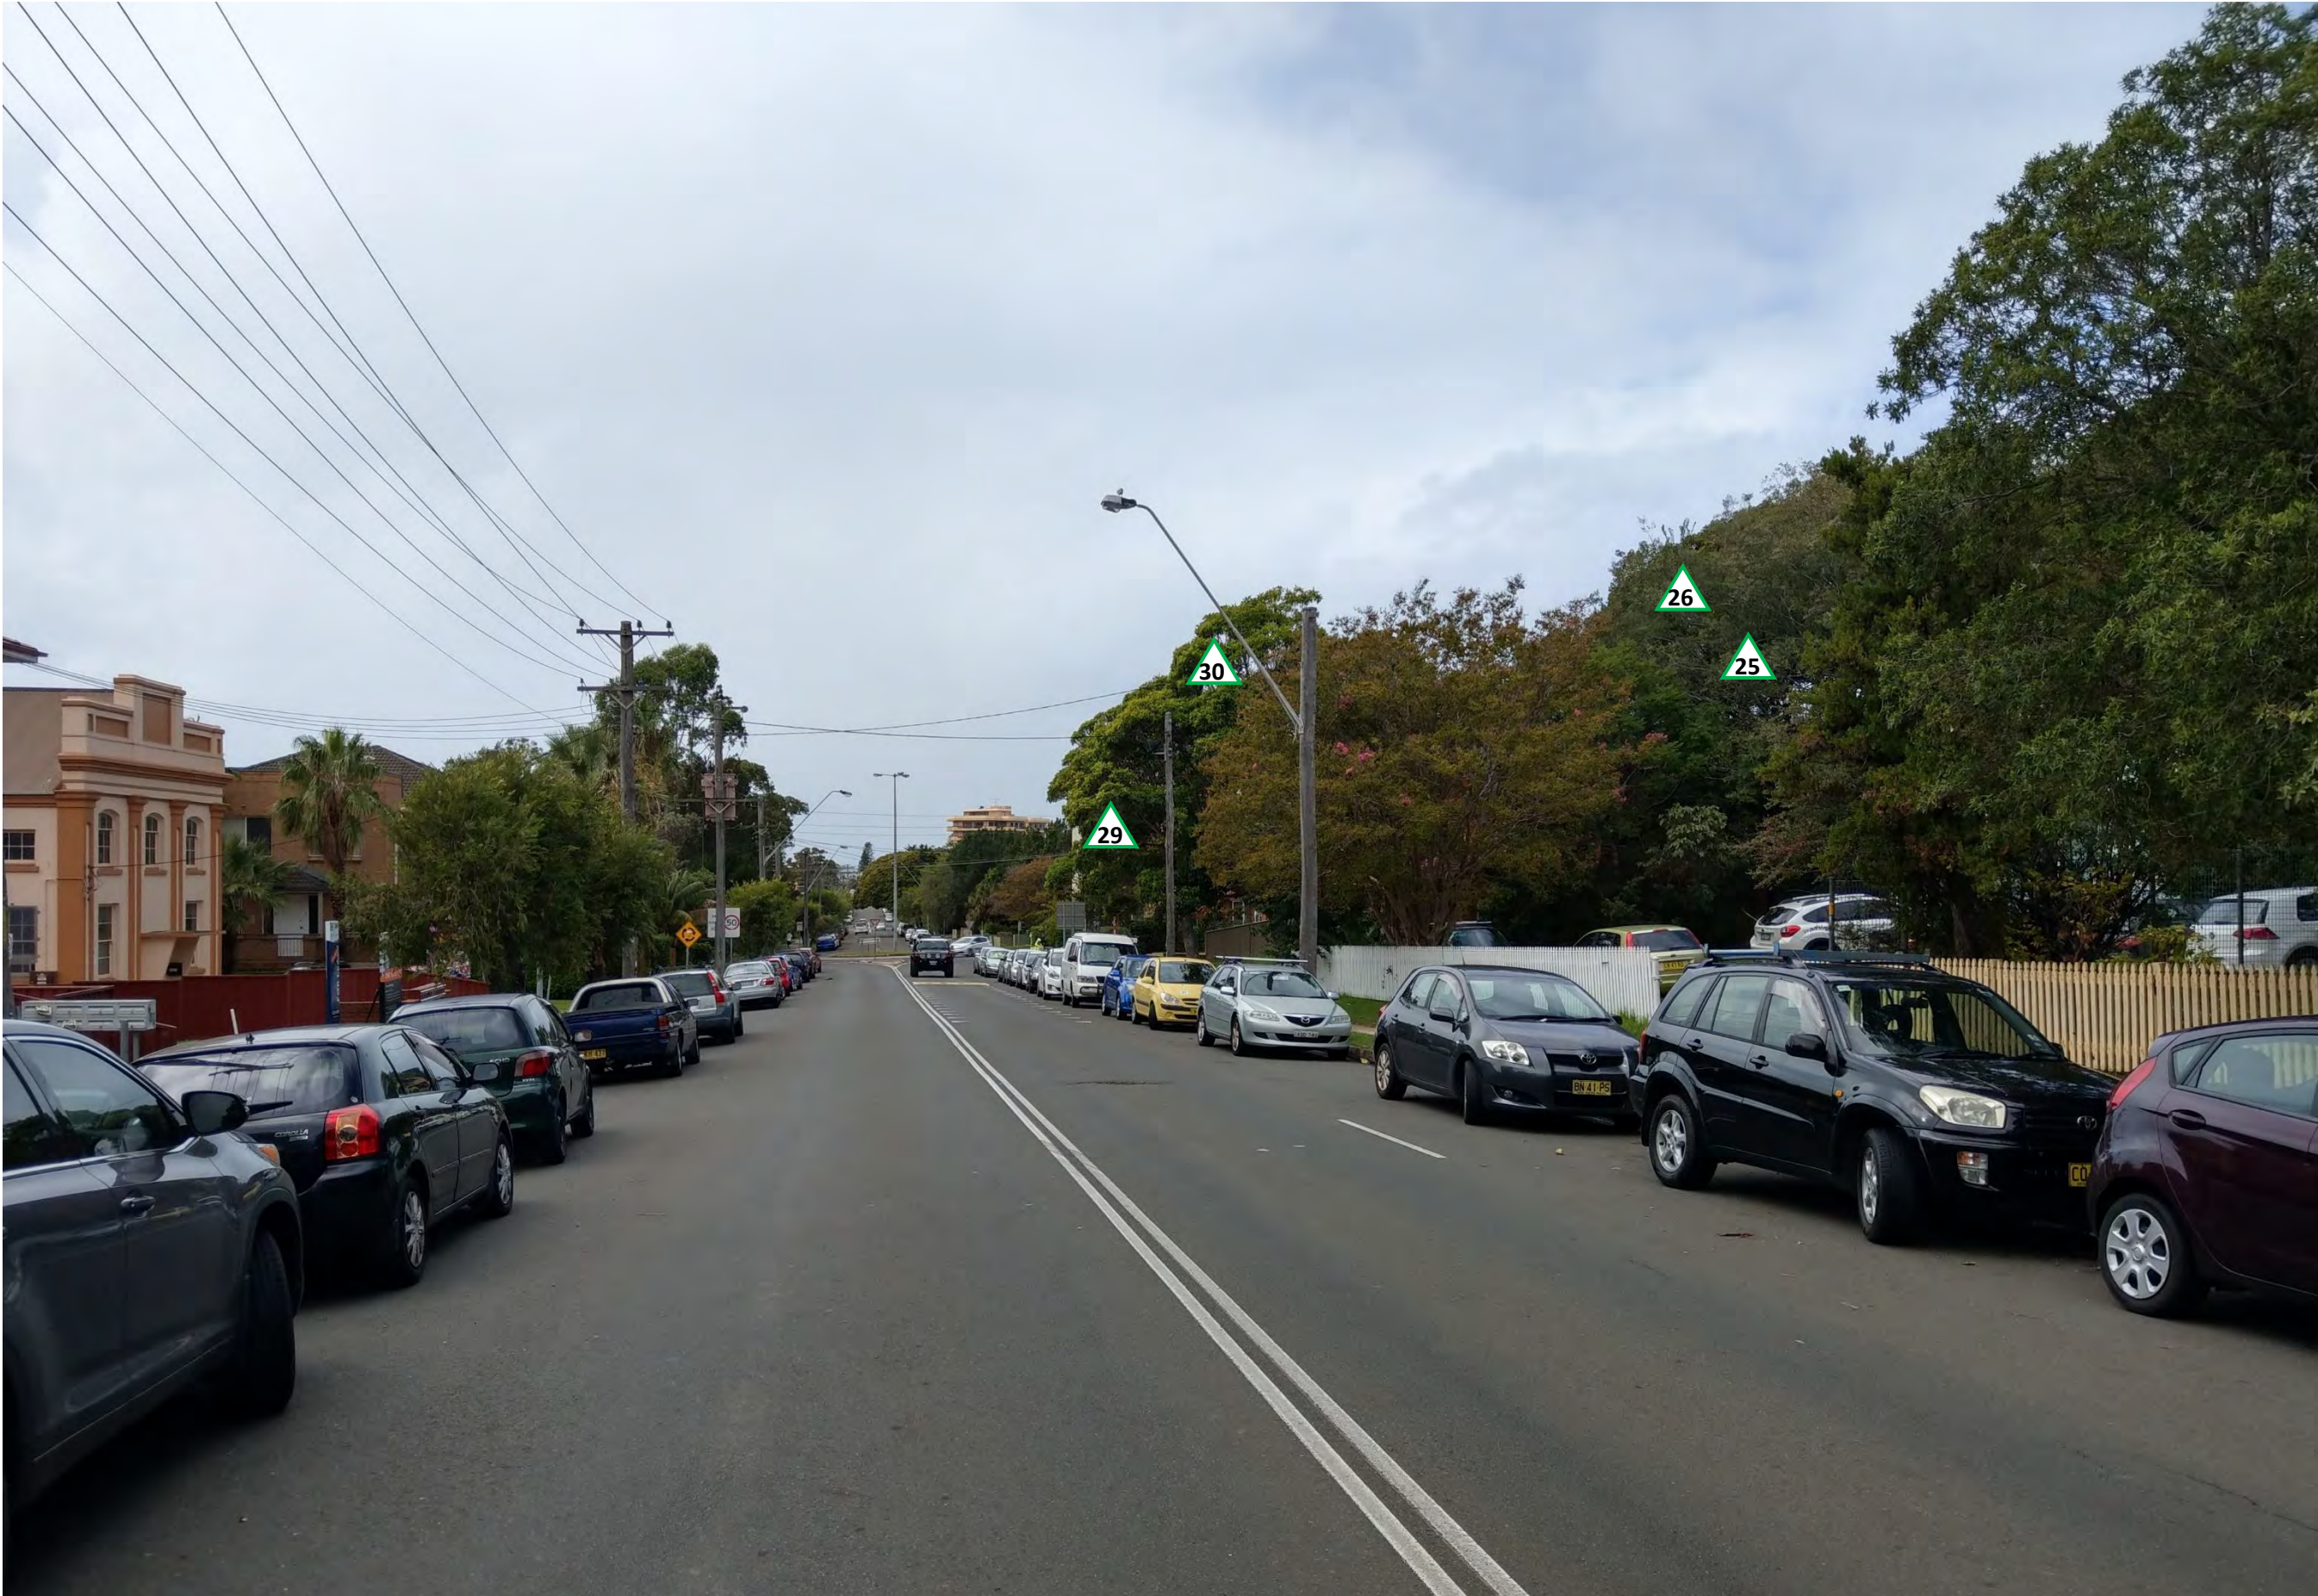
Photograph 2. (West aspect). This photograph illustrates the site heading east along Smith Street. The trees T25, T26, T29 and T30 can be seen from this aspect.

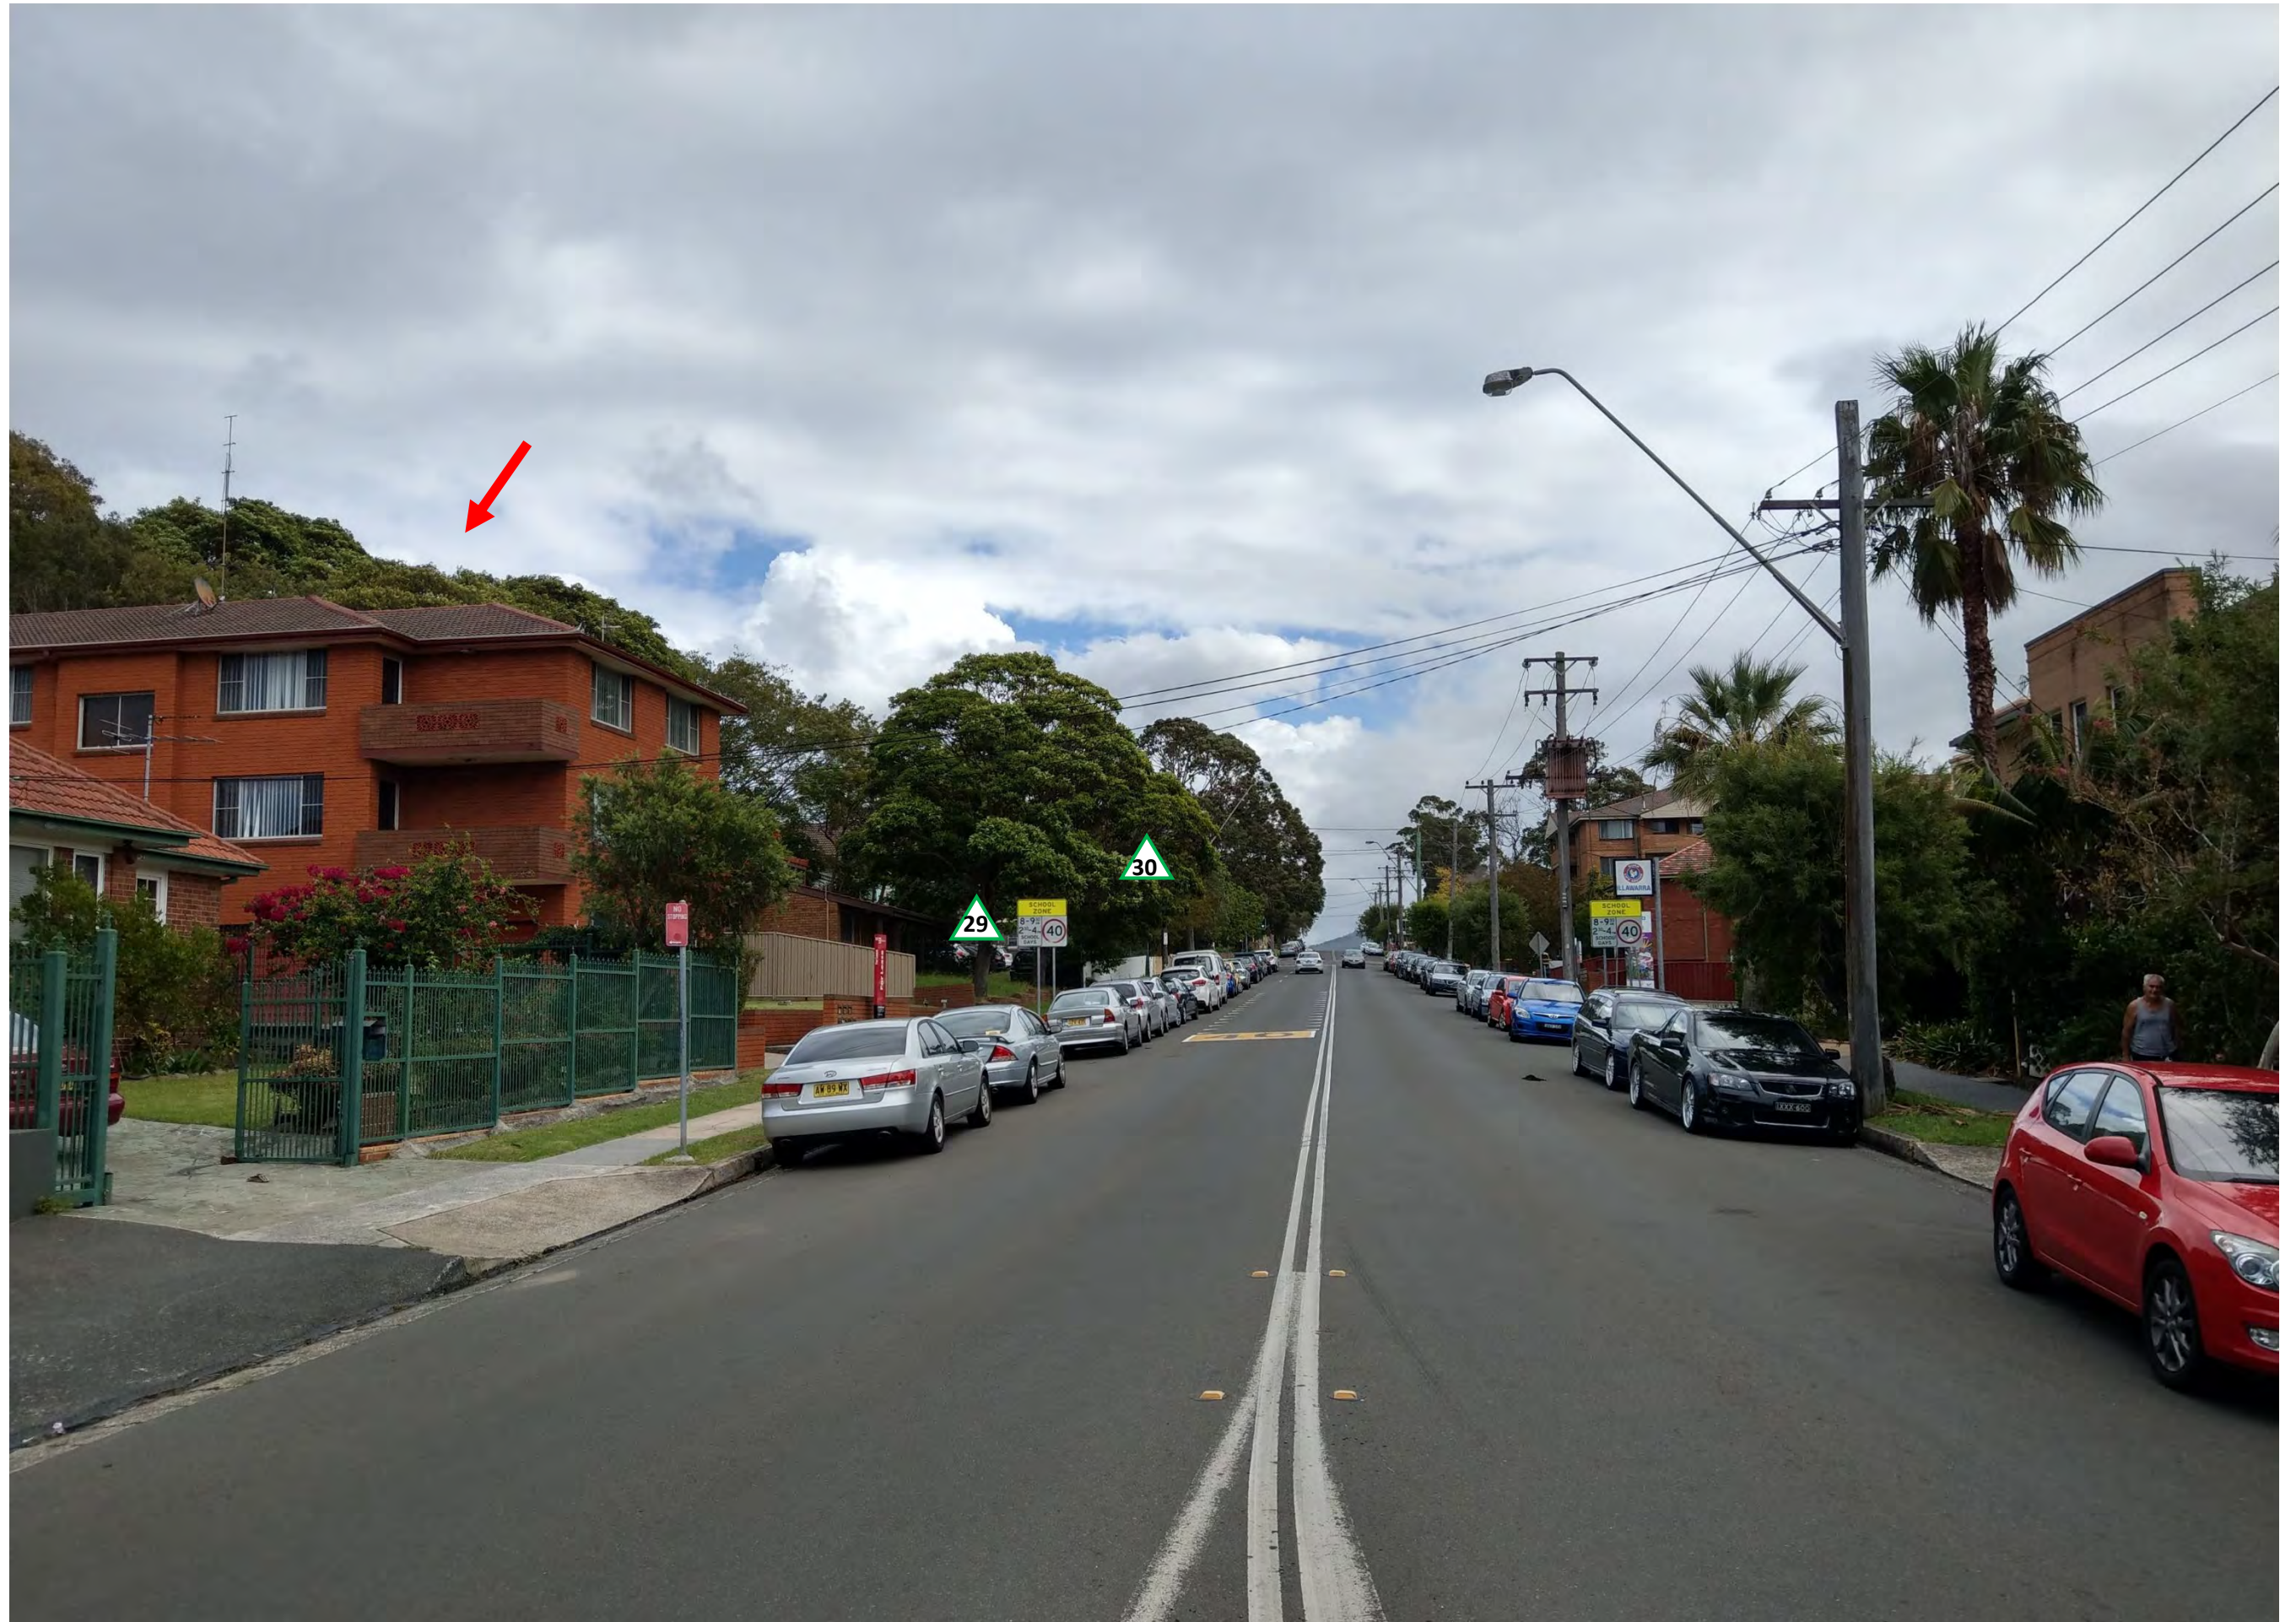
Photograph 3. (East aspect). This photograph illustrates the site heading west on Smith Street. The trees T29, T30 and the trees T25-T28 (red arrow) can be seen from this aspect.
