STATEMENT OF ENVIRONMENTAL EFFECTS

WOLLONGONG PUBLIC SCHOOL

NOVEMBER 2017
SA6418
FINAL
PREPARED FOR NSW DEPARTMENT OF EDUCATION

Arboricultural Impact Assessment Report.

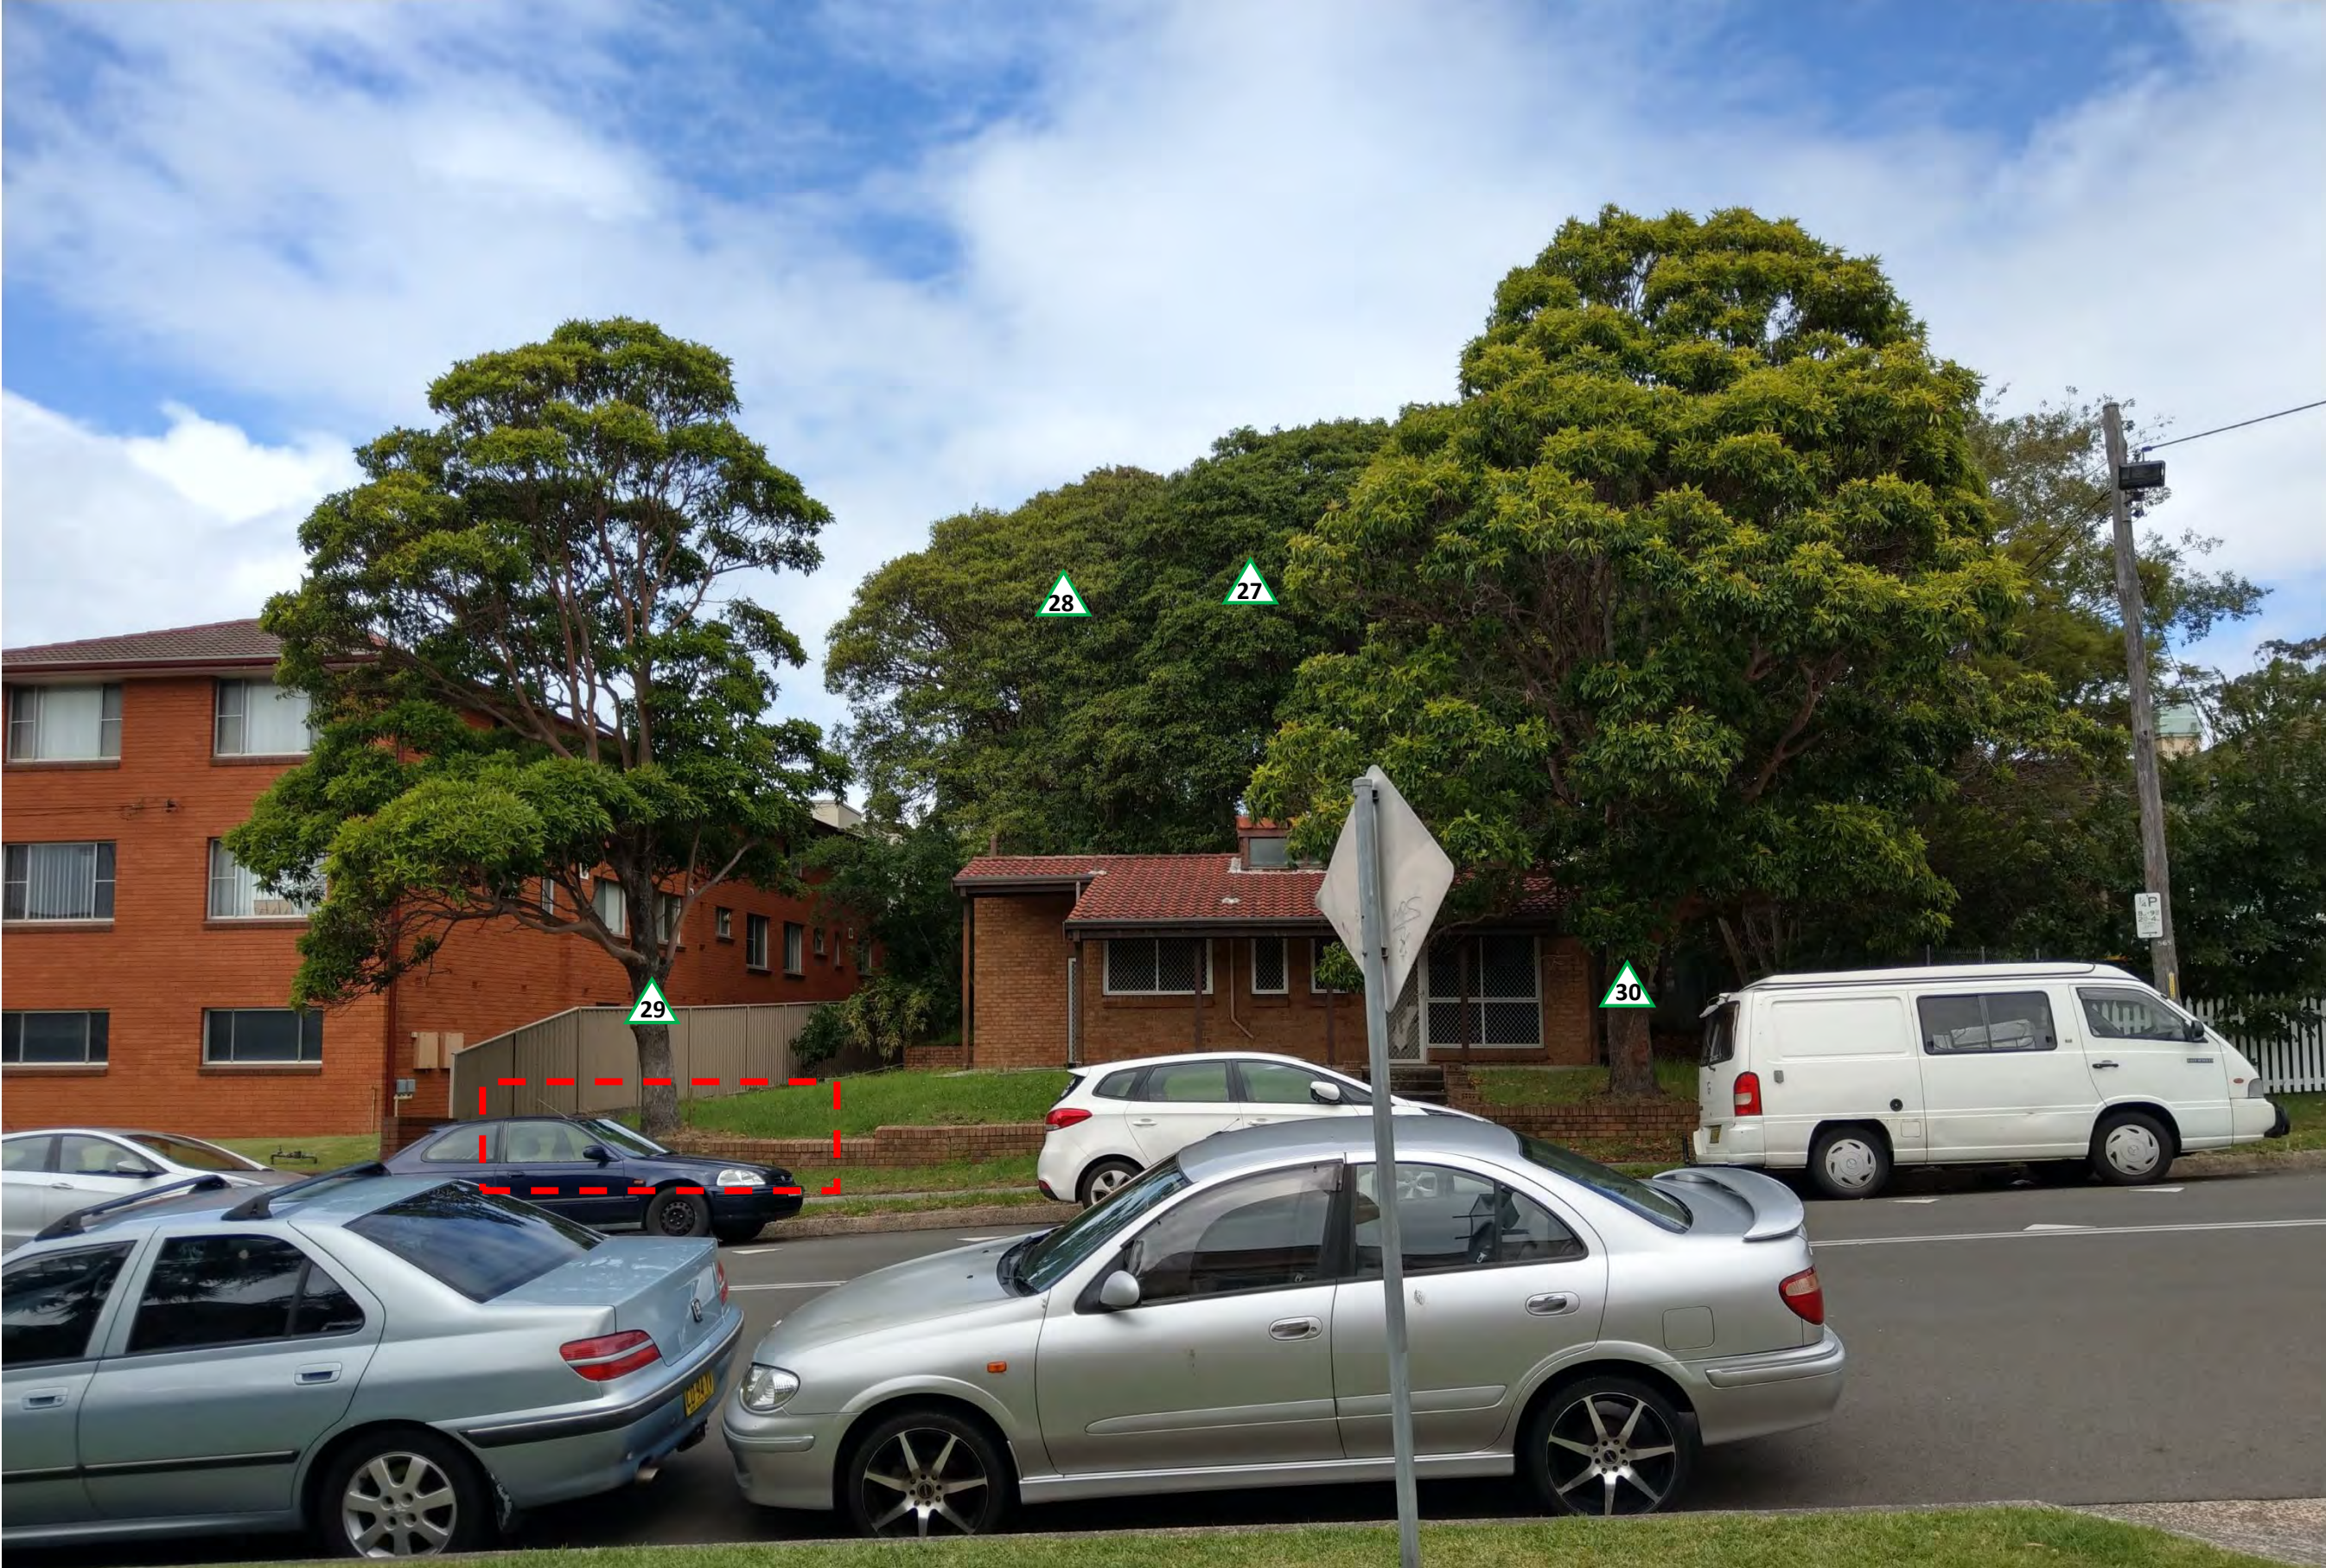
Photograph 4. (North aspect). This photograph was taken from opposite the site on Smith Street. The trees T27, T28, T29 and T30 can be seen from this aspect. The approximate location of the proposed site construction access road is illustrated with a (red dashed rectangle).

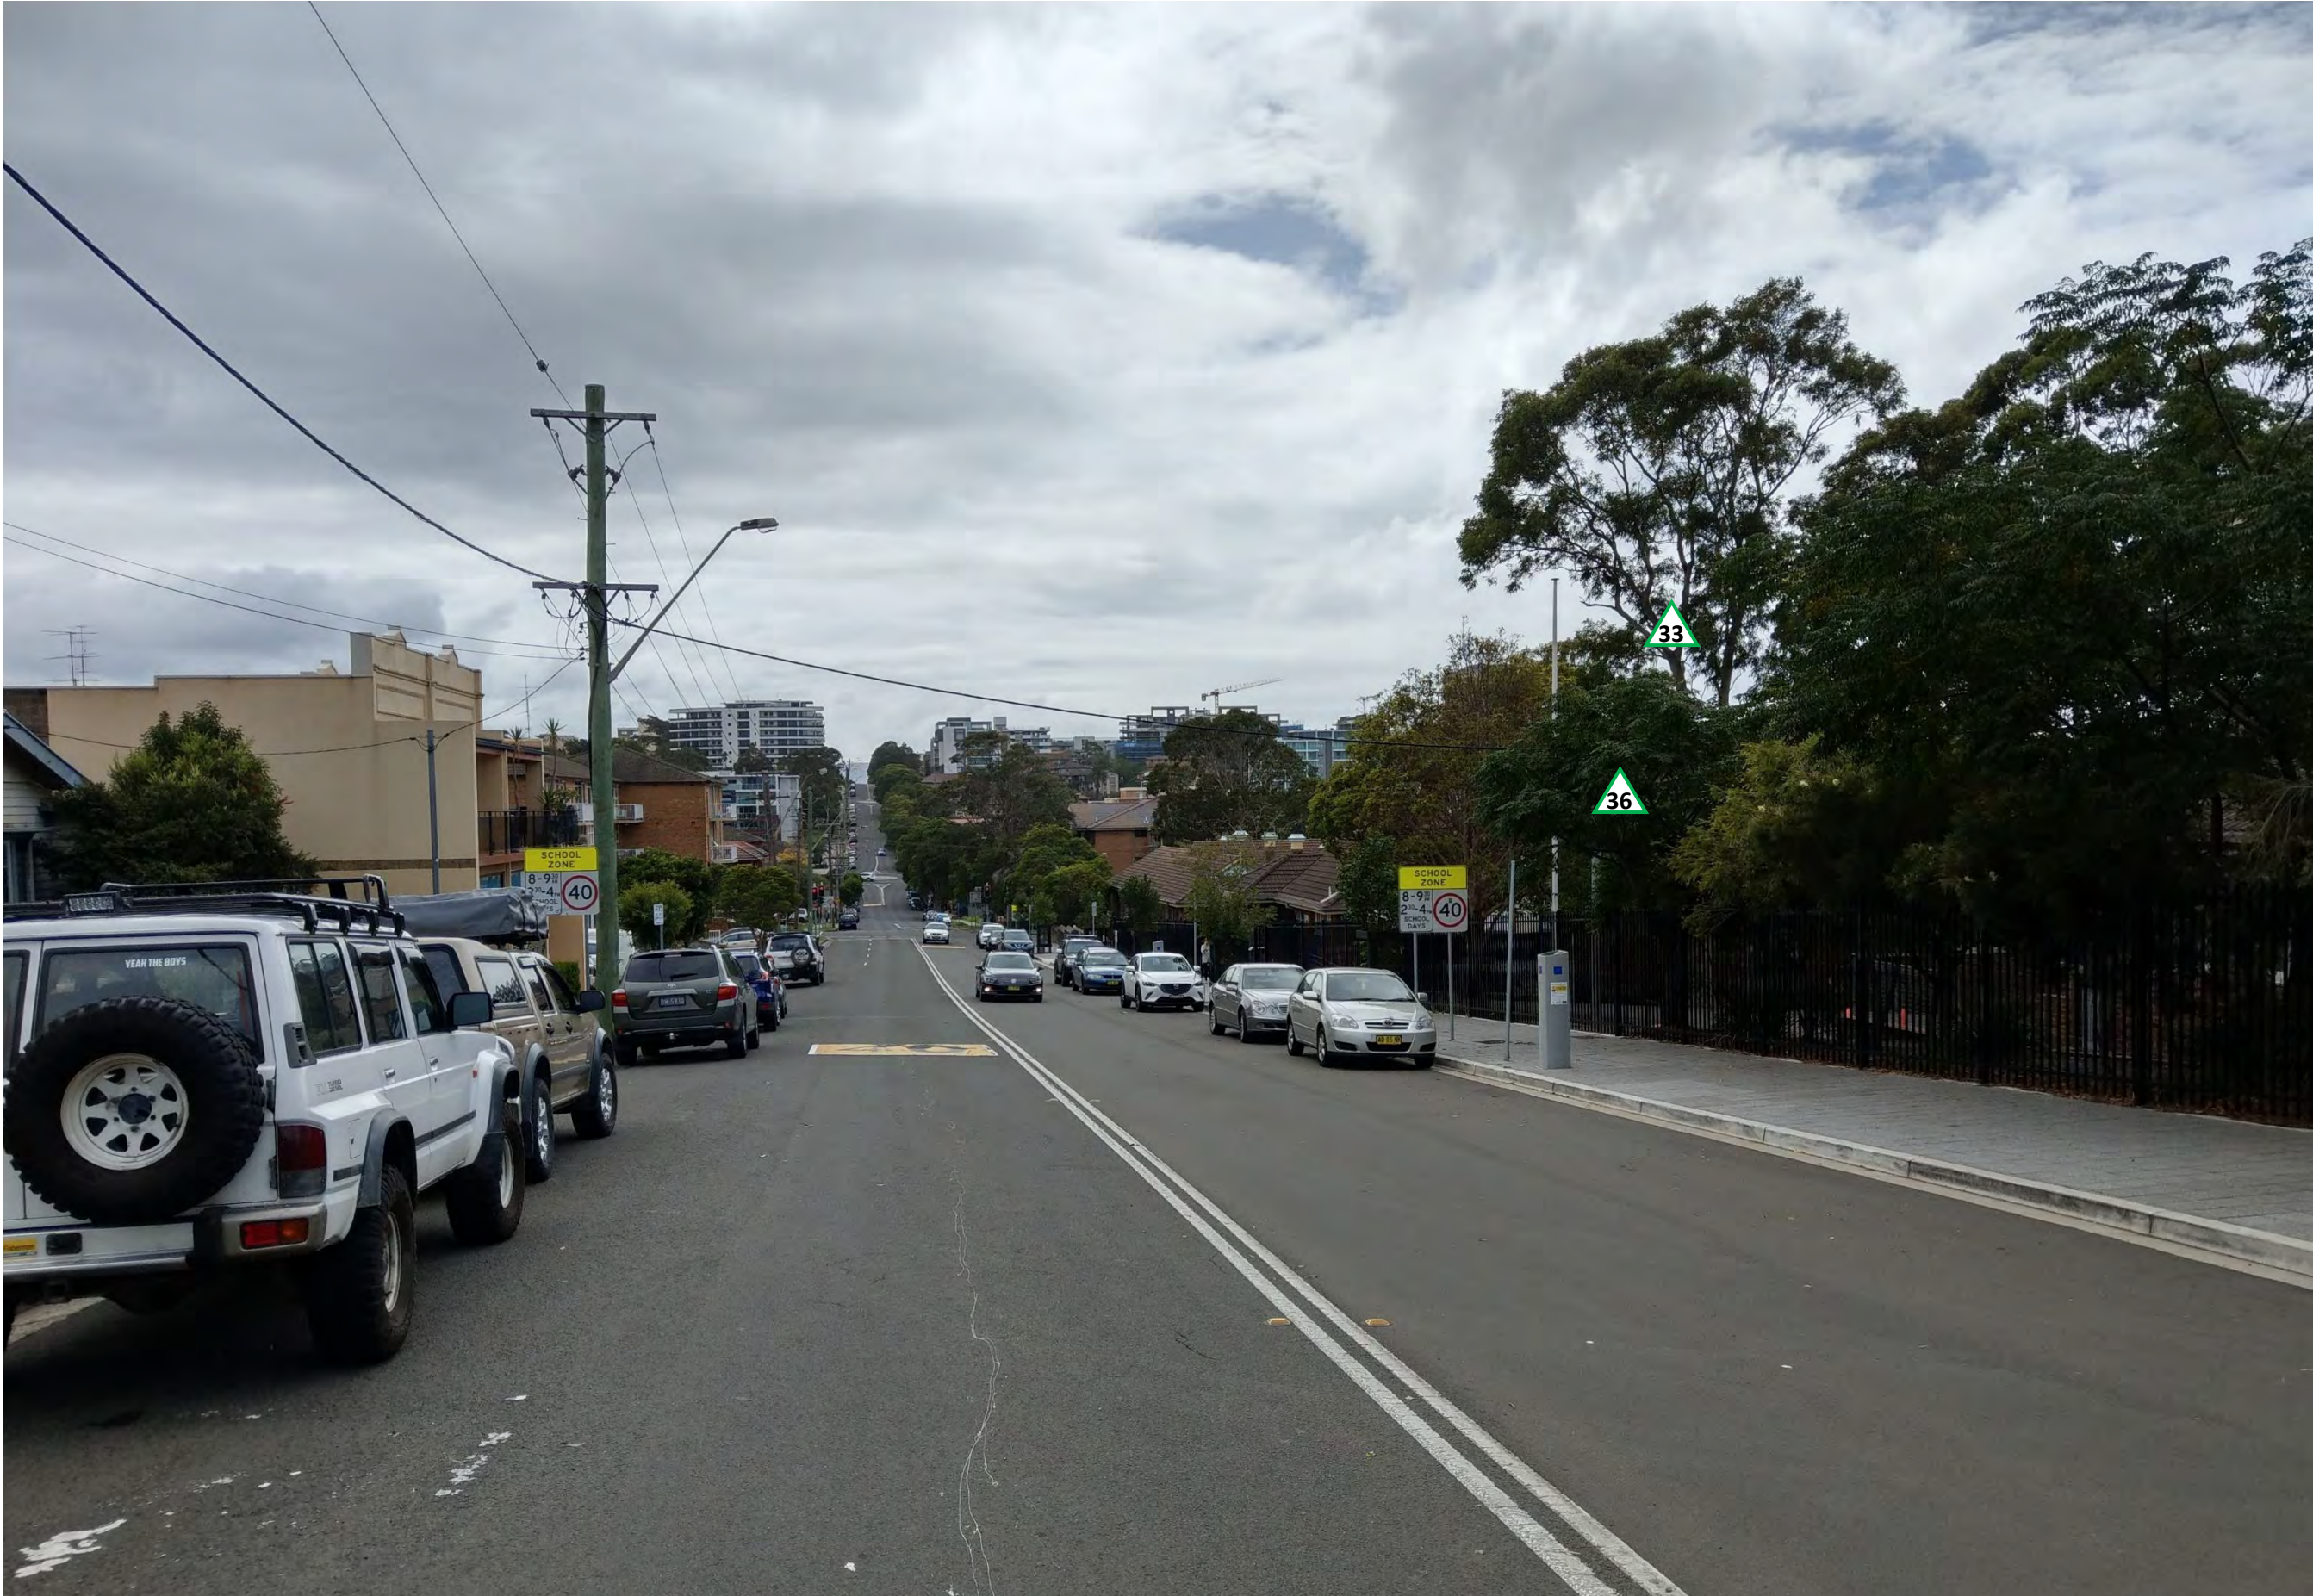
Photograph 4. (South aspect). This photograph illustrates the site heading north on Church Street. The trees T33 and T36 can be seen from this aspect.

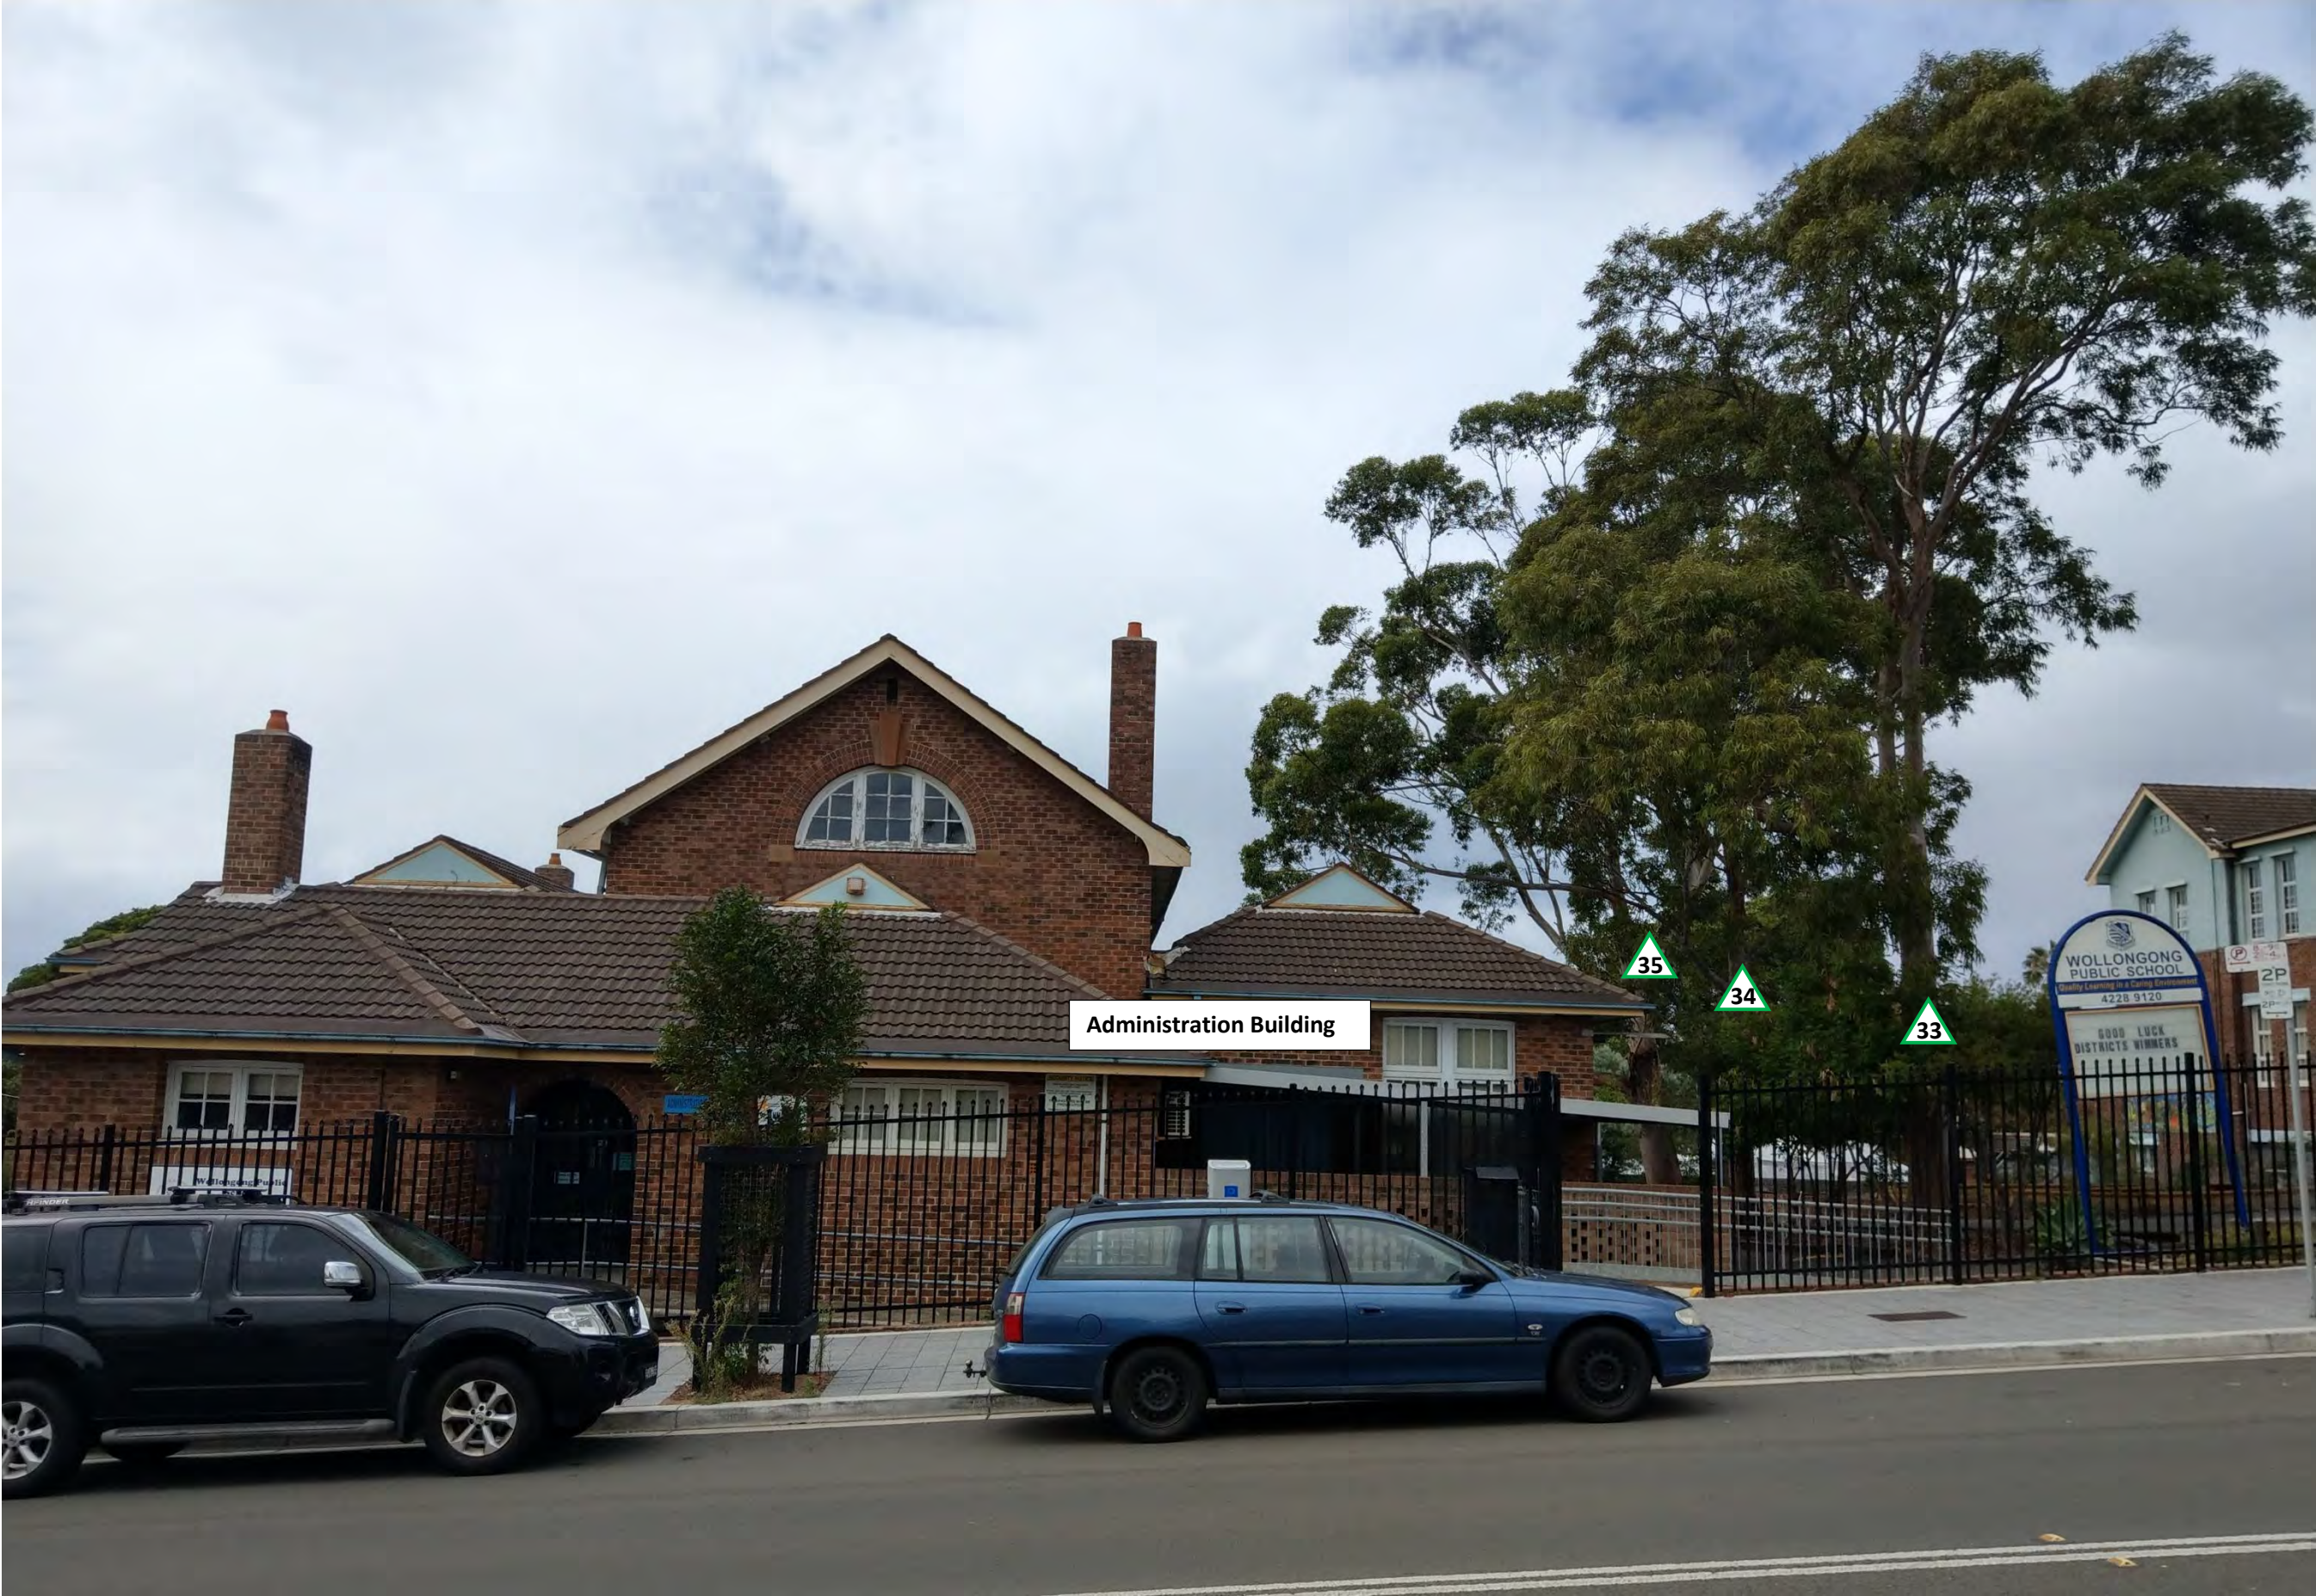
Photograph 5. (North West aspect). This photograph was taken from opposite the site on Church Street. The trees T33-T35 can be seen from this aspect.

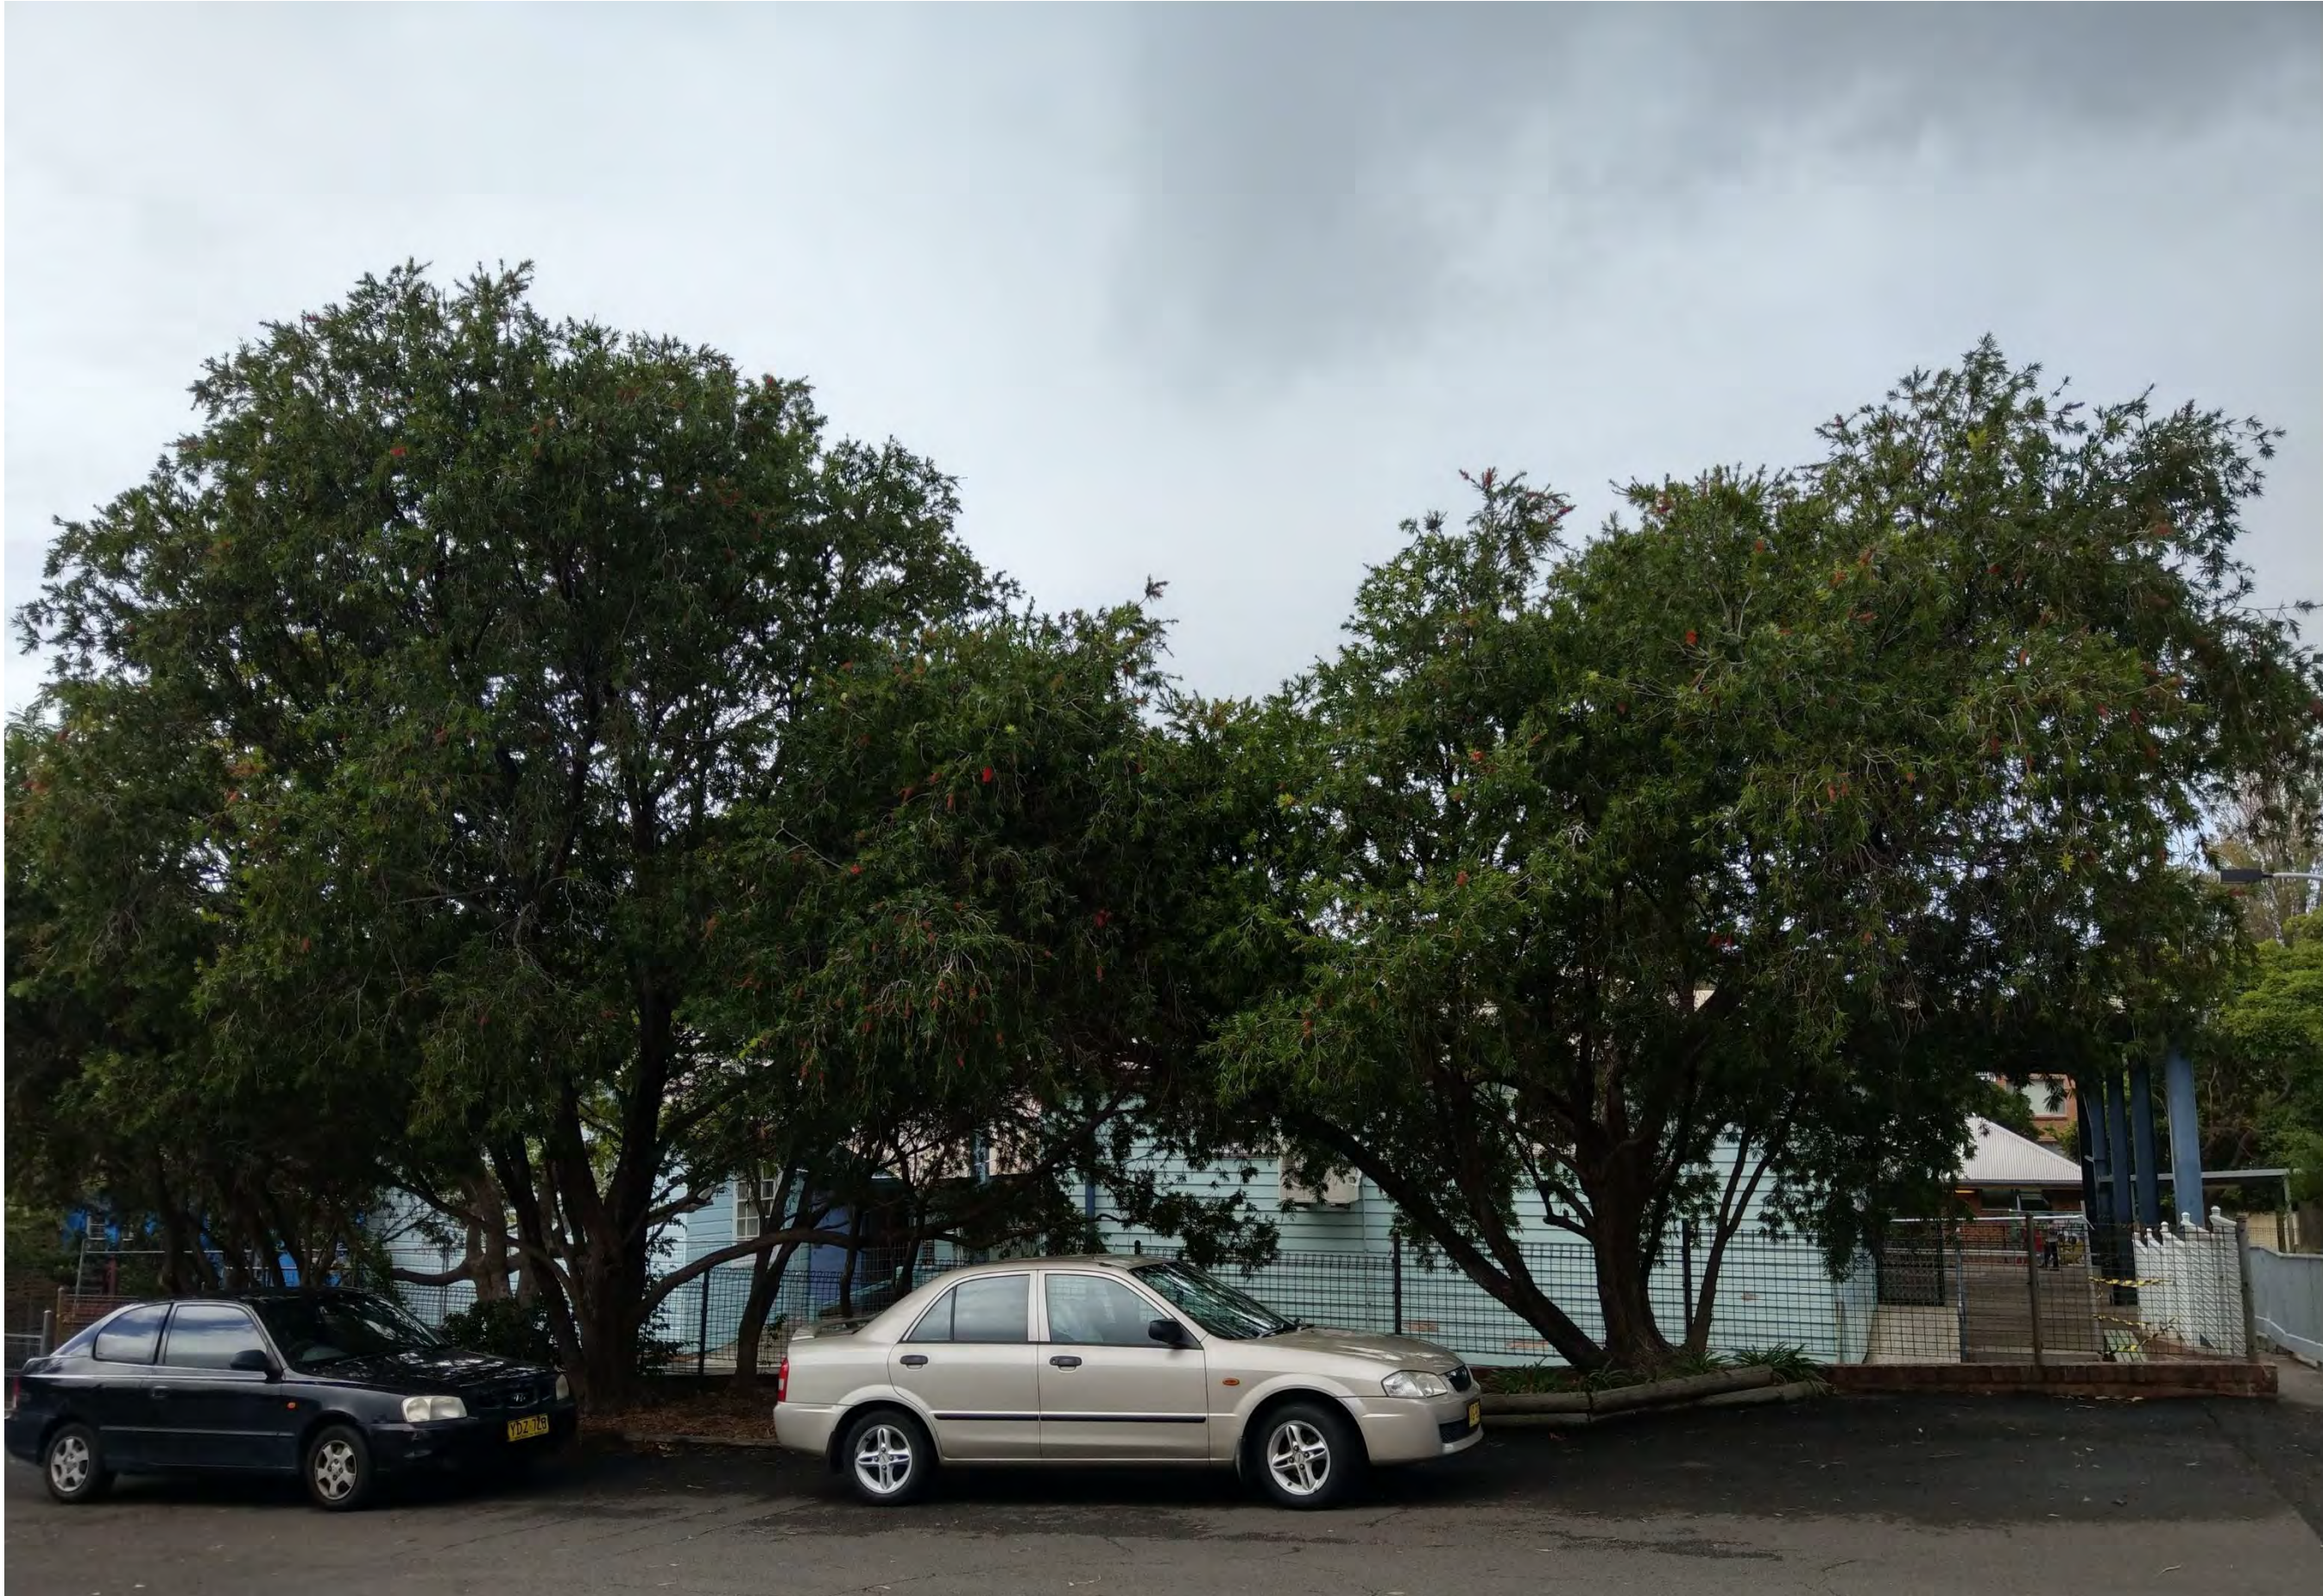
Photograph 6. (West aspect). This photograph illustrates the stand of six trees identified as T32.

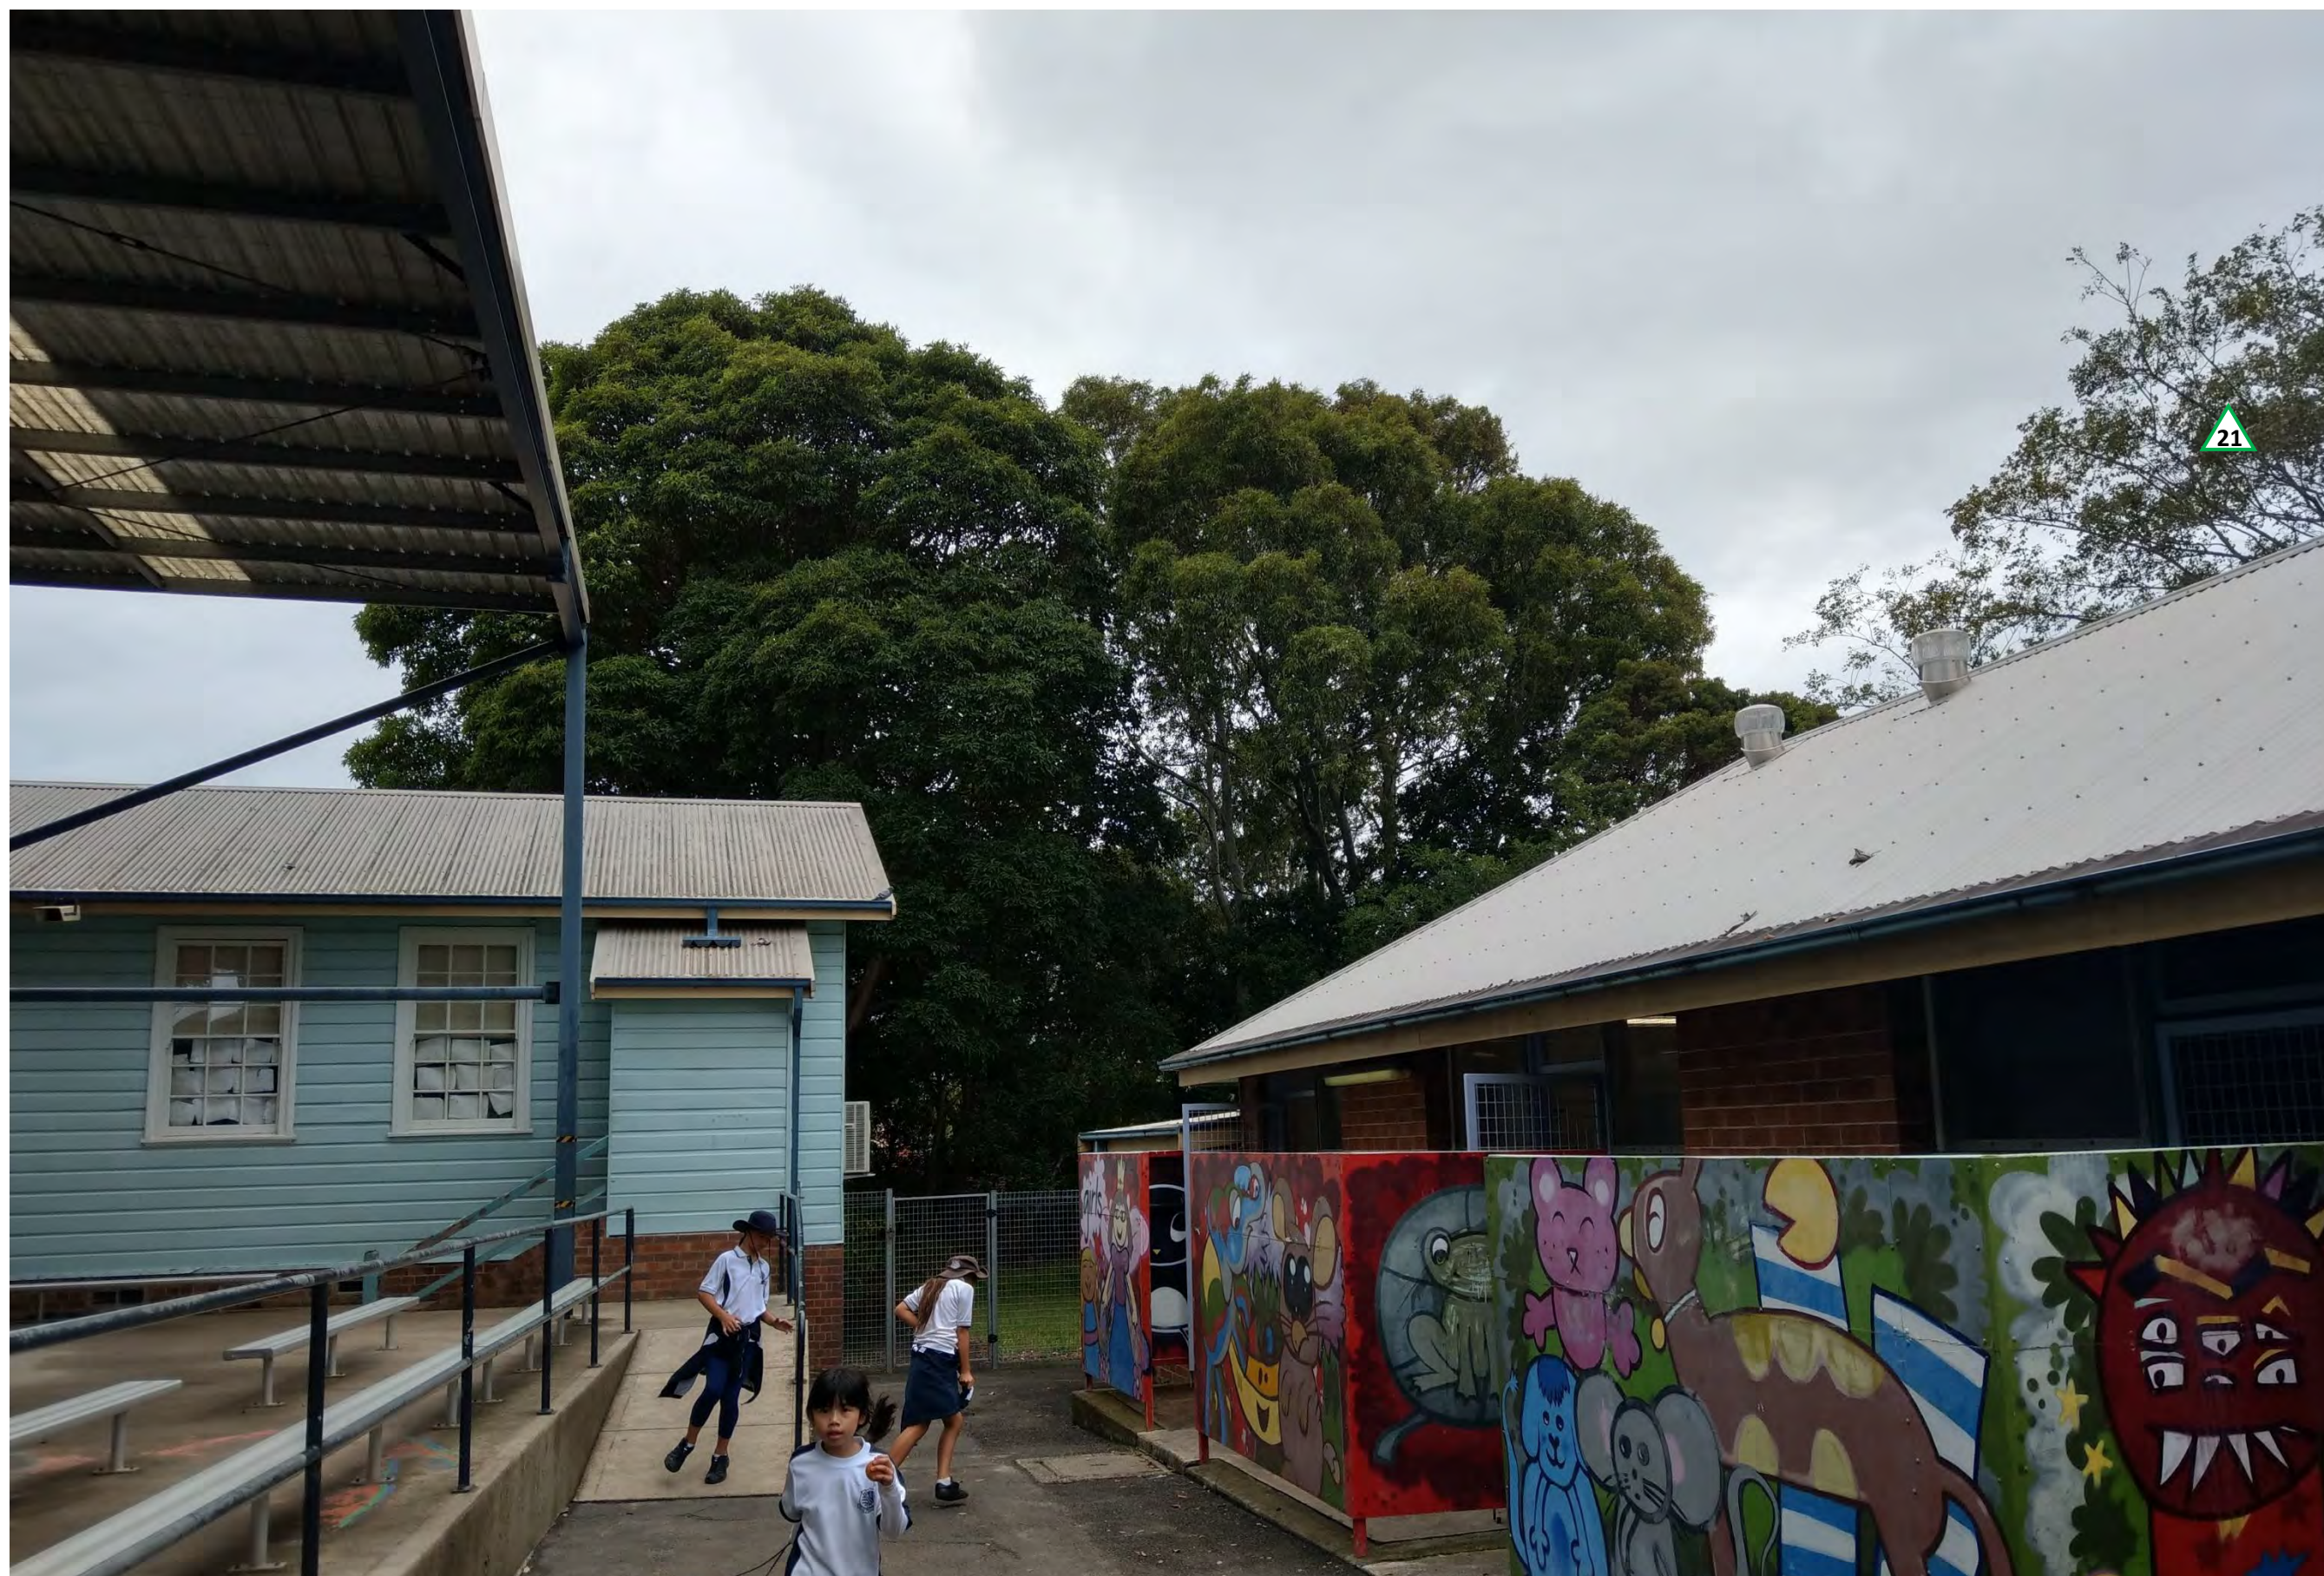
Photograph 7. (South aspect). This photograph illustrates the stand of trees located to the north east of the library. The trees T1-T11 and T21-T28 are located in this stand. Trees in this stand generally consist of Brushbox (*Lophostemon confertus*) which have been planted and Spotted Gums (*Corymbia maculata*) which seem to be naturally occurring. The neighbour's tree T21 is on the right.

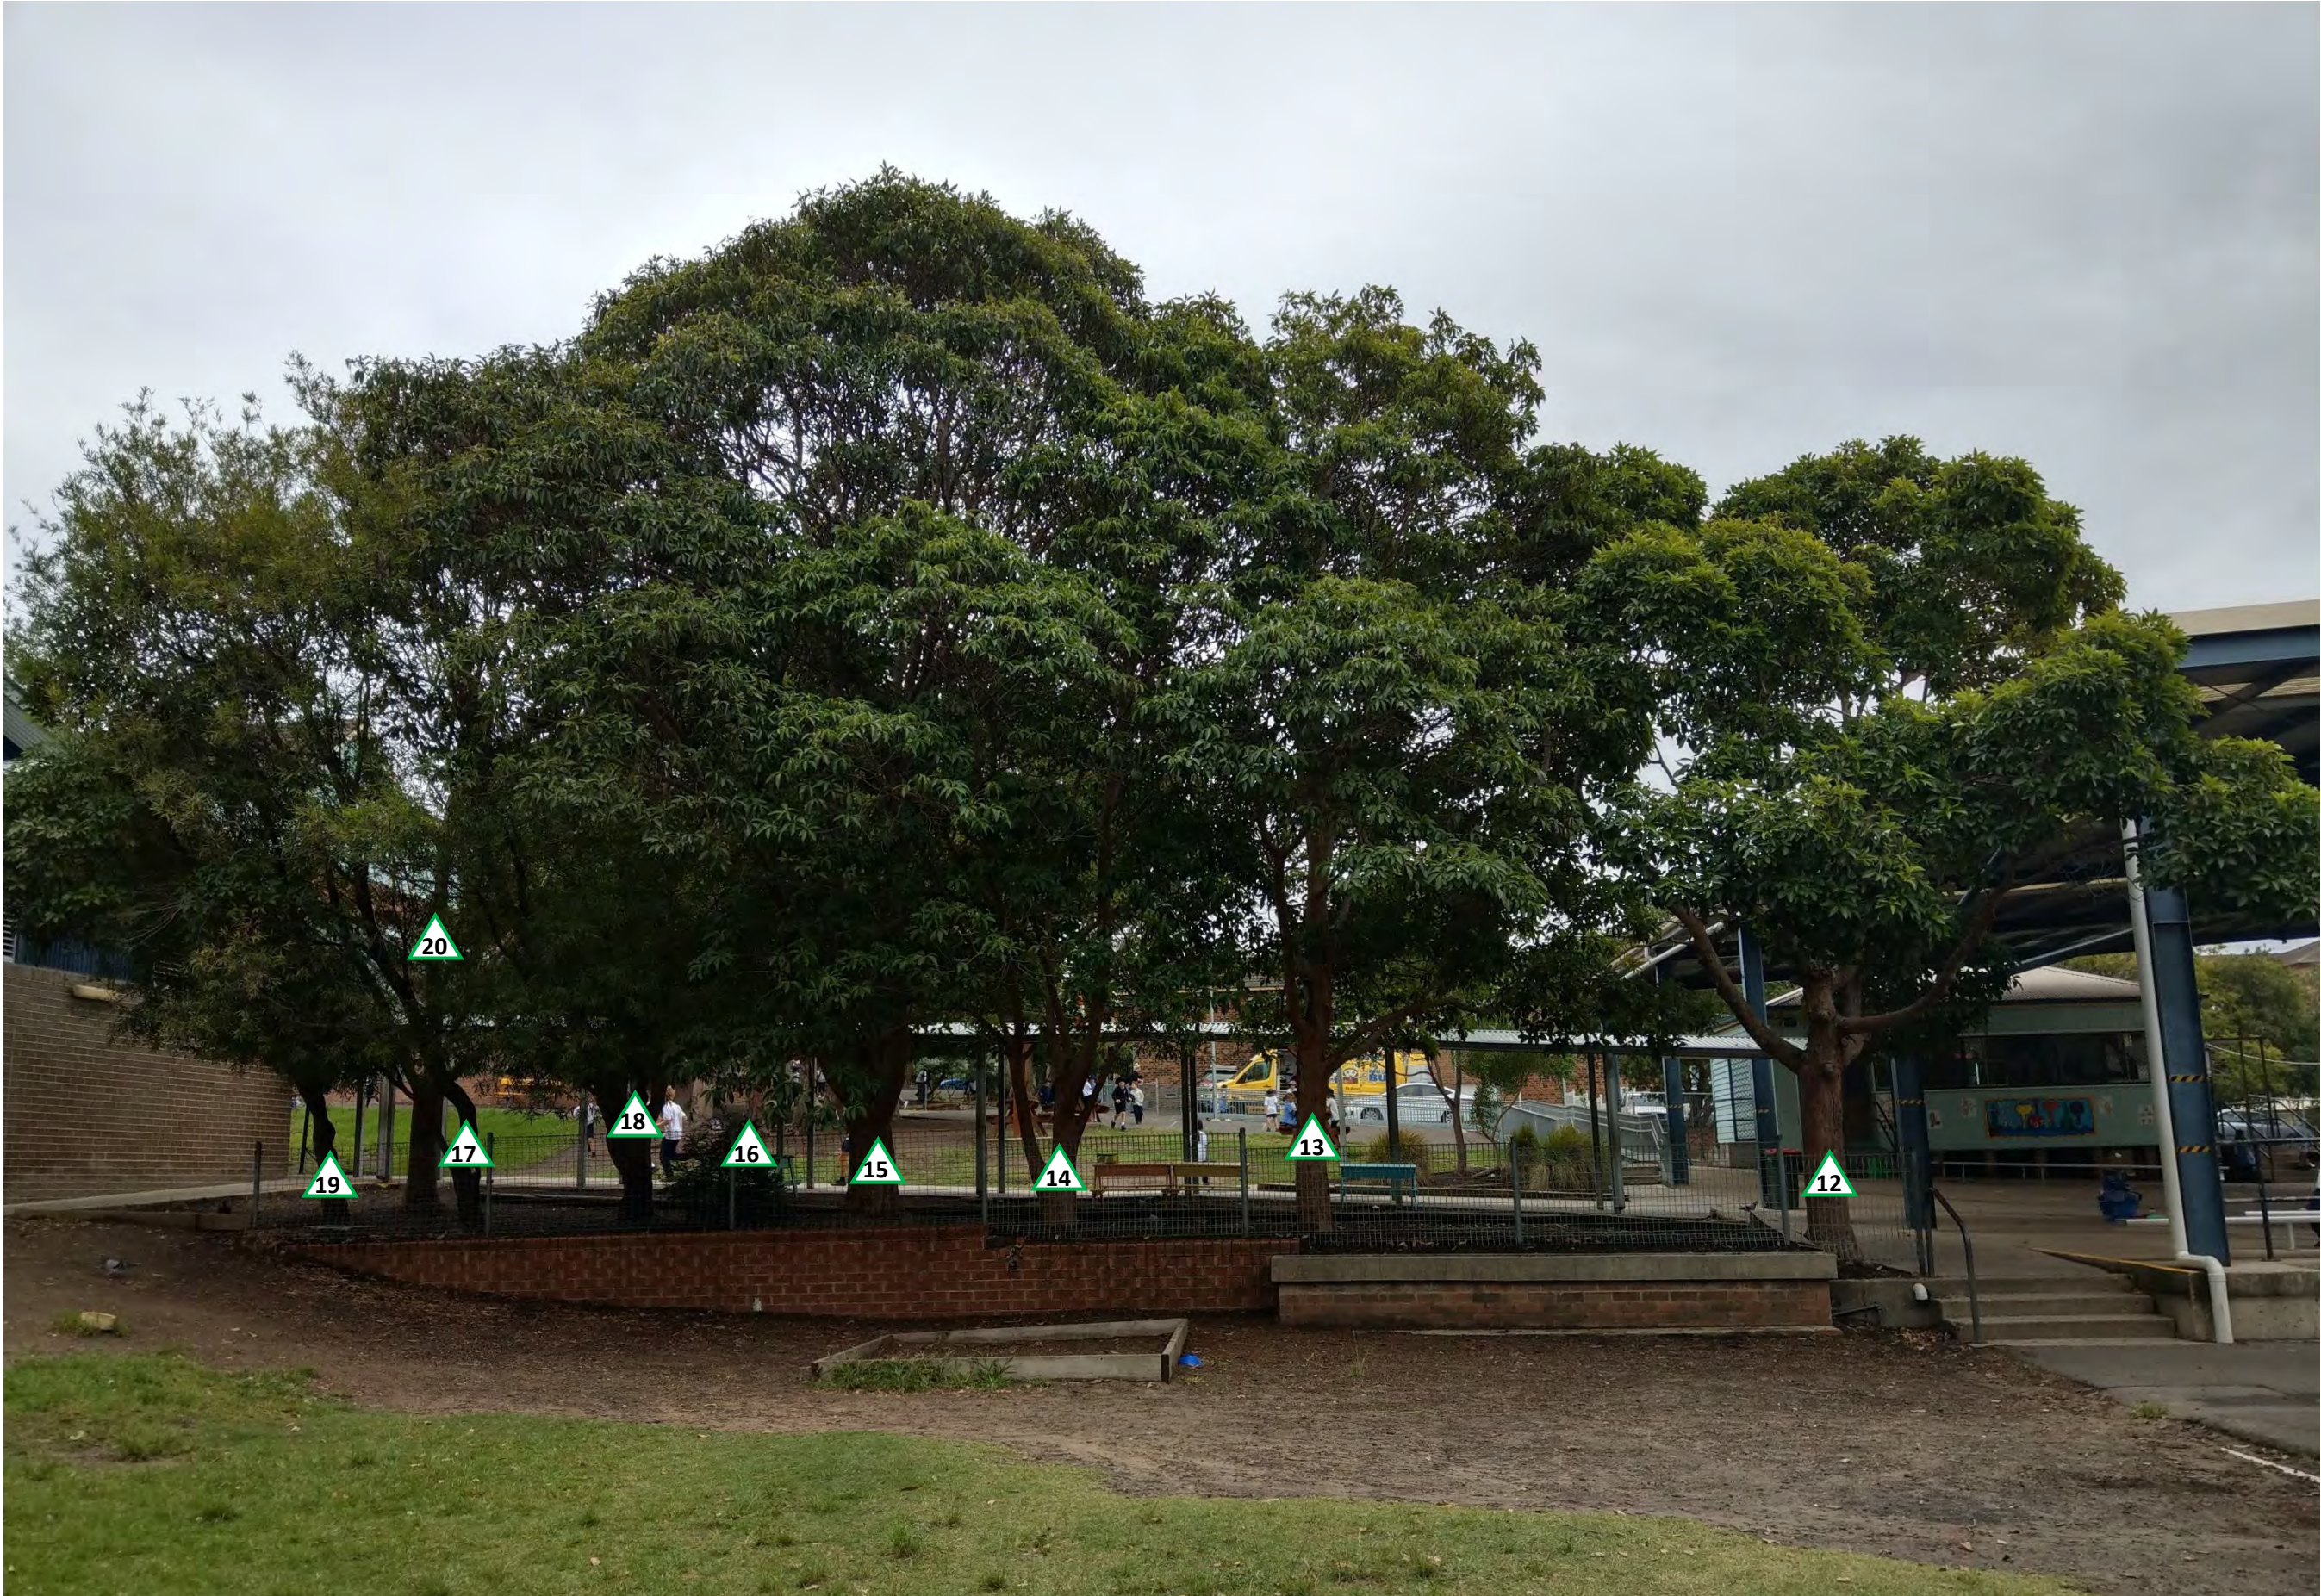
Photograph 8. (East aspect). This photograph illustrates the trees T12 – T20.
