STATEMENT OF ENVIRONMENTAL EFFECTS

WOLLONGONG PUBLIC SCHOOL

NOVEMBER 2017
SA6418
FINAL
PREPARED FOR NSW DEPARTMENT OF EDUCATION

Arboricultural Impact Assessment Report.

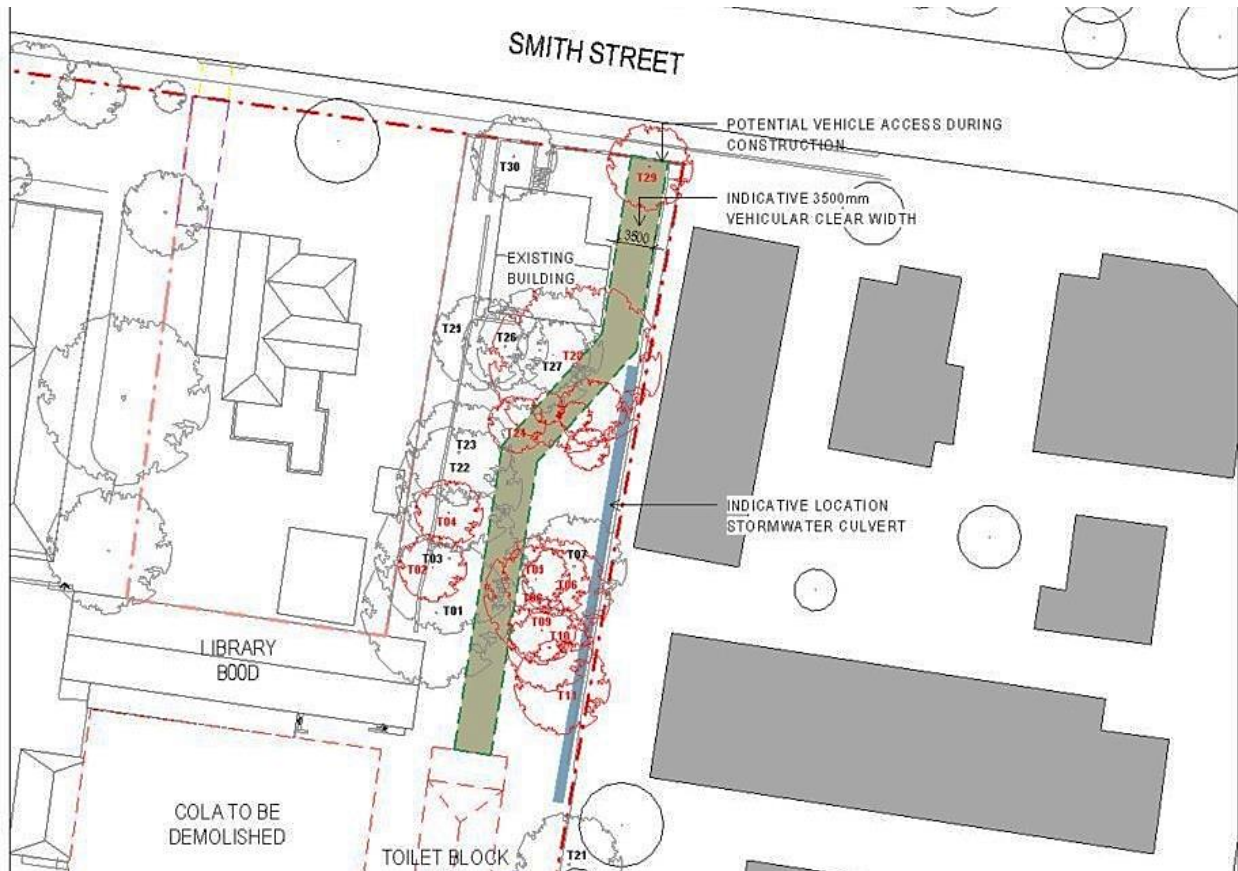
The location of the proposed site construction traffic turn towards the south west just past the Community Meeting Building. Although not marked on this drawing, the proposed site compound would be located between the stand of trees directly behind the Community Meeting Building T25-T28 and the tree T23 located further to the south.
