## Quarry Closure & Rehabilitation Plan

**Extractive Industry ('Rockwood Quarry') and  
Crushing of Recycled Concrete**

208 Winchester Lane, Table Top

August 2019

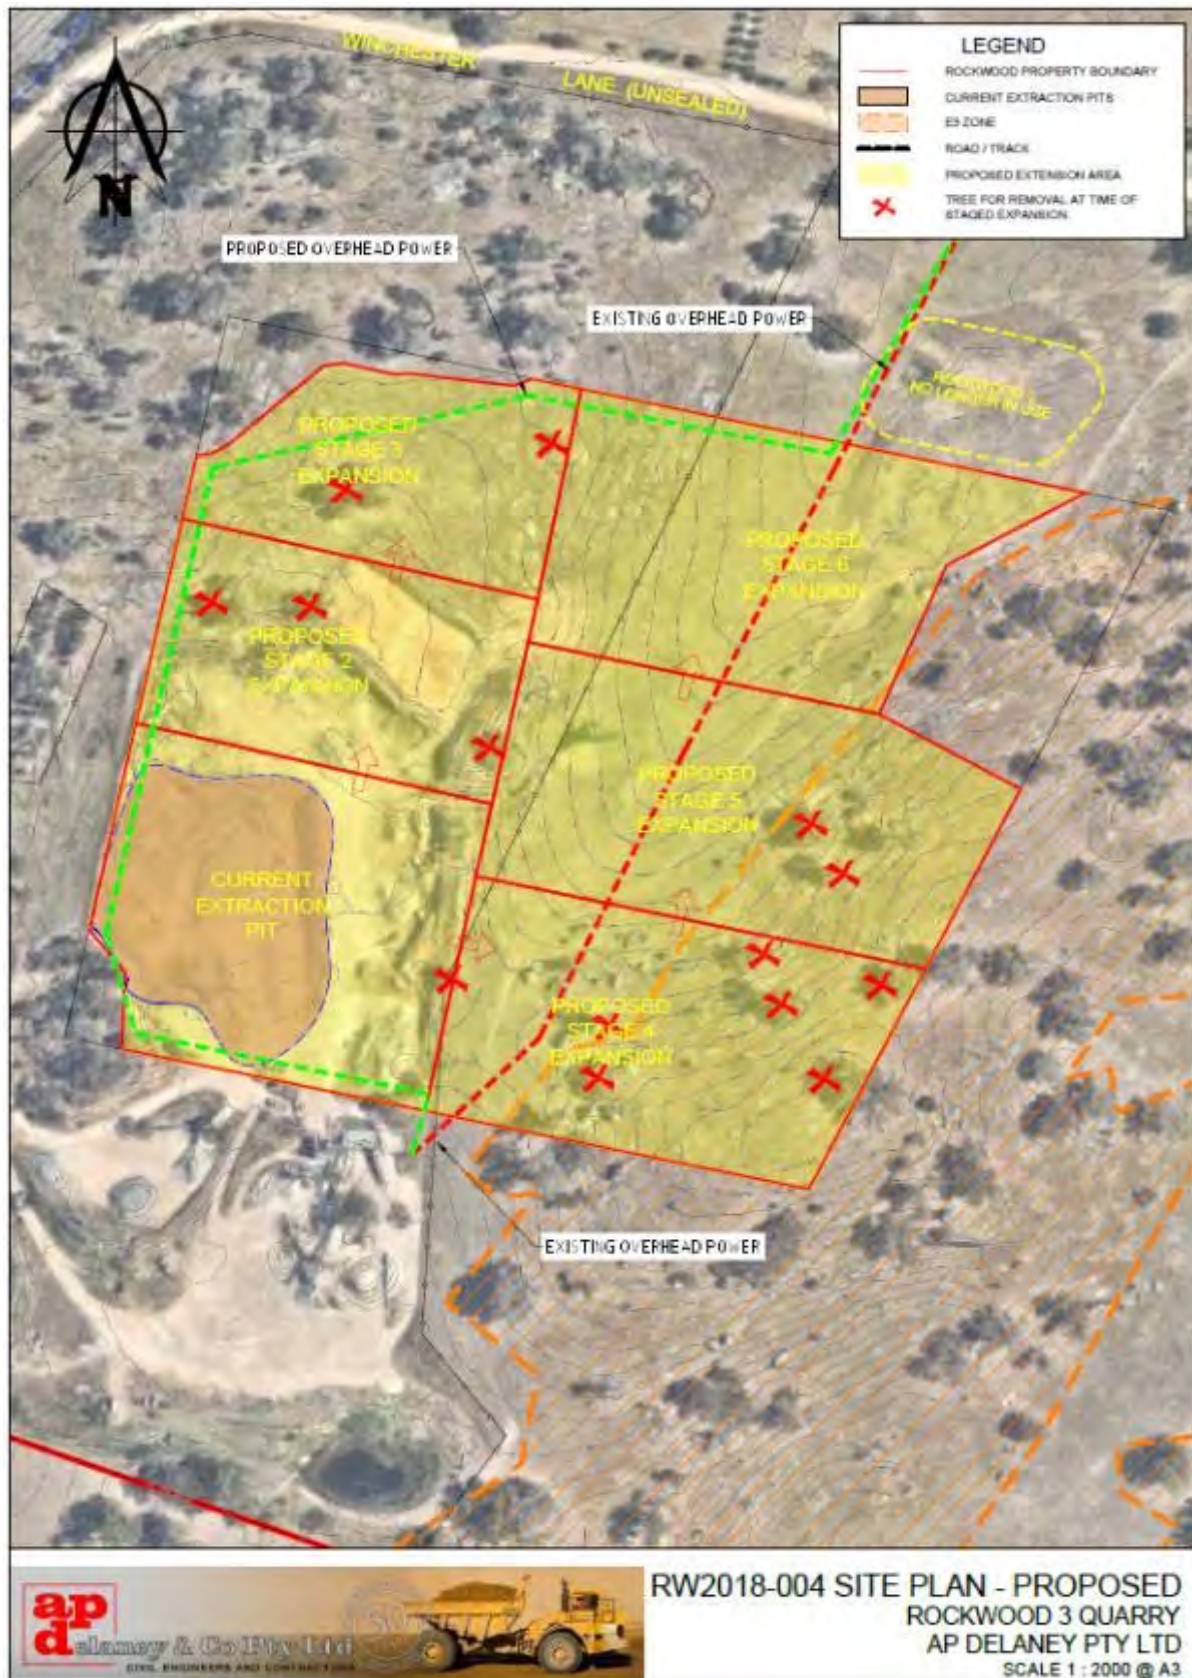
Figure 8 Proposed Extraction Staging Plan – Pit 3
