REPORT ON TRALEE HOMESTEAD AND WOOLSHED

Eric Martin and Associates

**ISSUE 1
13105
22 JULY 2013**

STRUCTURAL ENGINEERING REPORT ON CURRENT CONDITION 2010

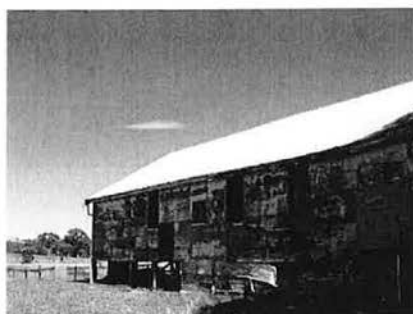
Northern side.

The northern gable ended shed is in fair to poor condition. I conclude that this part of the shed was constructed prior to the lean to section on the southern side. This gable ended shed consists of two different roof structures. The western end has 5 unusual large Oregon king post trusses to the roof. These in my opinion are structurally unusual and efforts should be made to retain or re-use these.

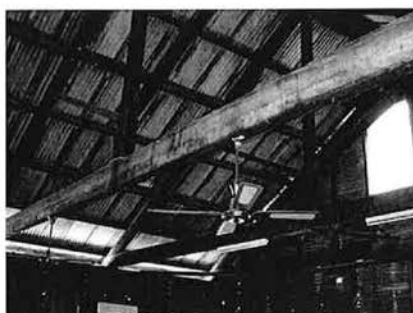
Fig. B.4.1.1.2. - View of the shed from the north. (Source: Eric Martin & Associates, 2010)

The eastern end has a more conventional cut roof propped onto central shearing pen columns. This is more normal structurally but reflects the construction methods prior to about 1960.

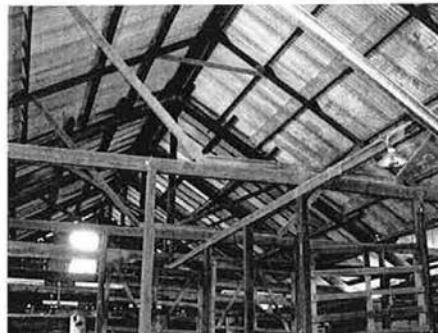
The lean to shed section is in poor condition and is not structurally unusual.

I conclude that a lean to section of this shed is structurally poor and should be demolished.

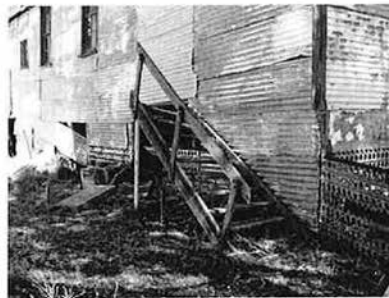
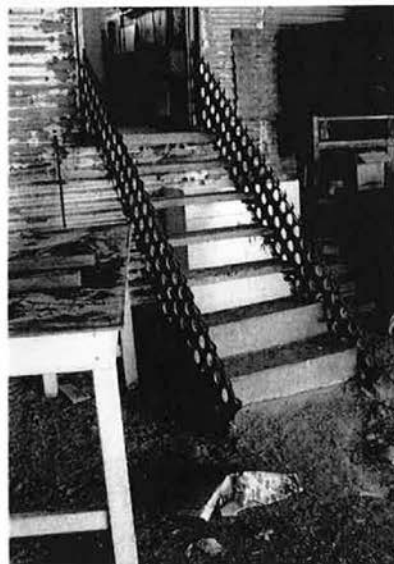
The sheds also have access stairs and ramps in poor condition.

- the stump foundations are towards the end of their life.
- the stumps have unknown embedment into the ground.
- approx 10% of stumps have failed or are missing.
- the whole structure is not tied down sufficiently for wind.
- the studwork in the end walls have inadequate support at the eaves line.
- the king post roof trusses have cracked members needing rectification and the joints need upgrading.
- The cut roof section roof members are inadequate to take N3 wind load and not tied down.
- The roof and wall sheeting needs increased number of connections.
- The external stairs need to be replaced completely.

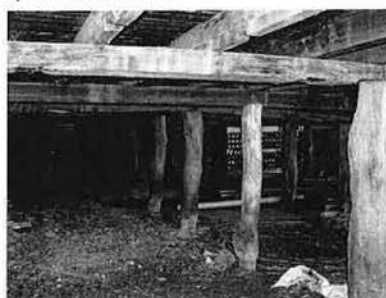
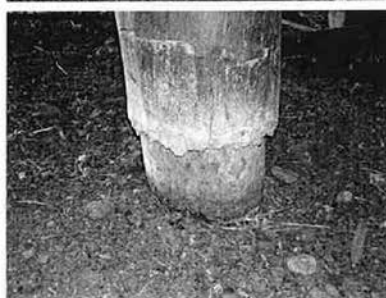
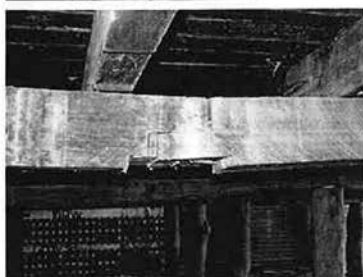
The foundations are Ø250-300 timber pier tree trunks set into the ground by an unknown amount.

These are in fair to poor condition with approx 15% either failed or subsided.

These piers are not a long term proposition and will need to be replaced if the shearing shed is used as a community facility as their design life is already exceeded. The reasons for this are that the timber piers themselves are subject to rot and termites. We have carried out a similar inspection at Yarralumla Woolshed which is having similar problems with its timber piers. In addition there is no tie down of the floor structure to the piers.
