GEOTECHNICAL INVESTIGATION REPORT

LOT 4, DARCY ROAD & HAWKESBURY ROAD, UWS WESTMEAD
PRECINCT, WESTMEAD, NSW

EI Report No. E23033 GA_Rev1

Date: 15 December 2016 2016

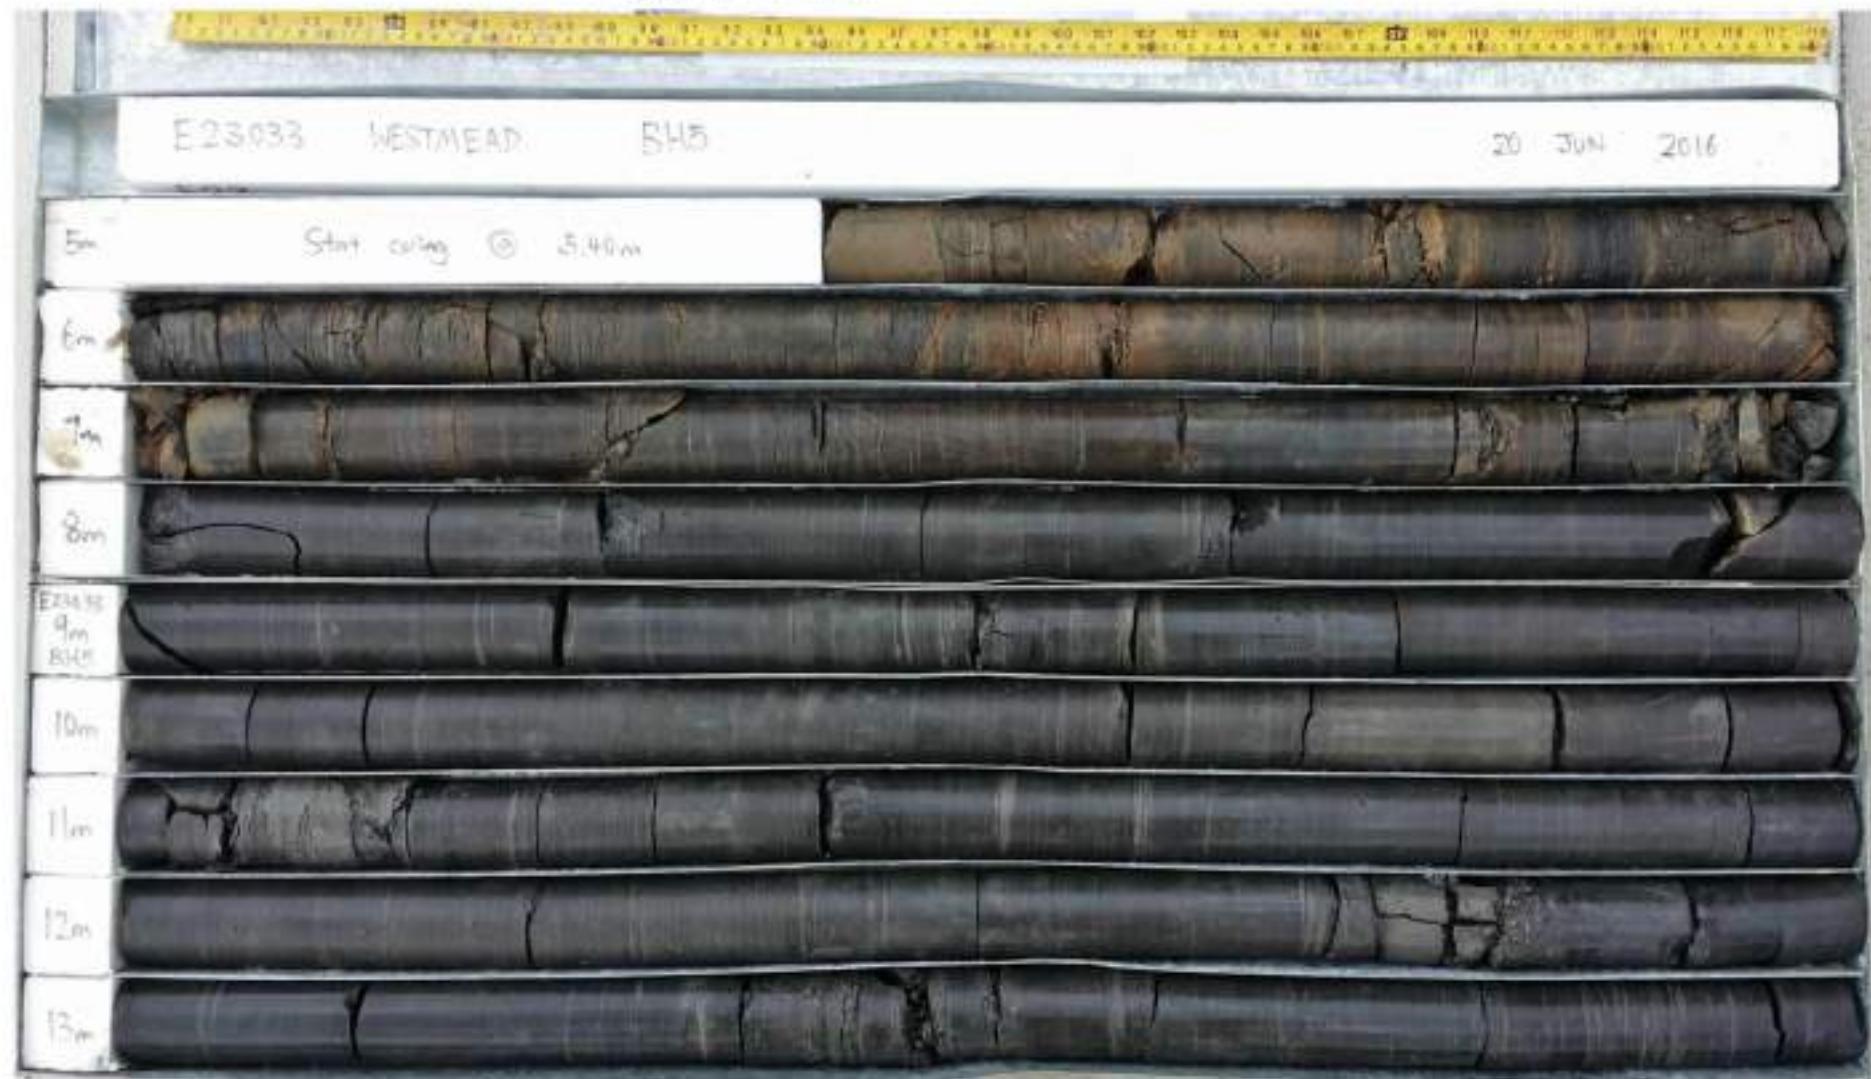
CORE PHOTOGRAPH OF BOREHOLE: BH5

East: 313562.1 m
North: 6257477.5 m MGA94 Zone 56
Surface RL: 30.30 m AHD
Inclination: -80°
Box: 1-2 of 4
Hole Depth: 24.00 m

Depth Range: 5.40 m to 14.00 m
Contractor: Rockwell Drilling Pty Ltd
Drill Rig: Hanjin DB8
LOGGED: JZ DATE: 20/6/16
CHECKED: SK DATE: 1/7/16

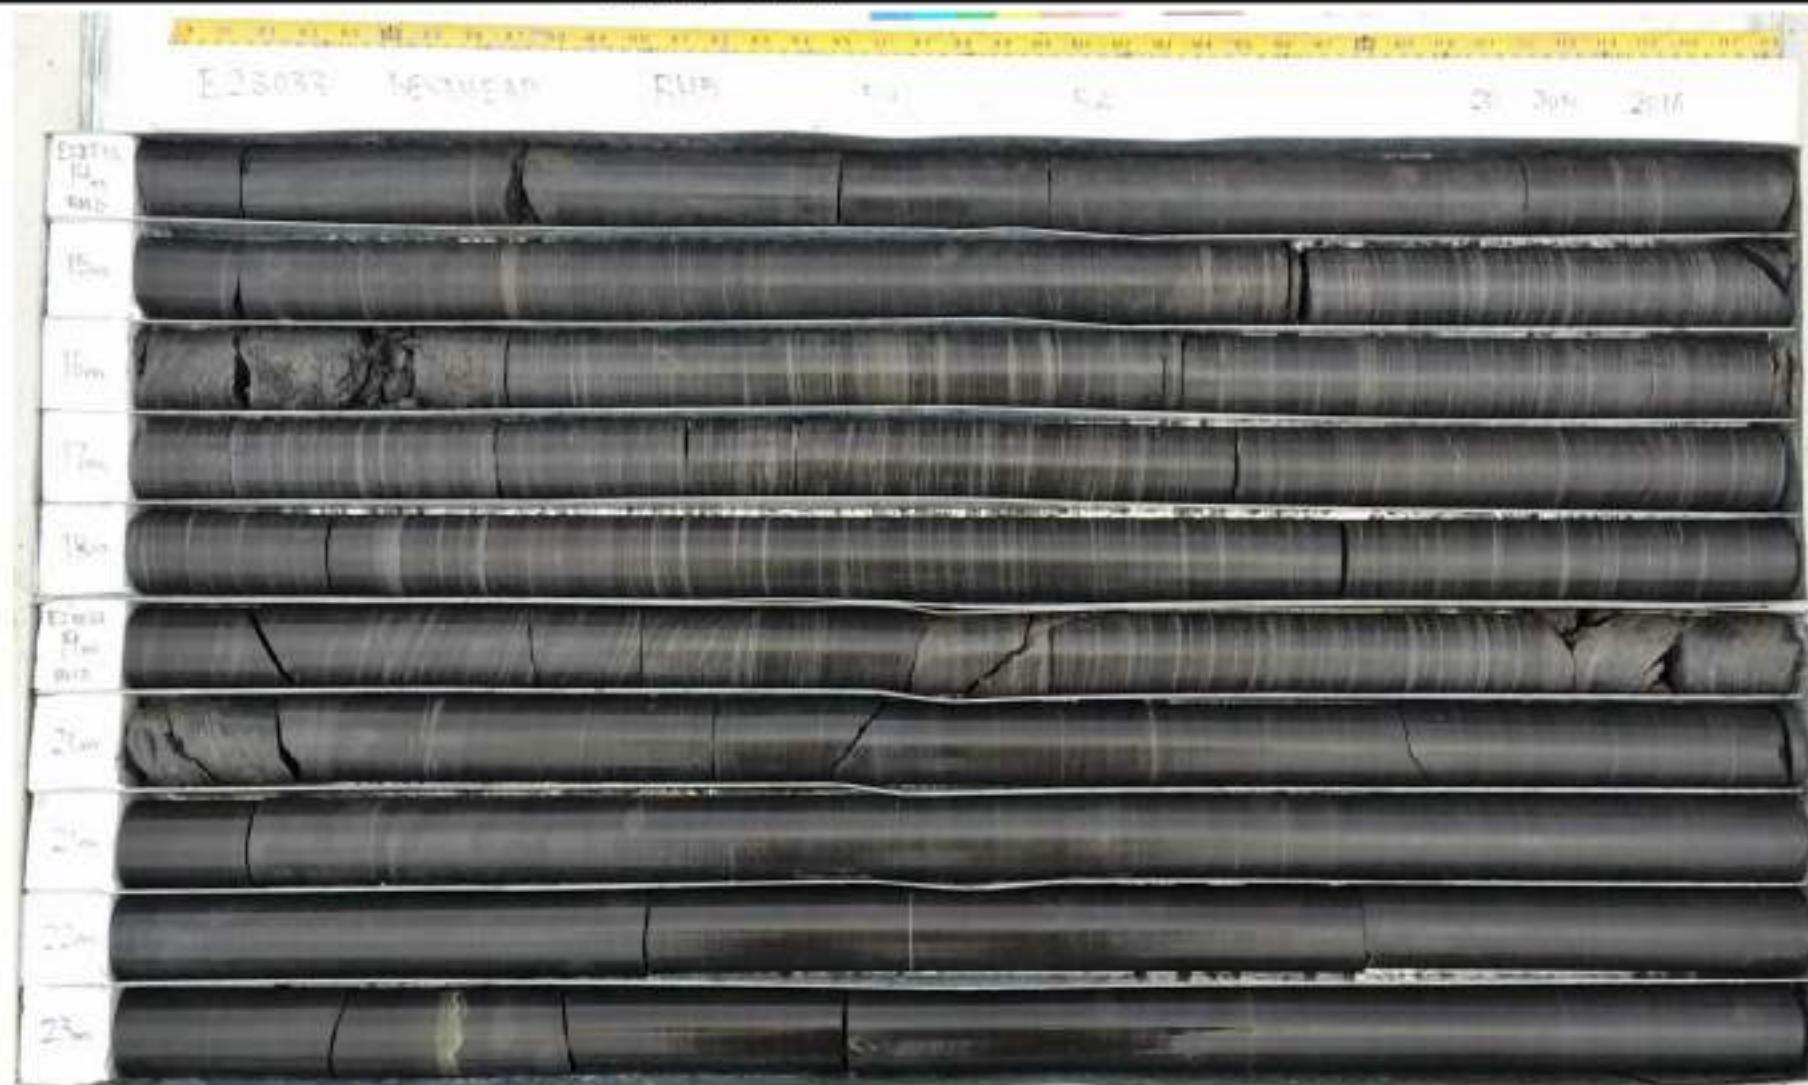
East: 313562.1 m
North: 6257477.5 m MGA94 Zone 56
Surface RL: 30.30 m AHD
Inclination: -80°
Box: 3-4 of 4
Hole Depth: 24.00 m

Depth Range: 14.00 m to 24.00 m
Contractor: Rockwell Drilling Pty Ltd
Drill Rig: Hanjin DB8
LOGGED: JZ DATE: 20/6/16
CHECKED: SK DATE: 1/7/16

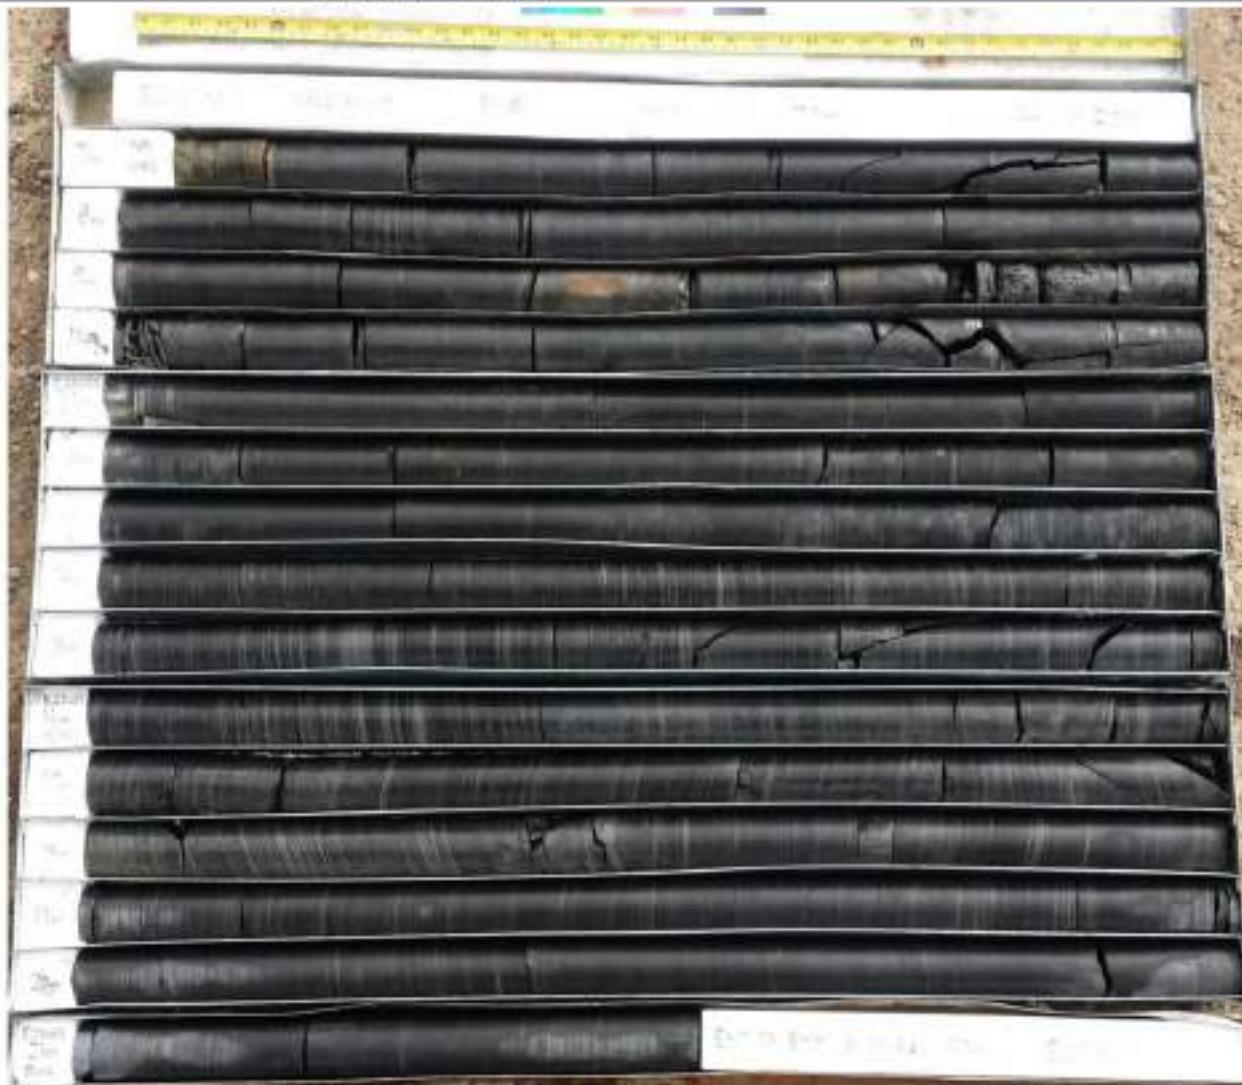
East: 313584.5 m
North: 6257500.8 m MGA94 Zone 56
Surface RL: 30.50 m AHD
Inclination: -80°
Box: 1-3 of 3
Hole Depth: 21.53 m

Depth Range: 7.00 m to 21.53 m
Contractor: Rockwell Drilling Pty Ltd
Drill Rig: Hanjin DB8
LOGGED: JZ DATE: 22/6/16
CHECKED: SK DATE: 1/7/16

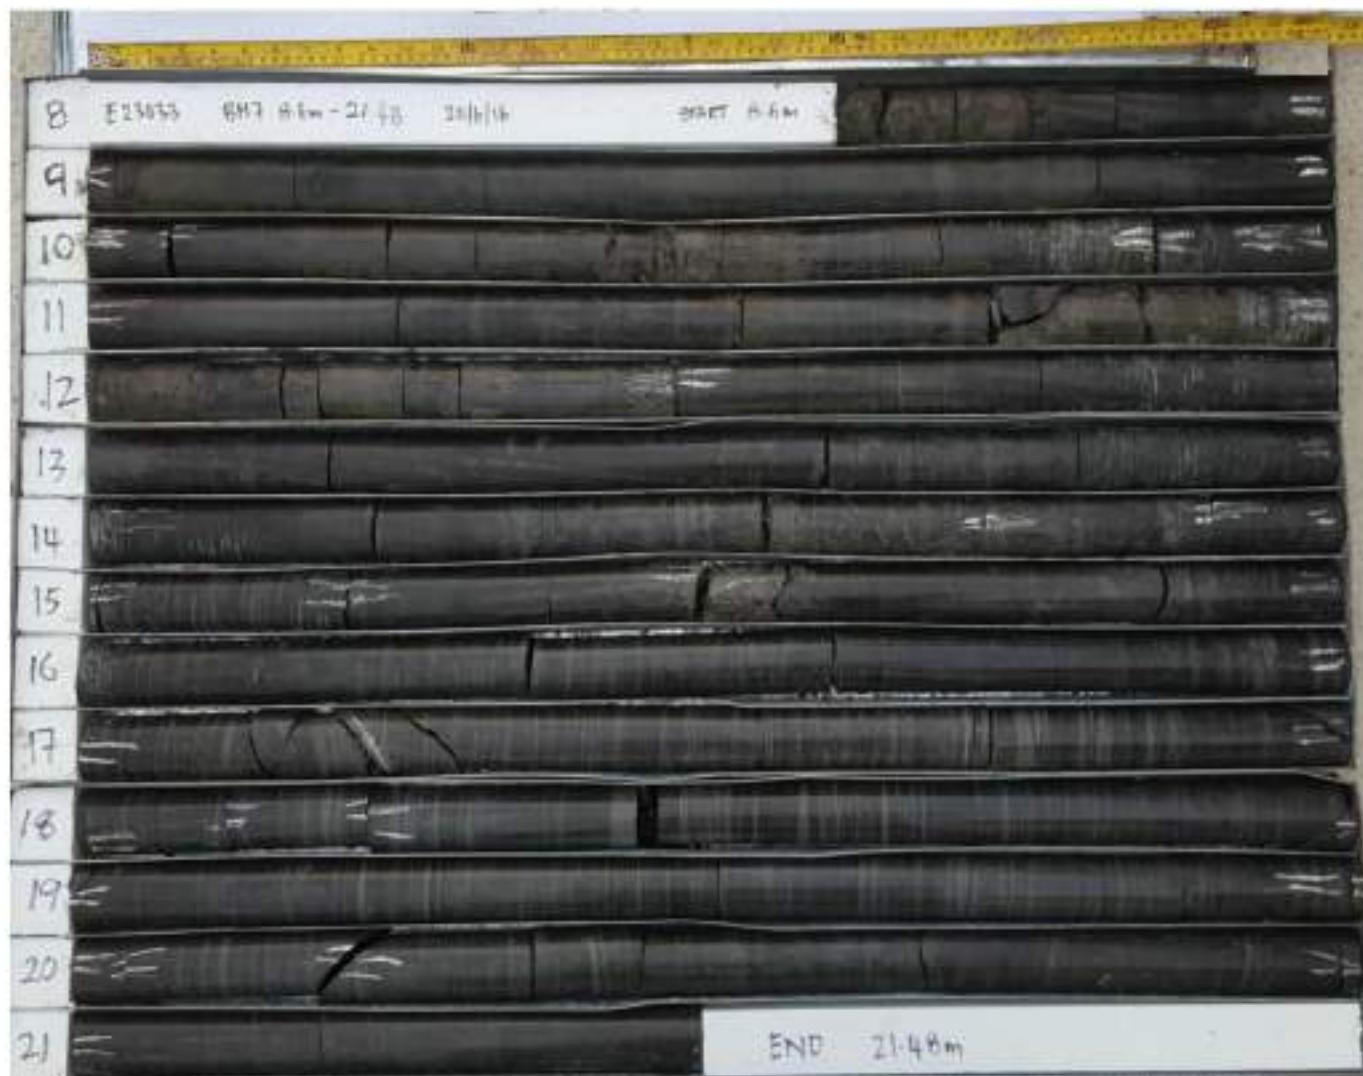
East: 313618.1 m
North: 6257466.4 m MGA94 Zone 56
Surface RL:
Inclination: -80°
Box: 1-3 of 3
Hole Depth: 21.48 m

Depth Range: 8.60 m to 21.48 m
Contractor: BG Drilling Pty Ltd
Drill Rig: Hanjin DB8
LOGGED: VL DATE: 20/6/16
CHECKED: SK DATE: 1/7/16

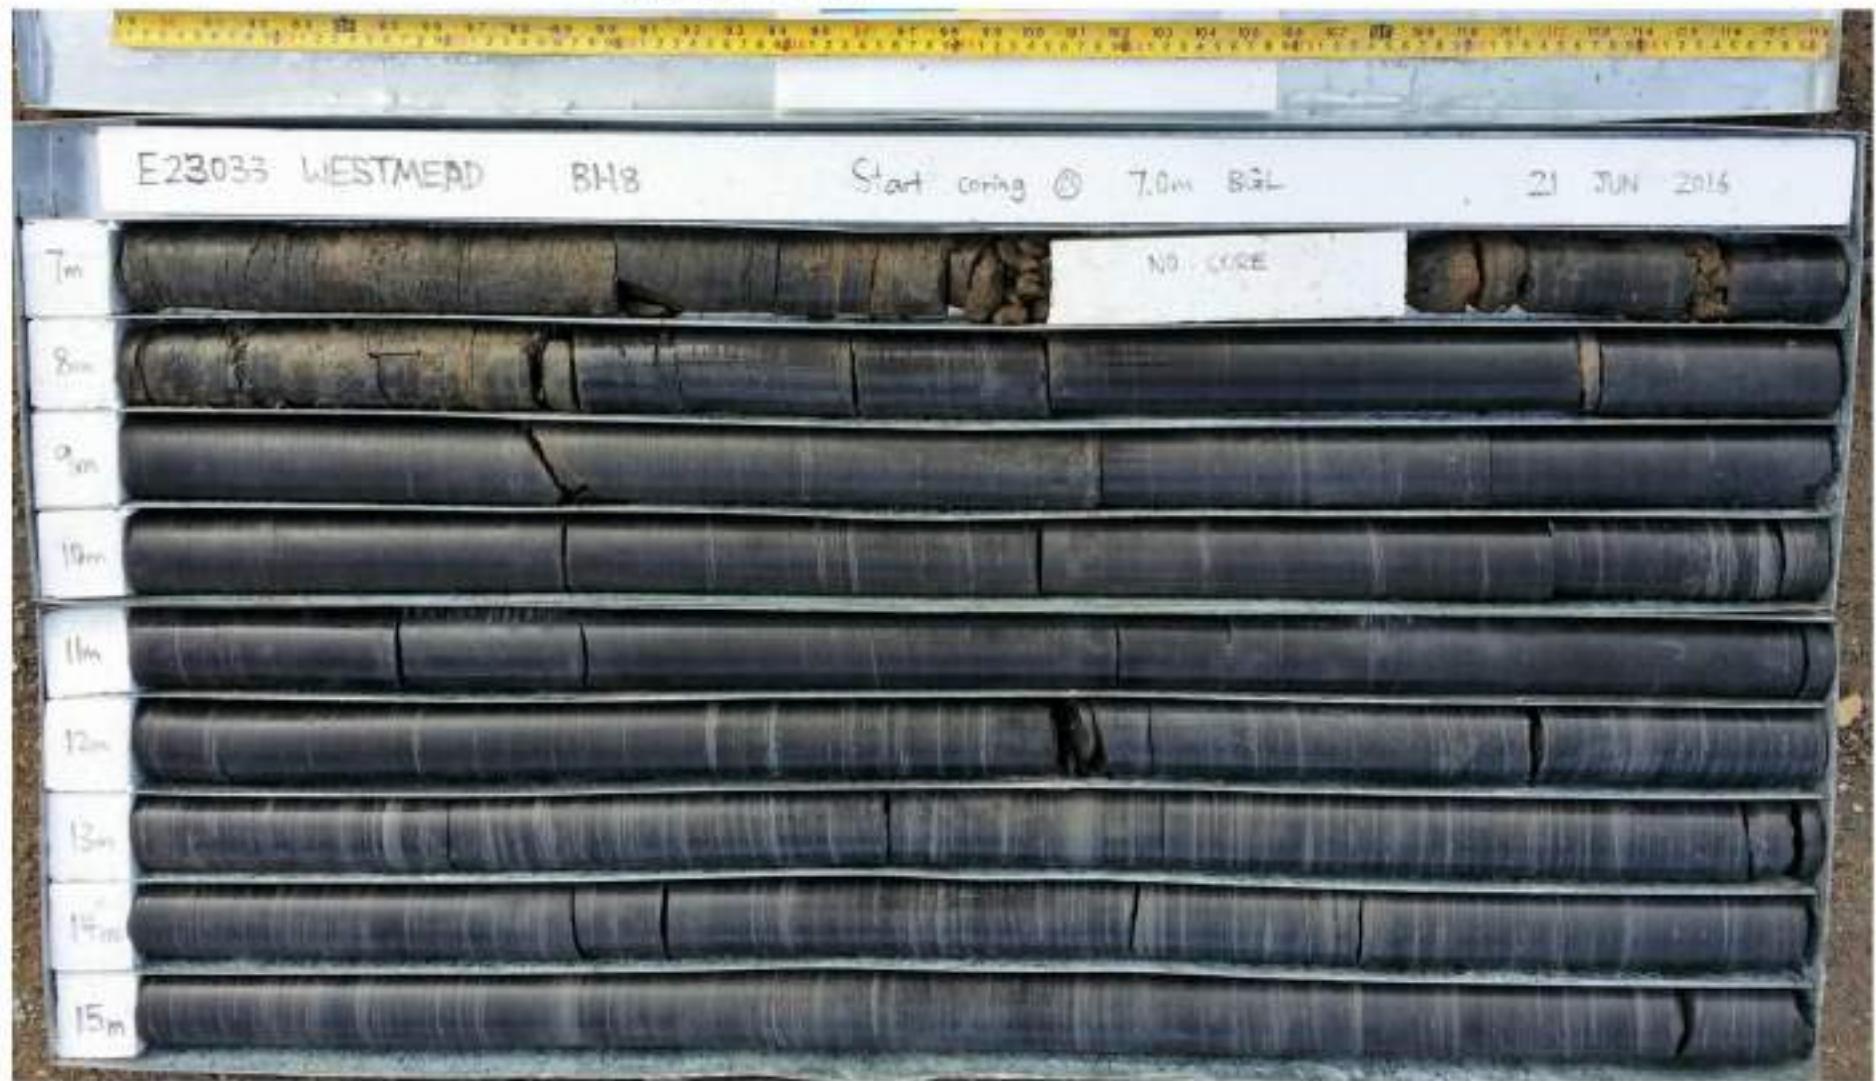
East: 313806.6 m
North: 6257536.4 m MGA94 Zone 56
Surface RL: 30.30 m AHD
Inclination: -80°
Box: 1-2 of 4
Hole Depth: 23.63 m

Depth Range: 7.00 m to 16.00 m
Contractor: Rockwell Drilling Pty Ltd
Drill Rig: Hanjin DB8
LOGGED: JZ DATE: 21/6/16
CHECKED: SK DATE: 1/7/16

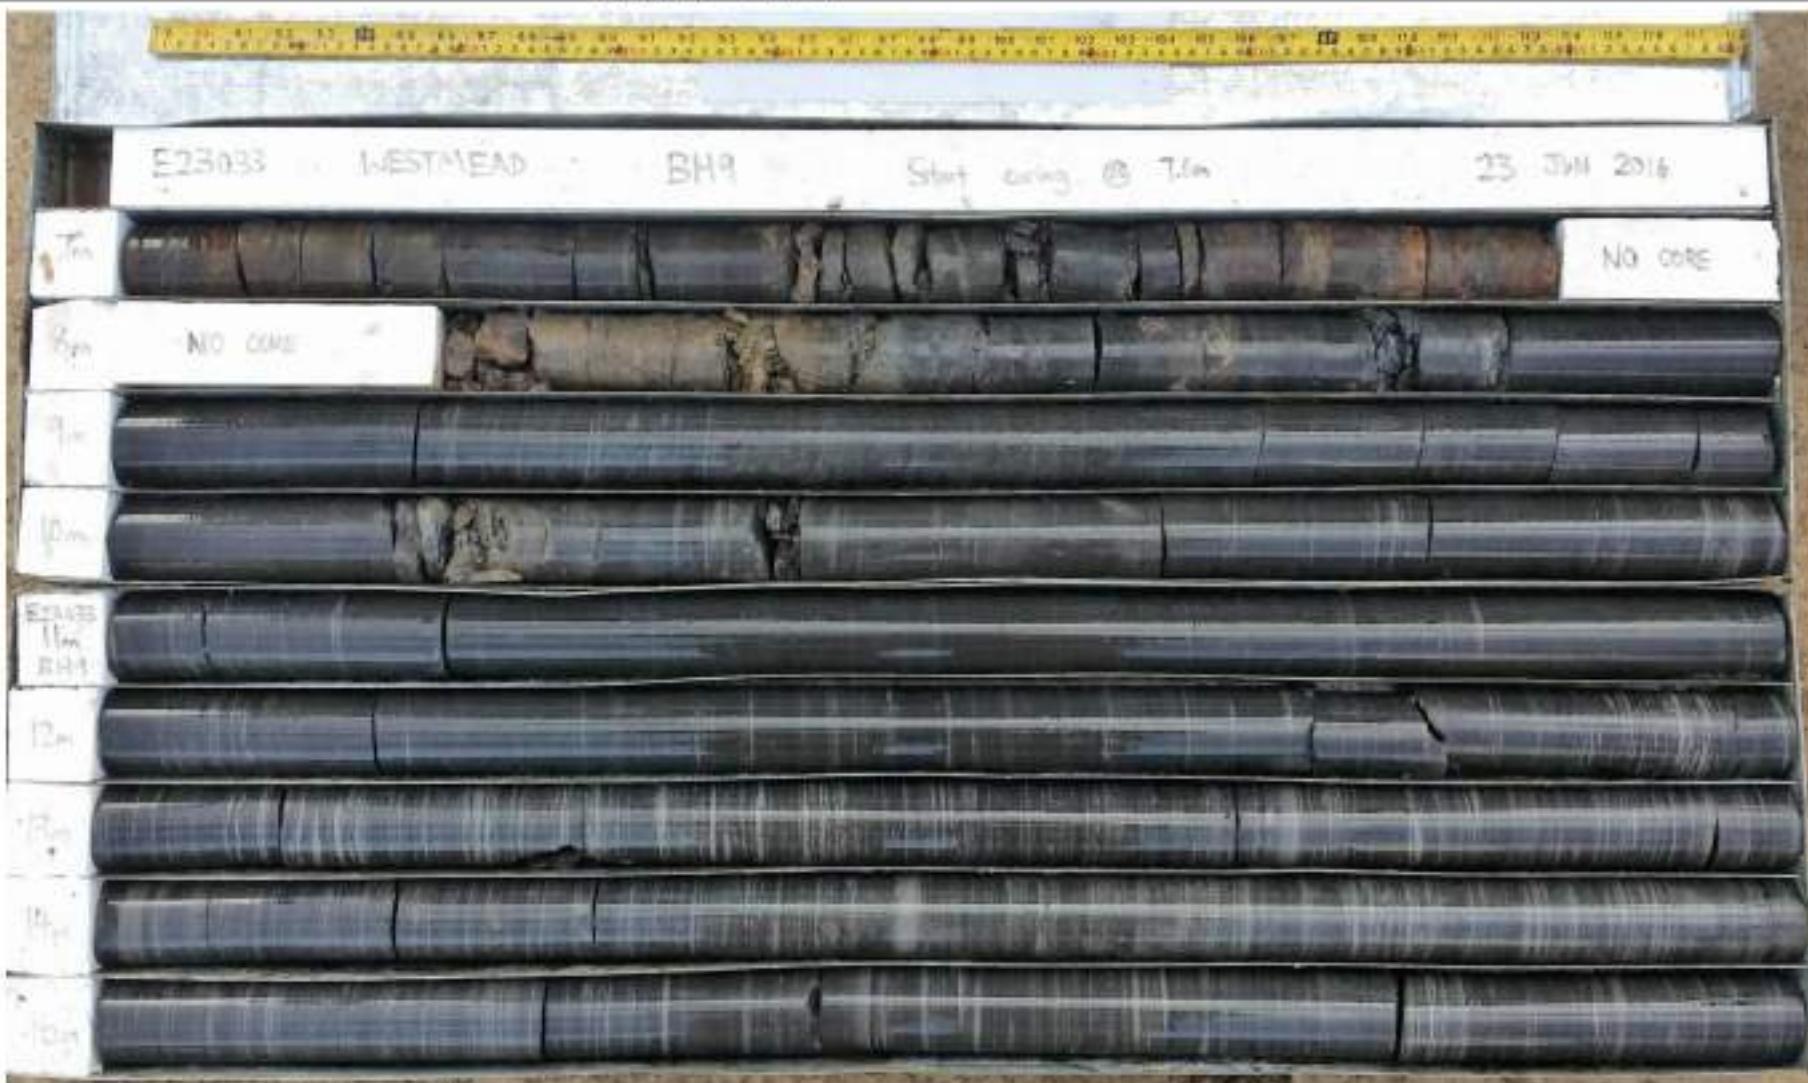
CORE PHOTOGRAPH OF BOREHOLE: BH9

Depth Range: 7.00 m to 16.00 m
Contractor: Rockwell Drilling Pty Ltd
Drill Rig: Hanjin DB8
LOGGED: JZ DATE: 23/6/16
CHECKED: SK DATE: 1/7/16

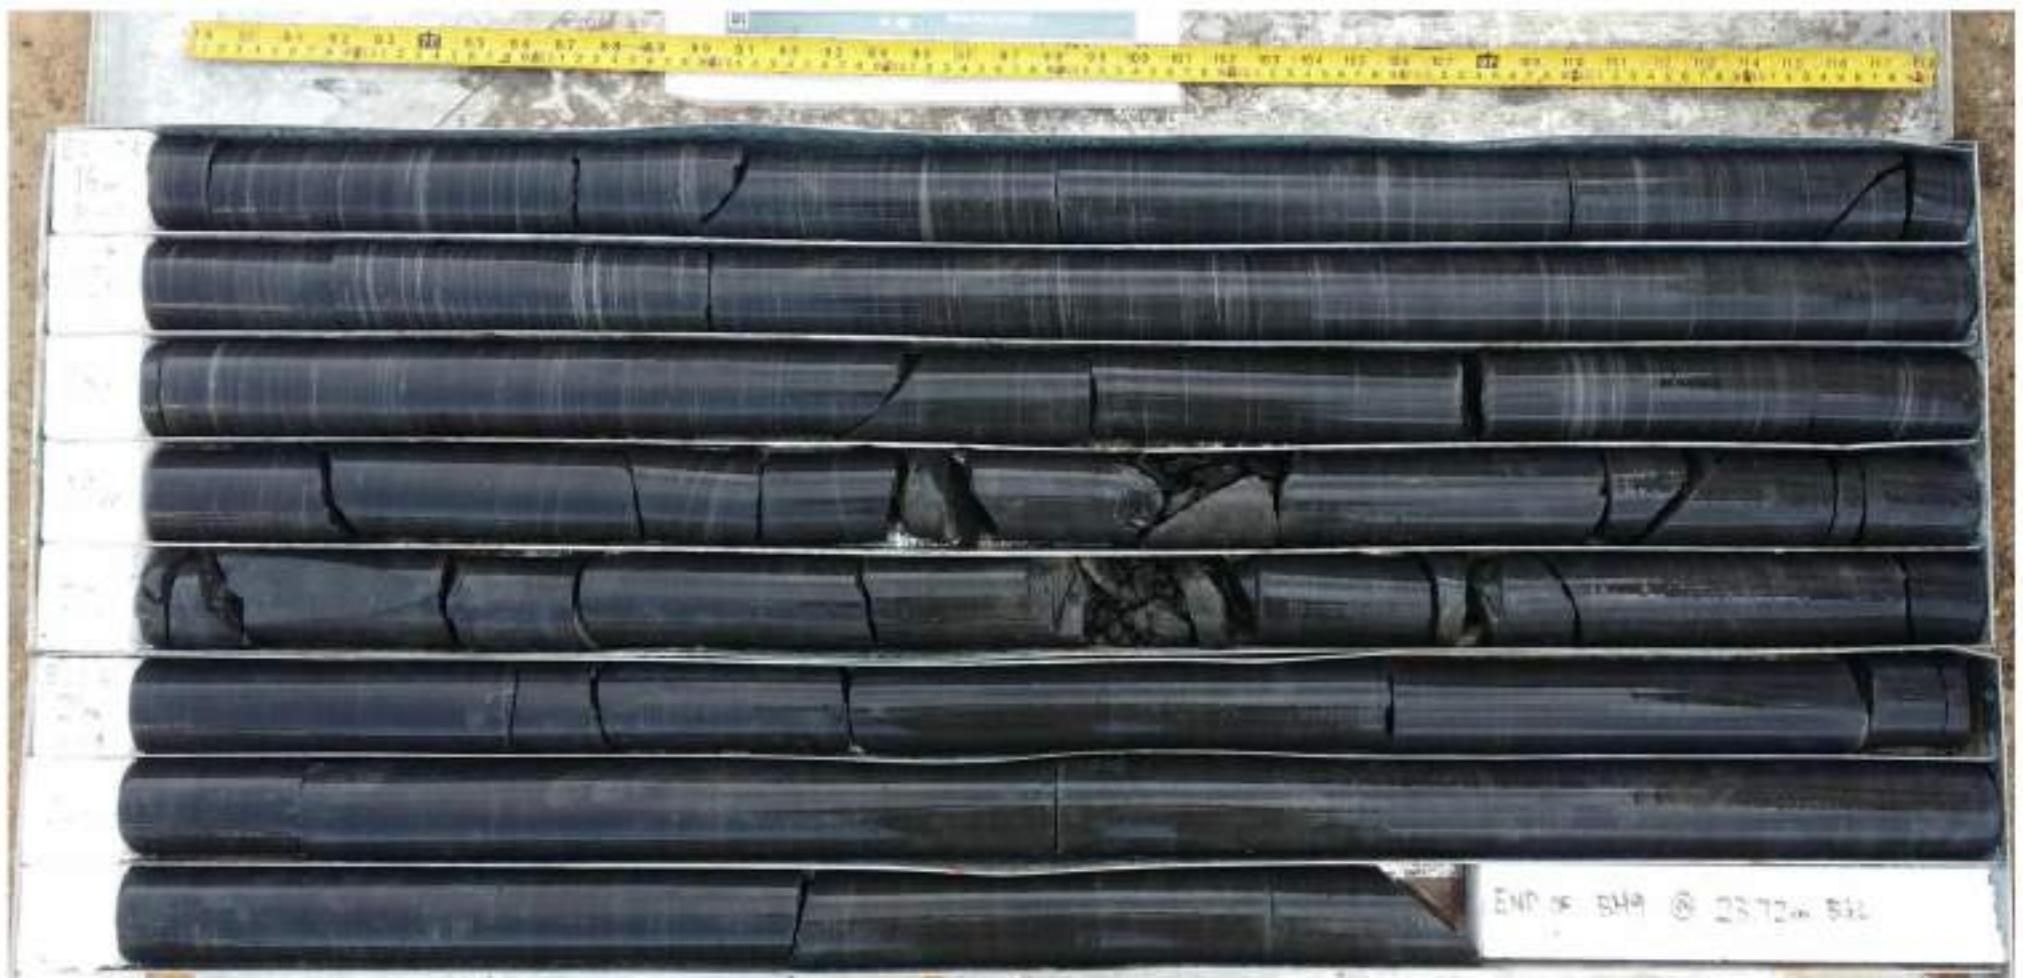
CORE PHOTOGRAPH OF BOREHOLE: BH9

East: 313631.9 m
North: 6257472.4 m MGA94 Zone 56
Surface RL: 30.30 m AHD
Inclination: -80°
Box: 3-4 of 4
Hole Depth: 23.72 m

Depth Range: 16.00 m to 23.72 m
Contractor: Rockwell Drilling Pty Ltd
Drill Rig: Hanjin DB8
LOGGED: JZ DATE: 23/6/16
CHECKED: SK DATE: 1/7/16
