Site Audit Report

0503-1609

Lot 4 in Proposed Sub division PPN DP 1202362  
Western Sydney University  
Cnr Hawkesbury and Darcy Roads, Westmead NSW

6 October 2016

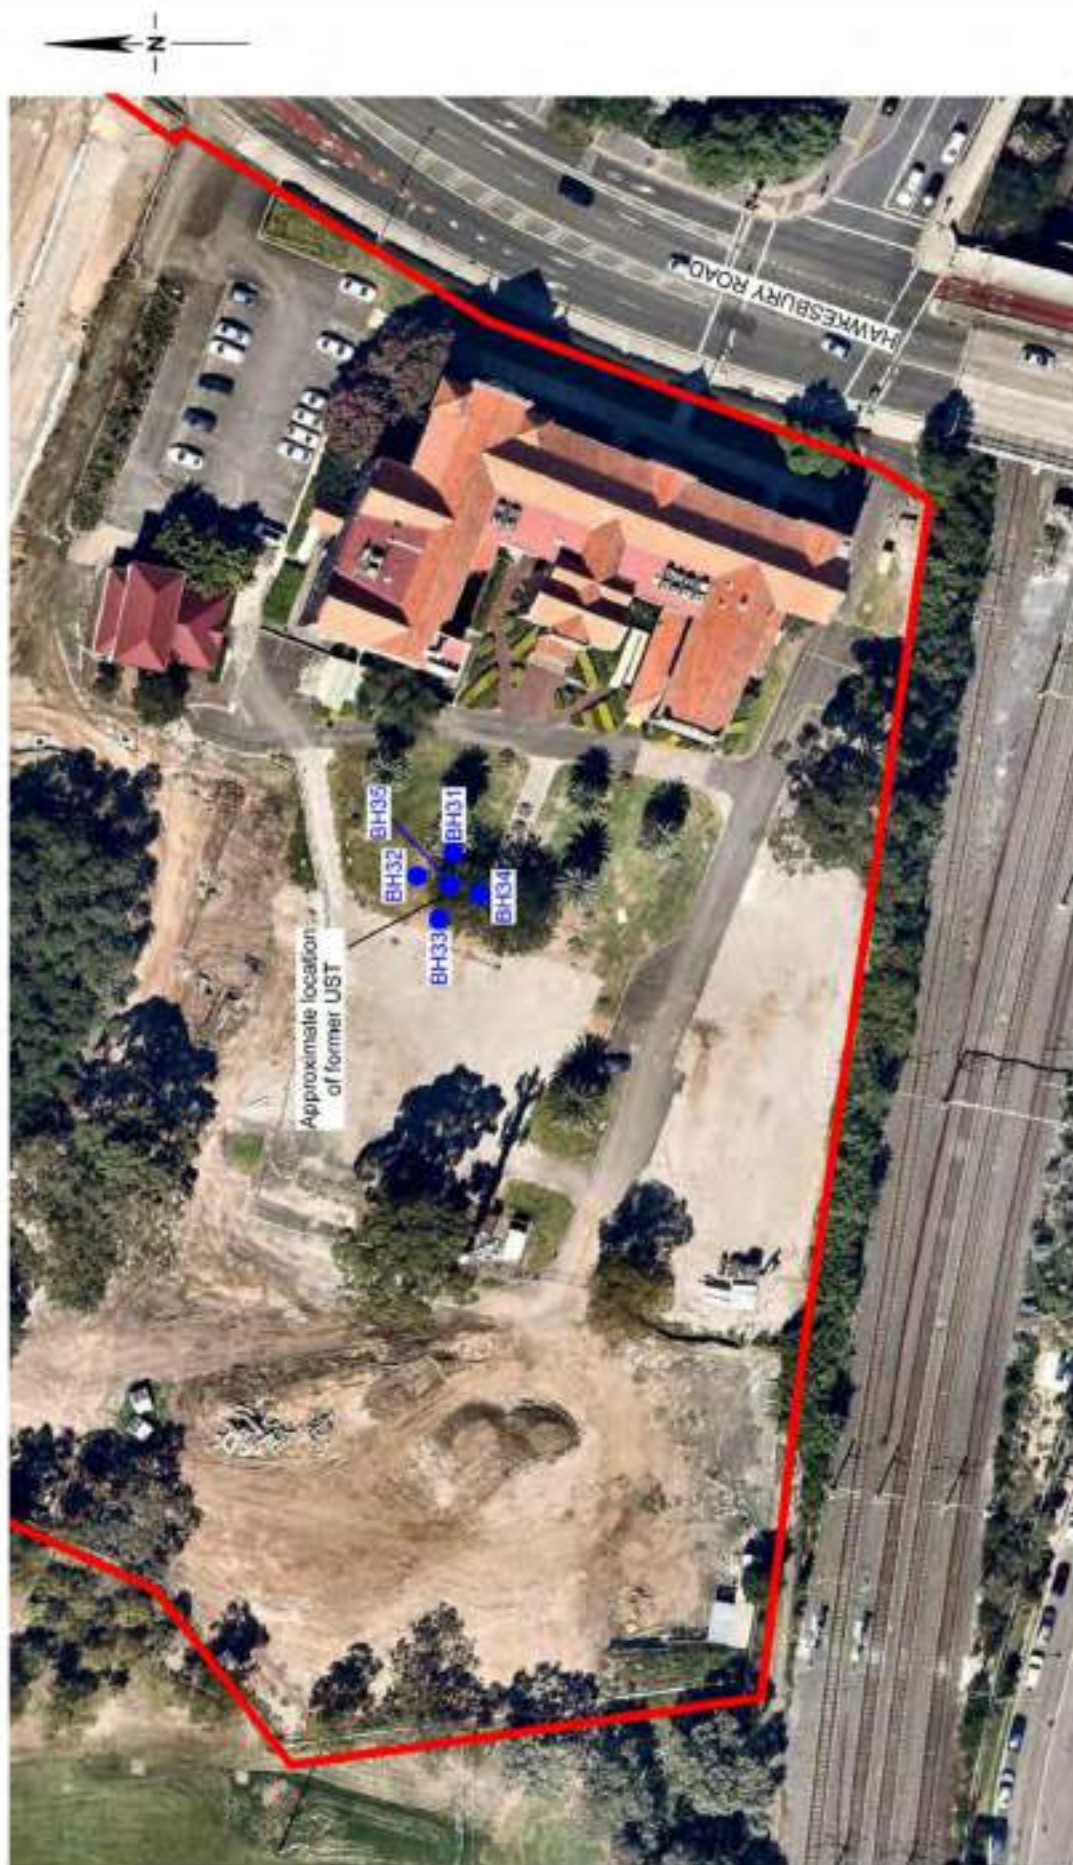
<p><b>PO Box 880</b>  <b>Perth NSW 2750</b>  <b>Tel: 02 4722 2700</b>  <b>Fax: 02 4722 2777</b>  <b>e-mail: info@geotech.com.au</b>  <b>www.geotech.com.au</b></p>	<p><b>NOTES</b></p> <ol style="list-style-type: none"> <li>1. Site features are indicative and are not to scale.</li> <li>2. This drawing has been produced using a base plan provided by others to which additional information e.g test pits, borehole locations or notes have been added. Some or all of the plan may not be relevant at the time of producing this drawing.</li> </ol>	<p><b>WSU Westmead Campus Redevelopment</b>  <b>chr Darcy &amp; Hawkesbury Roads</b>  <b>Westmead</b></p>	<p>Drawing No: 12619/3-AA5          Job No: 12619/3          Drawn By: MH          Date: 23 March 2016          Checked By: AB          File No: 12619-3          Layers: 0, AA5</p>
<p><b>GEOTECHNIQUE</b>  <b>PTY LTD</b></p>		<p><b>Borehole Locations</b></p>

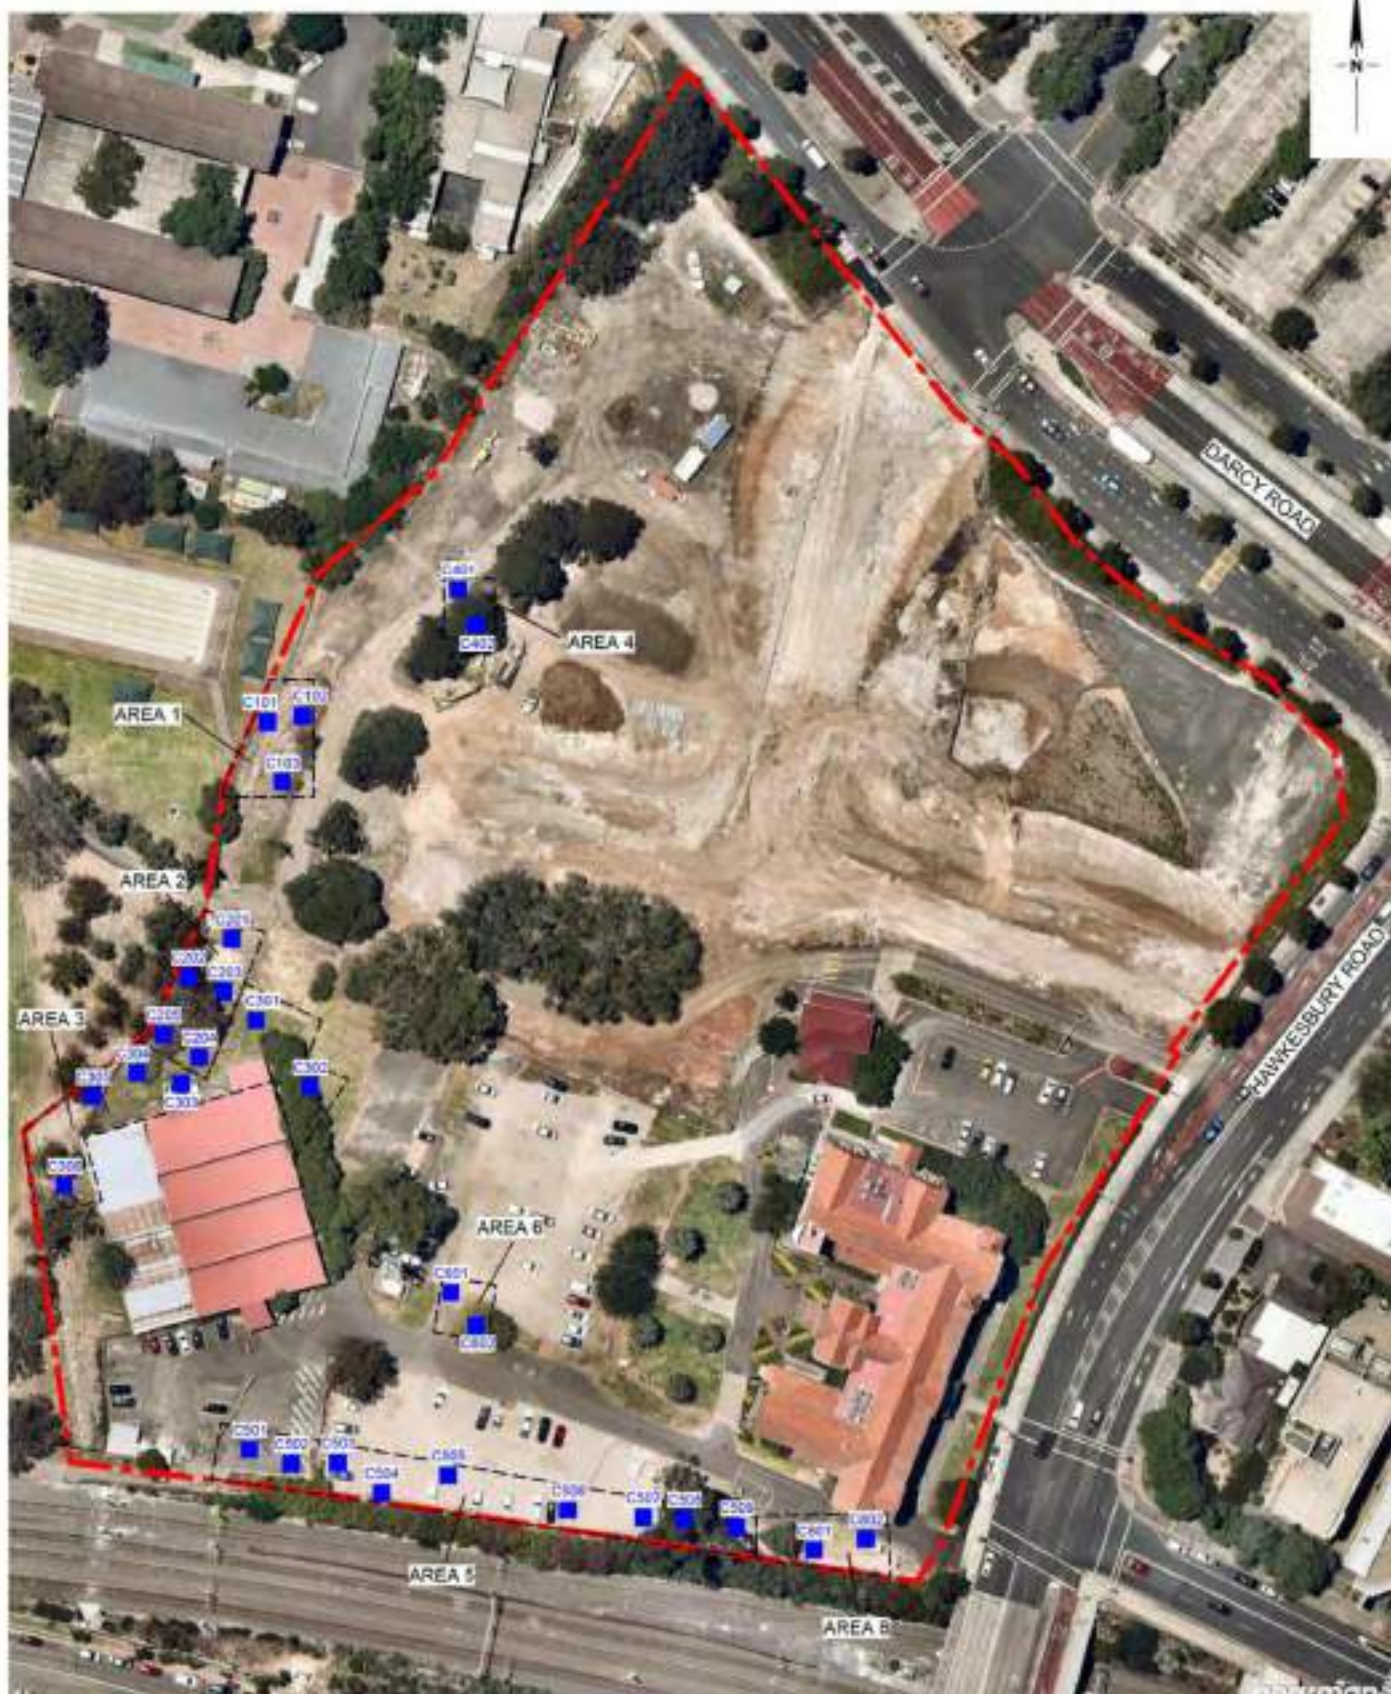
<p>APP Corporation Pty Ltd UWS Westmead Campus Redevelopment cnr Darcy &amp; Hawkesbury Roads Westmead</p>	<p>Drawing No: 12619/3-AA2 Job No: 12619/3 Drawn By: MH Date: 19 February 2016 Checked By: AB</p>	<p>Validation Sample Locations in Areas 2 &amp; 3</p>	<p>NOTES</p> <ol style="list-style-type: none"> <li>1. Site features are indicative and are not to scale.</li> <li>2. This drawing has been produced using a base plan provided by others to which additional information e.g test pits, borehole locations or notes have been added. Some or all of the plan may not be relevant at the time of producing this drawing.</li> </ol>
<p>PO Box 880 Perrith NSW 2750 Tel: 02 4722 2700 Fax: 02 4722 2777 e-mail: info@geotech.com.au www.geotech.com.au</p>	<p>GEOTECHNIQUE® PTY LTD</p>	<p>APP Corporation Pty Ltd UWS Westmead Campus Redevelopment cnr Darcy &amp; Hawkesbury Roads Westmead</p>	<p>File No: 12619-3 Layers: 0, AA2</p>
