PRELIMINARY SITE INVESTIGATION

BBC DEVELOPMENTS PTY LTD

2 Mark Street & 1-3 Marsden Street, Lidcombe, New South Wales

Report No: 17/0492

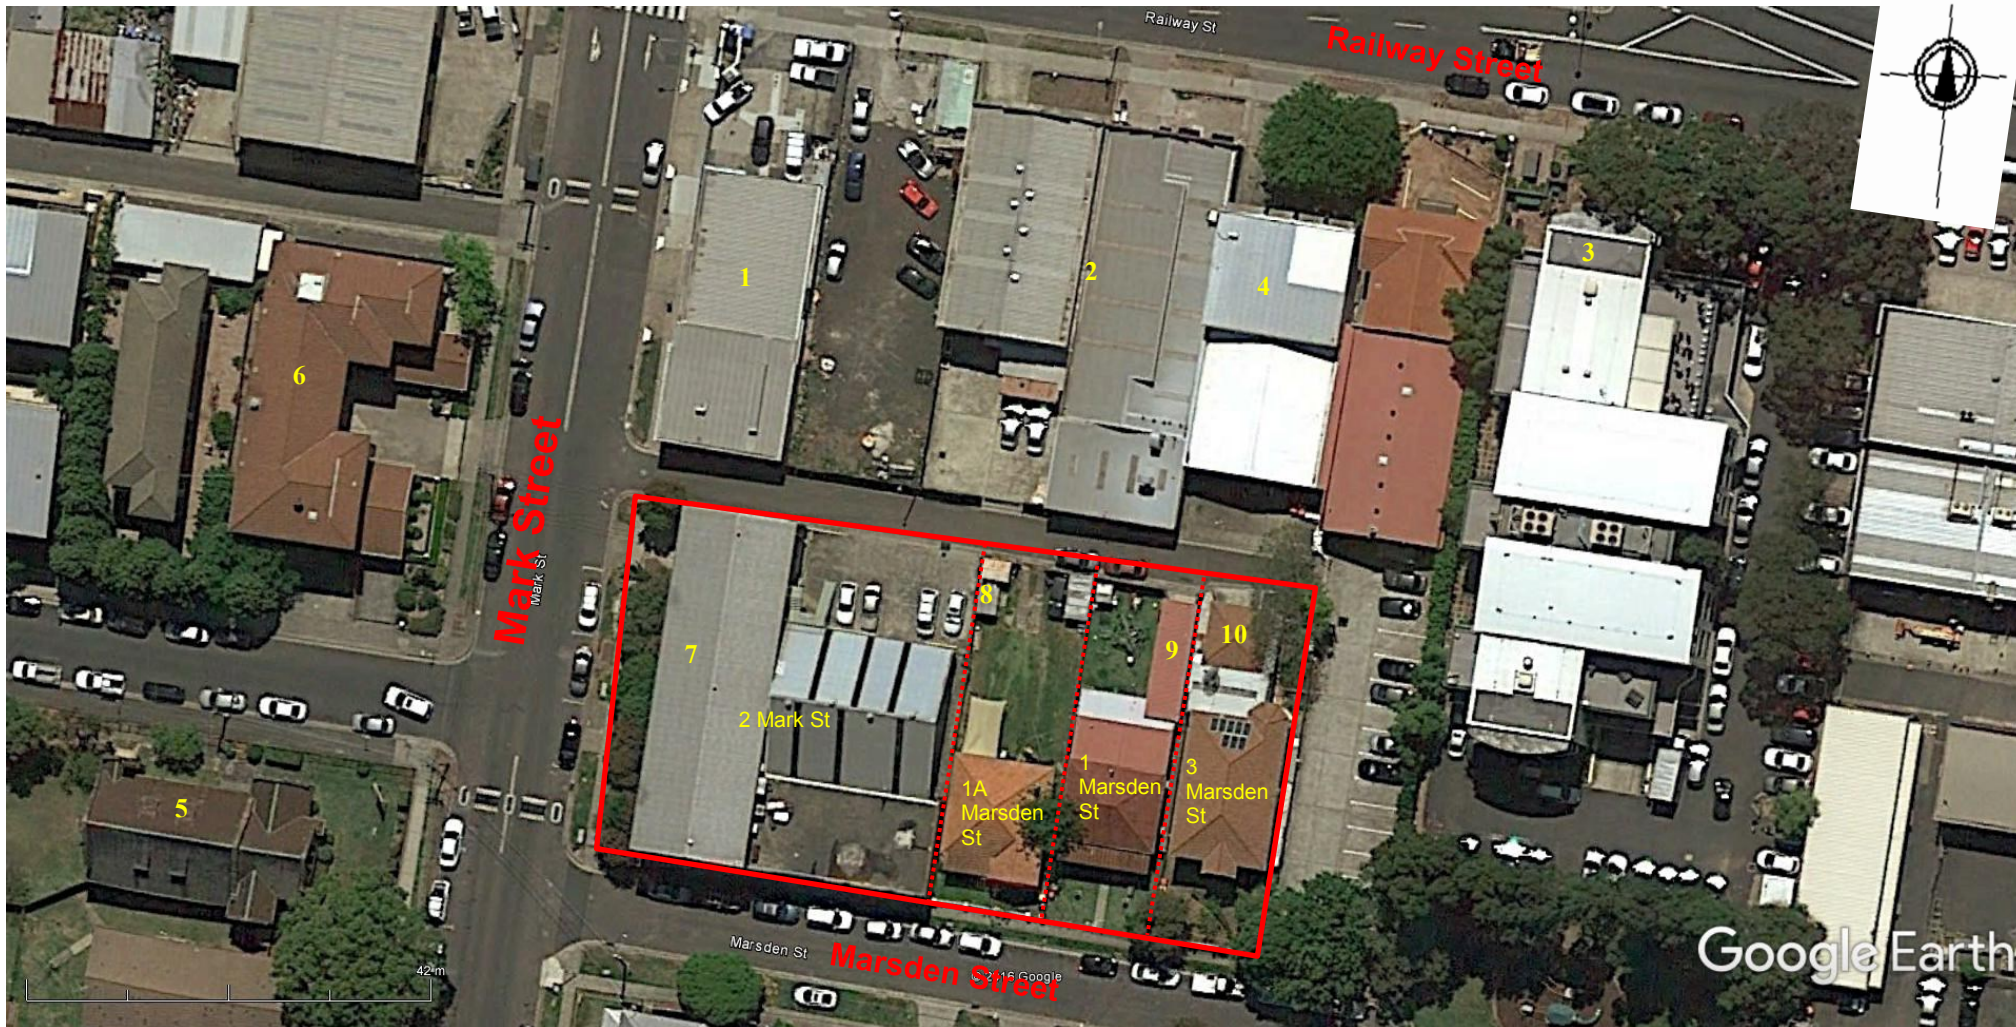
Drawing No: 17/0492/2

The site was inspected on 27 February 2017 to confirm the condition of the land, and to identify potential contamination sources. A plan showing the current site configuration is shown on Drawing No. 17/0492/2. The key site features as determined by the site inspection are:

- The site comprises rectangular-shaped parcel of land which combines one commercial and three residential allotments on the eastern side of Mark Street. The site is bounded by Mark Street to the west, Marsden Street to the south, a carpark area and the Chinese Elderly Welfare Association building to the east and commercial/industrial blocks of land to the north, including a service station (Metro), a furniture warehouse (Emons Furniture) and a joinery (ADL Kitchens and Joinery);
- The site has a westerly to southerly slope, falling approximately 1 to 2 metres across the length and width of the site; and
- Surface soils across the site were visually observed to comprise light brown silty clays with a low to moderate plasticity.

- 1 - Metro Service Station
- 2 - Emons Furniture
- 3 - CFMEU Construction
- 4 - ADL Kitchen and Joinery
- 5 - St Stephen's Anglican Church
- 6 - Lidcombe Motor Inn
- 7 - Brick Factory Building
- 8 - Metal Sheds
- 9 - Garage with Metal Roof
- 10 - Brick Garage

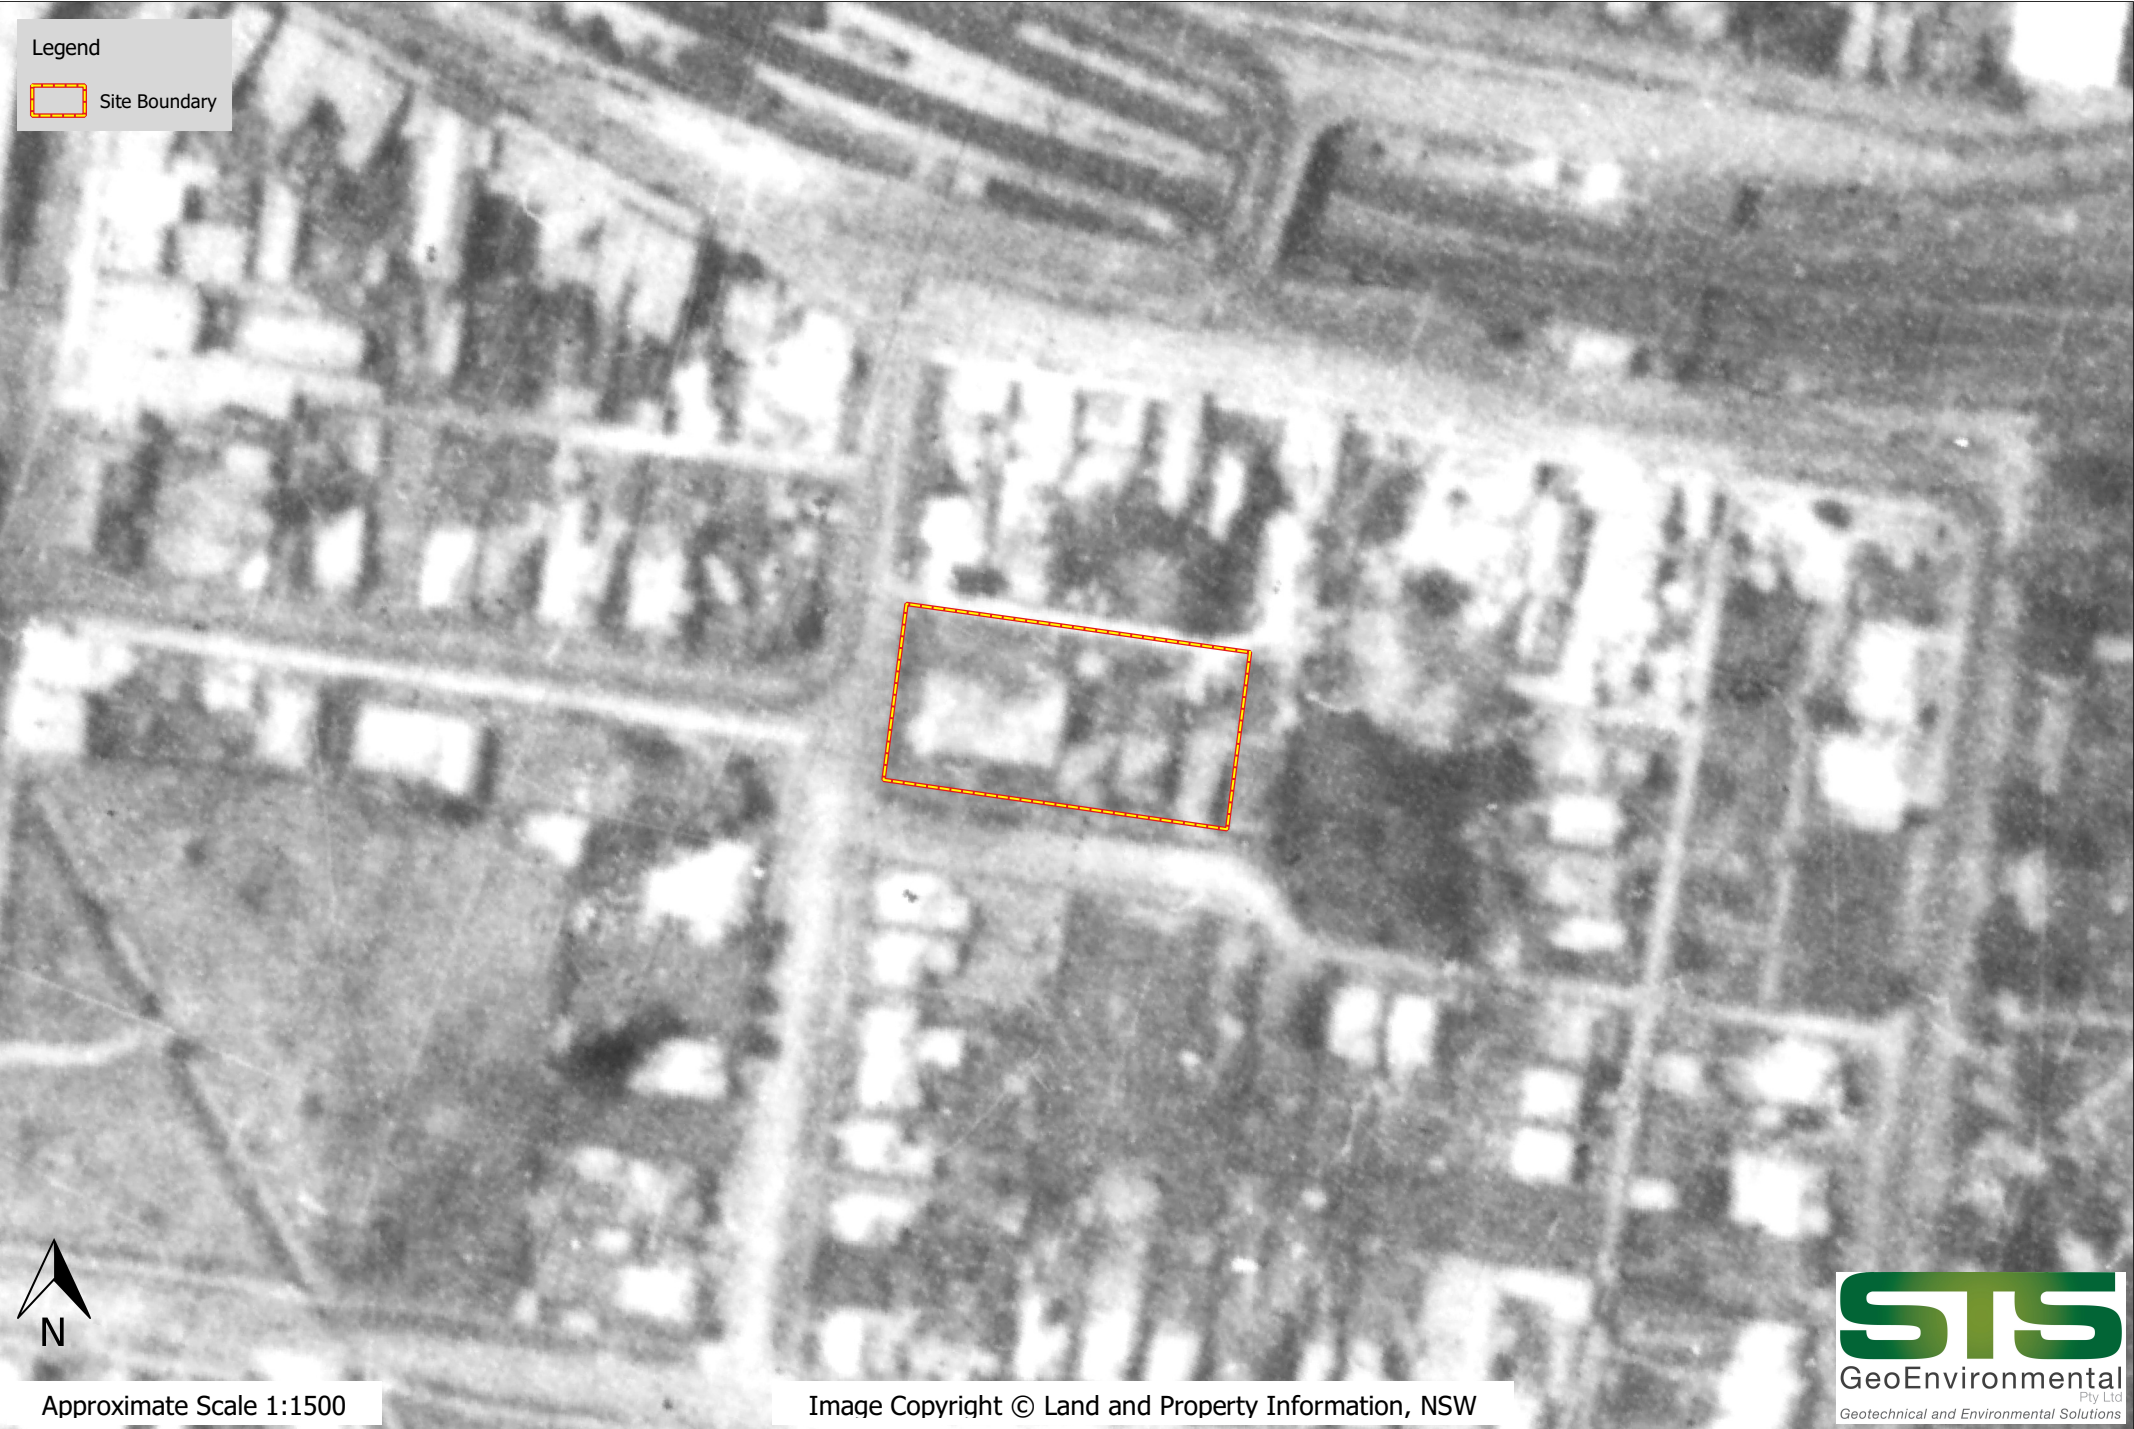
1930 Aerial Photograph Showing the Site and Surrounds

Year	Site Features	Surrounding Land Use
1930	The site contains three free standing residential buildings adjacent to Marsden Street and a large warehouse/factory building located in the allotment at 2 Mark Street. The resolution of the aerial photograph is poor.	The land surrounding the site is also residential land with some areas of open and seemingly unused land to the west and east of the site.
1956	Rear yard sheds and garages have been constructed in the three residential allotments, covering large portions of the backyard areas in 1A, 1 and 3 Marsden Street.	The land surrounding the site has continued to be developed for a low density residential land use to the west and south and a commercial/industrial land use to the north of the site. with previously empty allotments to the south of the site having been filled by low density residential houses.
1965	The site features are essentially unchanged, although the backyard at 3 Marsden Street appears to have had a wall-type structure removed.	The surrounding land is largely unchanged, although warehouse constructions have taken place north of the site. A service station has been constructed about 30 m north of the site.

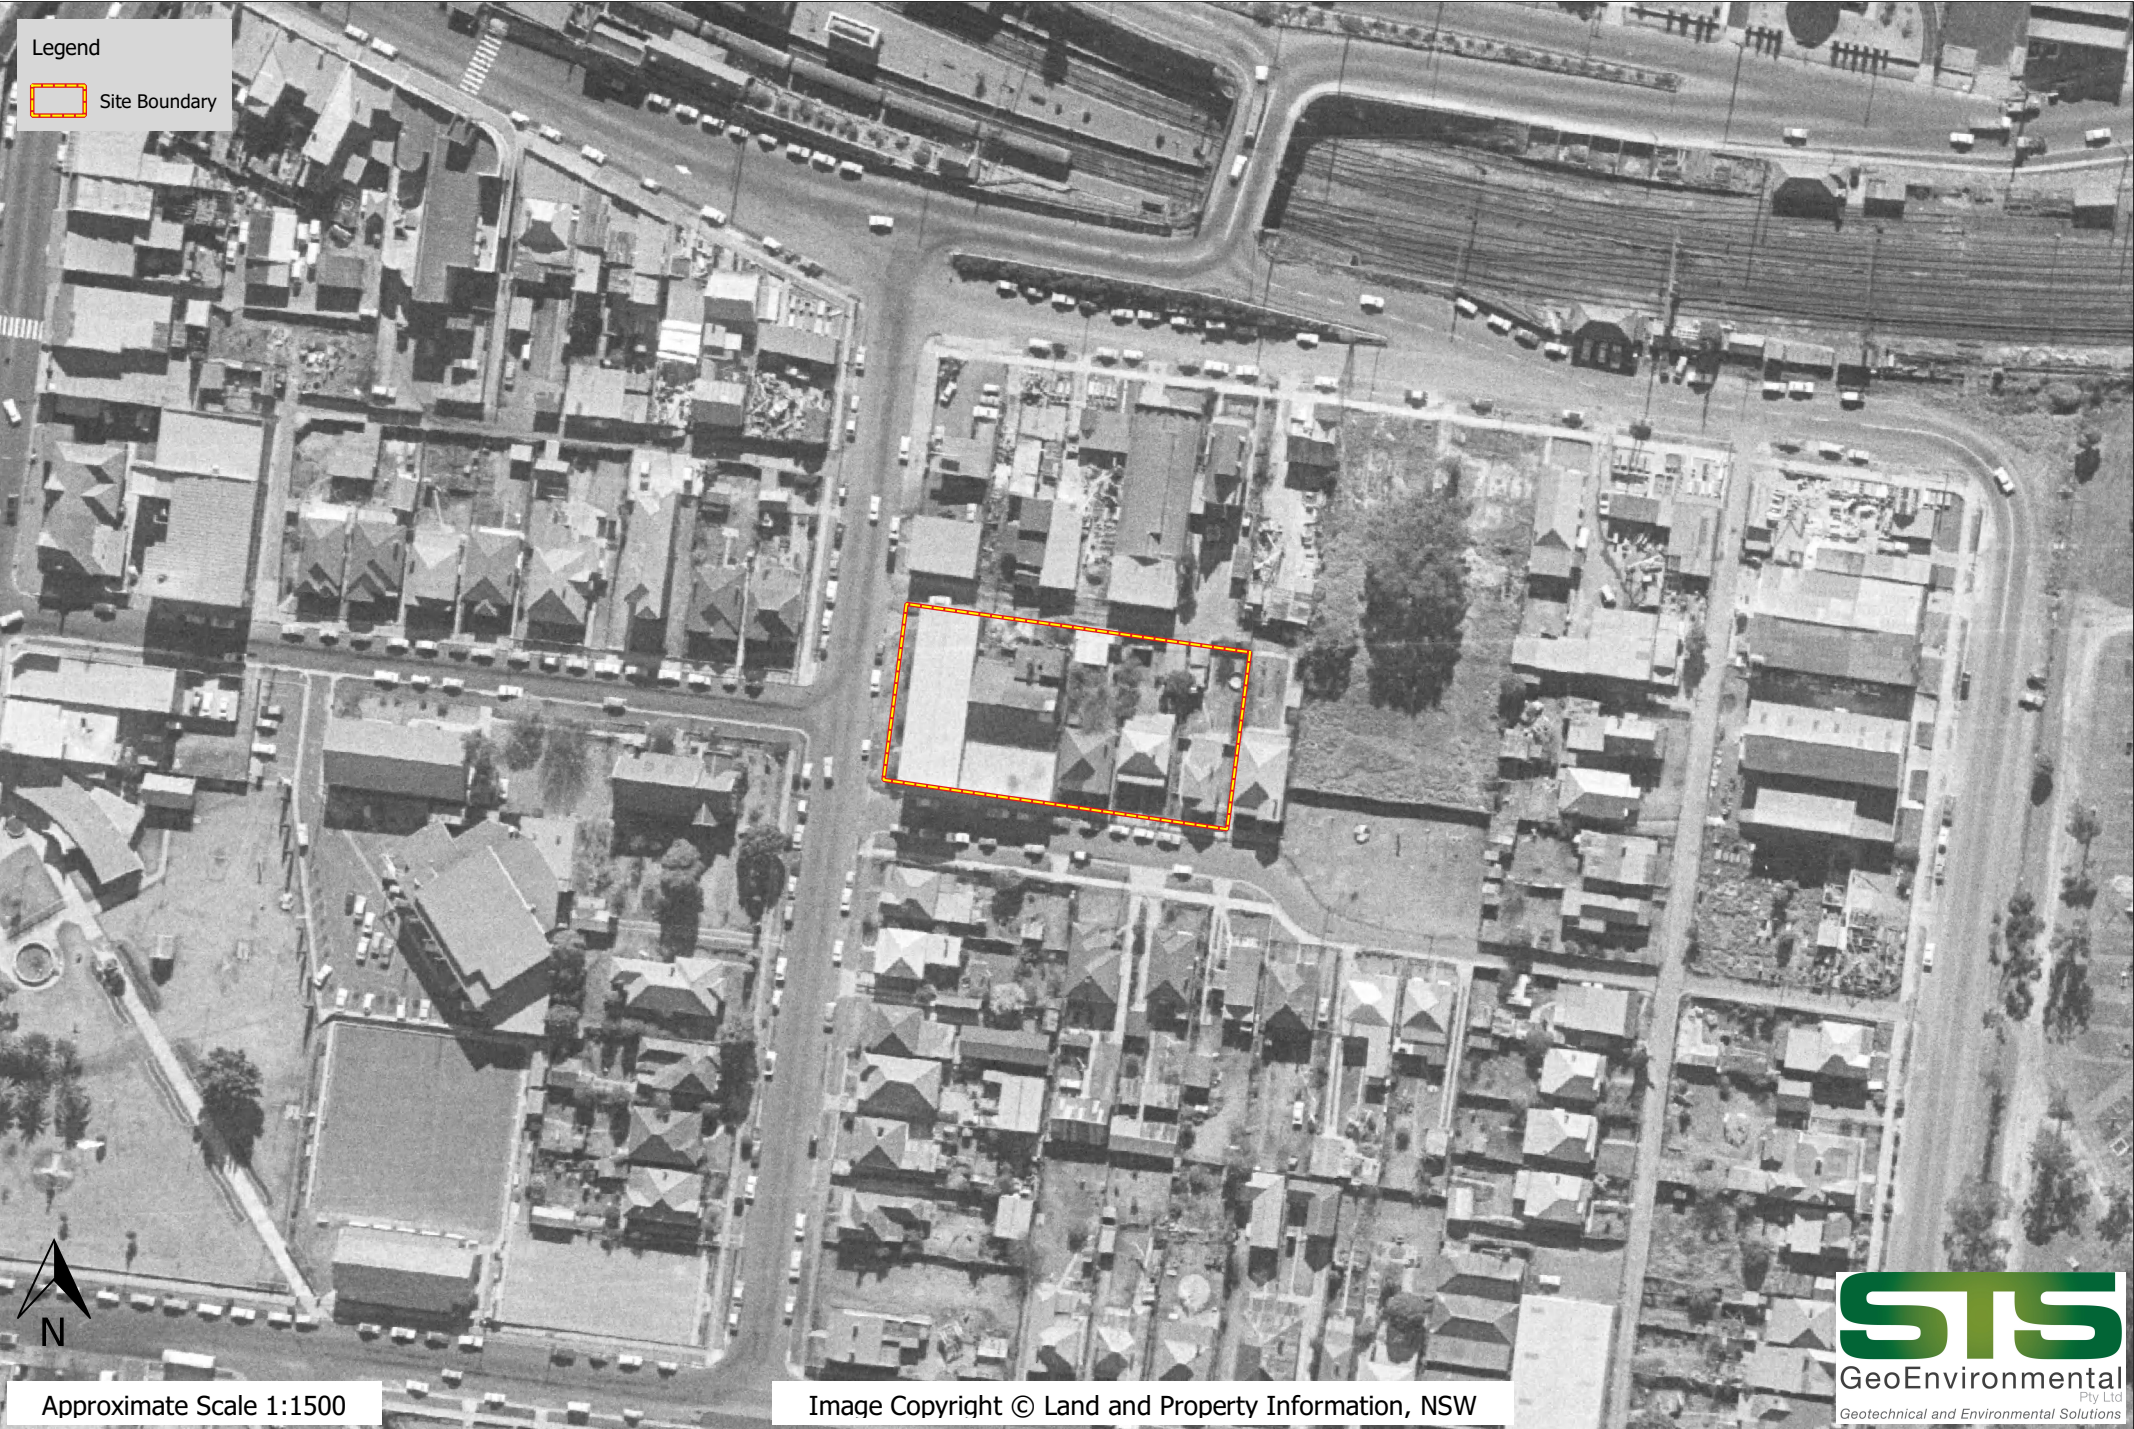
1970 Aerial Photograph Showing the Site and Surrounds

1970	A large warehouse has been constructed in the allotment at 2 Mark Street. The site features of the three residential allotments are essentially unchanged.	The land use surrounding the site is largely unchanged.
1986	The site features are essentially unchanged.	The land use surrounding the site is largely unchanged. Further commercial warehouse constructions have taken place about 30 m north-east of the site and about 100 m east of the site.
1994	The site features are essentially unchanged. A garage has been constructed in the north-eastern portion of the allotment at 1 Marsden Street.	The land use surrounding the site is largely unchanged.
2005	A shed in the northern portion of 1A Marsden Street has been removed. A larger garage has been constructed in the north-eastern portion of 1 Marsden Street and a new residential building has been constructed at 3 Marsden Street.	Several large high density apartment buildings have been constructed to the east, north-east and south of the site. Further building demolitions have been undertaken to the south-east of the site for construction of high density residential buildings.
