Citation: Biosis (2016). Yarrabilly Estate Retirement Village Stage 1 subdivision: Aboriginal cultural heritage due diligence assessment. Report for Fraish Consulting. Authors: R. Morris, S. Keats, M. Smith Biosis Pty Ltd, Sydney. Project no. 23961

Biosis Pty Ltd was commissioned by Fraish Consulting to undertake an Aboriginal cultural heritage due diligence assessment for the proposed subdivision of 10 hectares of Lot 4 DP1092182 for Stage 1 of the Yarrabilly Estate Retirement Village, Cowra NSW. The assessment focused on a review of background resources including soil landscapes, geology, hydrology and past reports and site records to inform predictive statements about the likelihood of Aboriginal heritages sites to occur within the study area.

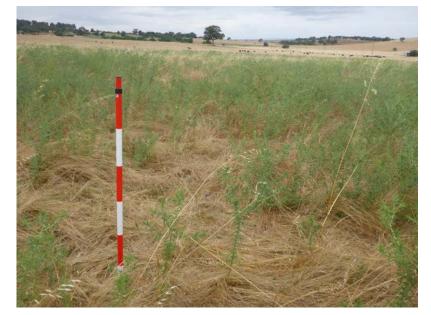
Plate 3 Dense vegetation in the central portion of the study area, view north, 1 metre scale

ground vegetation cover throughout the majority of the study area, which severely limited the potential for the identification of surface artefacts (Plate 3 and Plate 4).

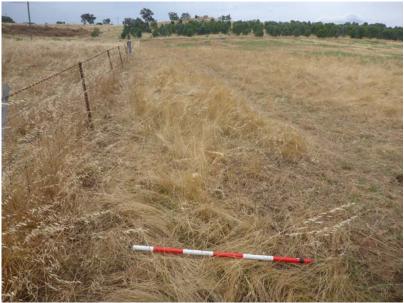
Plate 4 Grass cover along fenceline in the central portion of the study area, view west, 1 metre scale

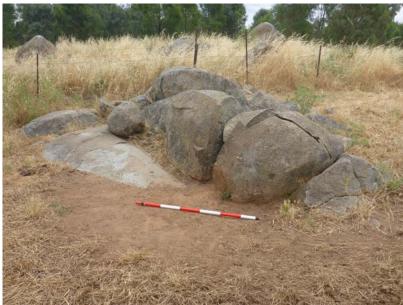
Plate 6 Area of exposure around a granite outcropping on the western edge of the study area, view west, 1 metre scale

Exposure refers to the geomorphic conditions of the local landform being surveyed, and attempts to describe the relationship between those conditions and the likelihood the prevailing conditions provide for the exposure of (buried) archaeological materials. Whilst also usually expressed as a percentage estimate, exposure is different to visibility in that it is in part a summation of geomorphic processes, rather than a simple observation of the ground surface (Burke and Smith 2004: 79, NSW NPWS 1997: Appendix 4). Overall, the study area displayed very few areas of exposure excepting around the base of granite outcroppings and trees, along fencelines and on the south western crest (Plate 6 and Plate 7).

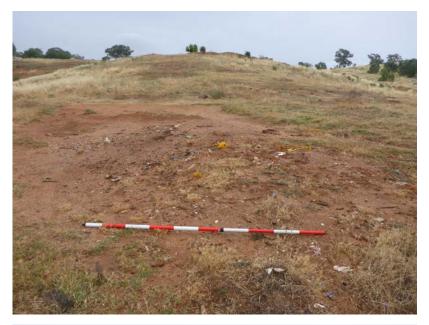
Plate 7 Area of disturbance in the south west corner of the study area, view west, 2 metre scale

The study area is contained within four broad landform units, all of which were assessed as a part of the survey. The central, northern and eastern portions of the study area are comprised of a basic slope landform sloping downwards to the east (Plate 9). This is associated with the most prominent ridgeline in the Cowra locality directly to the west of the study area, providing an excellent outlook east over the region. The eastern edge of this crest extends between 10 and 20 metres into the western portion of the study area (Plate 6 and Plate 10). While the crest has been subject to some disturbance from initial vegetation clearing and subsequent fence construction, it has been assessed as holding archaeological potential. This is due to its location on the periphery of the ridge landform in which large numbers of scarred trees and artefact sites have previously been recorded. Both this area of potential and previously identified sites outside the study area are shown in Figure 4. Where a spur of this ridgeline extends into the south western corner of the study area it has been subject to extensive subsurface disturbance from human agents and was therefore assessed as possessing no archaeological potential (Plate 7).

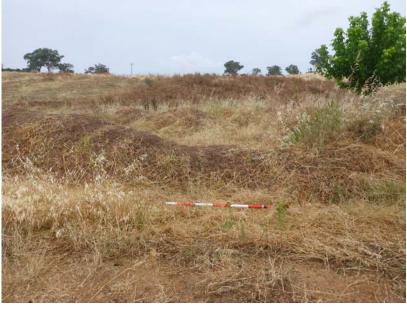
Plate 8 Earthworks and the dumping of waste from vegetation clearing on crest in the south west corner of the study area, view west, 1 metre scale

and wallabies, livestock movement and sometimes exposures from slumping or scouring. Disturbances associated with recent human action occur throughout the study area but are focused in its the south western corner. Human agents include farming practices, such as initial vegetation clearance for the creation of paddocks, fencing and stock grazing; and rubbish dumping. The majority of the study area has been subject to extensive clearing for animal grazing and continues to be used for this purpose today. A crest in the south eastern corner of the study area has been subject to extensive disturbance, with its slopes cleared to the clay subsoil. This has created exposures up to 10 metres across which appear to have been affected by slopewash (Plate 7). The peak of the crest has been used for the stockpiling of soils and waste from vegetation clearing and large amounts of rubbish, including plastic, glass, textiles and household appliances were visible both within these exposures and buried within the soil (Plate 8).

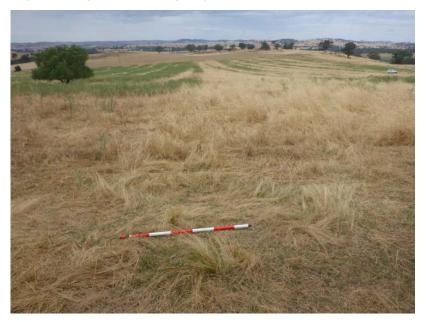
Plate 9 Basic slope landform within the study area, view east, 1 metre scale

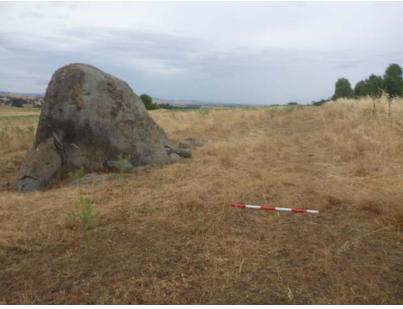
Plate 10 Edge of crest landform along the western edge of the study area, view south, 1 metre scale

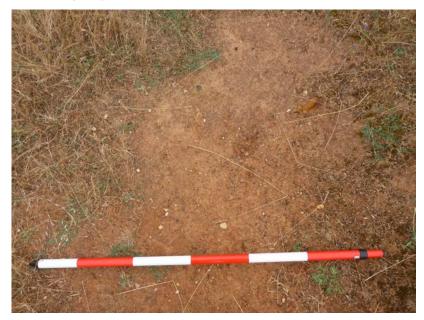
Plate 11 Area of exposure within drainage depression, view south, 1 metre scale

During the survey, a well incised but unmapped drainage channel was identified running from the western slope of this ridge into another low order, unmapped stream to the south, bisecting the southern half of the study area. At the time of the survey the channel was dry, but its definition suggests it has provided a longstanding non-perennial water source for the study area that was likely exploited by Aboriginal groups. Overall visibility within and surrounding the drainage channel was poor (<5%) with only one exposure measuring approximately 1 metre by 5 metres (Plate 11). Visibility approached 100% and appears to be the result of water movement along the drainage channel revealing the clay subsoil. No artefacts were identified and due to the shallow soil profiles and steep banks of the depression it has been assessed as holding no archaeological potential.

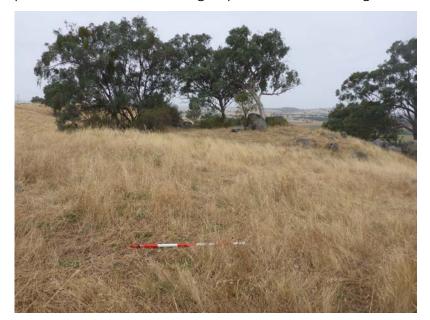
Plate 12 Crest landform in south east corner of the study area, view south, 1 metre scale

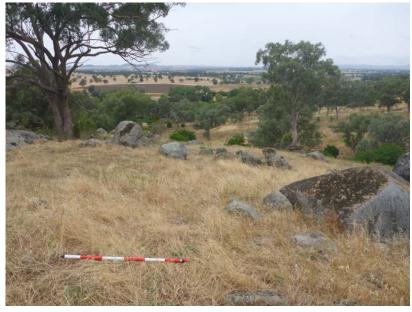
Plate 13 Location of CPP01, view south, 1 metre scale

During the survey CCP01 (AHIMS #44-4-0369), an isolated find recorded by Artefact in 2011 slightly to the east of the current study area, was inspected on the basis of GPS coordinates. Artefact (2011) noted that the site was located outside of their study area and that topsoil within the area appeared truncated and as such, no significant archaeological deposits were likely to be located in the vicinity of the isolated find. While the artefact was unable to be relocated due to poor visibility, its recorded location was determined as belonging to the same crest landform which comprises the south eastern corner of the study area (Plate 13). Due to this previous find, its comparatively intact native vegetation and suitability as a campsite indicates that the landform is considered to hold the potential to contain intact subsurface archaeological deposits, despite shallow soil profiles recorded in the area. Conditions at the time of the survey appear to have been similar to the conditions encountered by Artefact during the initial inspection. As such, it is determined that visibility is
