## **CONSERVATION MANAGEMENT PLAN**

Dawn Fraser Baths, Balmain

August 2018

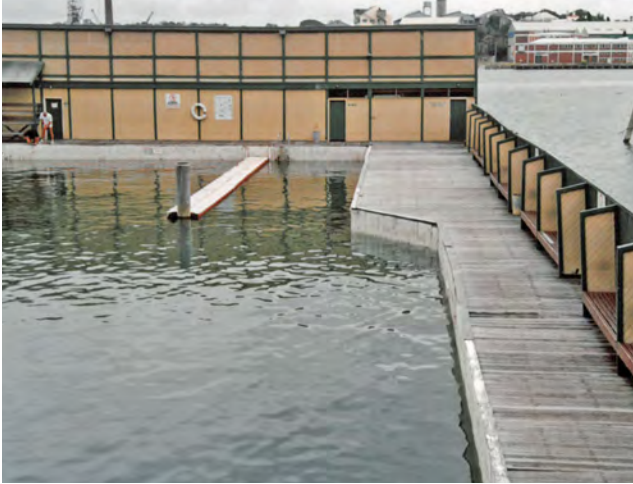
**Figure 2.36**  
1993 photograph showing the altered pontoon location, required for the installation of the sun deck  
*Source: 2013 CMP*

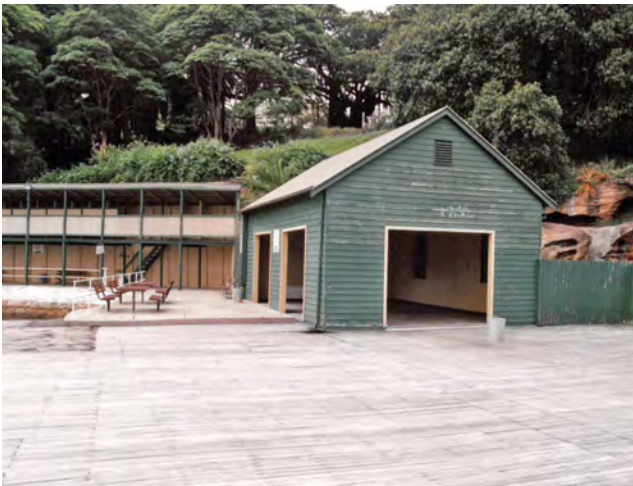
**Figure 2.37**  
1993 photograph showing the c.1984 deck addition and alterations to the Western Shed  
*Source: 1993 CMP*

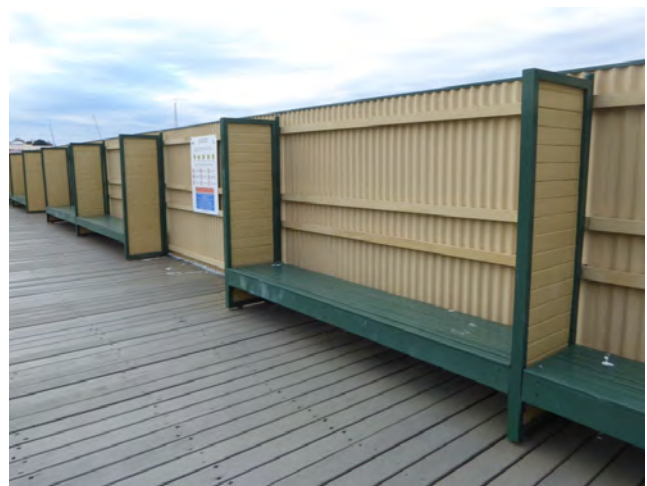
**Figure 3.10**  
The wide change booths along the east boardwalk wall, installed in 1993-95

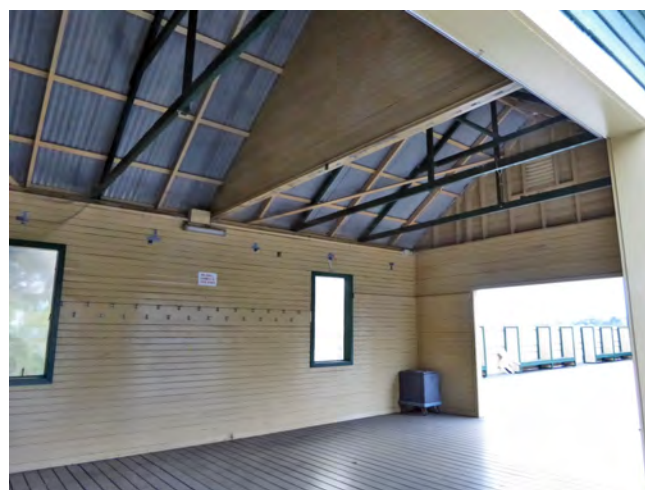
**Figure 3.11**  
The 1926 Western Shed, which has been highly altered to be

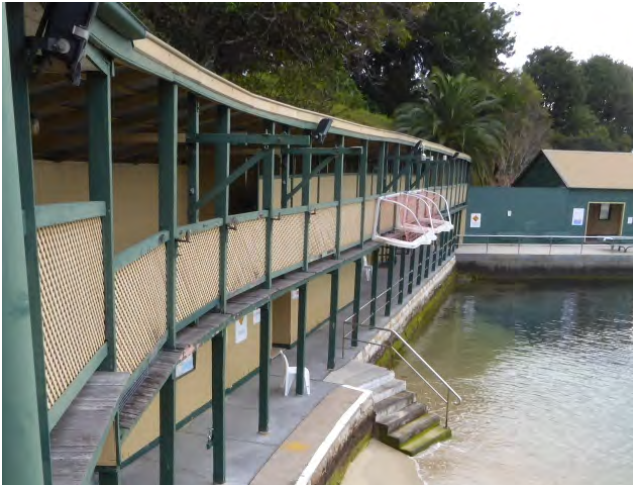
**Figure 3.12**  
The roof line and first floor walkway are no longer straight but have twisted from exposure to the environment and aging

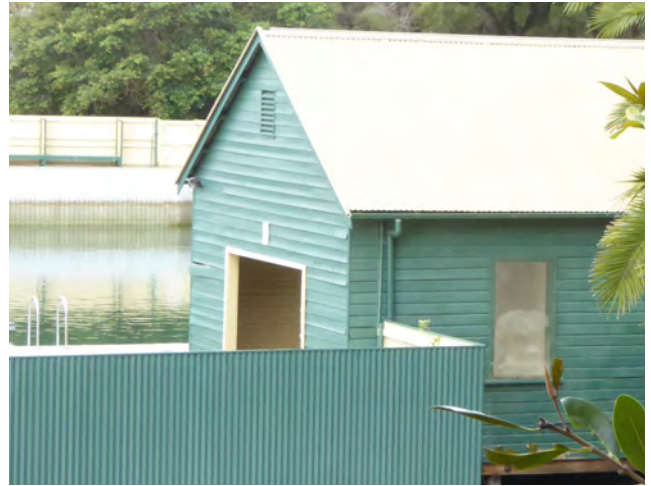
**Figure 3.15**  
The cladding on the northern elevation to the Western Shed is distorted

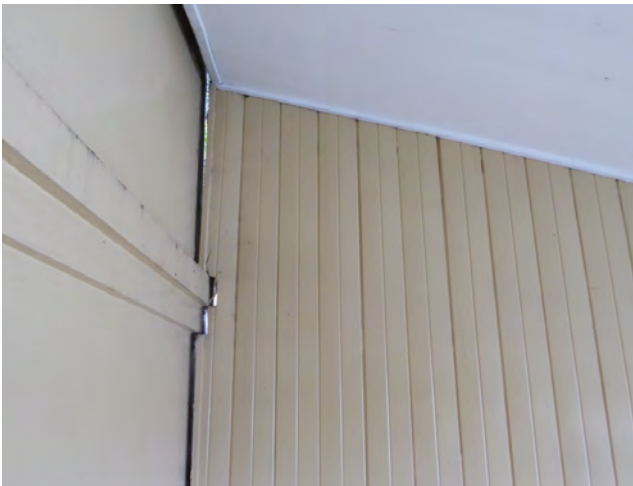
**Figure 3.13**  
The end of the western side of the 1900 Southern Pavilion has pulled away from the masonry Entry Building

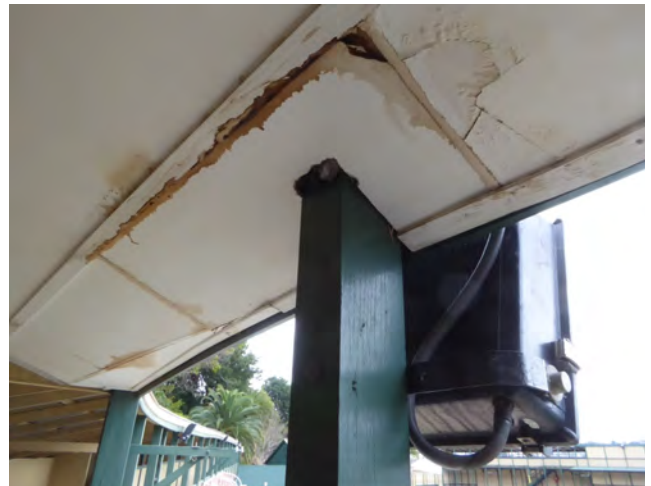
**Figure 3.16**  
A water damaged ceiling sheet on the balcony of the 1926 Entry Building

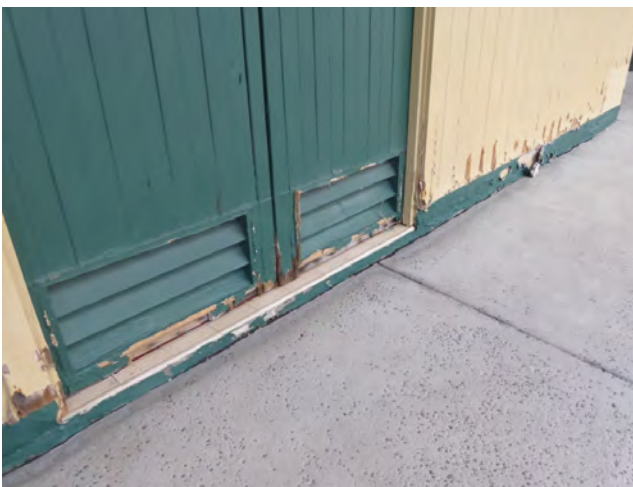
**Figure 3.14**  
The timber near the ground floor walkway is rotting. This area is prone to flooding during king tides

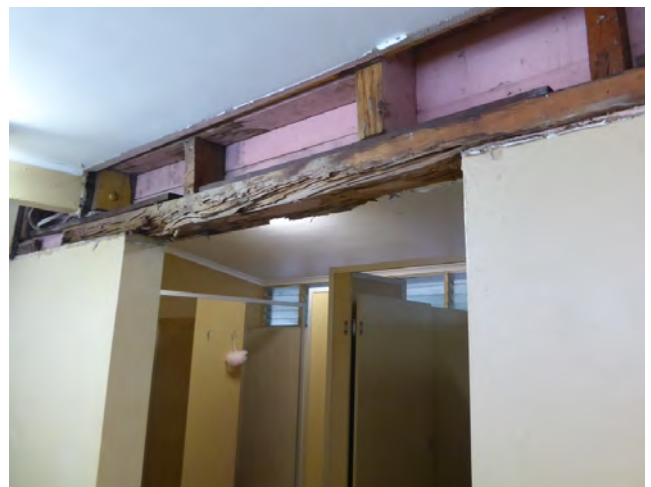
**Figure 3.17**  
A highly deteriorated structural beam in the male bathrooms, on the line of the southern perimeter to the 1900 pavilion
