Report on  
Geotechnical and Acid Sulfate Soil Assessment

Gosford RSL Club Redevelopment  
2-22 Yallambee Ave, West Gosford

Project 83326.00  
March 2018

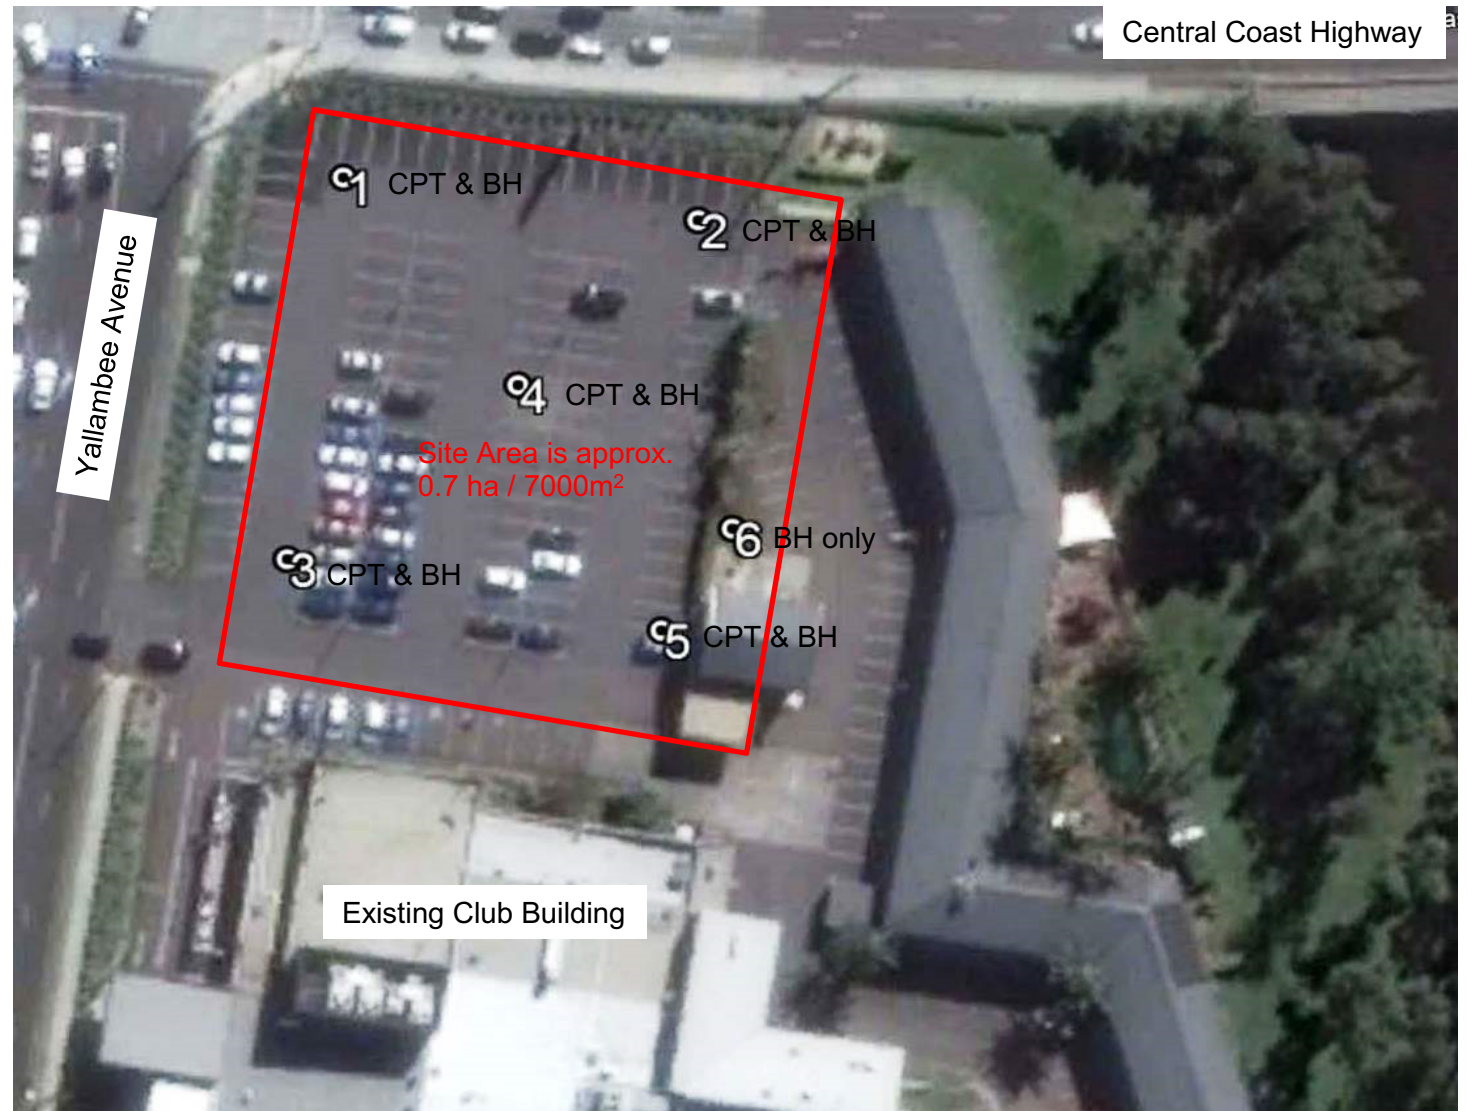
Note: Location 6 was a borehole only, no CPT

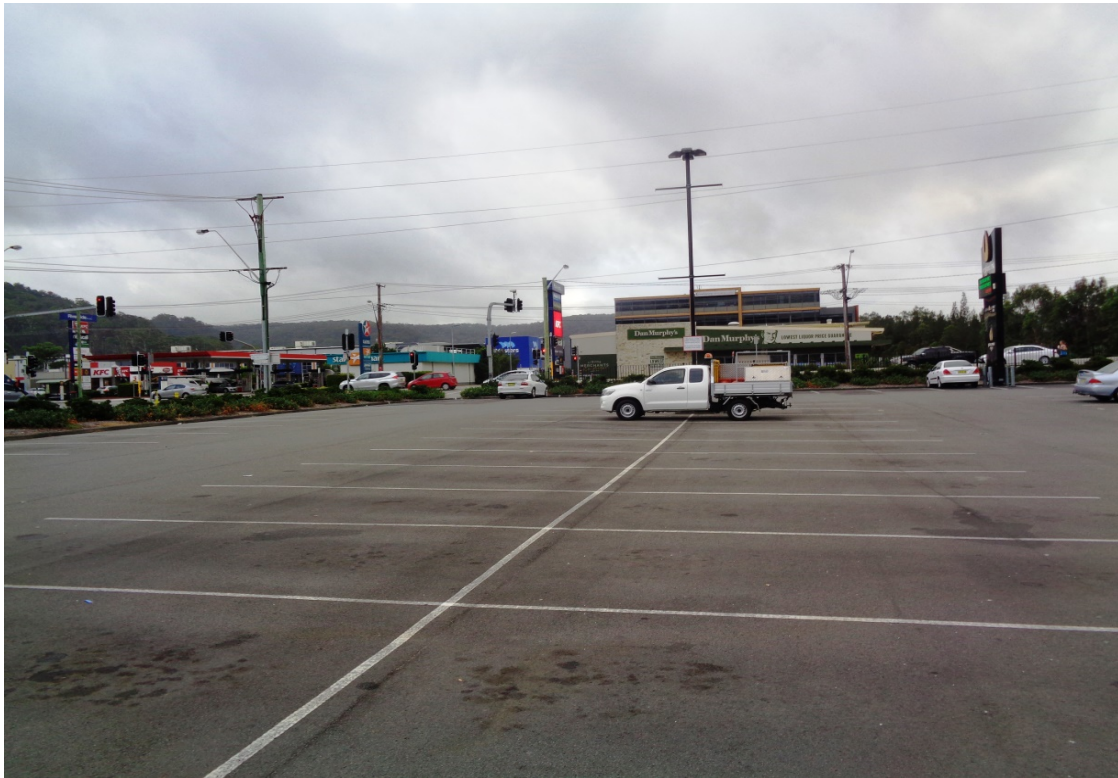
Photo 1 - Site, looking toward the north, minor oil staining on asphalt pavement, 29 Jan 2018.

The majority of the surface was asphalt paved and appeared to be in relatively good condition. The site surface had a slight slope down toward the east, in the direction of Narara Creek.
