Report on Preliminary Site Investigation for Contamination

Gosford RSL Club Redevelopment Part of 2-22 Yallambee Ave, West Gosford

Prepared for Gosford RSL Club

Project 83326.00 March 2018

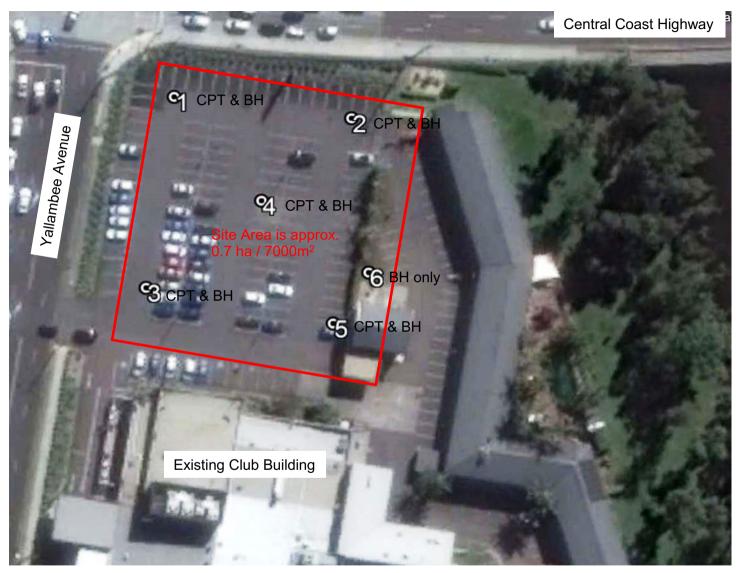
CLIENT:	Gosford RSL Club	Test Location Plan	PROJECT:	83326.00
OFFICE:	Central Coast	2-22 Yallambee Avenue	DWG No:	2
DATE:	6 Feb 2018	West Gosford	REVISION:	0

The borehole locations are shown in Drawing 1, Appendix A. The borehole logs are provided in Appendix C along with notes on descriptive terms and symbols. The subsurface conditions encountered in the boreholes are summarised as follows:

Note: Location 6 was a borehole only, no CPT

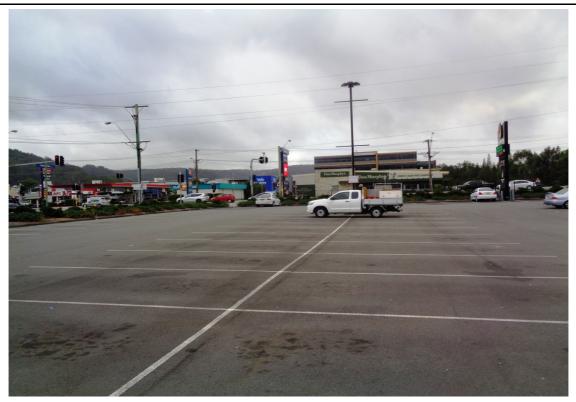
The majority of the surface was asphalt paved and appeared to be relatively good condition apart from some minor surficial oil staining. The site surface had a slight slope down toward the east-south-east, toward the Narara Creek.

Photo 1 - Site, looking toward the north, minor oil staining on asphalt pavement, 29 Jan 2018.

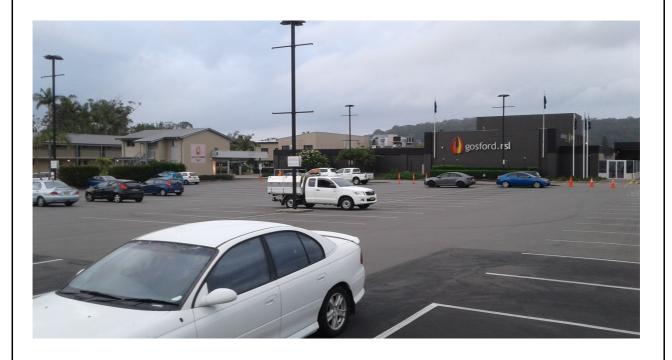
Photo 2 - Site, looking toward the south, existing RSL Club Building at the rear, 29 Jan 2018.

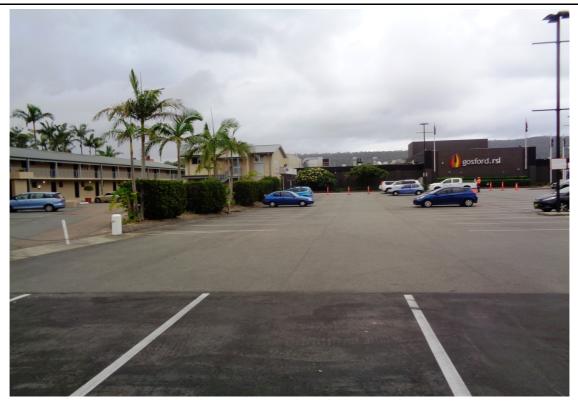
Photo 3 - Hotel Reception Building, looking toward the south-east, 29 Jan 2018.

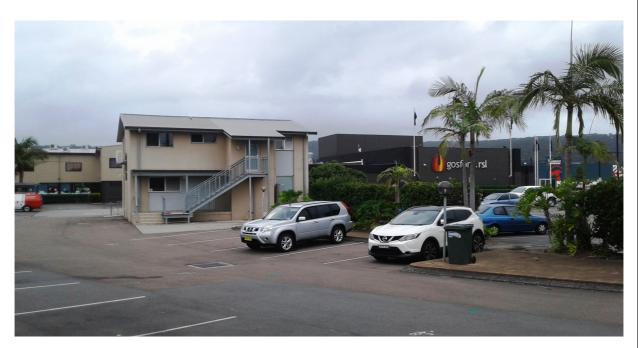
Photo 4 - Hotel Receptioon Building, looking toward the south-west, 29 Jan 2018.

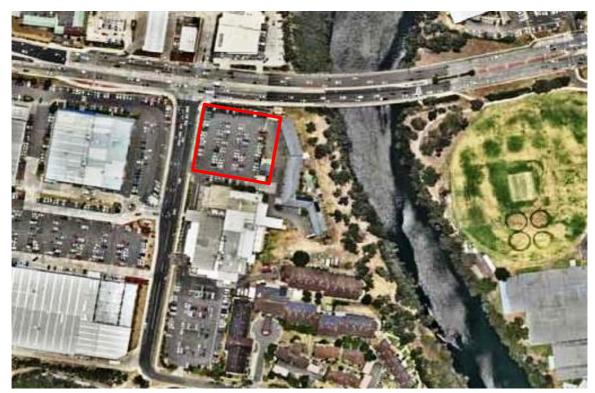
Photo 9 - 2017

The site appears in a similar condition to that noted at the time of the field work (January 2018). The site appears occupied by a ground level sealed car park. The existing RSL Club Building is located to the south and part of the existing Hotel Reception building is located in the south-east corner of the site. The surrounding area appears occupied by other commercial land uses.
