Taree Police Station

Heritage Assessment and Impact Statement

Report prepared for GroupGSA Pty Ltd

May 2018

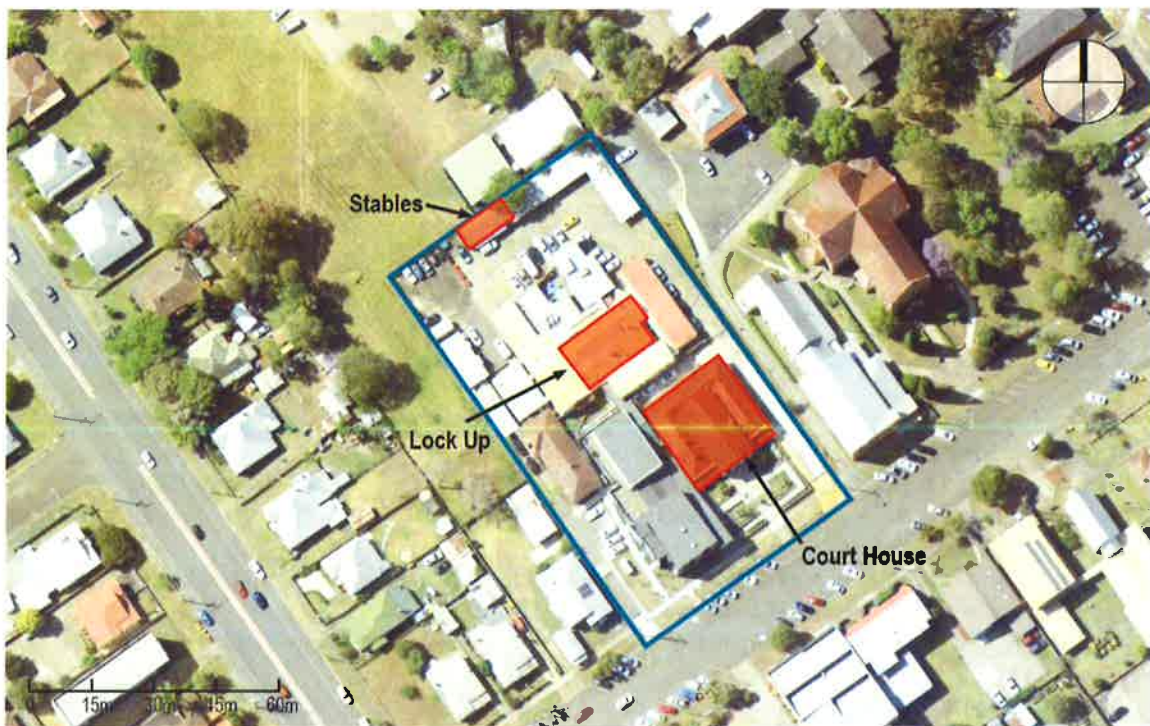
Figure 3.1 Aerial view showing the existing arrangement of buildings on the site (outlined in blue) and location of the surviving buildings from the 1880s justice precinct, including the courthouse, police lockup, lockup keeper's residence and stables (shown in red). (Source: Six Maps, with GML overlay, 2018)

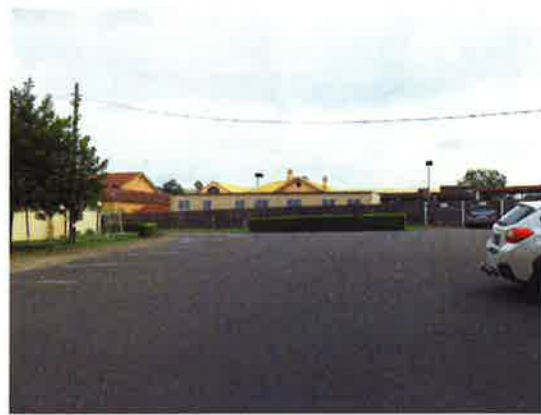
Figure 3.4 The roof of the original lockup and lockup keeper's residence is visible over the roof of a demountable office located adjacent to the original entrance to the police station. View from the adjoining Our Lady of the Rosary Catholic Church site to the east.

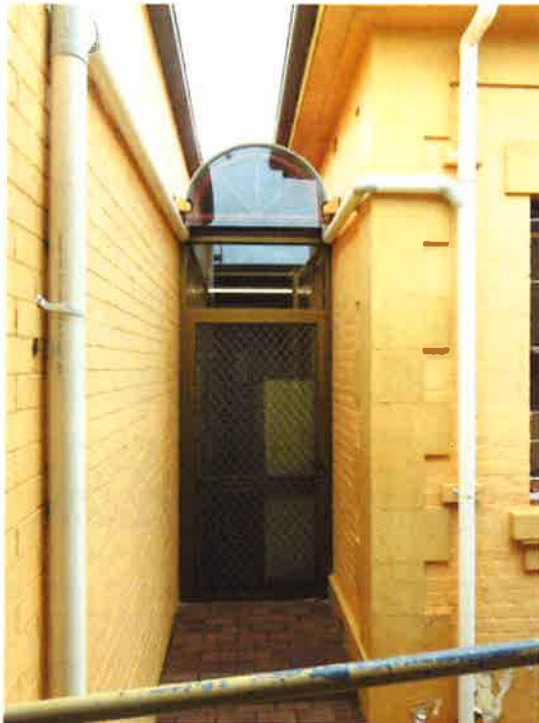
Figure 3.7 Side entrance to police station replacing southern verandah—original lockup keeper's residence located on the right and 1990s meal room on the left.

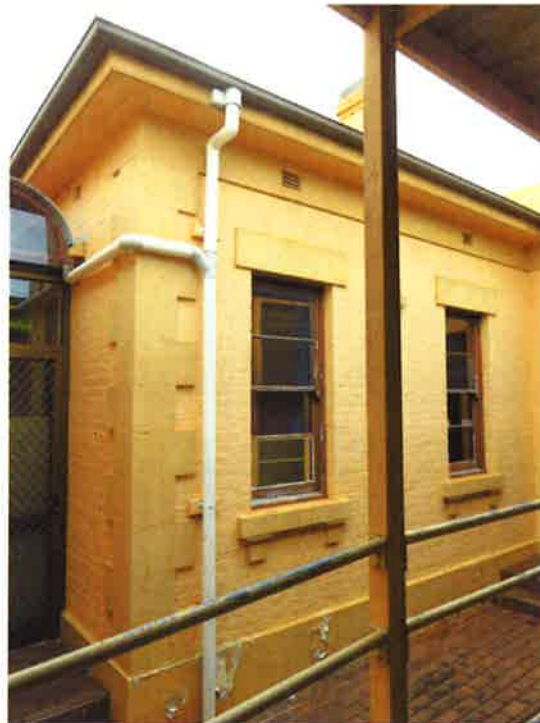
Figure 3.8 Original entrance front (east elevation) to lockup and lockup keeper's residence, showing rendered detail on front façade, including quoins, plinth, top band, sills and lintels.

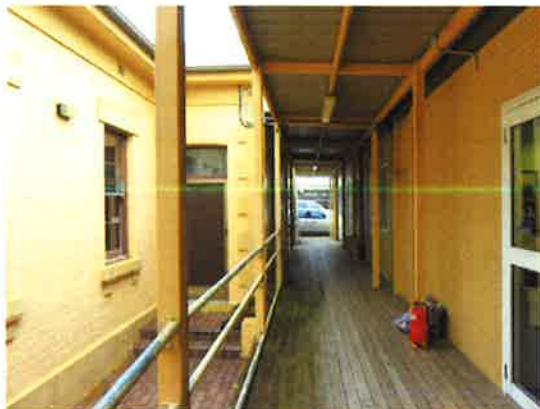
Figure 3.9 View along original entrance front to the lockup showing the entrance to the original charge room (left of verandah). The demountable building on the right holds offices.

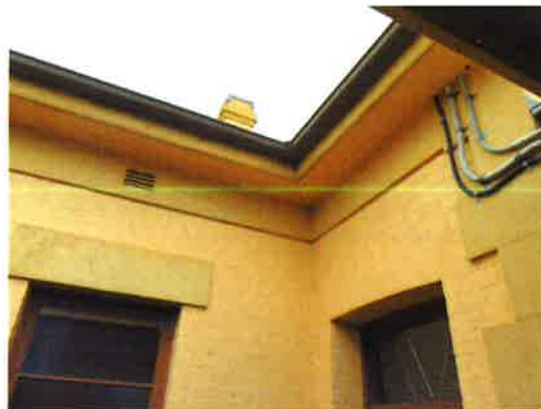
Figure 3.10 Detail of original lockup building showing rendered detail, eaves and chimney.

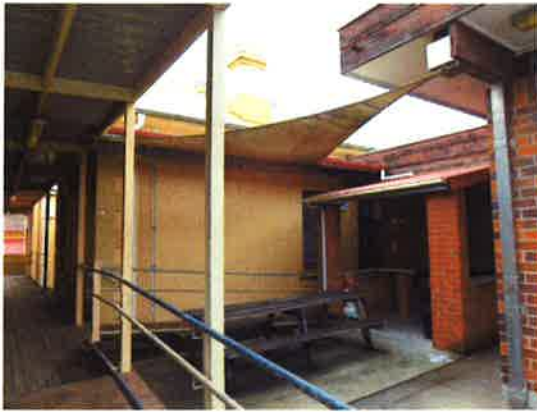
Figure 3.11 Rear elevation (north) of original lockup. The brick structure on the far right is the 1968 addition.

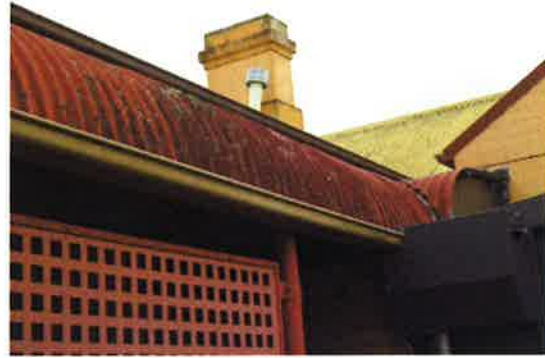
Figure 3.12 Bullnose verandah roof bellows to 1990s additions. The chimney is original.

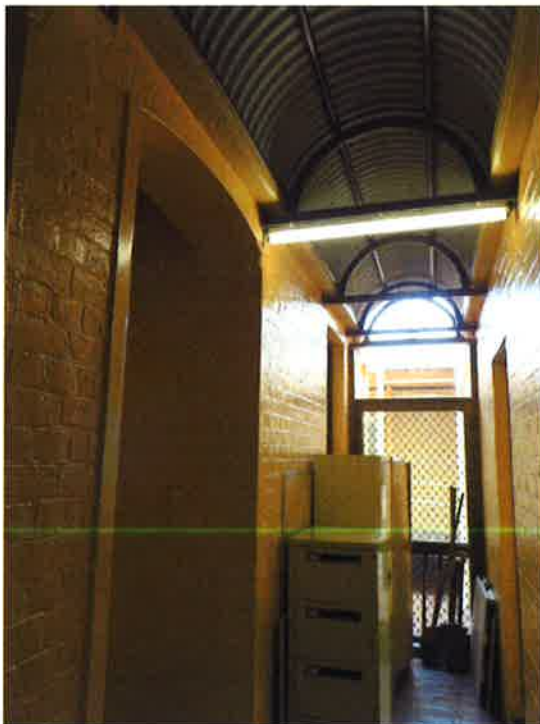
Figure 3.13 Breezeway between original building (left) and 1990s addition (right). The original entrance to the former lockup keeper's residence is on the left. The breezeway replaces the earlier verandah.

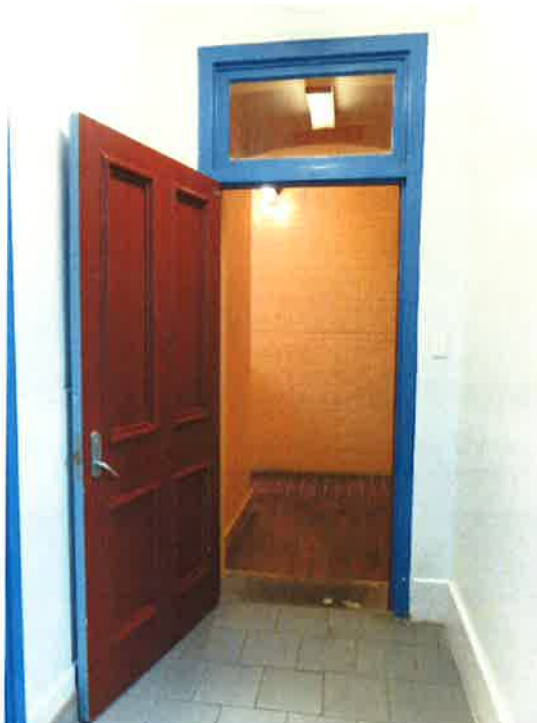
Figure 3.15 Original entrance door to former lockup keeper's residence looking out to breezeway from entrance hall. The original timber floor has been replaced with a concrete slab, the skirting is rendered and the ceiling is plasterboard.

Internally the surviving original floors are timber (carpeted) and the walls are plastered with a cementitious dado running around the lower portion. Several of the floors have been replaced with concrete and flat cement skirtings have been applied in place of the older two-tiered timber skirtings. The ceilings have been replaced with fibrous sheet or plasterboard and have either quad mouldings or plasterboard scotia cornices. No original architraves or sill boards survive. Several circular wall vents survive in a band below the ceiling.

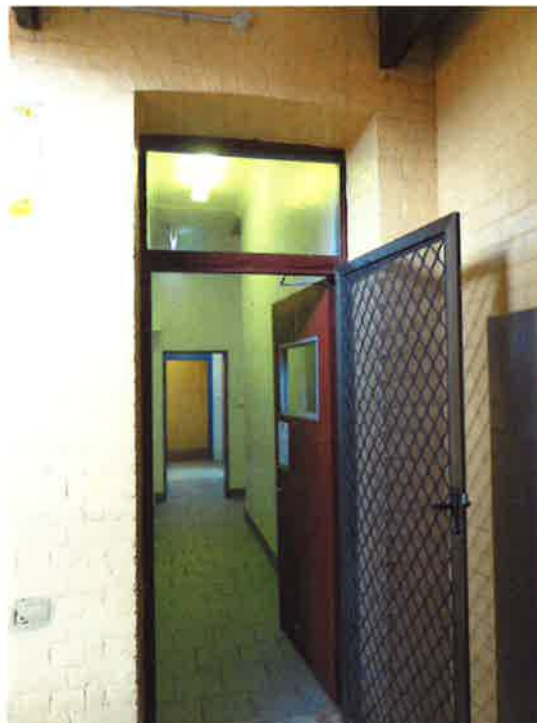
Figure 3.16 Rear door to the former lockup. The opening is original, but the door has been altered. The original floor has been replaced with concrete and tiled.

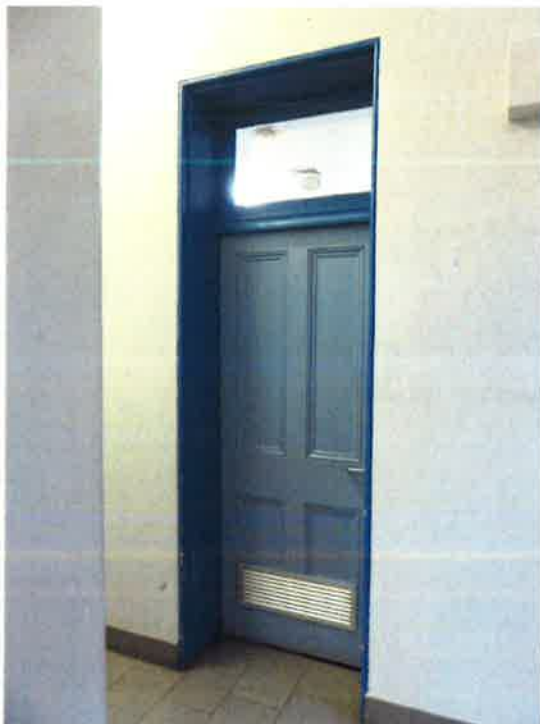
Figure 3.17 Original internal door to former charge room.

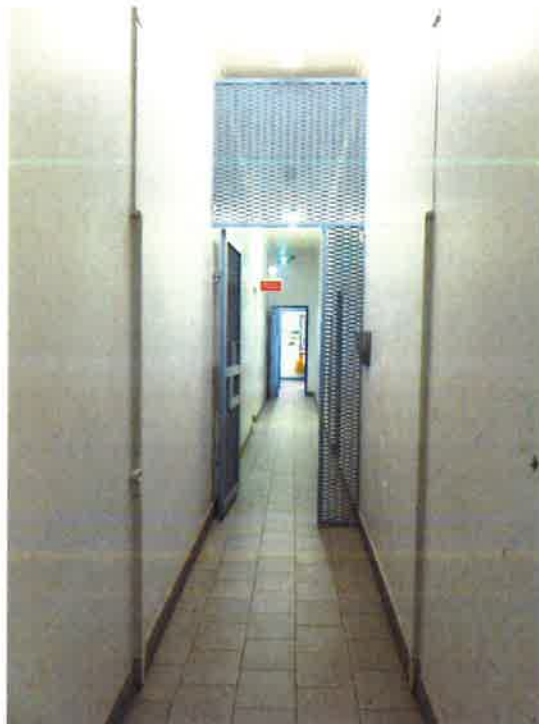
Figure 3.18 The iron frame for the former gate to the cells remains, but the security gate has been removed.

There have been substantial internal alterations to the layout of the building. Within the lockup, none of the original cells survive intact. These have been replaced with modern steel and Perspex enclosures. The fixings of the original iron gate that secured the corridor to the cells provides the only surviving evidence of the original lockup arrangement. The lockup keeper's residence has also been substantially altered with removal of its hallway and reconfiguration of most of its rooms, window and doors. The western wall of the former kitchen has been totally removed. The fireplaces have all been blocked up, with either textured brick fireplace surrounds inserted for space heaters or blocked up totally and plastered over.

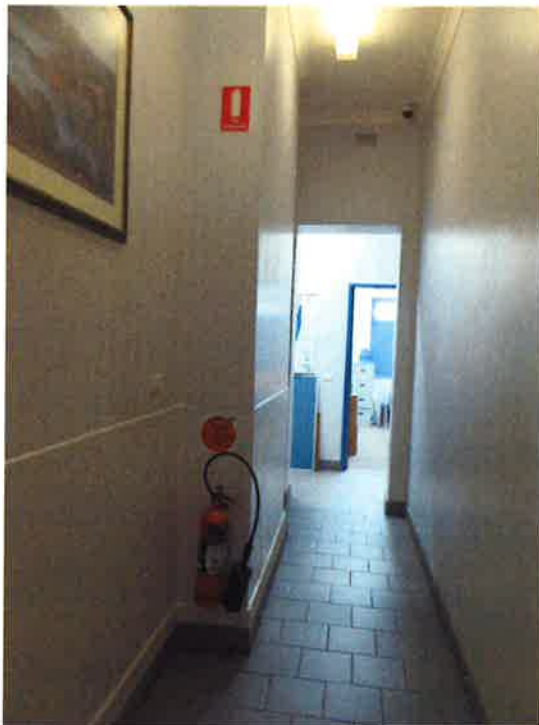
Figure 3.19 Chimney breast of the western room of the central pair of rooms in the former lockup keeper's residence is now located in a passageway that connects the cells to the courthouse. The room has been substantially reconfigured, with windows and doors relocated and replaced. The fireplace has been bricked up.

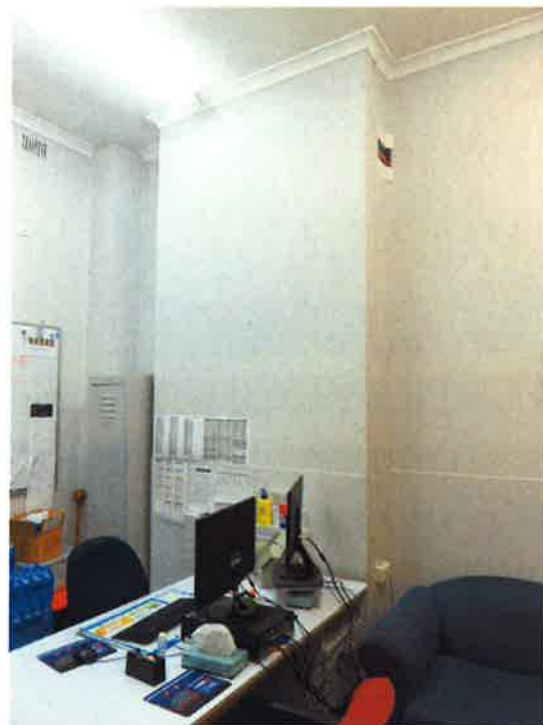
Figure 3.20 Chimney breast of the eastern room of the central pair of rooms in the former lockup keeper's residence. A rendered dado runs around the original walls.

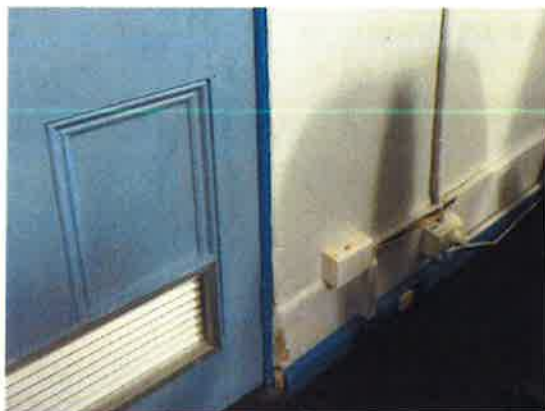
Figure 3.21 Remnant of original skirting survives in the former charge room (now an office).

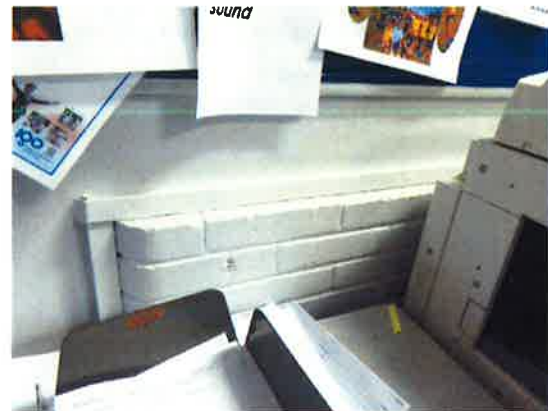
Figure 3.22 The fireplaces have been bricked up during the early to mid twentieth century.

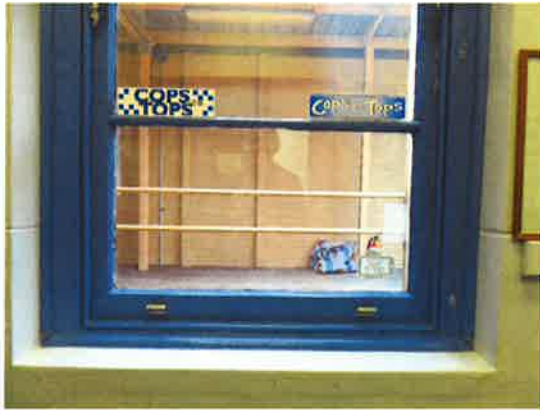
Figure 3.23 Windows with horizontal glazing bars appear to have been inserted into original openings during the 1940s.

The windows appear to have all been replaced in the 1940s, as they have horizontal glazing bars as shown in the 1940s drawings, and are inconsistent in proportion with traditional 1880s double hung windows, such as those that survive in the courthouse adjacent. Only four original four-panel doors appear to survive—the entrance to the former residence, the entrance to the former charge room, the rear door to the lockup and one internal door, which leads to the original charge room.

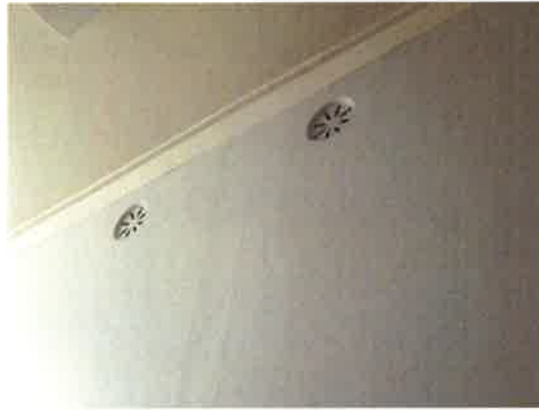
Figure 3.24 Original wall vents.

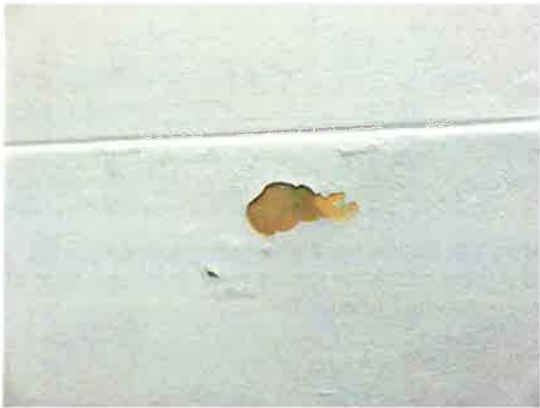
Figure 3.25 Evidence of early colour schemes survive below the existing paint finishes.

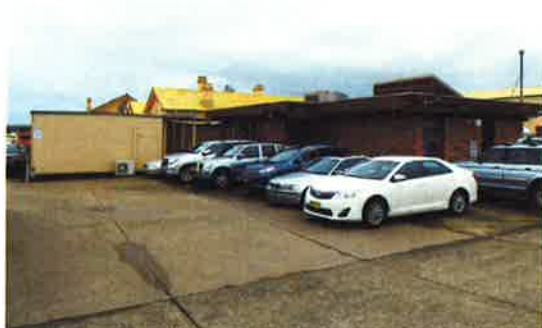
Figure 3.29 View of the 1968 addition to the north of the former lockup. A demountable office is located to the east and the roof of the original lockup is visible over the top.

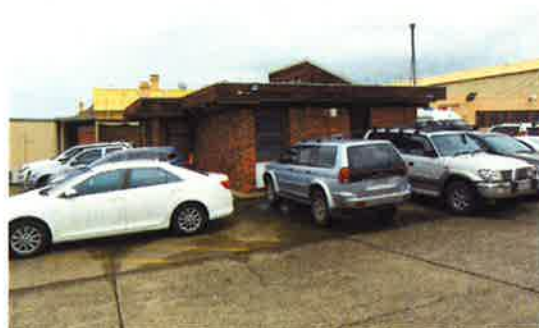
Figure 3.30 The 1968 addition is of brick construction with a flat roof, featuring deep weatherboard fascias and concealed gutter detail.

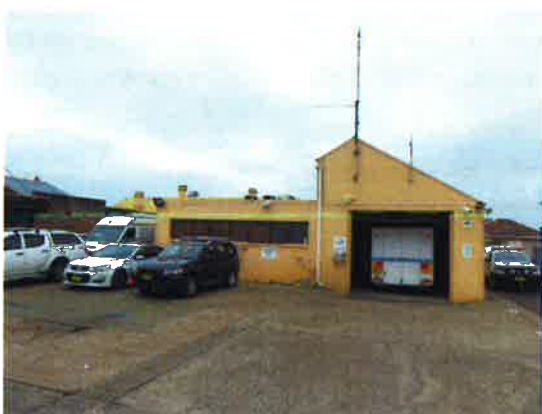
Figure 3.31 1990s prisoner loading dock at the rear (north) of the police station.

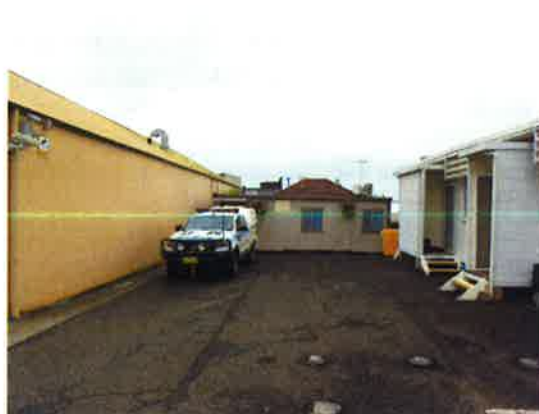
Figure 3.32 Western side of 1990s additions showing demountable buildings and roof of c1970s building, now used for forensics. This is located on the western block previously occupied by the sergeant's quarters.

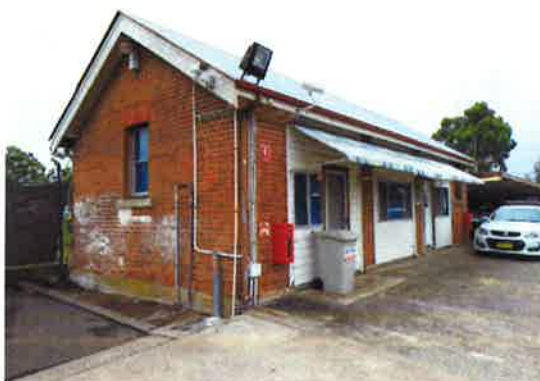
Figure 3.35 Former stables building, located against the northern boundary of the site.

In keeping with the former police lockup, the building has rendered plinth and sills and a splayed brick arched head over the western window opening. The head was previously tuckpointed. The window, however, has been replaced with an aluminium framed window. An original timber framed window appears to have been relocated and had its original glass louvres removed (eastern window in southern wall).

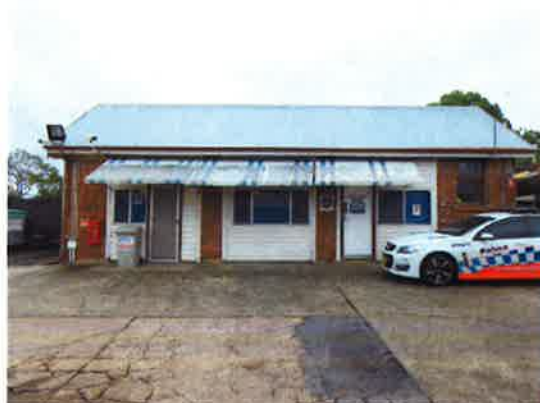
Figure 3.36 The large openings from when the stables were converted to garages during the 1940s have been infilled to enable the building's use as offices.

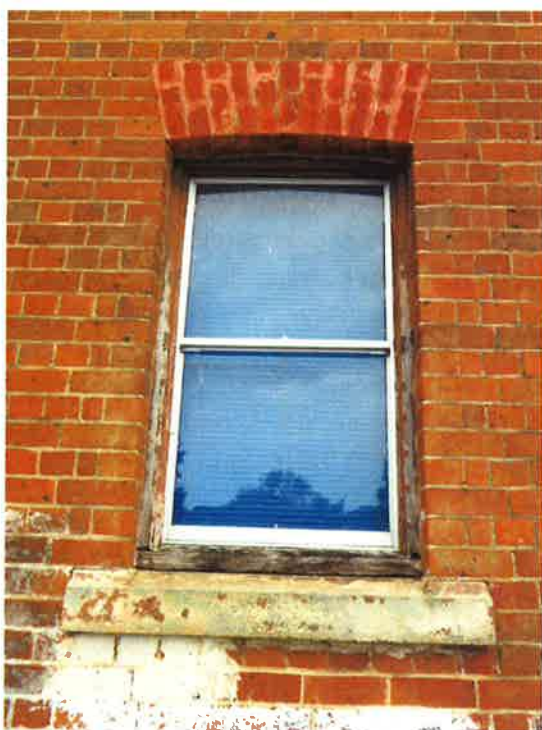
Figure 3.37 Original window opening in the western elevation, showing tuckpointed head and rendered sill. The window has been replaced in aluminium.

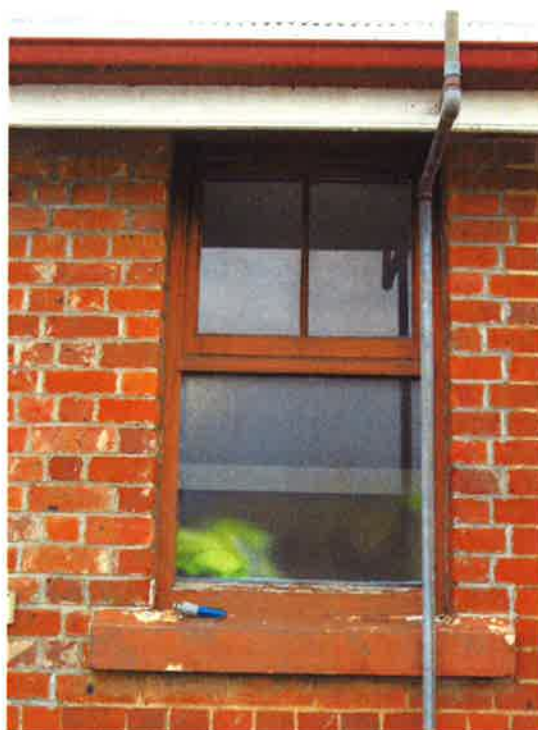
Figure 3.38 Original window opening to former stables (south elevation). Glass louvres have been replaced with a fixed sash.

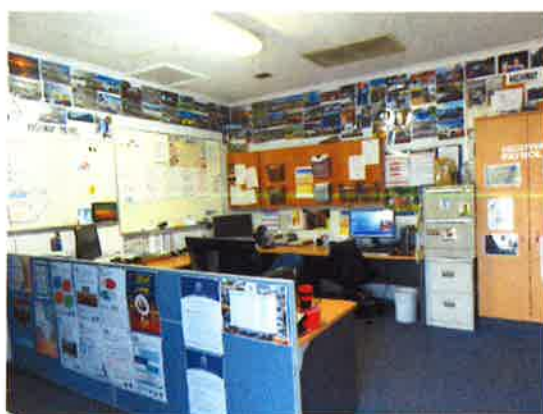
Figure 3.39 Interior of the stables has been relined and refitted as an office.

The current fitout includes sheet linings to all the original brick walls, and one stud wall, which has been inserted to divide the space.

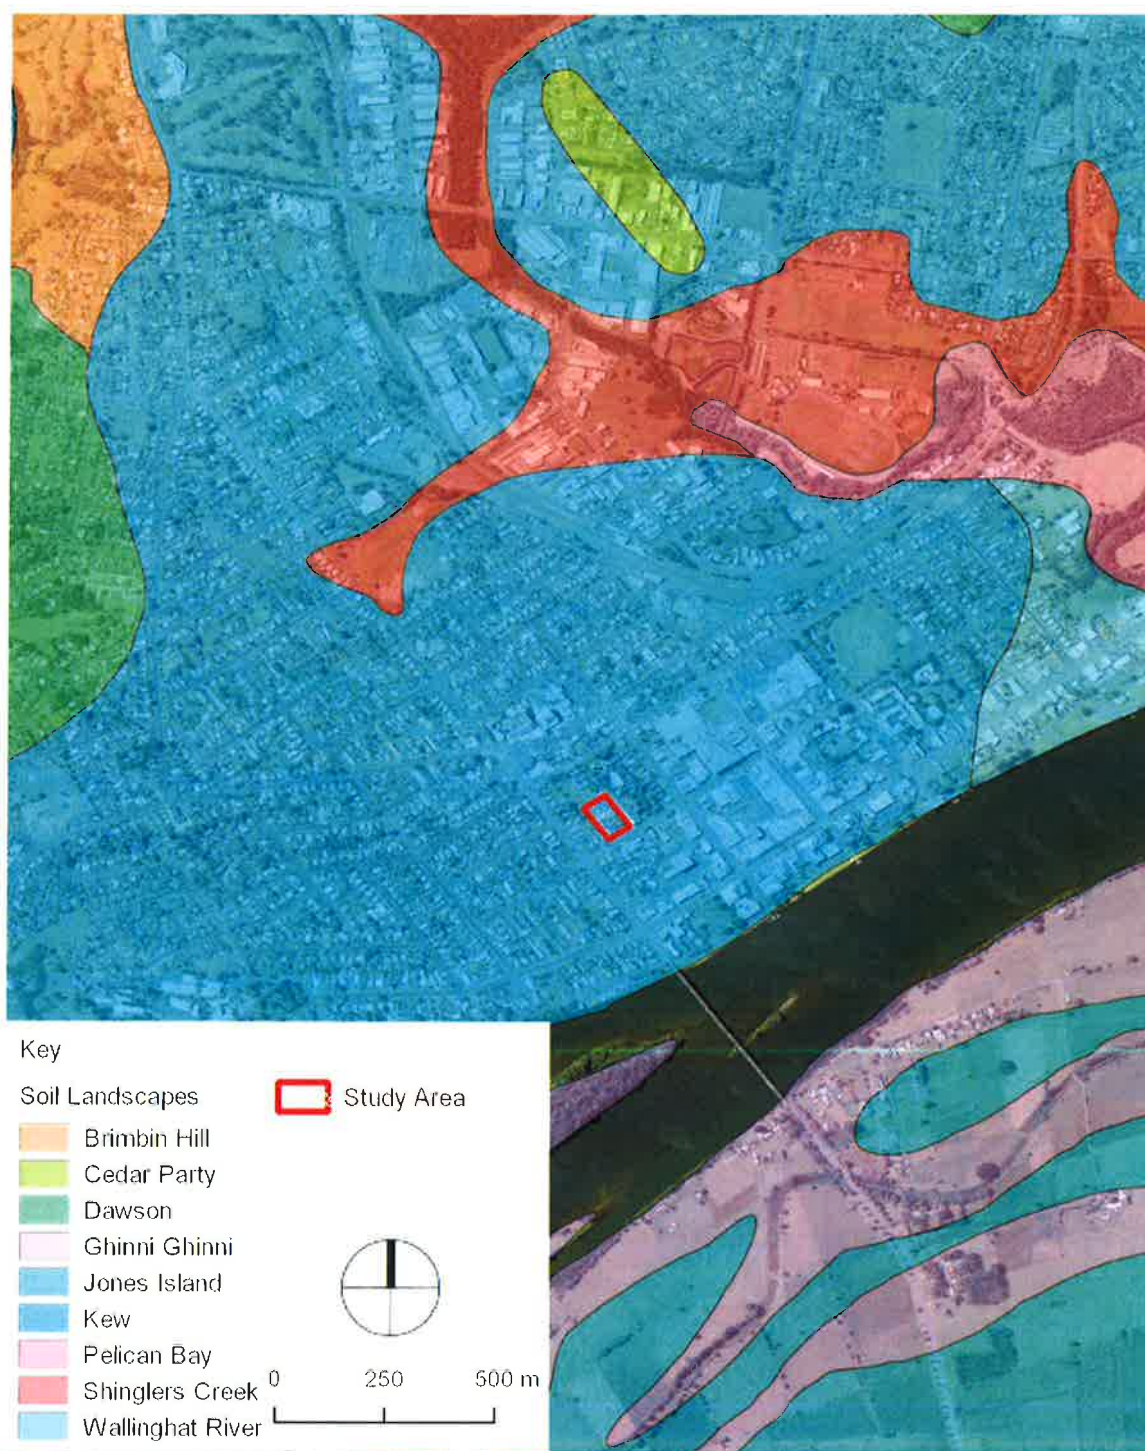
Figure 5.3 Soil landscapes surrounding the study area. (Source: NSW Globe with GML additions, 2018)

The Kew soil landscape overlies the geology in the study area (Figure 5.3). Kew is a residual soil landscape and is shallow to moderately deep (25–<100 cm). It contains moderately to imperfectly drained Brown and Yellow Kurosols (Yellow Podzolic Soils and Soloths), occasionally Bleached or Mottled, and Lithic Brown-Orthic Tenosols (Lithosols), as well as shallow to moderately deep (25–<100 cm), imperfectly drained Mottled and Bleached-Mottled, Yellow and Brown Kurosols (Yellow Podzolic Soils and Soloths) and Grey Kurosols (Gleyed Podzolic Soils).³

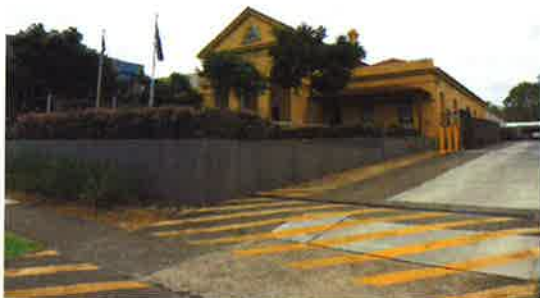
Figure 9.3 The booster pump will be located in front of the garden wall at street level.
