Report on  
Preliminary Site Investigation (PSI) for Contamination

Proposed Harrington Waters Lifestyle Village  
26, 48 and 56 Manor Road, Harrington

Project 31872.02  
July 2019

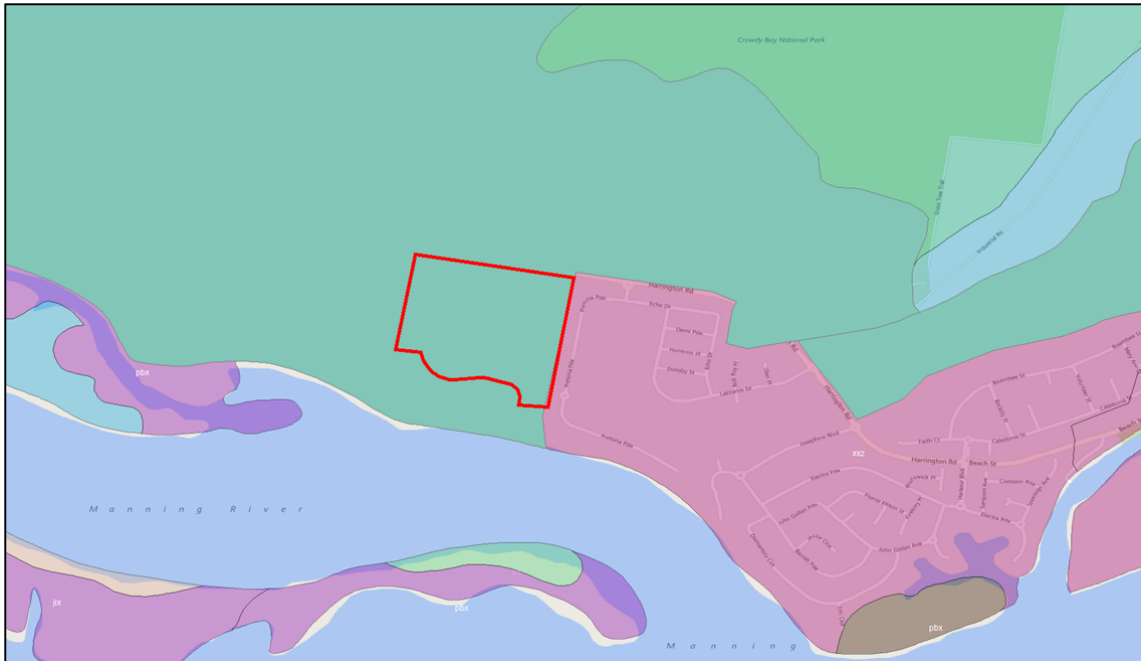
**Figure 2: Soil landscape map with approximate site location (red square)**

Reference to the Soil and Land Resources of the Hunter Region (Figure 2) indicates the site is mapped as comprising aeolian soils of the Harrington landscape (green shading). Also within close proximity to the east is mapped as comprising disturbed terrain (purple shading) associated with the previous residential development.

The Harrington landscape is characterised by “level plain to gently undulating plain on Pleistocene backbarrier quartz sands”. The soils within this landscape are characterised as “non-cohesive, wind erosion hazard, poor drainage, seasonal waterlogging”.

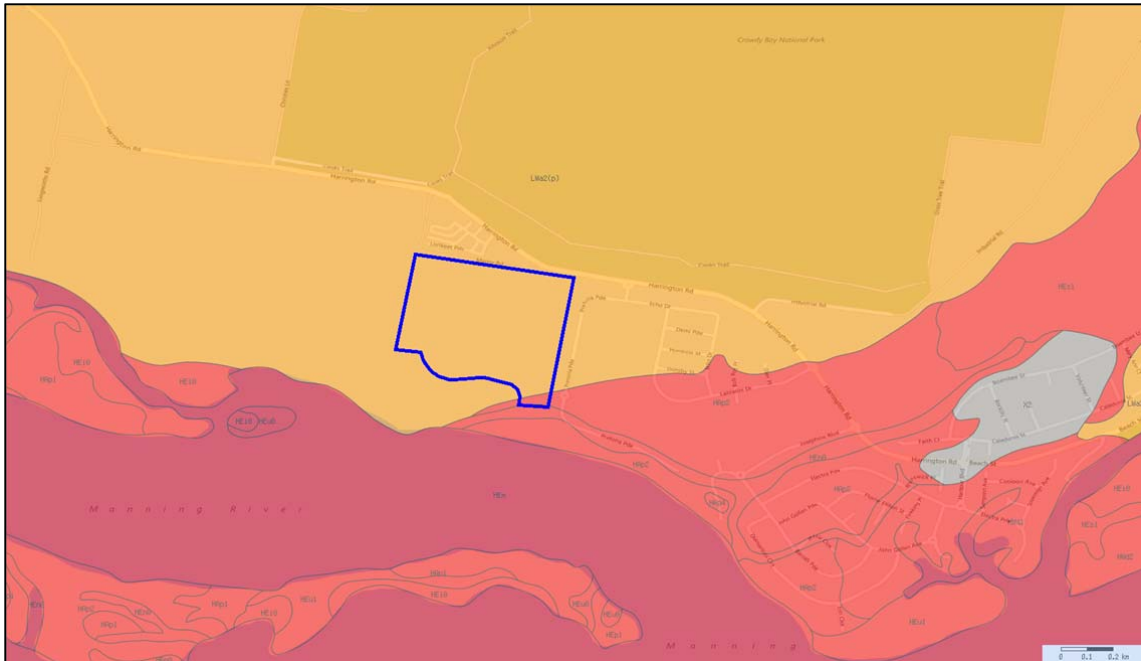
**Figure 3: Acid Sulfate Soils Map with approximate site location (red square)**

Reference to the Cundletown 1:25,000 Acid Sulfate Soil Risk Map (Figure 3) indicates the majority of the site is located within an area of *“low probability of occurrence at depths between 1 m and 3 m below the ground surface”* (yellow shading). The south eastern corner of the site is located within an area of *“high probability of occurrence between 1 m and 3 m below the ground surface”* (red shading).

A total of 49 ASS screening tests and five (5) detailed ASS tests were carried out on soil samples from the investigation, which indicated that 'actual' acid sulfate conditions were not present at the site in the samples tested. However the results indicated that 'potential' acid sulfate soils were present at the site up to the investigation depths (i.e. 10.5 m) and an acid sulfate soil management plan (ASSMP) is required for any excavation activities.
