Report on
Preliminary Site Investigation (PSI) for Contamination

Proposed Harrington Waters Lifestyle Village
26, 48 and 56 Manor Road, Harrington

Project 31872.02
July 2019

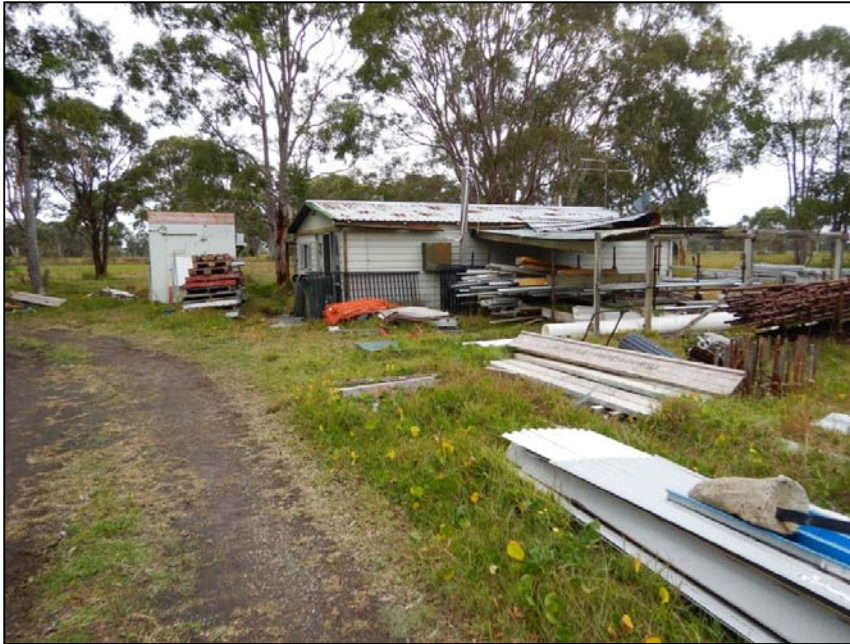
Figure 5: View of weatherboard house and surrounding stockpiled material

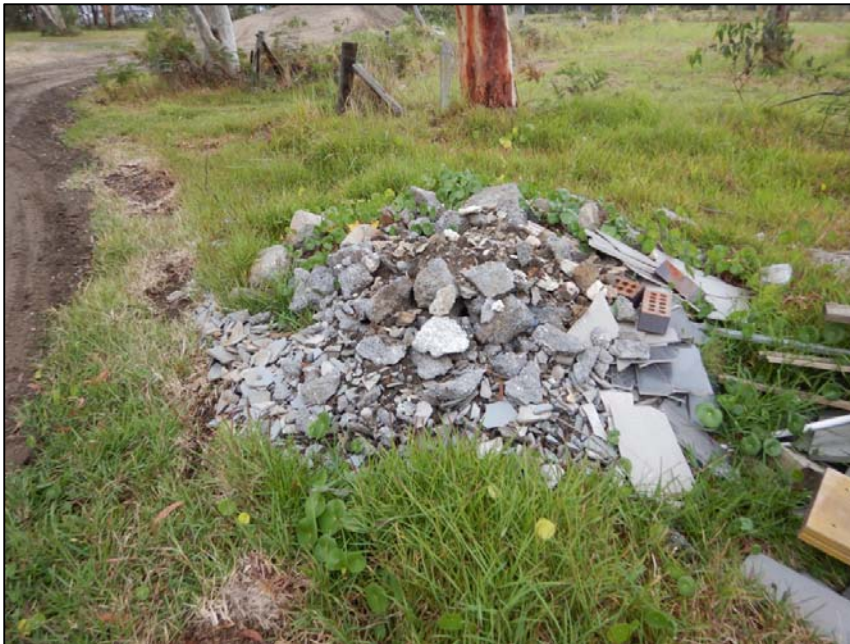
Figure 6: View of stockpiled concrete fragments, bricks and tiles

It is noted that fill materials have been identified within the site (source unknown) together with the presence of anthropogenic inclusions which are considered to be typical of the presence of demolition waste and hazardous building materials (including asbestos containing materials). Additional assessment is therefore recommended to better characterise site conditions. An unexpected finds protocol is also recommended during development to manage this risk.

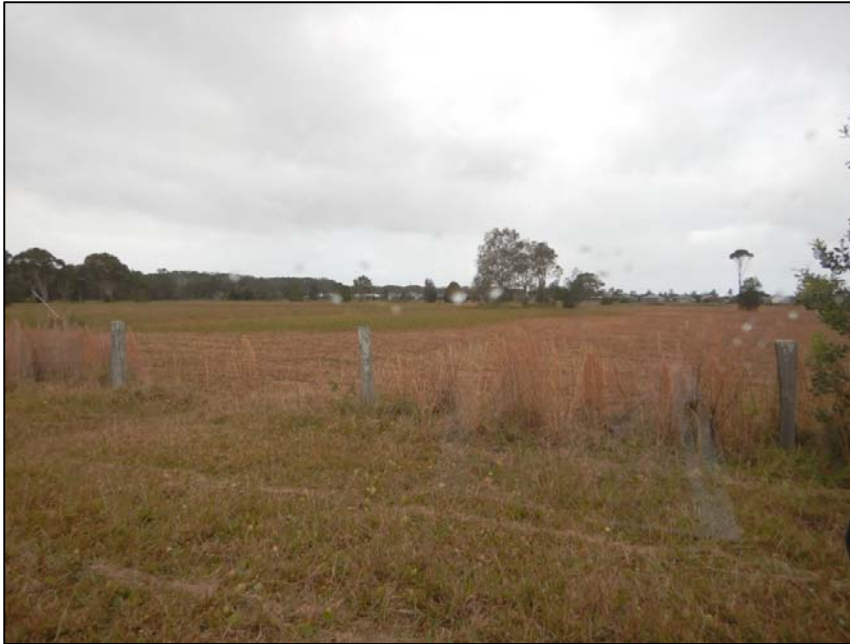
Figure 7: View north east from Lot 2 eastern boundary

- The site generally had a good covering of grass across the majority of the site (Figure 7);
- Mature to semi mature trees along the northern boundary of the lots, sporadic coverage of trees across the rest of the site;

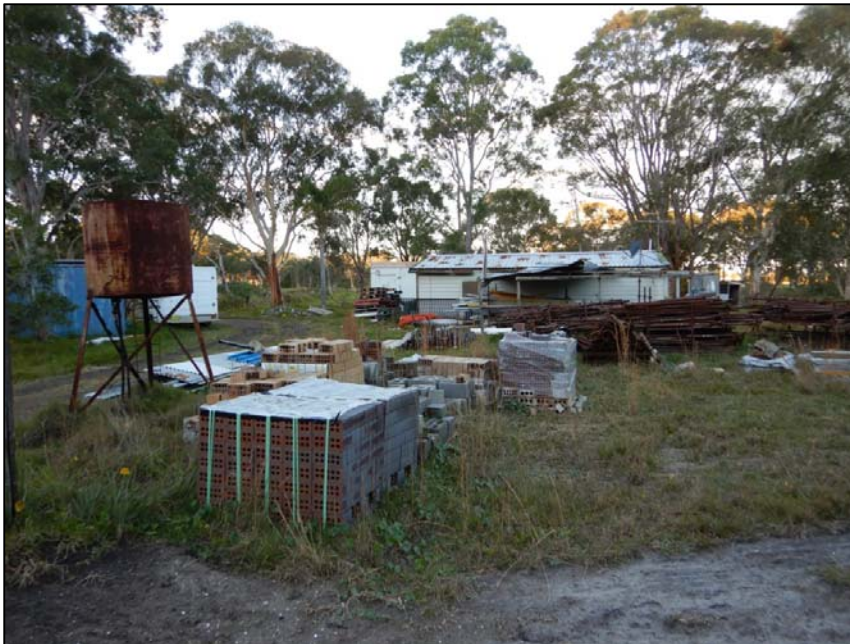
Figure 8: View of above ground tank and bricks

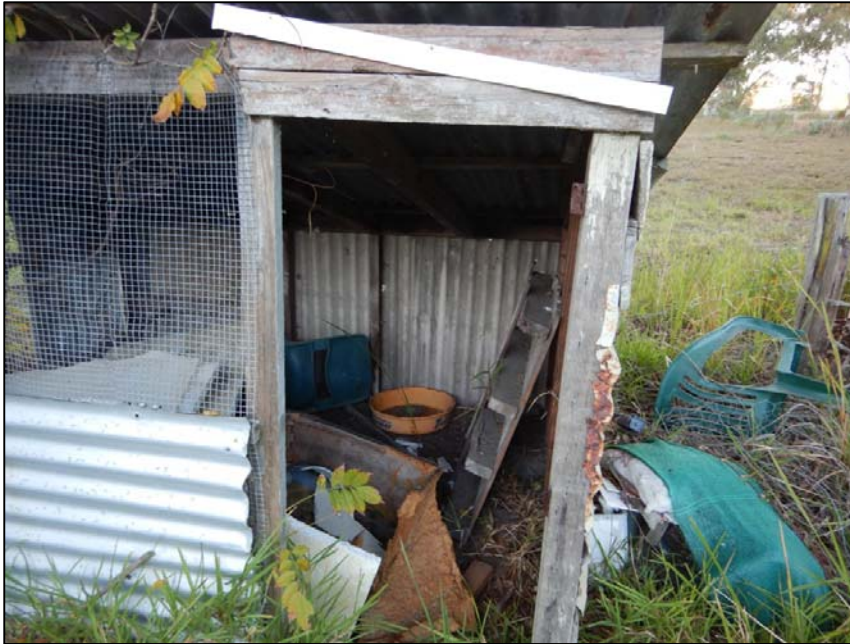
Figure 9: View of small shed with fibro sheeting (possible ACM) on walls

Hazardous building materials (HBM) including asbestos, were observed at the surface on the site or on existing structures at the site. Laboratory testing undertaken on collected samples indicated the presence of asbestos to the laboratory reporting limits within one of the samples analysed. Owing to the presence of fill/anthropogenic inclusions and historical demolition activities at the site, there is a risk of HBM (including ACM) in unobserved or untested parts of the site.

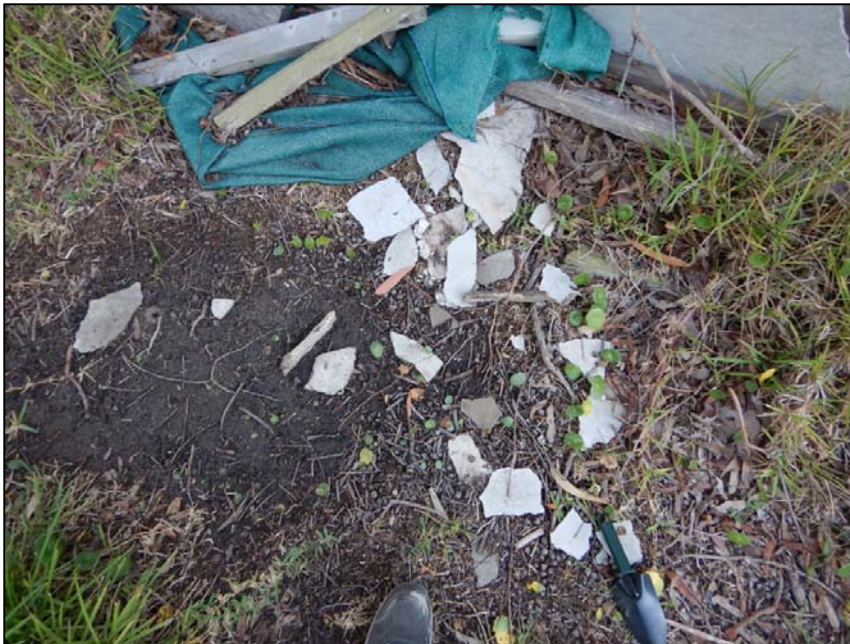
Figure 10: Fibro fragments around weatherboard house

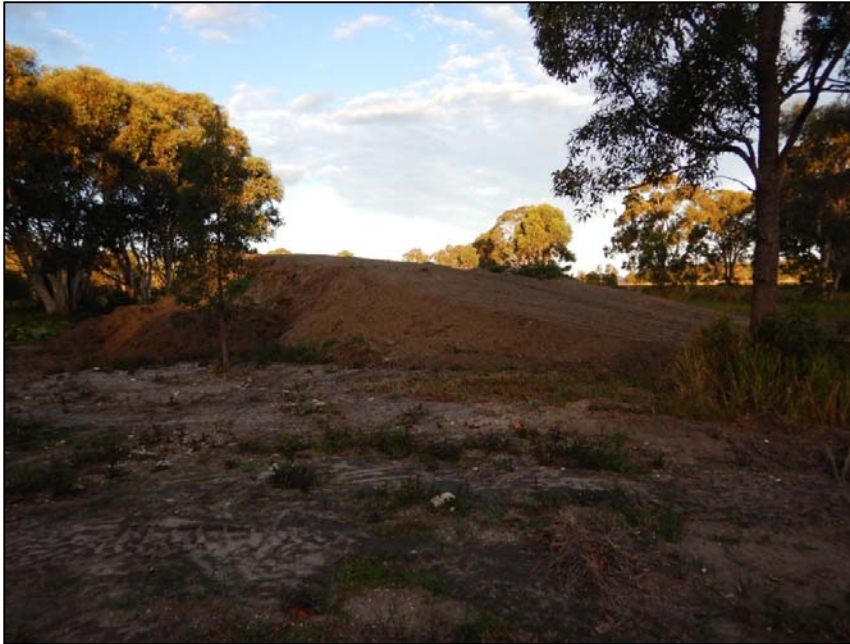
Figure 11: Large stockpile of soil

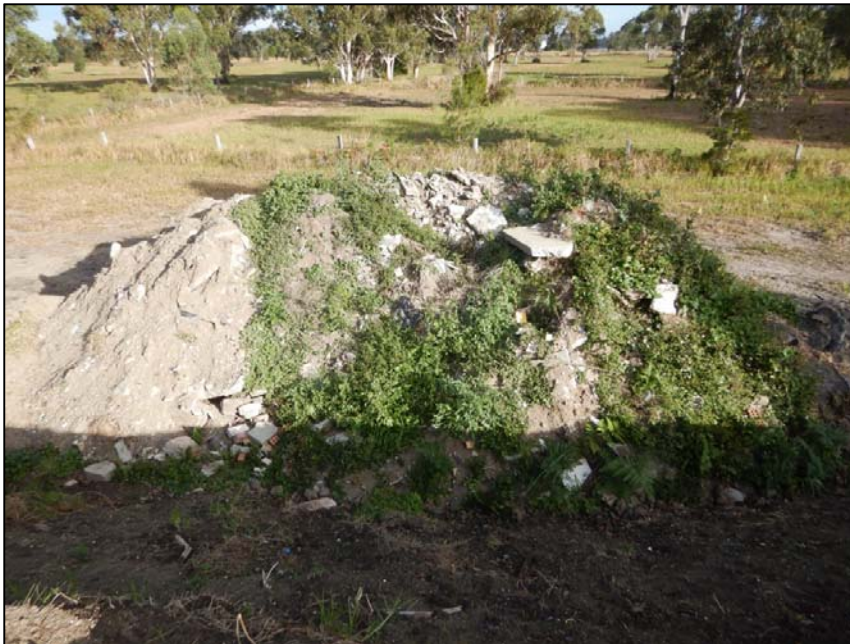
Figure 12: Stockpile of soil, bricks and concrete adjacent to large stockpile

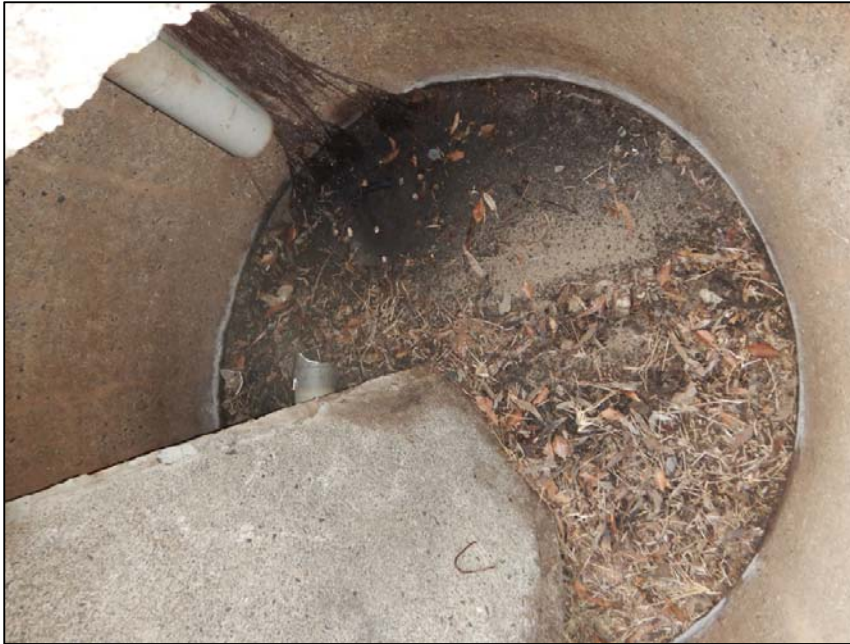
Figure 13: View of inside of concrete septic tank

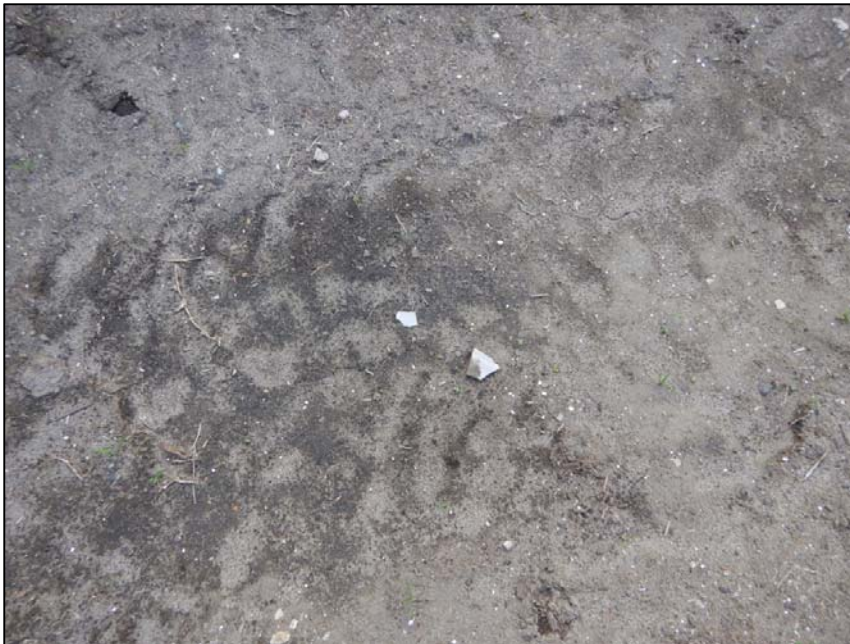
Figure 14: Evidence of Fill and possible ACM fragment

During development, it is recommended that appropriate inspections are conducted and if any materials are encountered that are different to the materials sampled and tested or exhibit signs of contamination (e.g. anthropogenic inclusions, fibro fragments, staining or odours etc.), these should be appropriately segregated for further assessment. The handling, transport and disposal / re-use of the materials should be conducted in accordance with regulatory and statutory requirements.
