Proposed Seniors Living  
Development  
Contamination  
Assessment

Boundary Road, Medowie  
NSW

NEW15P-0033D  
8 December 2017

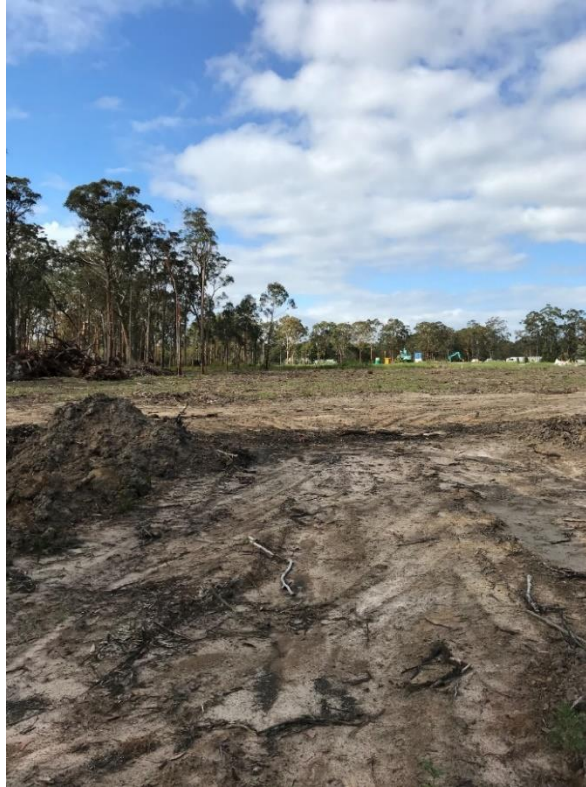
- The former residence and sheds had been removed from the southern portion of the site.

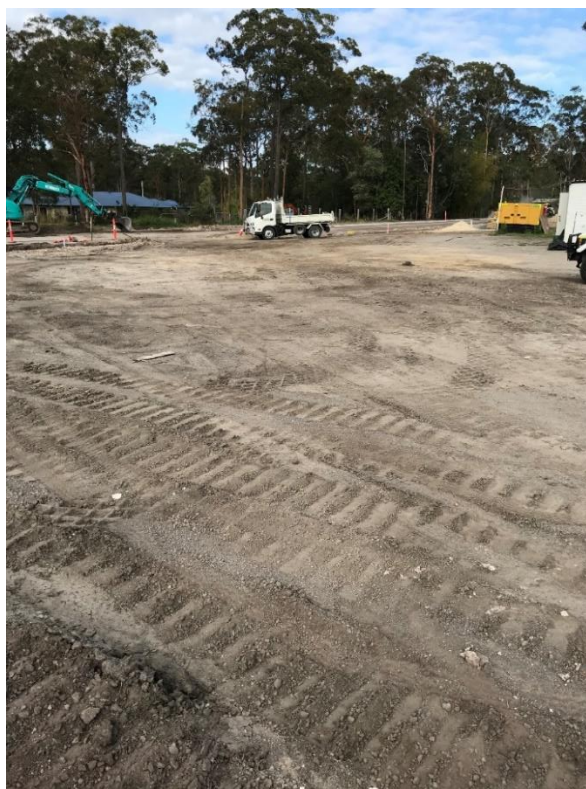
- The contractor for the subdivision works had set up a site office and vehicle parking area in the southwest portion of the site, near the footprint of the former residence. No stained soils were observed in the site office and parking area.

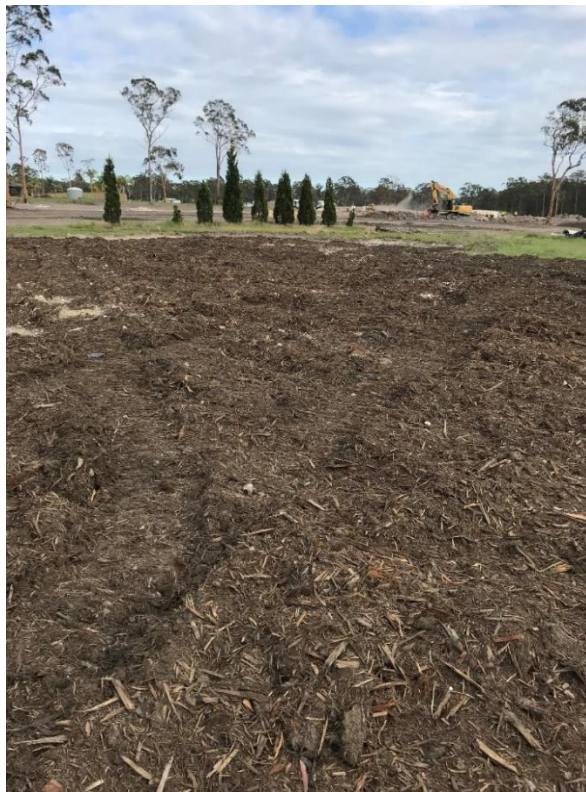
- The footprint of the former residence was covered in mulch and woodchip from the cleared vegetation.

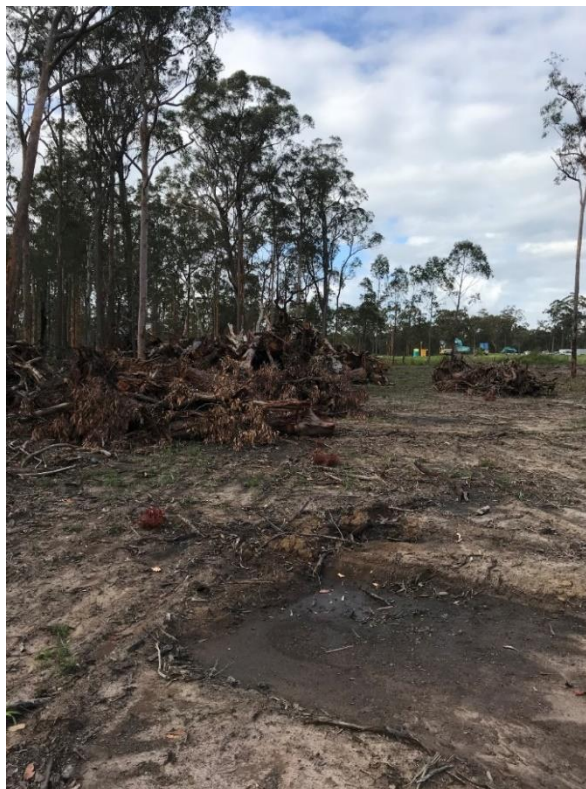
- The site was progressively being cleared of vegetation, with the western portion cleared and the eastern portion partially covered in bushland and several stockpiles of trees observed.

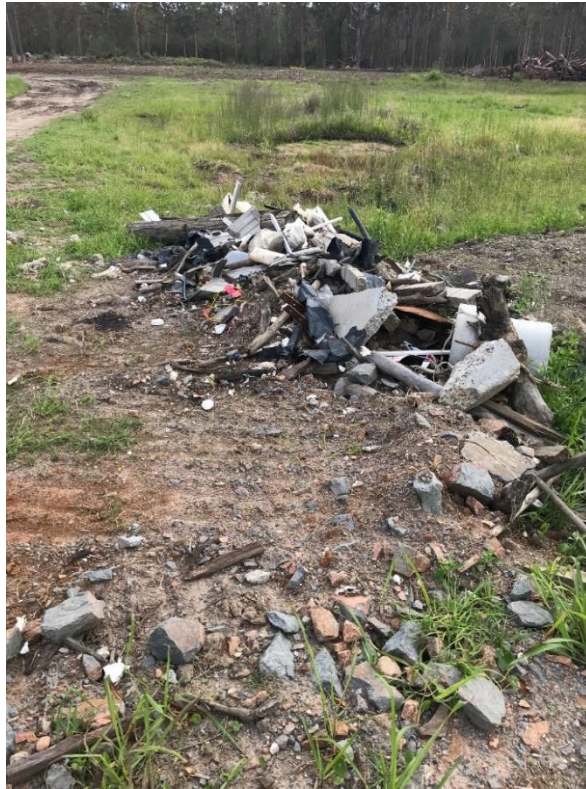
- A small amount (approx. 1m<sup>3</sup>) of anthropogenic materials such as glass, plastics, concrete, bricks, timber and metals were stockpiled near the site office.

The anthropogenic materials observed during the walkover should be removed from the site, and disposed and/or recycled at an appropriately licensed facility. Should material require disposal from the site, it will require classification in accordance with the NSW EPA (2014) Waste Classification Guidelines, or a relevant resource recovery order/exemption under Part 9, Clause 91 to 93 or the POEO (Waste) Regulation 2014. Should fill material be imported to the site, it will need to classify as Virgin Excavated Natural Material as described in the NSW EPA (2004) Waste Classification Guidelines, or meet a relevant resource recovery order/exemption.

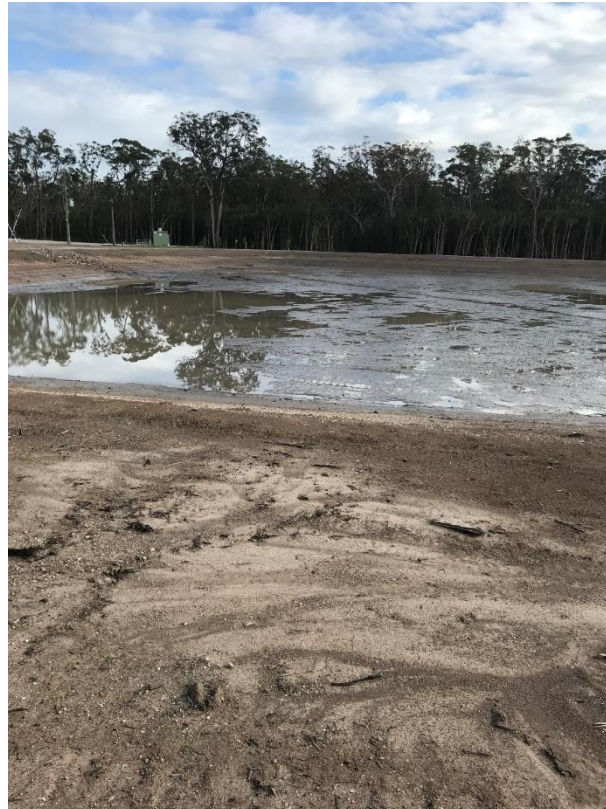
- A large man-made detention basin had been constructed to the north east of the site for collection of excess surface water runoff.
