Report on  
Geotechnical Investigation

New Science and Technology Building  
6A Waropara Road, Medowie

Prepared for  
Medowie Christian School

Project 81808.03  
July 2018

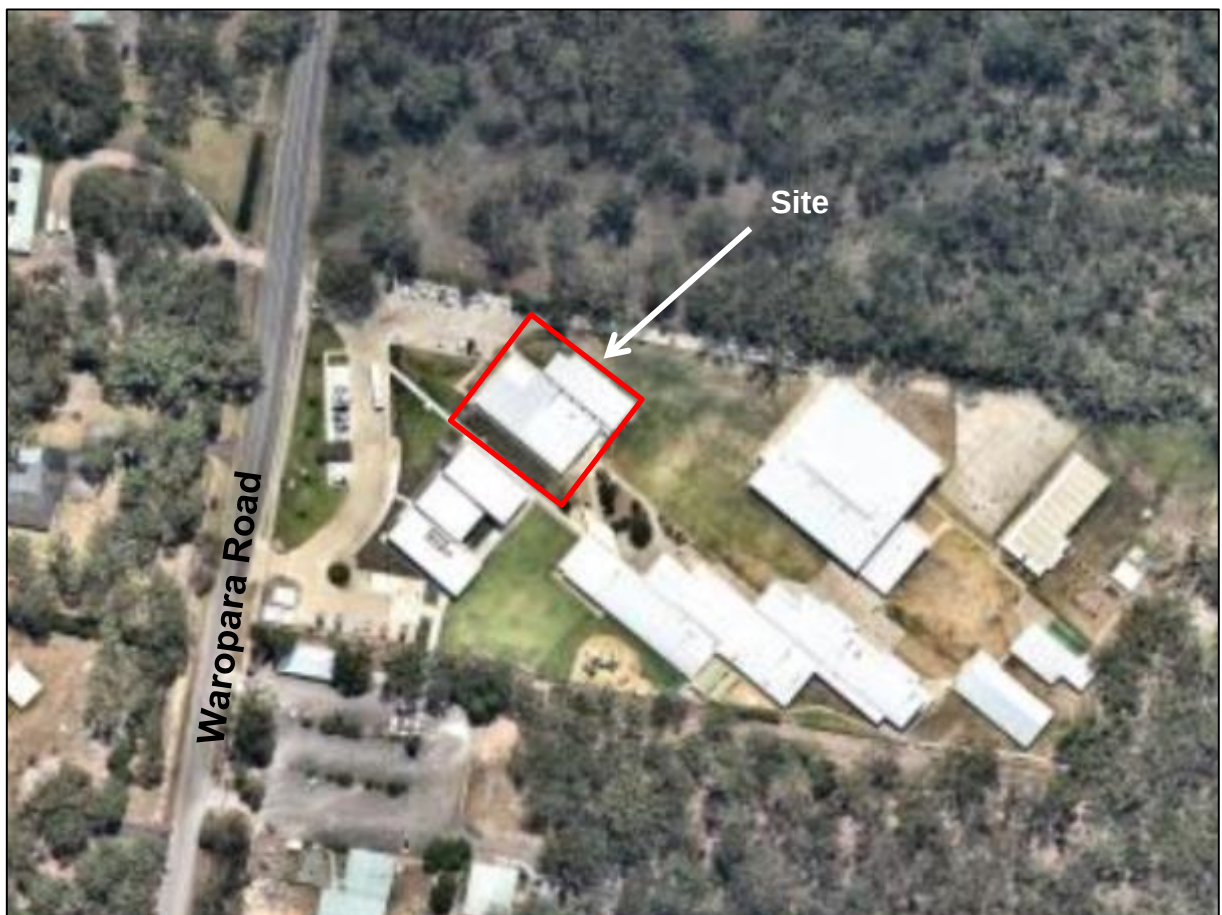
**Figure 1: Aerial image of Medowie Christian School showing site location of proposed new building.**

The site of the proposed new building is shown below in Figure 1.

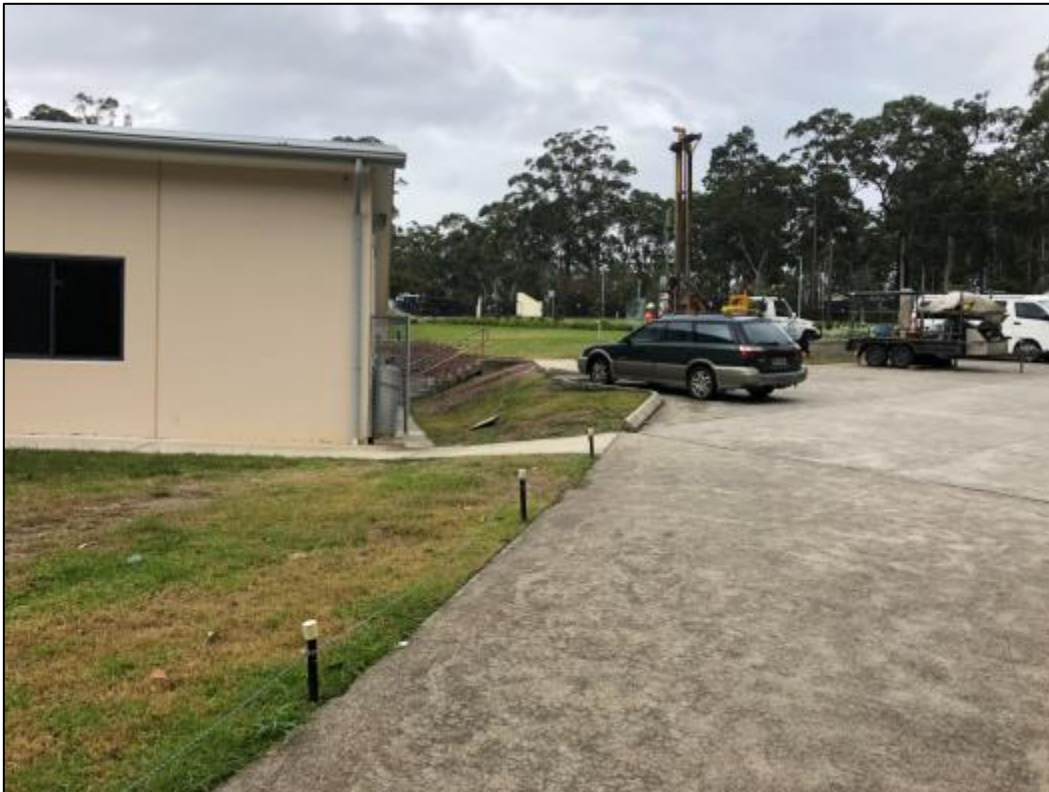
**Figure 2: Looking south-west towards existing Block S with Bore 101 in the background.**

Features of the site are shown in Figures 2 to 4 below.

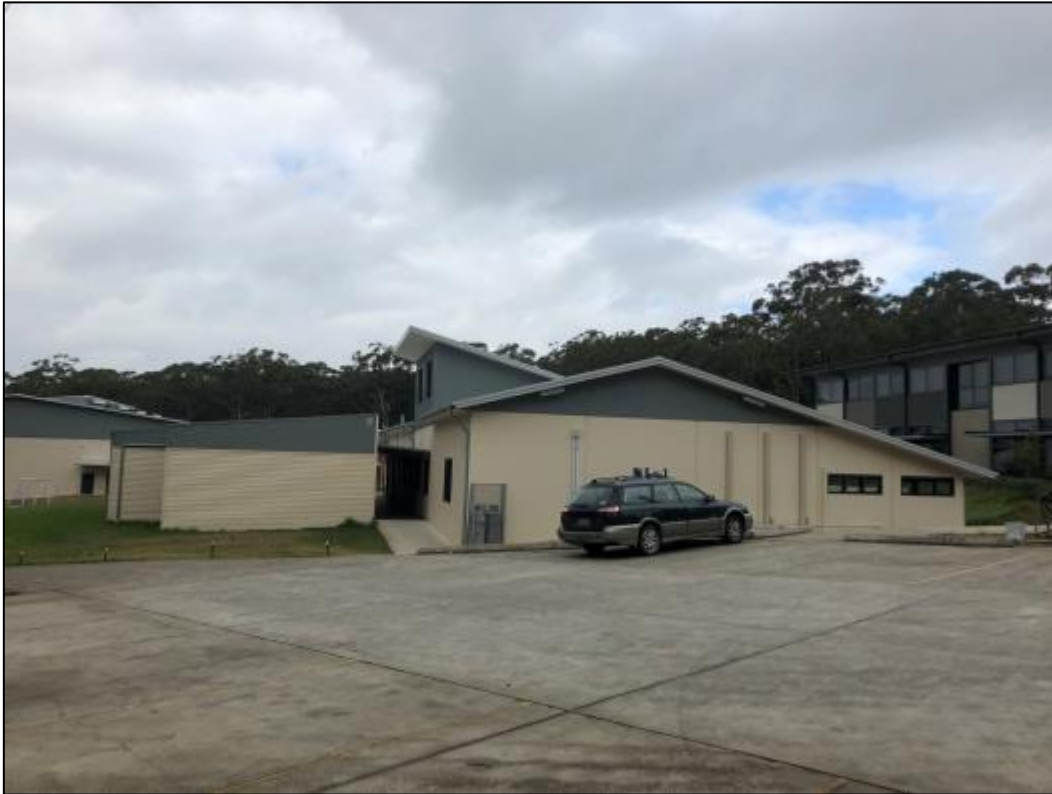
**Figure 3: Looking south-east towards Block S from existing carpark.**

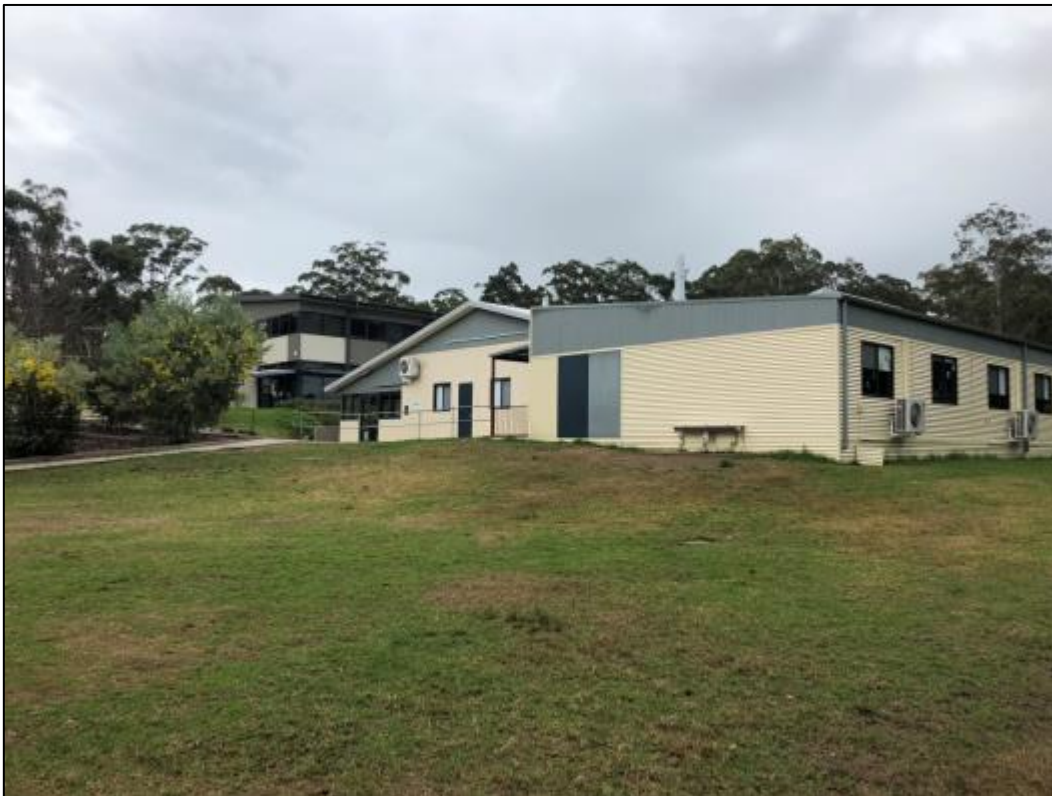
**Figure 4: Looking north-west toward Block S.**
