Report on Preliminary Site Investigation for Contamination

Proposed Residential Development Kings Hill, North Raymond Terrace

Prepared for PM No 1 Pty Ltd

Project 81502.14 August 2020

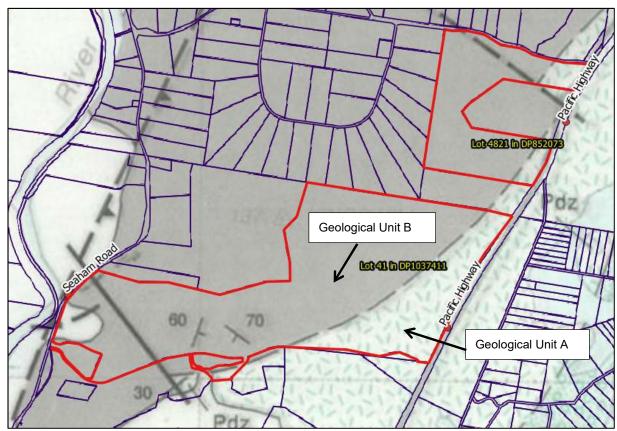
Figure 2: Extract from geological mapping (red - site boundaries)

The mapping indicates that the site lies over two geological units, as follows:

The conditions encountered in the former pits within the site were generally indicative of these two geological units.

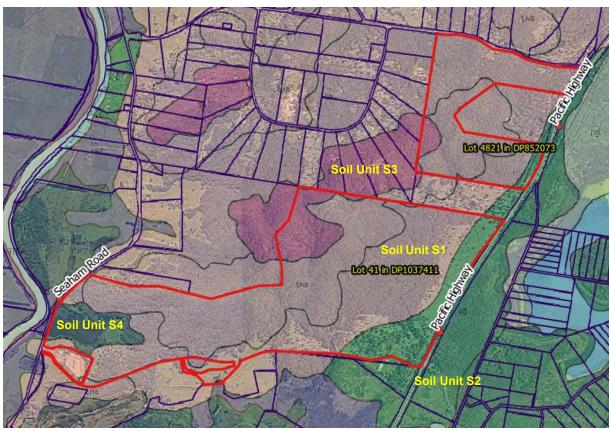
Figure 3: Extract from Soil Landscape Mapping (red – site boundaries)

The mapping indicates that the site extends over soils belonging to four landscape groups, as follows:

- Soil S1:Ten Mile Road Group (erosional). Limitations associated with this soil group include a high
 water erosion hazard, localised shallow soils, high run-on and seasonal waterlogging. These soils
 have been reported to be strongly to extremely acid;

- Soil S2: Wallalong Group (residual). Limitations associated with this soil group include high water erosion hazard, localised seasonal waterlogging and shallow soils. These soils have also been reported to be very highly acidic;

- Soil S3: Birdsview Variant A. Limitations associated with this soil group include steep slopes, mass movement hazard, water erosion hazard, high run-on, localised foundation hazard and localised shallow soil; and

- Soil S4: Hexham Swamp. Limitations associated with this soil group include flood hazard, permanently high watertable, seasonal waterlogging, foundation hazard, groundwater pollution hazard, highly plastic potential, acid sulfate soil.

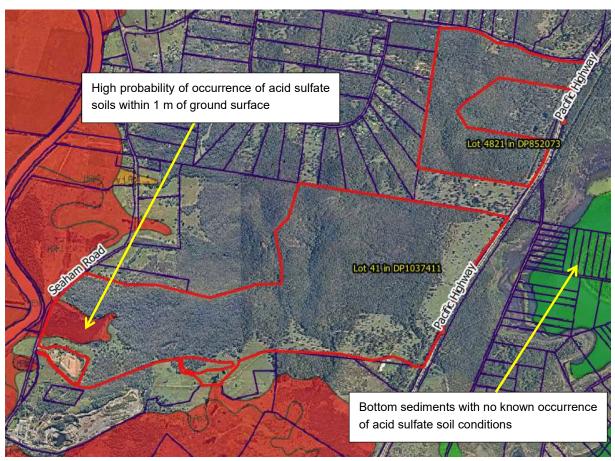
Figure 4: Extract from acid sulfate soil mapping (red – site boundaries)

Reference to the statewide digital acid sulfate soil mapping indicates that the site is located in an area mapped as having no known occurrence of acid sulfate soils. It is noted that an area mapped as having a high probability of acid sulfate soils is located in the south-western area of the site (the wetland) and also immediately to the south of the site. Figure 4 below is an extract from the acid sulfate soil mapping for the area.

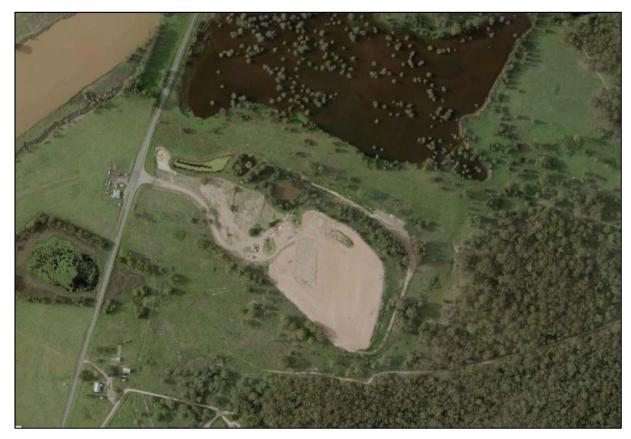
- The landfill operated from approximately 1988 to 1998;
- Putrescible waste was disposed at the landfill (i.e. solid waste);
- A waste thickness of up to 5 m is present;
- The landfill is no longer operational, however, it has not been appropriately decommissioned or capped. Capping activities were underway at the time of assessment (refer Figure 12) although details of the capping and decommissioning have not been provided;
- A monitoring program is in place for the landfill.

Figure 12: Image of Council landfill (image date 2 March 2020 by Metromap)

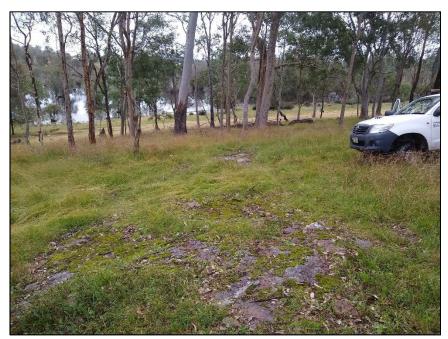
Figure 14: Rock outcrop in the western area of the site (near Bore 1005 - July 2020)

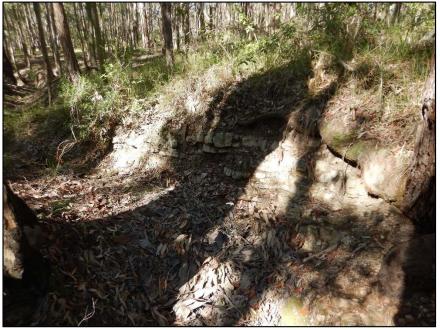
Figure 18: Existing cutting in central area of site (exposing sandstone and siltstone)(July 2020)

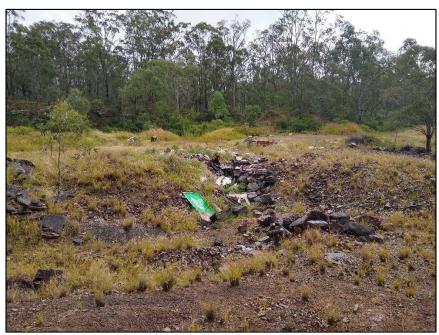
- A former quarry in the northern part of the site (refer Figure 21 to Figure 23);
- A number of different anthropogenic materials were observed within this area, including timber, plastic, asphalt, household waste, metal;
- An area of possible extraction activities in the western part of the site (refer Figure 24), possibly for localised filling activities to the south of the site.

Figure 21: Former quarry in northern part of the site

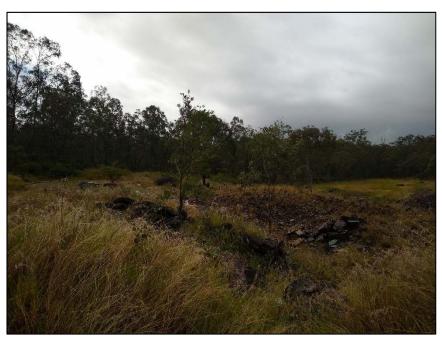
Figure 22: View of former quarry in northern area of the site

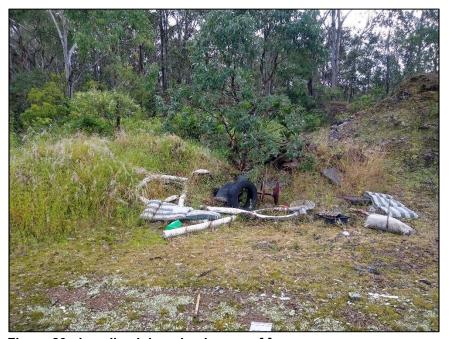
Figure 23: Localised dumping in area of former quarry

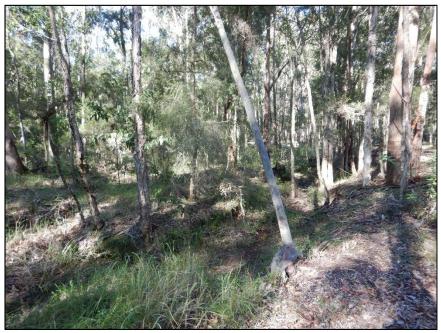
Figure 24: Image looking east into area of possible former extraction activities
