Report on  
Assessment of Ground Gases

Proposed Residential Development  
Kings Hill, North Raymond Terrace

Prepared for  
PM No 1 Pty Ltd

Project 81502.13  
September 2020

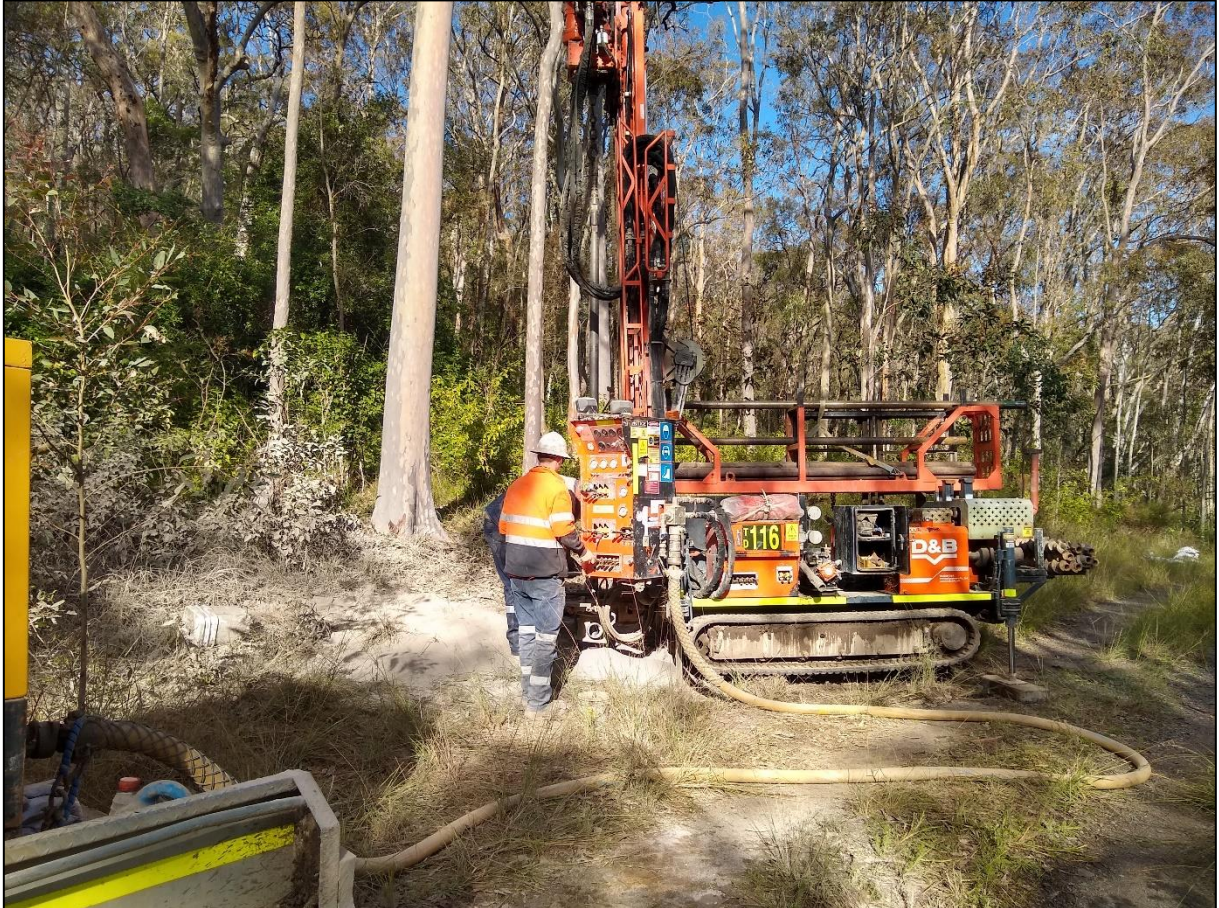
The field work was carried out over the period extending from 27 July 2020 to 31 August 2020 and included the drilling of test bores and the installation of gas monitoring wells. The bores were drilled using a track mounted drilling rig using percussion drilling (refer Figure 5).

Seven bores (Bores 6001 to 6005, 6001A and 6002A) were drilled to depths ranging from 1.5 m to 30.2 m. The deeper boreholes (Bores 6001 and 6002) were drilled to the approximate depth of the inferred groundwater table (i.e. to saturated ground). The remaining shallow bores (Bores 6001A, 6002A, 6003 and 6005) were drilled to about the top of bedrock.

**Figure 5: Drilling rig configuration**

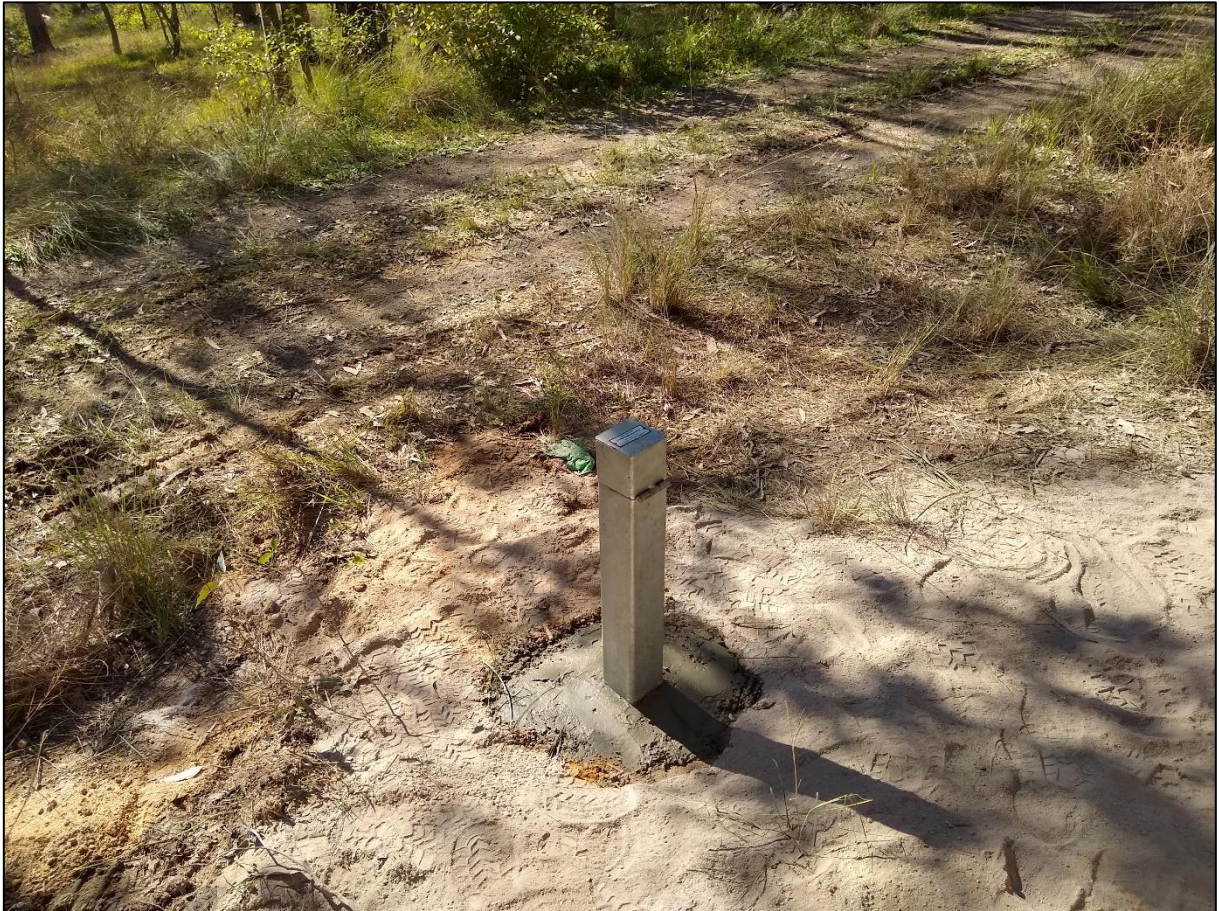
Following the completion of drilling gas monitoring wells were installed within the bores to facilitate ongoing gas monitoring. The monitoring wells were constructed of 50 mm diameter flush threaded Class 18 uPVC and machine slotted screens. A sand filter was installed to approximately 0.5 m to 2 m above the screened section, with an approximately 0.6 m to 1 m thick bentonite sealing layer above. The upper section of the annulus of the piezometers was backfilled with cuttings and 7 mm screened sand to approximately 1 m below the surface where a 1 m concrete plug was installed. Each well was fitted with a gas-tight cap with quick connect gas fitting. A steel monument cover was placed at the surface (refer Figure 6).

**Figure 6: Typical Well installation on site**

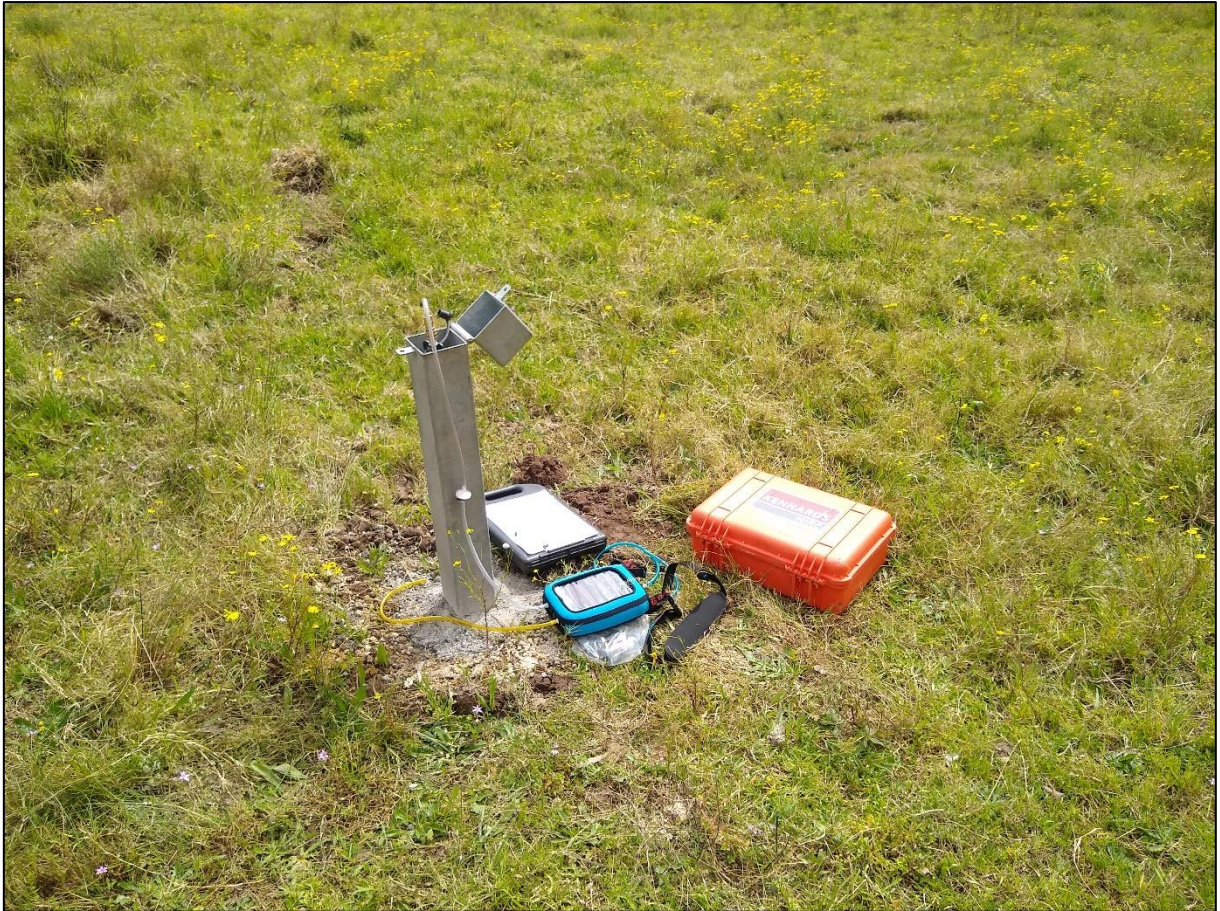
- Record the barometric pressure;
- Connect the tube on the calibrated landfill gas analyser (GA5000) to the quick connect gas fitting on the well cap (refer Figure 7); and

- Set the analyser pump on and record concentrations of methane, carbon dioxide, oxygen, carbon monoxide and hydrogen sulphide, generally at 30 second intervals, for a minimum of ten minutes and until concentrations have generally stabilised.

**Figure 7: Gas monitoring set up**

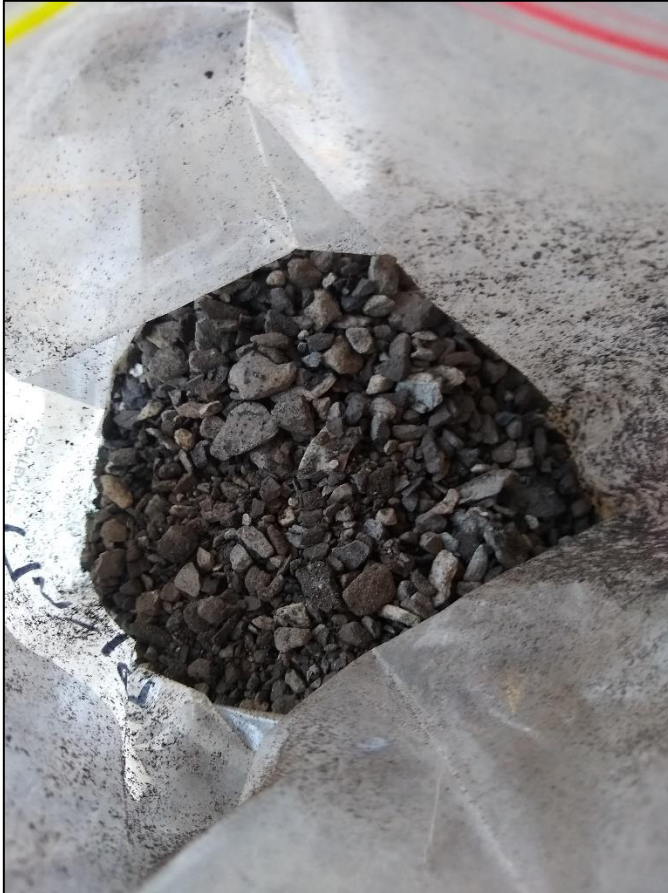
**UNIT 2 – Sandstone BEDROCK**, sandstone or conglomerate bedrock with occasional carbonaceous layers (refer Figure 8).

**Figure 8: Carbonaceous seams within sandstone bedrock (Bore 6001)**

Overall, the results to date indicate a CS1 classification based on the procedures outlined in NSW EPA (2020) which is defined as 'very low risk'. DP note that the absence of methane in the subsurface gas mixture suggests the gas present is unlikely to be sourced from landfill gas (ie: the biodegradation of putrescible waste) but rather from naturally occurring sources (ie: breakdown of organic matter in soils and carbonaceous seams within the rock strata at depth).

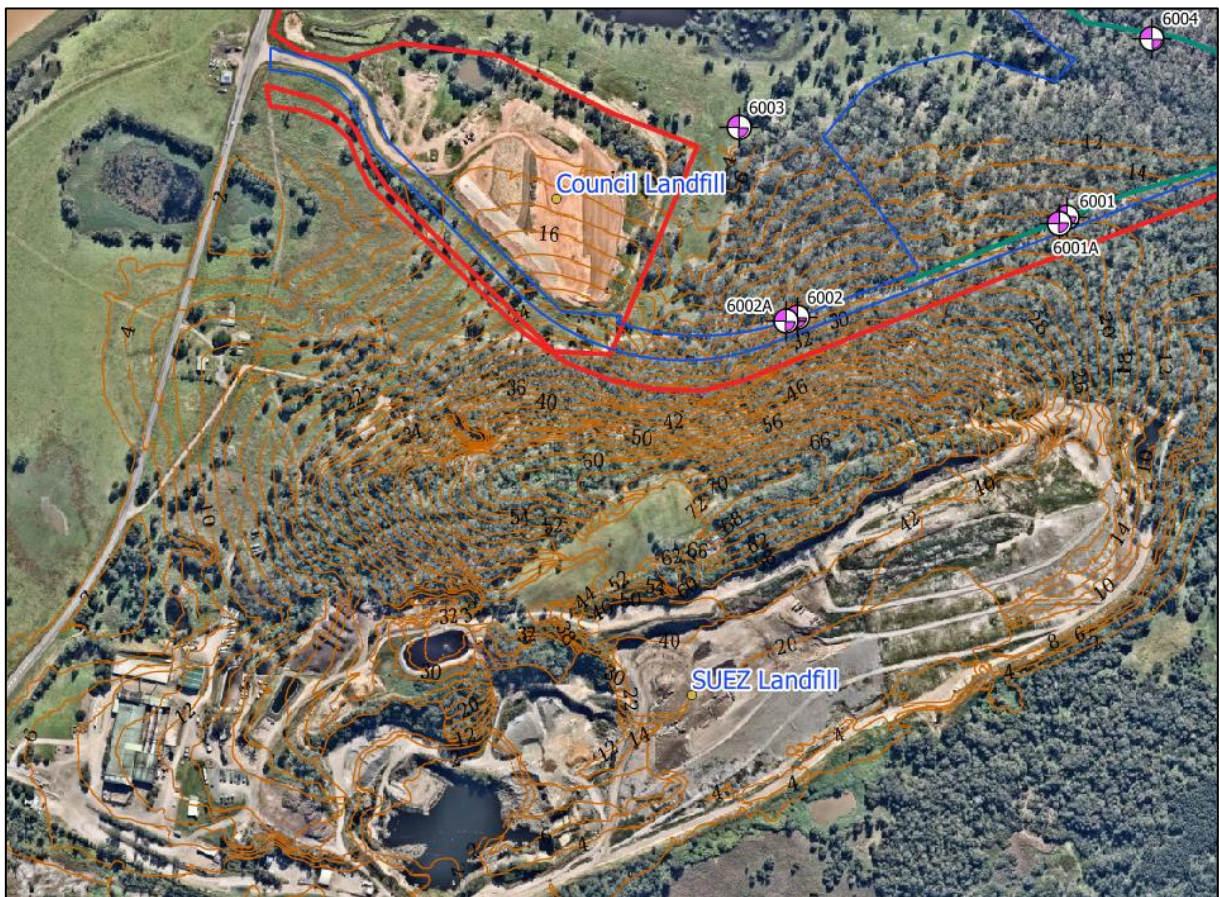
- The elevation of the base of the landfill is likely to be about RL 2 m AHD. With the ground surface in the area of the proposed residential development in the range of 6 m AHD to 20 m AHD. The surface topography between the Suez landfill and the development site contains a ridgeline, roughly orientated east to west, with surface levels in the order of 28 m AHD to 72 m AHD. The results of the bores indicate that the intervening strata is predominantly sandstone, although some carbonaceous and coal seams may be present. This is consistent with information provided in ERM (2019) which indicated that coal seams may be present within the northern wall of the Suez landfill.

**Figure 9: Aerial image of landfills with surface level contours**
