RE: Development Application for the Construction and Operation of a 4.99MW Solar Farm at Carrigan Road, Boggabilla (Lot 1 DP1236244) Response to Office of Environment and Heritage

FLOOD AND DEBRIS ASSESSMENT

KENTUCKY SOLAR FARM

Kentucky Lane, Boggabilla NSW 2409 Lot 1 in Deposited Plan 1236244

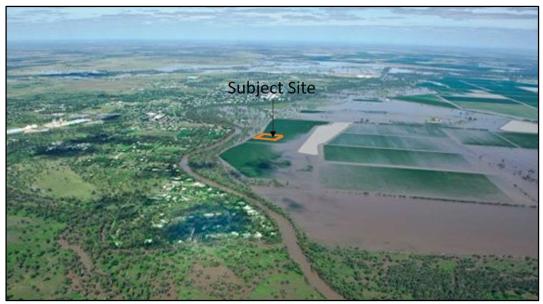
Figure 3 shows the wider context of the flood event. The floodplain to the south is fully inundated. The solar farm is located on a high natural bank area which is typical of the natural river system. Floodwater inundates this area, but the depth is considered relatively minor.

Figure 3: View west to east across the subject site during the 2011 flood event⁴

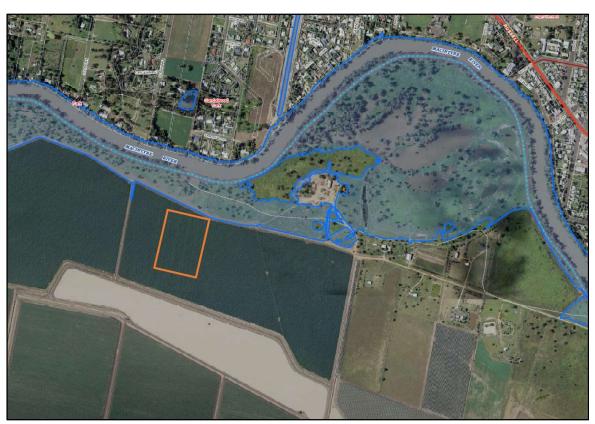
Figure 4 is an extract of the Goondiwindi 2011 Flood Map prepared by the Department of Environment and Resource Management. The background image was taken on the 14th of January, 2011.

Figure 4: Overhead aerial imagery of flood water on 14th January 2011

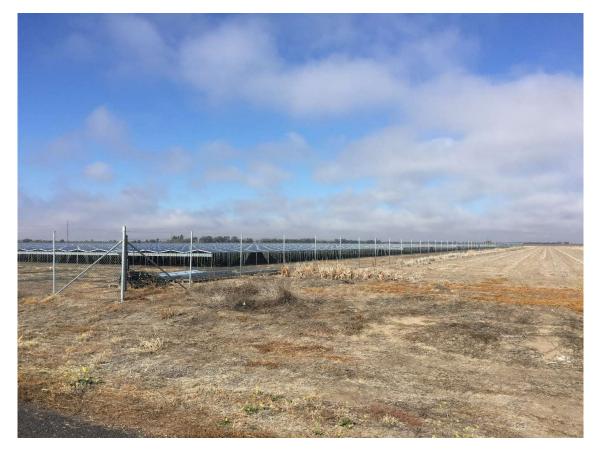
The dimensions of the Chillamurra farm is similar to the proposed Kentucky farm. The development will therefore impose a width of approximately 290m north-south and a total of approximately 550m in an east-west direction. The main flow direction of water is east to west and therefore the proposed Kentucky farm will not impose any significant additional blockage to the passing of flood water moving west.

Figure 8: Chillamurra Solar Farm fence on downstream side.
