PORT MACQUARIE STAGE 2 CSU PORT MACQUARIE

LANDSCAPE DEVELOPMENT APPLICATION

L003 (Review of Additional Landfill Gas Investigation - Rev 0).docx
Attachment 2 – Site Layout
,

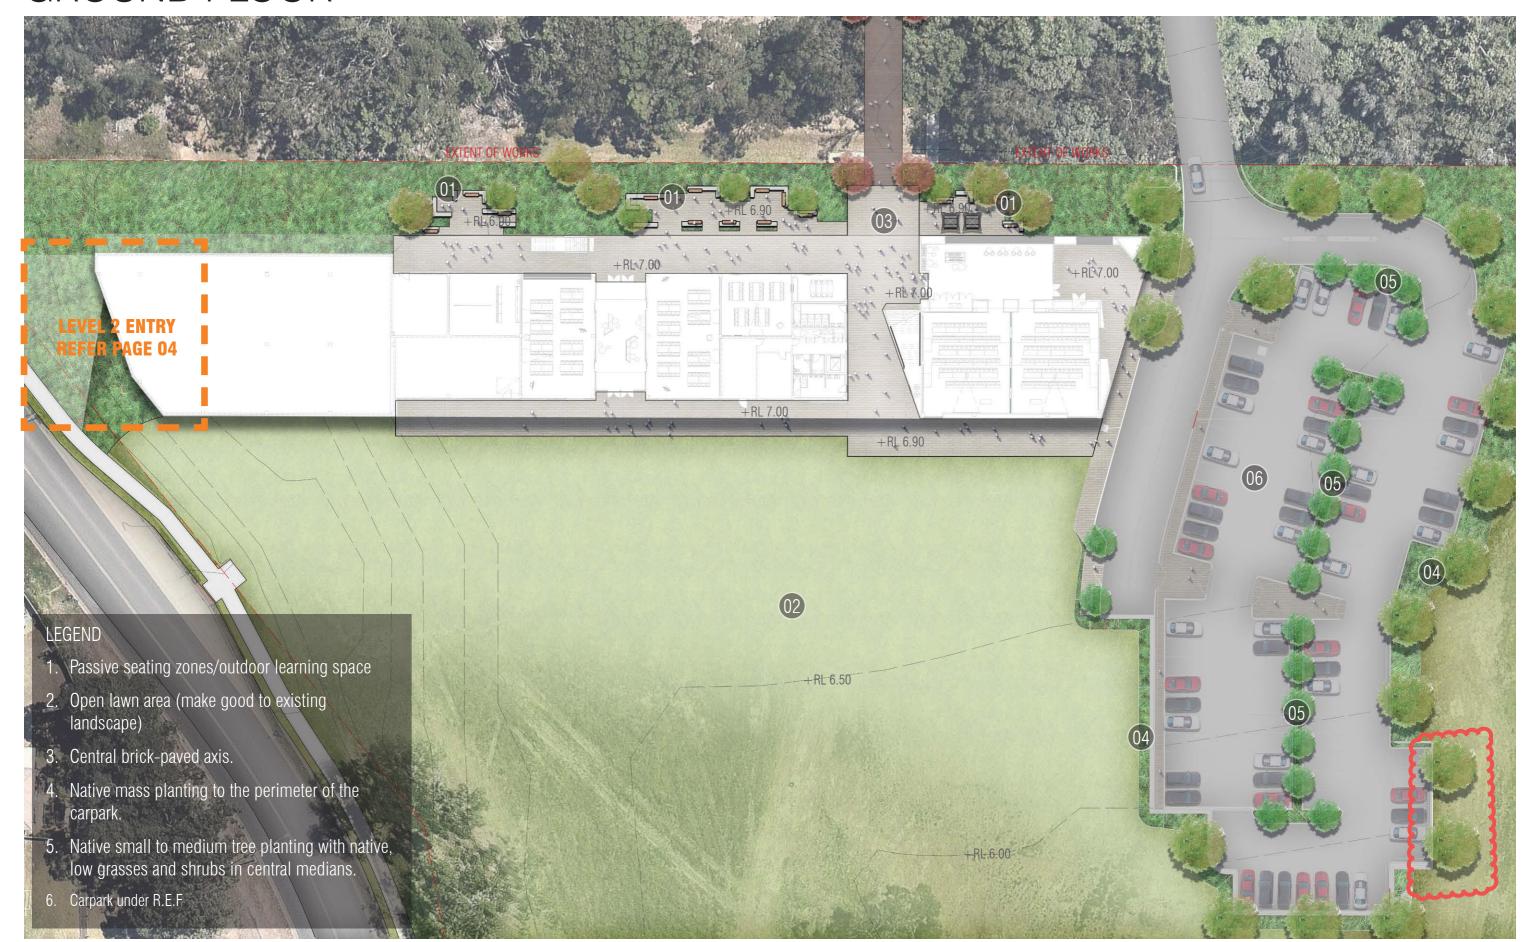
LANDSCAPE MASTERPLAN

GROUND FLOOR

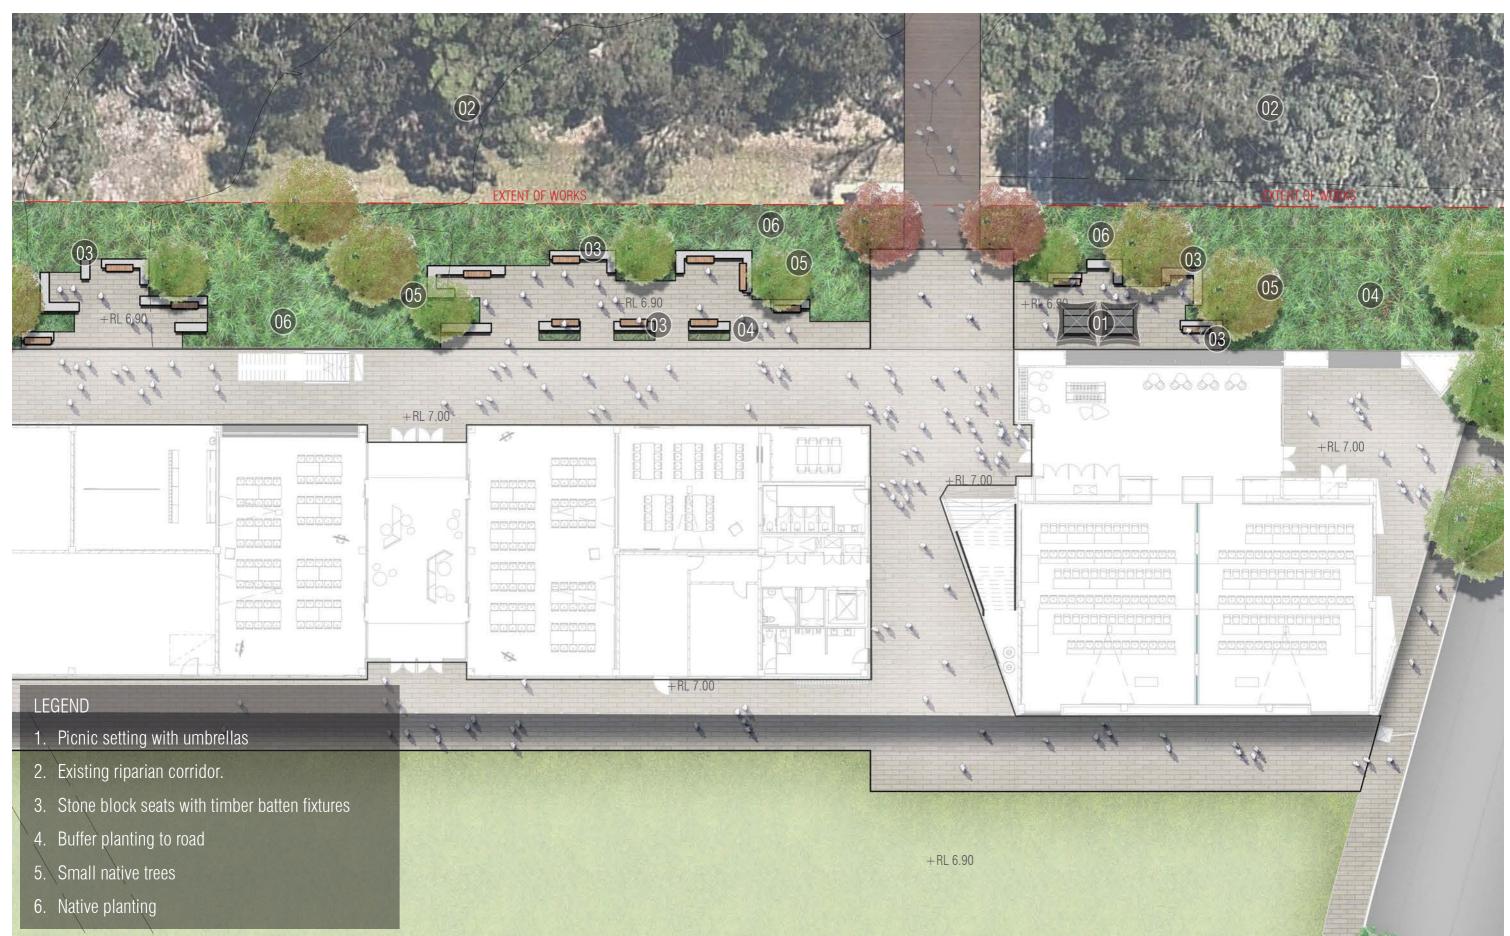
LANDSCAPE DETAIL PLAN

GROUND FLOOR

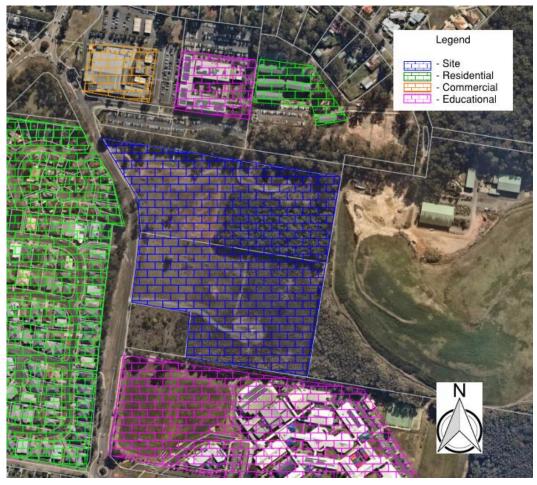
Figure 1.1 Location map of identified receivers in relation to proposed development (Source: Nearmap)

As shown in Figure 1.1, the site is surrounded by a mixture of urban development including residential and commercial buildings. Table 1.1 outlines the identified noise sensitive receivers which have the potential to be affected by noise emissions from the proposed development. Approximate distances from the proposed development have also been provided.

The proposed stage 2 building works is located in the northern half of the site highlighted in Figure 1.1.

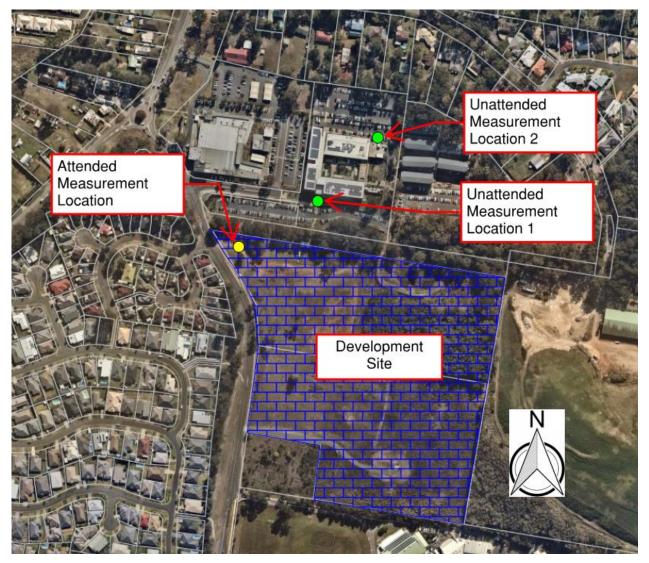
Figure 2.1 Indicative logger locations, CSU PMQ development (Source: Nearmap)

The CSU PMQ Stage 1 noise survey consisted of two unattended noise loggers setup within the development site of Stage 1.

WSP undertook attended noise measurements at the Stage 2 development site to validate the previous unattended measurements. Indicative locations of the logging equipment are shown in Figure 2.1.

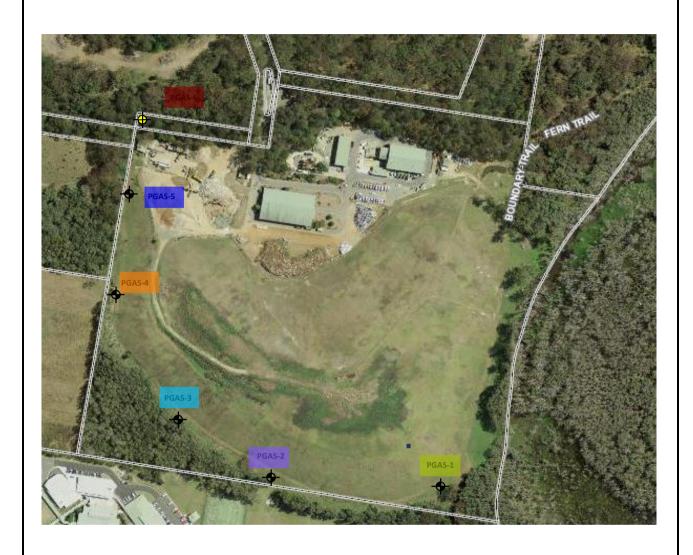
L001 (Review of Landfill Gas Investigation - CSU Port Macquarie Stage 2 - Rev 0).docx
Attachment 3 – Bore Locations

Legend
-	 	Bore Location

Current plans for the Stage 2 CSU development (refer **Attachment 3**) show that a portion of the proposed building lies within a 250 metre buffer around the former landfill site boundary. Further assessment of ground gas risks has therefore been recommended to determine whether gas protection measures are required on the CSU site. Additional assessment should involve the installation of a network of monitoring bores on the CSU site with at least six measurements (preferably during falling atmospheric pressure) of gas concentration and flow being completed over a minimum period of 3 months. Landfill gas monitoring bores (minimum of six) should be located as follows:
