## ARBORICULTURAL IMPACT ASSESSMENT

**Yagoona Public School**

Version 3

18 October 2017

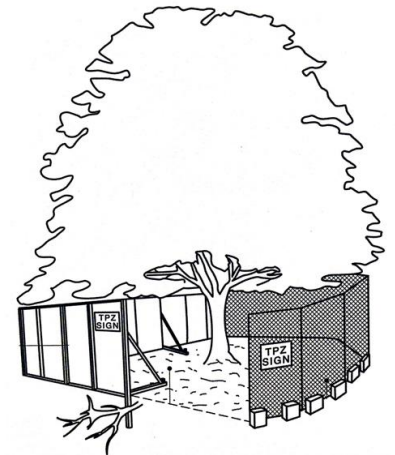
Trees that are to be retained must have protective fencing erected around the TPZ (or as specified in the body of the report) to protect and isolate it from the construction works. Fencing must comply with the *Australian Standard, AS 4687-2007, Temporary fencing and hoardings*.

- Enclosed to the full extent of the TPZ (or as specified in the Recommendations and Tree Protection Plan).
- Temporary mesh panel fencing (minimum height 1.8m).
- Certified and Inspected by the Project Arborist.
- Installed prior to the commencement of works.
- Prominently signposted with 300mm x 450mm boards stating, "NO ACCESS - TREE PROTECTION ZONE".
