Geotechnical Investigation Report

**Proposed Residential Development at
185 Fifth Ave, Austral NSW**

GM Architects Pty Ltd

Report No. P2017-014-G217 Rev 0

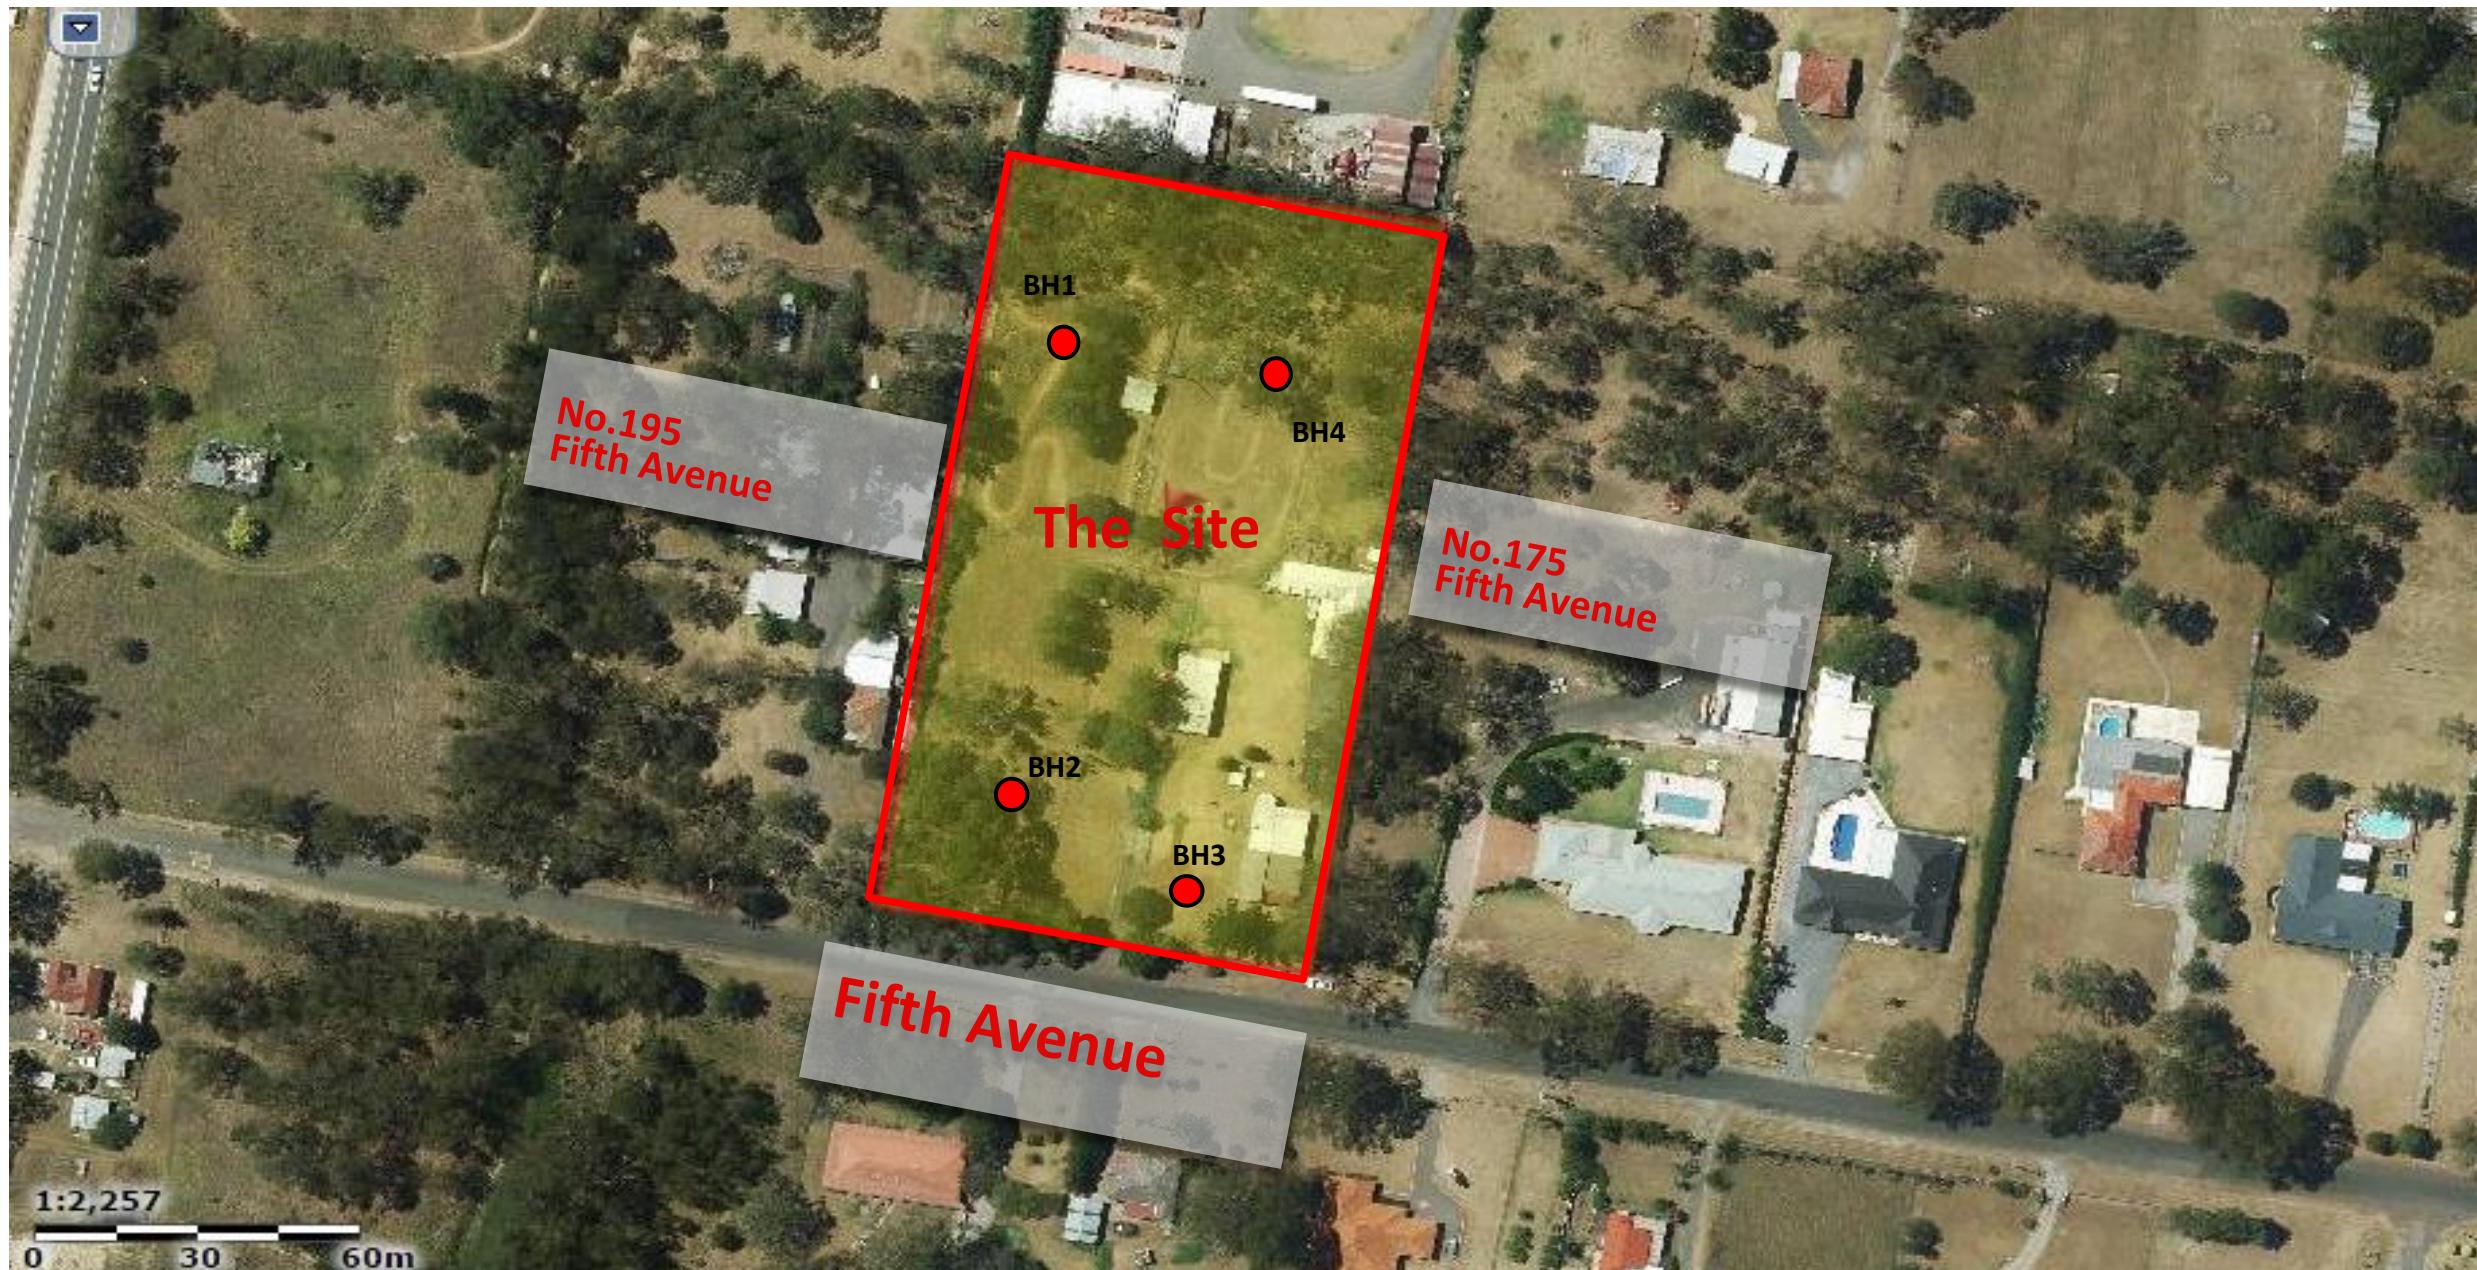
Key		DRAWN RL	Site Features and Borehole Location Plan
Site Boundary	—	FIGURE 2	GM Architects
Geotechnical Investigation holes	●	Job # G217	185 Fifth Avenue, Austral

The approximate locations of the investigation locations are shown in Figure 2 with respect to the current site layout, and in Figure 3 with respect to the future proposed basement footprints. A typical section of the proposed carpark basements and development above together with the investigation holes is shown in Figure 4. The Engineering Logs are presented in Appendix B, the Core logs are presented in Appendix C and the Core Photographs are presented in Appendix D.

- A detailed walk-over inspection of the site and surrounding environment to capture any significant geological features.
- Drilling of four (4) boreholes, BH1 , BH2, BH3 and BH4 using a 5 tonne truck-mounted drilling rig equipped with TC-bit attached to a solid flight auger and NMLC diamond rock corer. The boreholes were drilled down to a total depth of 9.7m (BH1), 8.9m (BH2), 7.3m (BH3) and 7.4m (BH4) below existing ground level.
- Standard Penetration Tests (SPT) was undertaken at regular intervals within the soil profile to assess the in-situ strength of subsoil properties.

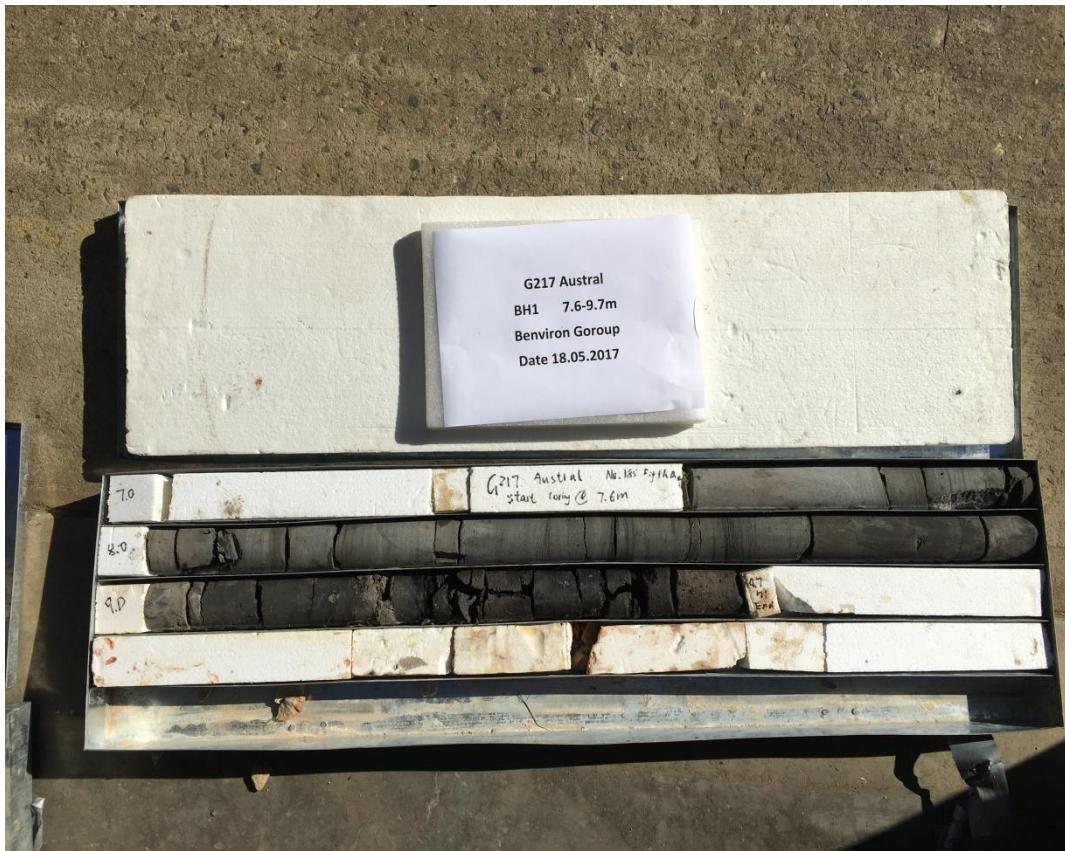
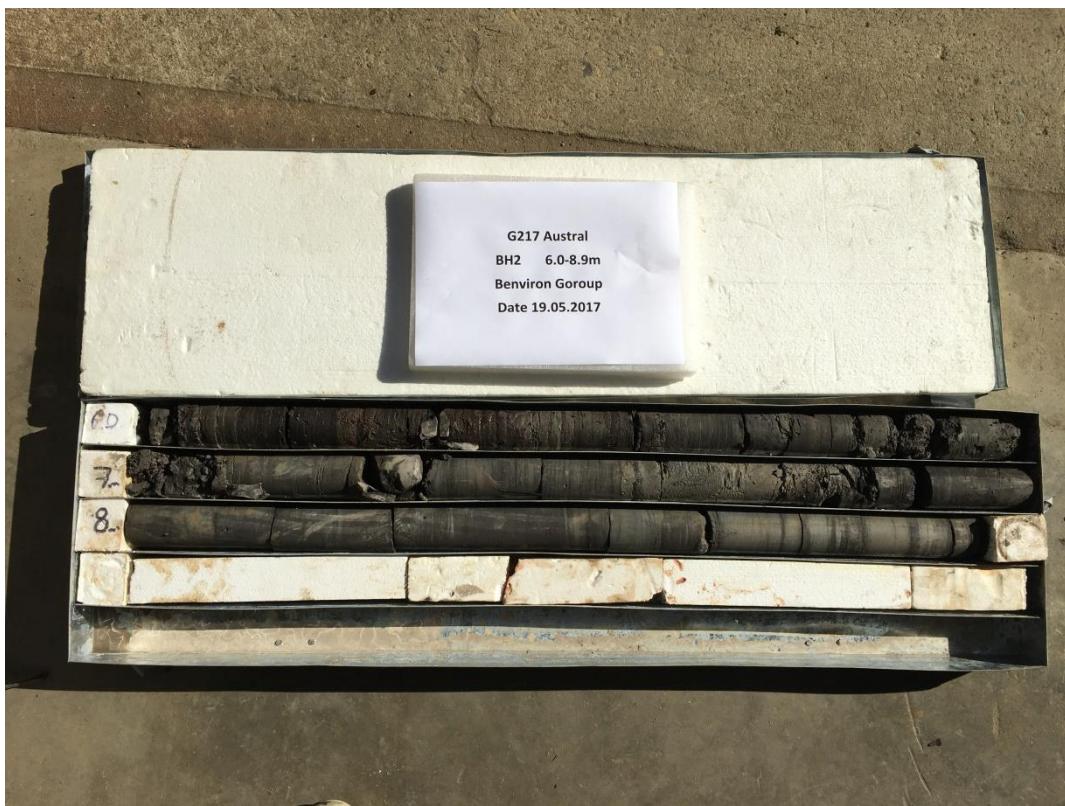
Core Photographs

7.0		Shale, greenish grey, very closely spaced to closely spaced, medium to high strength									7.0-7.08 Fracture Zone	7.0
				7.1											7.1 Clean Joints	7.1

7.2											7.23-7.30 Fracture Zone	7.2
				7.3											7.44 Clean Joints	7.3
				7.4											7.57 Clean Joints	7.4
				7.5											7.67 Clean Joints	7.5
