DETAILED SITE INVESTIGATION (DSI)

185 Fifth Avenue, Austral NSW

**Prepared for
GM Architects**

February 2018

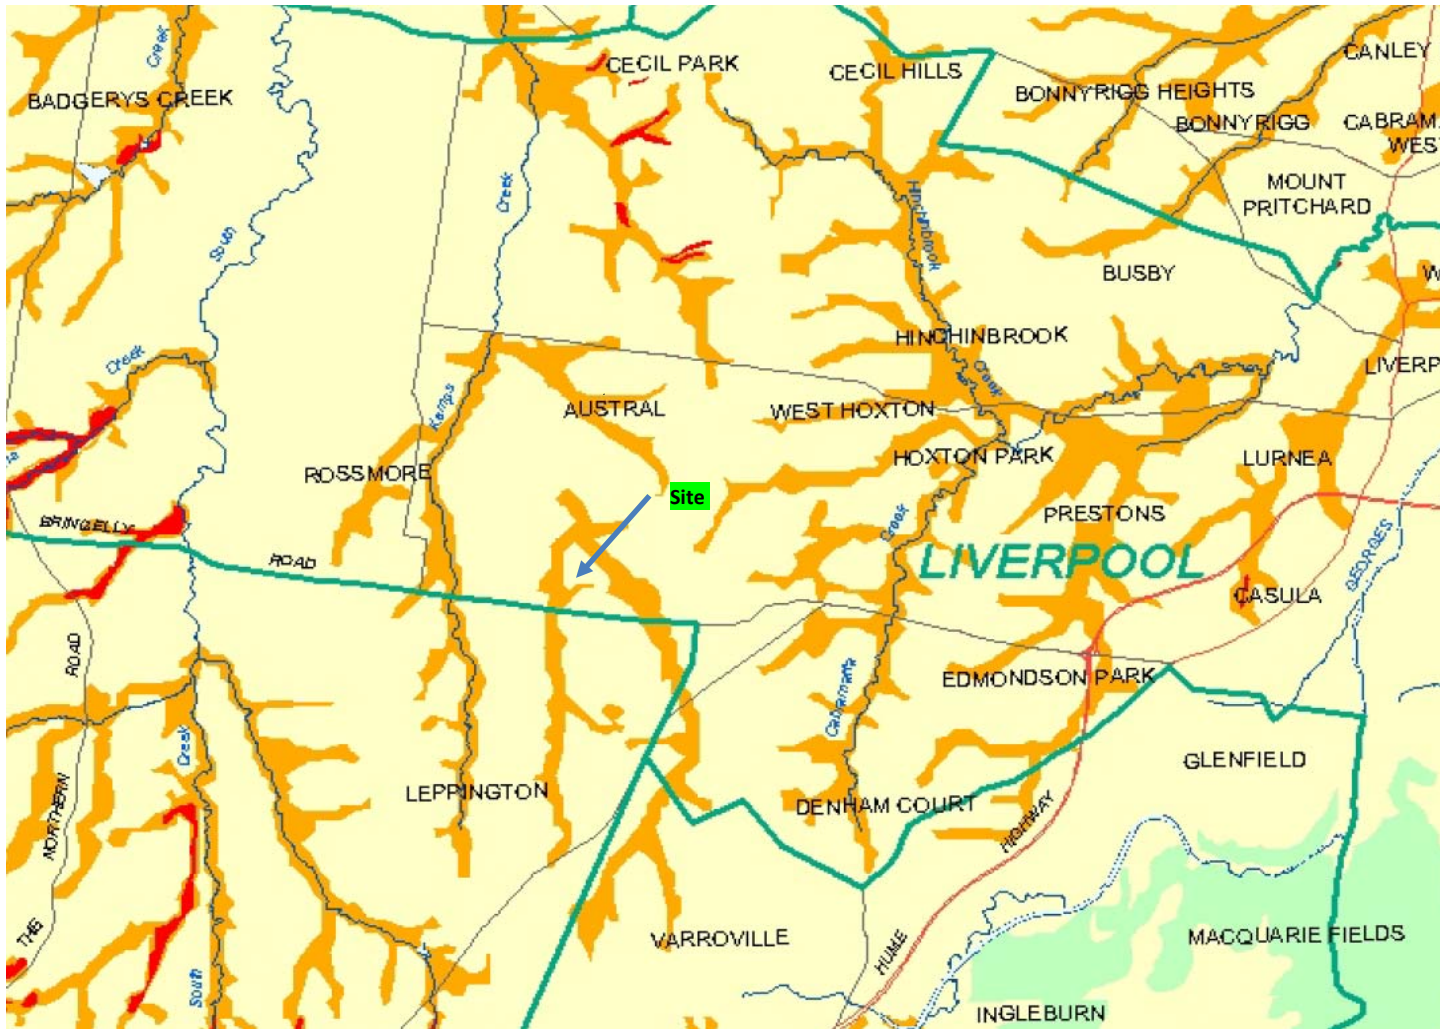
APPENDIX F SALINITY RISK MAP

Salinity Potential
