Report on

Geotechnical

Assessment

Address: 88-92 Elizabeth Drive, Liverpool

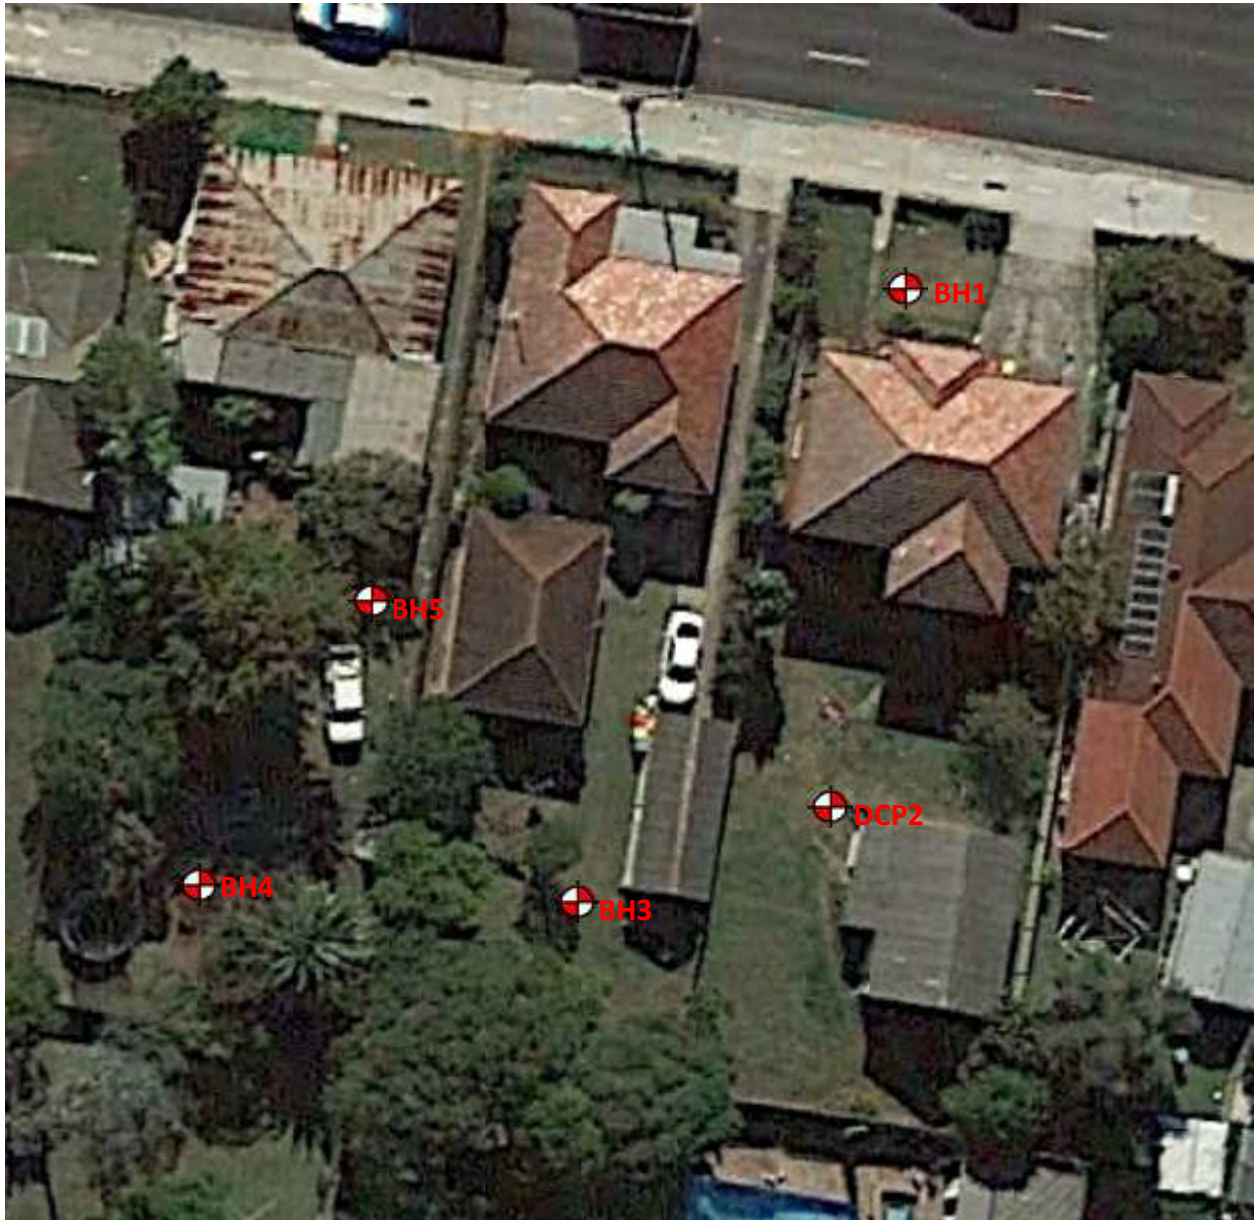
Figure 1 – Borehole and DCP Location Plan

Fieldwork was undertaken on 14 March 2017 and included drilling four boreholes (BH1 and BH3-BH5) using a 4WD Mitsubishi Triton Ute mounted drill rig using solid flight spiral augers to a maximum depth of 4.2m at the locations shown on Figure 1, attached in Appendix A. The Boreholes were supplemented with Dynamic Cone Penetrometer (DCP) testing for the measurement of soil strength properties.
