Report on

Preliminary Contamination Assessment

Address: 88-92 Elizabeth Drive, Liverpool

Job No: 26191

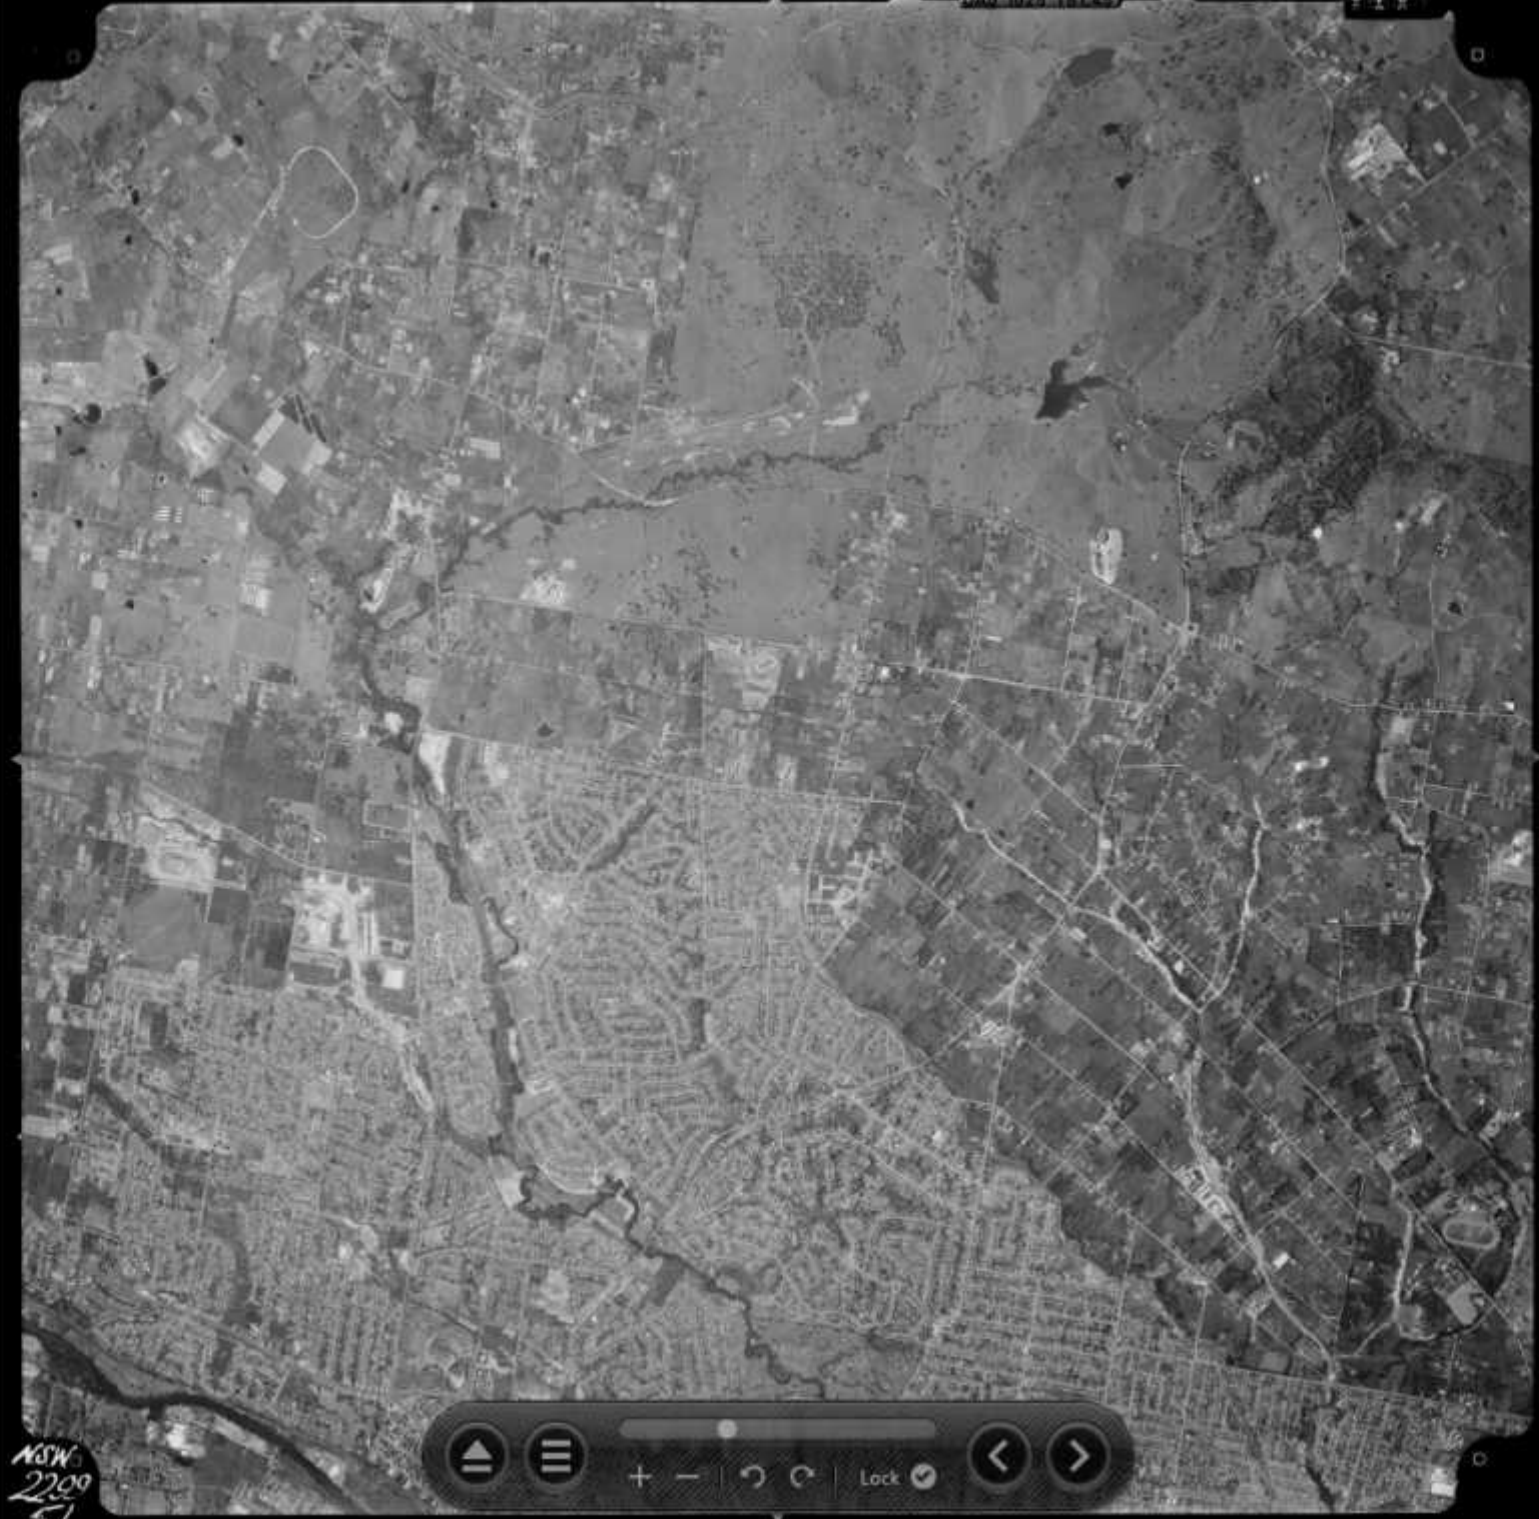
AERIAL PHOTOGRAPHS

1951 – The site is situated within a residential area with a cemetery located to the west.

1971 – The site is largely unchanged with the surrounding area having been slightly more developed with residential dwellings.

1986 – The site has undergone very little change as visible from the previous aerial photograph in 1971.

1998 – Little change present since the previous aerial photograph in 1986.

2004-2016 – The site has been unchanged since the photograph taken in 1998.

In summary, the aerial photographs reveal that the site was initially situated within a residential area evident from the photograph in 1961. The site has remained largely unchanged from the photograph in 1951 to the date of the site inspection in 2017.

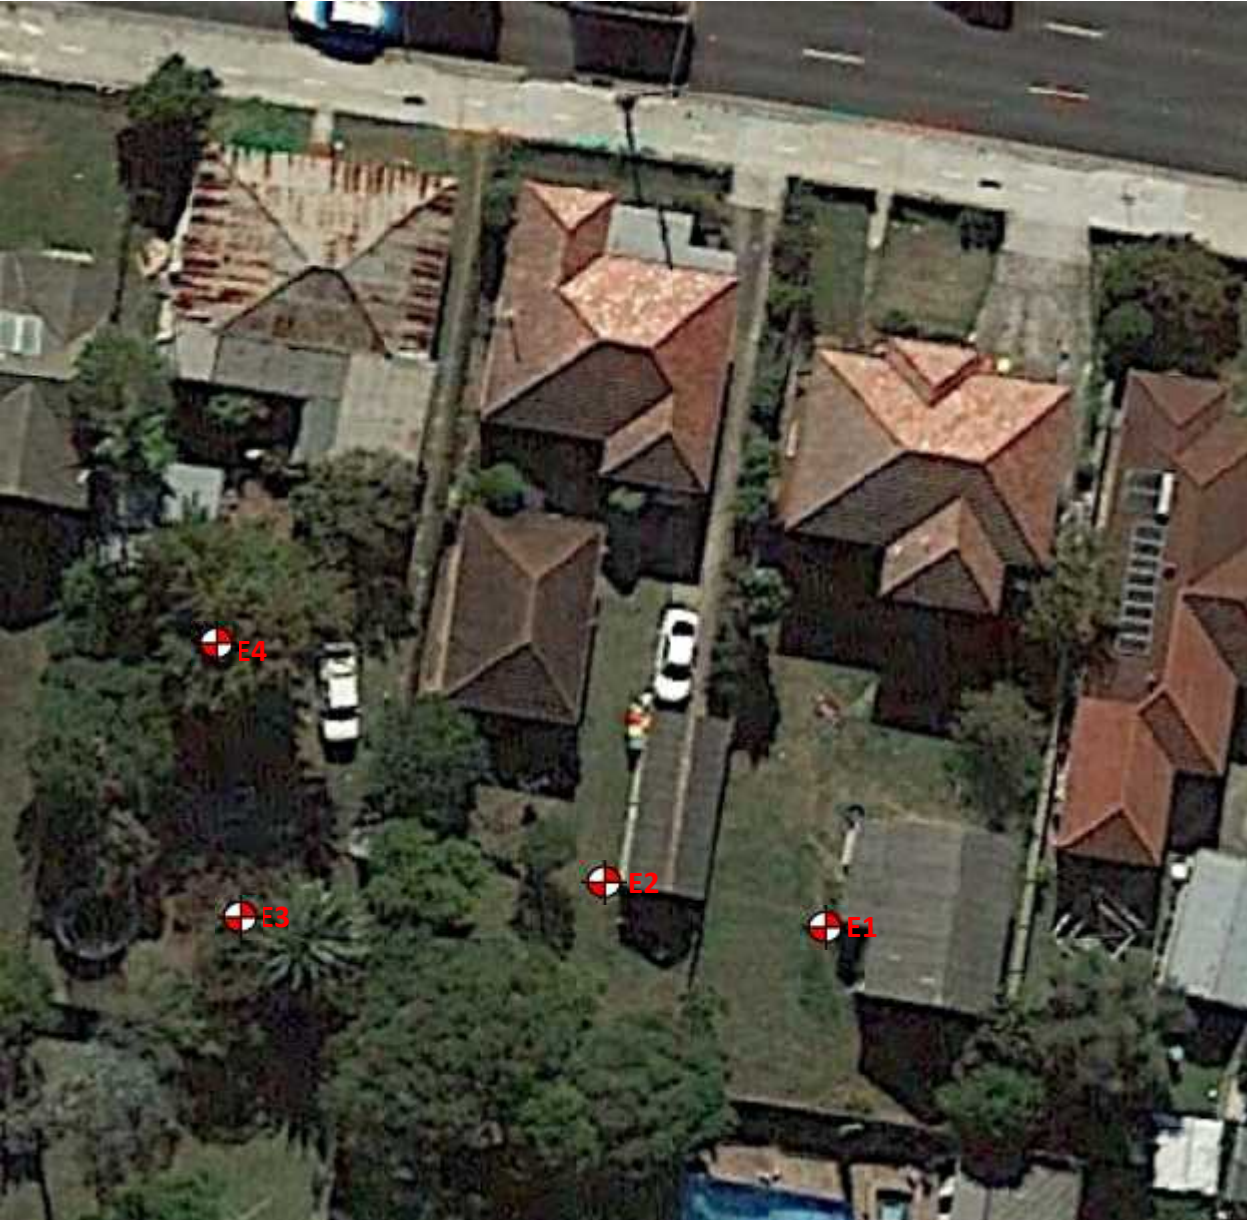
Figure 1 – Sampling Location Plan

Each sample location (refer to Figure 1) was excavated utilizing hand tools to a depth of 0.2m below ground surface. The sample was collected from the hole using a stainless steel trowel, which had been decontaminated prior to use to prevent cross contamination occurring.
