55 Martin Road, Badgerys Creek:

Flora and Fauna Survey and Impact Assessment

For Brent M Winning JP

By Ecological Consultants Australia Pty Ltd

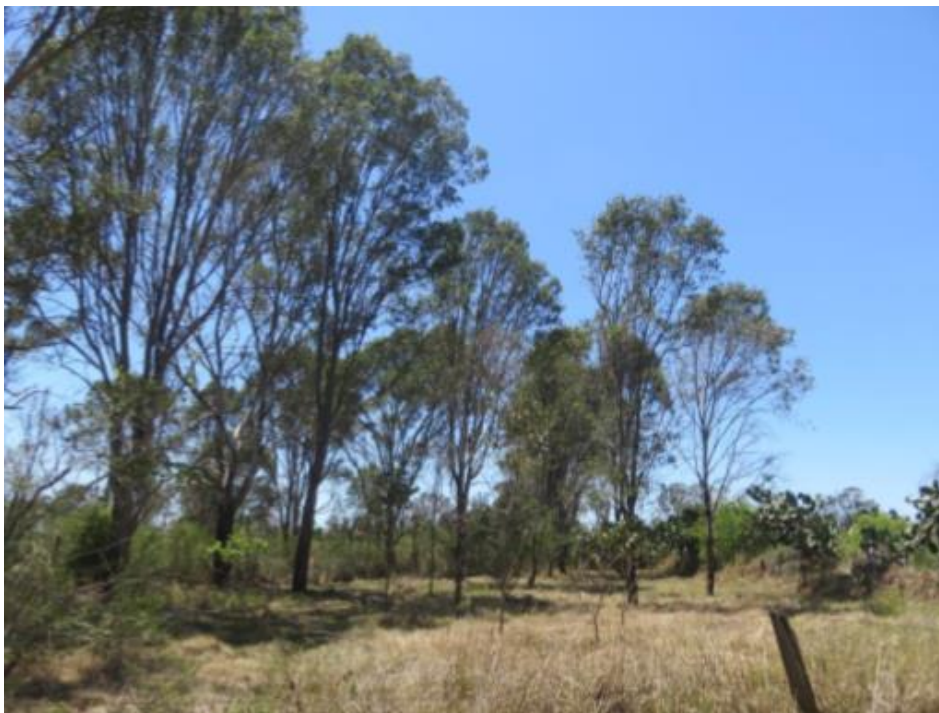
Figure 4. Canopy Cover south-western boundary. Source: Glenyss Laws Consulting Arborist

- Tree 17 is a closely aligned cluster of six remnant trees allocated a high retention value, the six trees are located within a horse paddock bounded by electrified fencing, as access was restricted DBH and DRB were estimated. The proposed staff visitor parking area falls within the footprint of one specimen and within the SRZ of the remaining five trees. The proposal is a major encroachment upon the six trees. To bring the design to an acceptable tolerance it will be necessary to redesign the staff visitor parking area and maintain a minimum 8.4m offset to the most northern tree in the cluster identified as T17F.

The trees on the northern boundary adjoining the existing dam did not form part of the onsite brief/meeting. It is expected a change to the groundwater regime will be created with the removal of the dam and installation of an overland drainage swale. The works will potentially impact the ground water flow within the rootzone of the group of remnant trees on the northern corner of the Lawson Rd frontage.

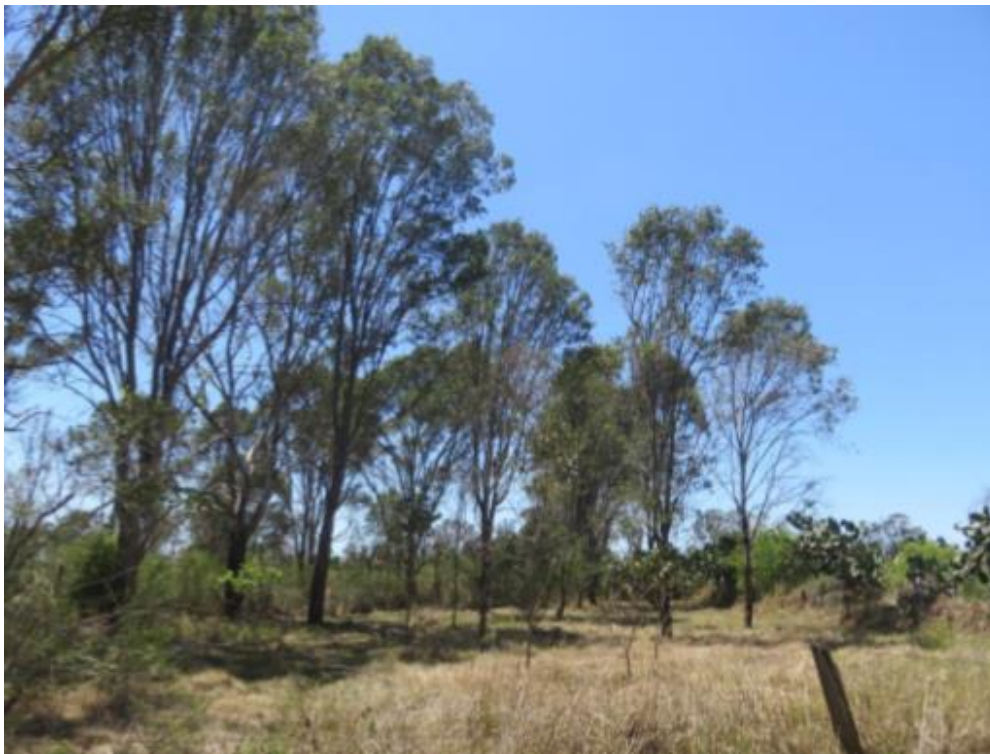
Figure 14. Canopy Cover south-western boundary. Source: Glenyss Laws Consulting Arborist.

Aims for bush regeneration and replanting works for the site will offset any damages from vegetation clearing and tree removal. Figure 14 below shows the trees on the southern-western boundary, Lawson Rd frontage where removal of eight trees will take place.

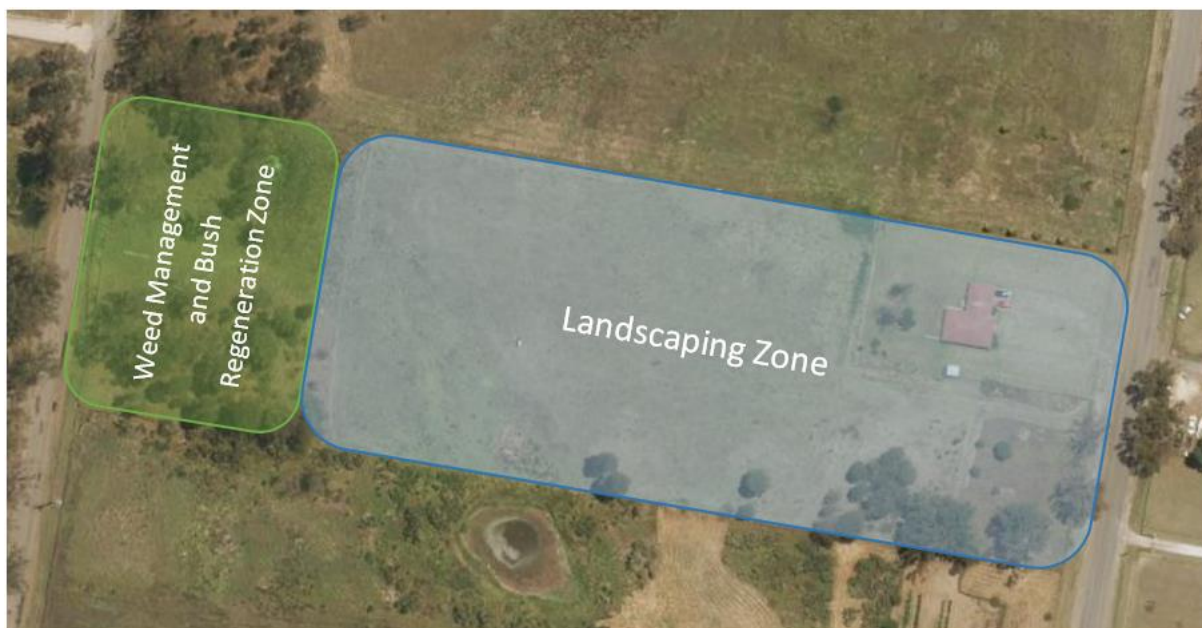
Figure 15. Proposed weed management, bush regeneration and landscaping zones. Source SixMaps 2018.

Bush regeneration and landscaping will occur within the designated areas shown below. See Landscaping Plan for specifics.

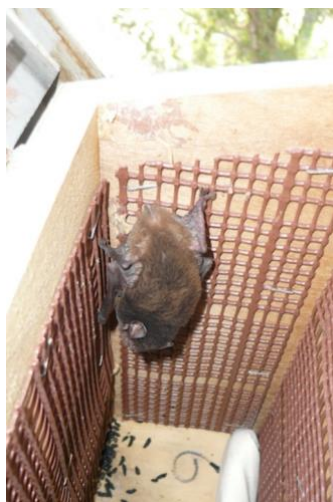
Although it is not critical, installation of two nest box designed for microbats should be added to the site to replace potential loss of roosting habitat.

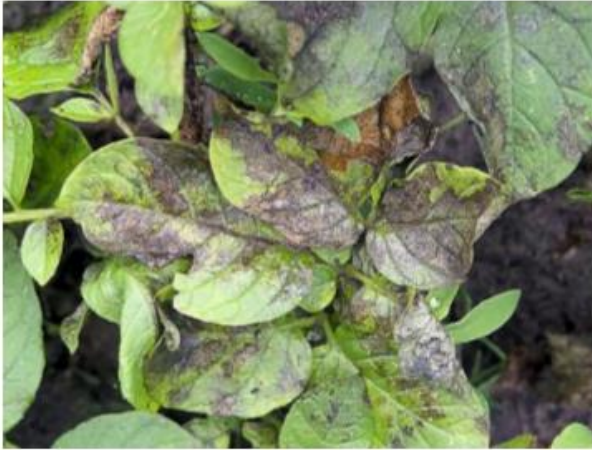
Phytophthora infected vegetation. (Image by Rasbak, licensed under the Creative Commons Attribution-Share Alike 3.0 Unported, 2.5 Generic, 2.0 Generic and 1.0 Generic license.)

Initial symptoms of Phytophthora include; wilting, yellowing and retention of dried foliage, loss of canopy and dieback. Infected roots blacken and rot and are therefore unable to take-up water and nutrients. Severely infected plants will eventually die. Symptoms can be more obvious in summer when plants may be stressed by drought. If you suspect that Phytophthora is on your site, please contact the Bushcare team to collect a soil sample to be lab tested. This is usually done in the warmer months where conditions are optimum for the disease.

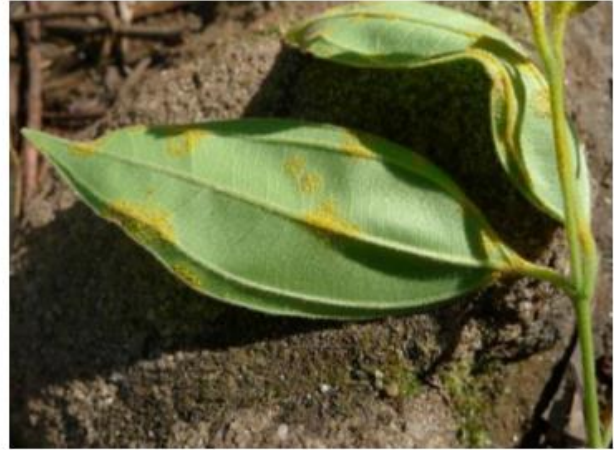
Myrtle Rust generally infects new leaf growth. (Image by John Tann, licensed under the Creative Commons Attribution 2.0 Generic license.)

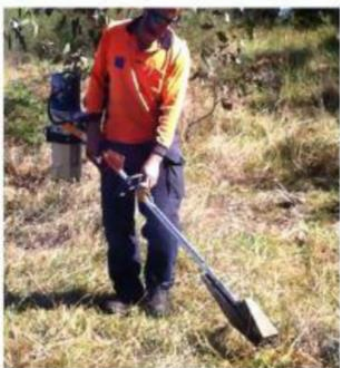
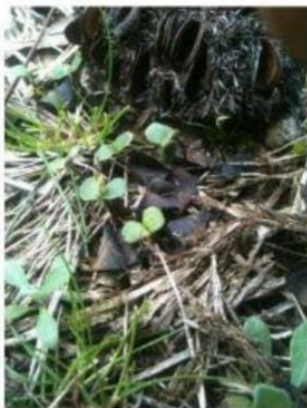
FLAME WEEDER – ECO BURN

Case Study: Weed
Mgt and Eco-burn
Glenorie in the
Hills Shire Council

Flame weeding should be undertaken outside of the fire seasons. Flame weeding allows for the mimicking of a burn in areas where a control burn could not be undertaken. See native plants regenerating after flame weeding.

While flame weeding is not suited to most streetscapes due to the fire hazard nor can it be used on materials such as soft fall and similar playground equipment it is noted that 'flame' weeding in waterways allows weed management in areas where herbicides are not permitted.
