Preliminary Salinity Risk Assessment for 53 Dwyer Road, Bringelly NSW

Prepared for	Sasanadhaja Buddhist Association Inc.
Prepared by	Jasmin Kable Whitehead & Associates Environmental Consultants Pty Ltd 197 Main Road CARDIFF NSW 2285
Telephone:	02 4954 4996
Fax:	02 4954 4996
email:	jasminkable@whiteheadenvironmental.com.au

Document and Project Details					
Document Title:	Preliminary Salinity Risk Assessment for 53 Dwyer Road, Bringelly NSW				
Author:	Jasmin Kable				
Project Manager:	Mark Saunders				
Date of Issue:	04/09/17				
Job Reference:	1816_Preliminary Salinity Assessment_002				
Synopsis:	This document presents the results of a preliminary 'soil salinity' risk assessment for the proposed development at 53 Dwyer Road, Bringelly NSW.				
Client Details					
Client:	Sasanadhaja Buddhist Association Inc.				
Document Distribution					
Version Number	Date	Status	DISTRIBUTION – NUMBER OF COPIES (p – print copy; e – electronic copy)		
			Client	Other	Other
001	31/08/17	Draft	1e	-	-
002	04/09/17	Final	1e	-	-
Document Verification					
Checked by: Mark Saunders			Issued by: Jasmin Kable

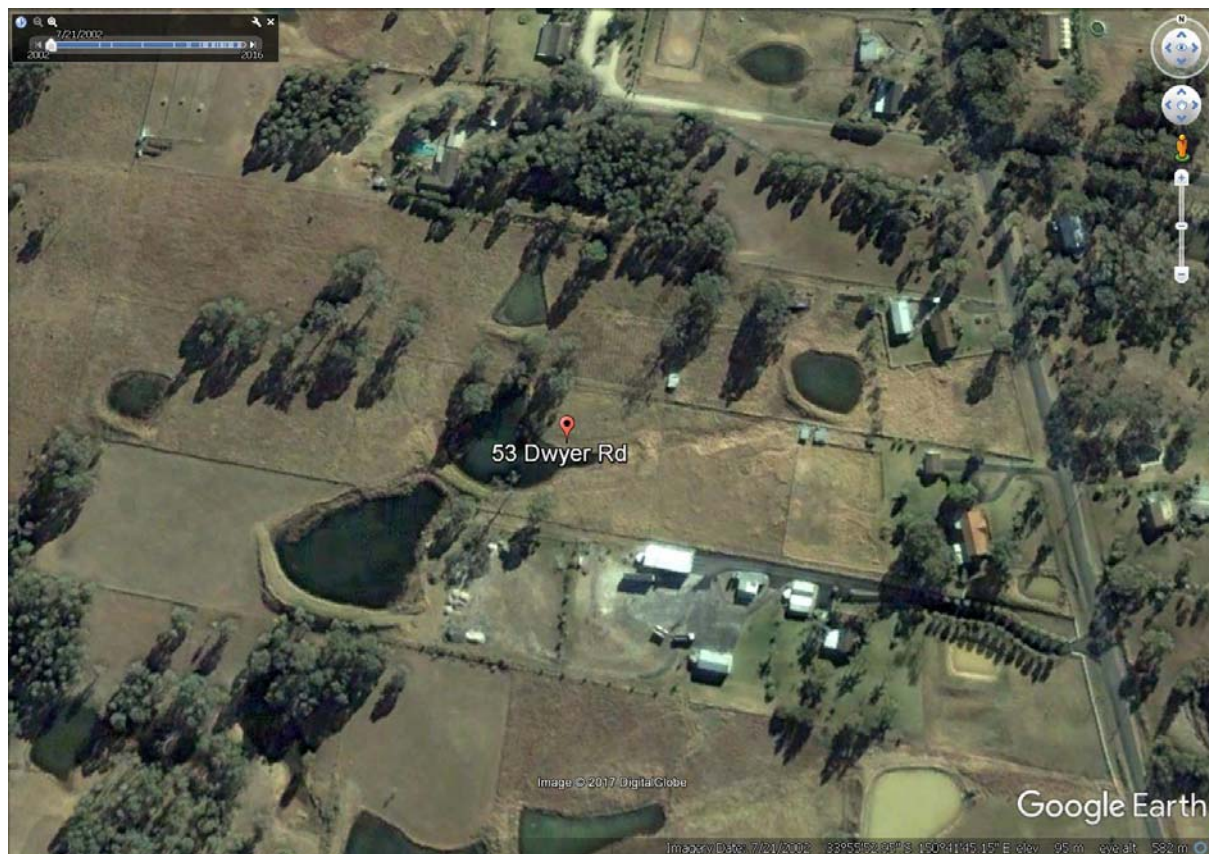
Google Earth Image 21/07/2002

A review of the historical aerial imagery from published sources (Nearmap and Google Earth) confirms that Site land use remained unchanged between 2002 and 2017, with the Site and surrounding areas predominantly used for either large-lot rural residential and/or agricultural purposes. There were no obvious signs of salinity (bare areas, tree die-off etc.) at the Site observed in the examined historical images (copies attached in Appendix B).

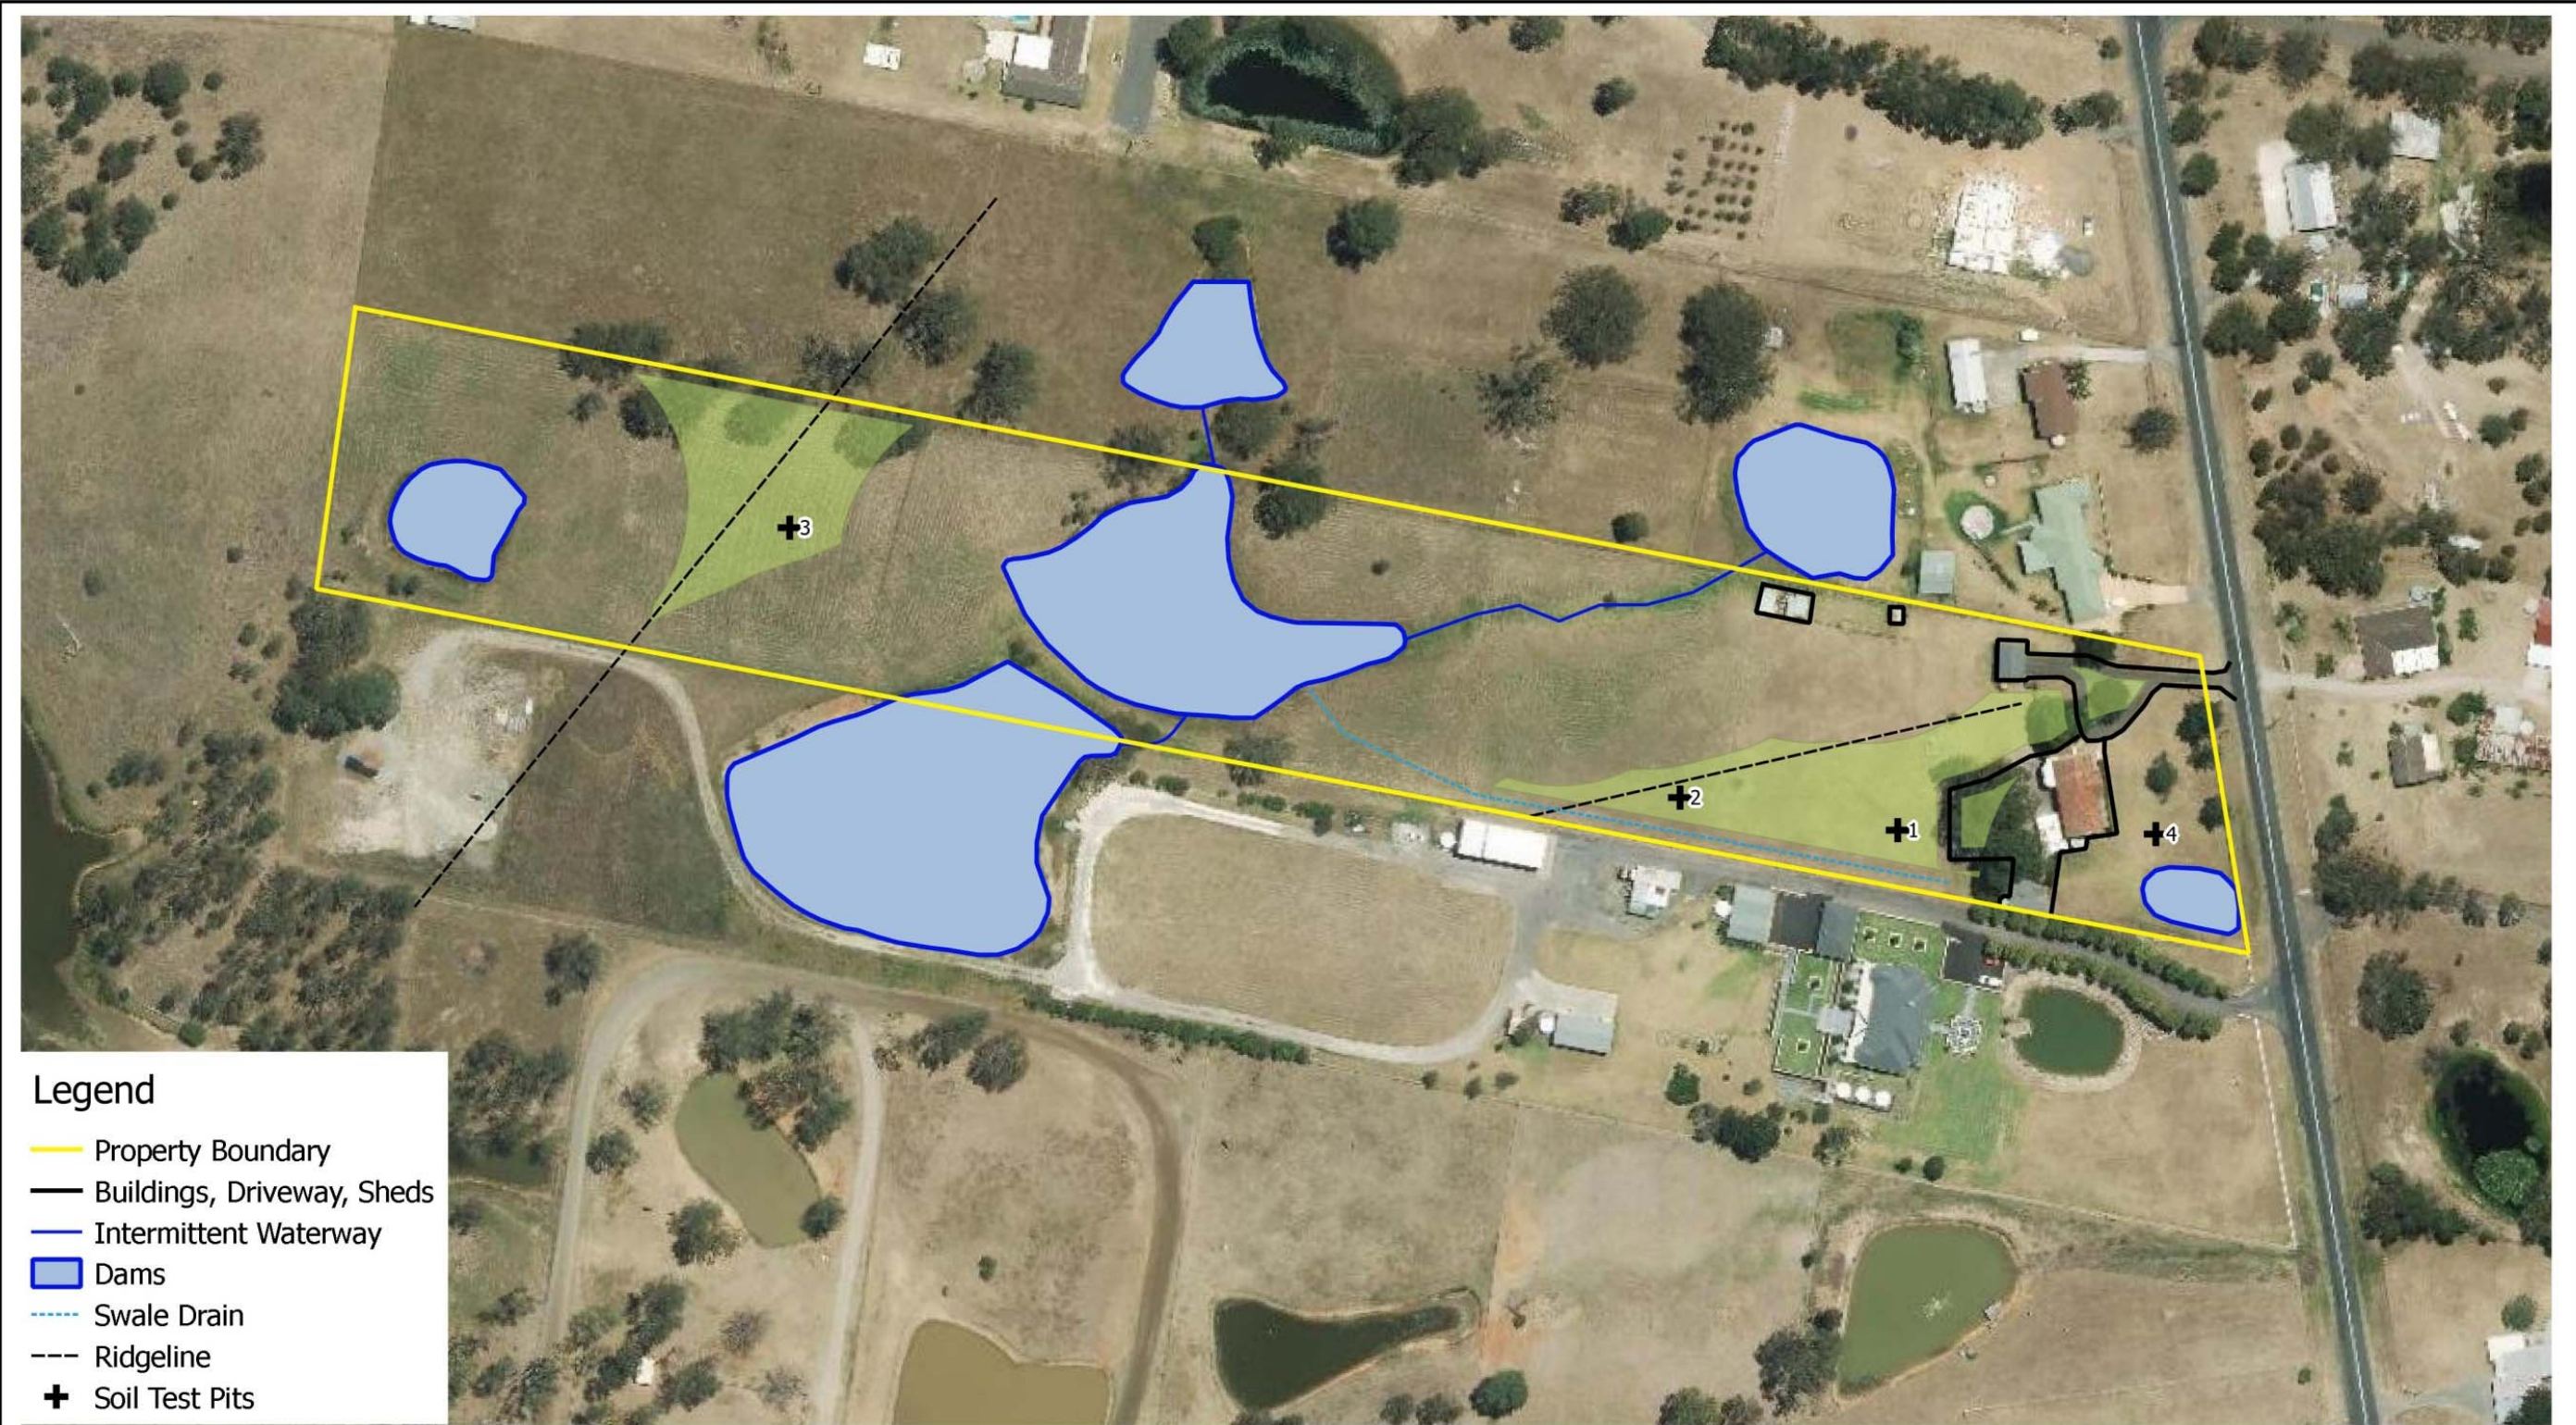
Figure 1: Constraints Map

A site and soil assessment was undertaken on 6th June 2017 by Mark Saunders of Whitehead & Associates. A Site Plan was prepared and is attached in Appendix C. Site slopes were typically between 0-10%, as denoted on the Site Plan. The Site was primarily vegetated by a good cover of mown lawn/pasture grasses with no notable erosion observed. There were no obvious signs of potential salinity at the Site, with no physical features (scolds, waterlogging etc.) or vegetation (salt tolerant) indicators observed. There were also no notable areas of poor drainage outside of the delineated drainage lines and dams. There were no signs of staining or corrosion of brickwork/concrete structures associated with the existing dwelling at the Site.

Site soils were observed and examined to a general depth of 900mm by excavating four (4) test pits (TPs) using a hand auger. Three test pits were augured within the eastern portion of the Site, with TP4 located close to the eastern dam and Dwyer Road. One test pit (TP3) was augured within the western portion of the Site between the two major dams. Samples of discrete soil horizons were collected for subsequent laboratory analysis; pH, Electrical Conductivity (ECe) and Emerson Aggregate Class. Appendix D provides the soil bore log summaries for each test pit, with Appendix E providing soil analytical data and interpretation.

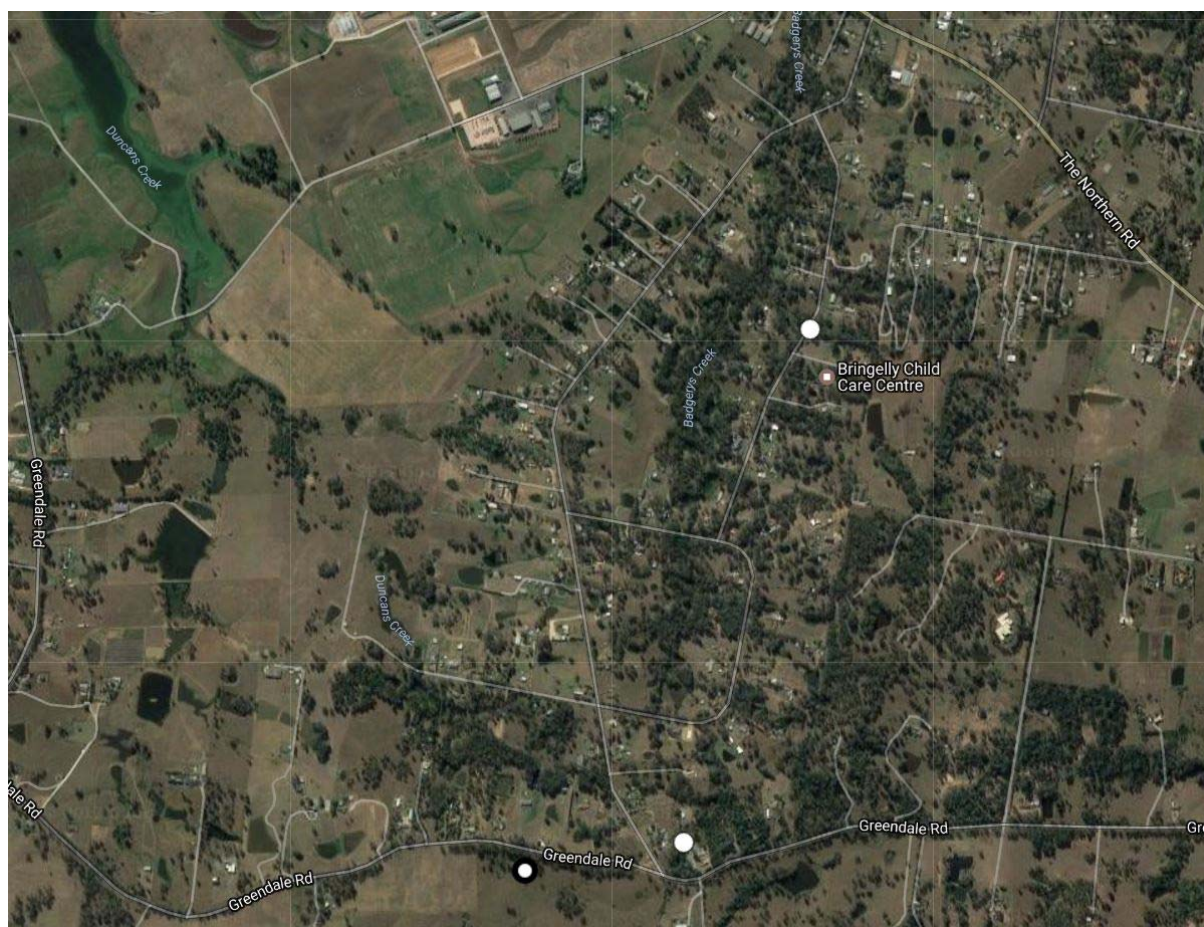
SALIS Soil Data Reports

A search of the DIPNR NSW Soil and Land Information System (SALIS) database was also undertaken, with three test locations identified adjacent to the Site, and on the same 'bt' Soil Landscape. The soils were typically described as Yellow Podzols with light clay to sandy clay overlying moderately structured medium clay, overlying massive light to medium clay. No salting was evident at the SALIS soil test pit locations. The SALIS soil profile reports and a map showing their locations with respect to the Site are attached in Appendix F.
