Report Type: Preliminary Site Investigation

Site Address: 61 – 65 Lucas Avenue & 36 McKay Avenue, Moorebank, NSW

Report Number: 2868/ER-1-1

Report Date: 2nd June 2017

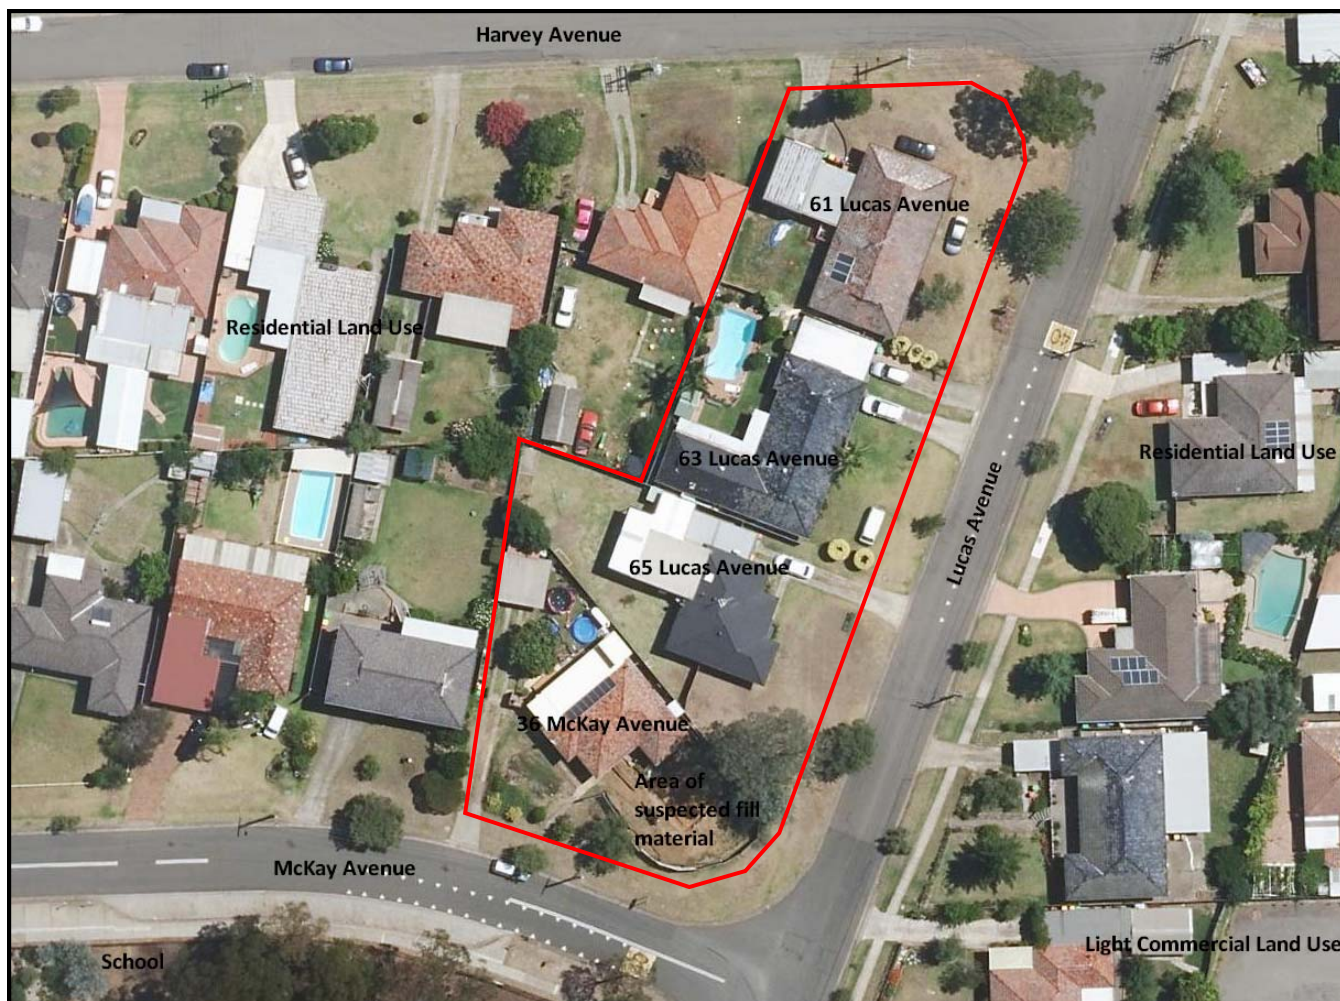
Figure 2.2: Site Layout and Features

At the time of inspection, the site was consisted of four (4) low density residential properties. The properties all comprised dwellings with driveways, garages and grass lawns. No asbestos containing material (ACM) was observed on the ground surface of the site. Suspected fill material (foreign materials in surface soils) was observed in the front yard of 36 McKay Avenue. The site features are shown in **Figure 2.2** below and are discussed further in **Section 4**. For site photographs, refer to **Appendix B**.

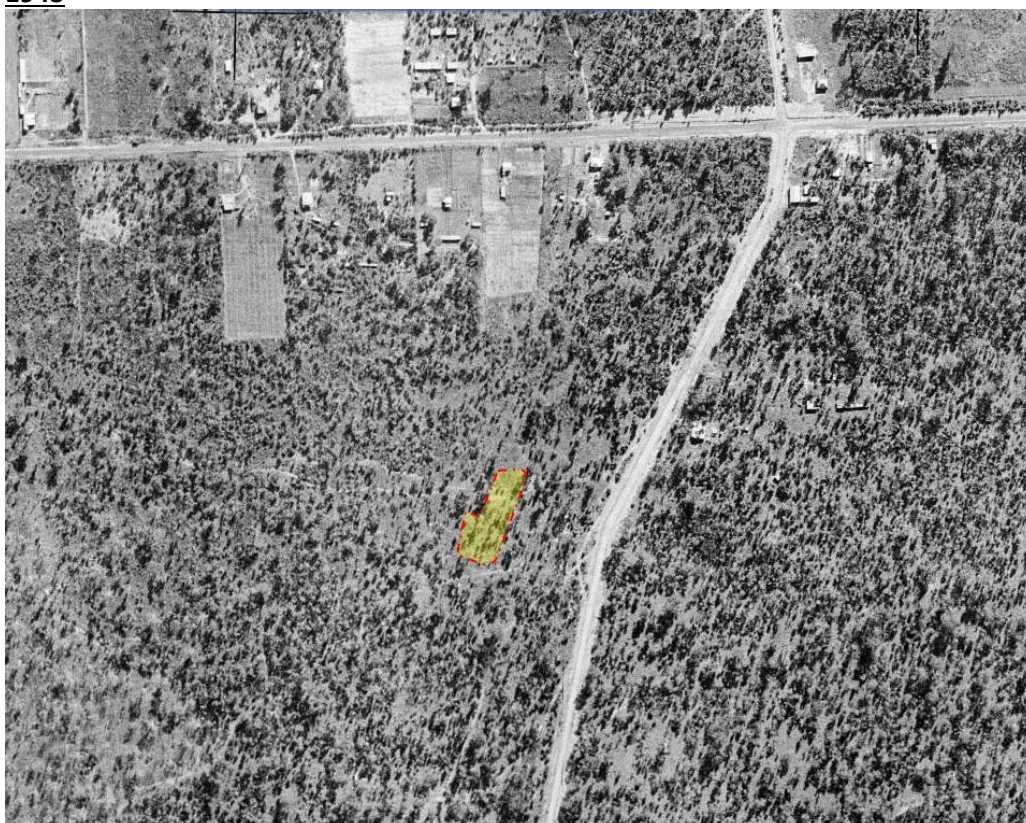
1943

The site was observed to consist of vacant bushland. The site and surrounding areas were heavily vegetated with native trees. Further to the north, small rural residential properties were observed adjacent to a road (the current Newbridge Road). A road (the current Nuwarra Road) was observed to the east and comprised an unsealed road.

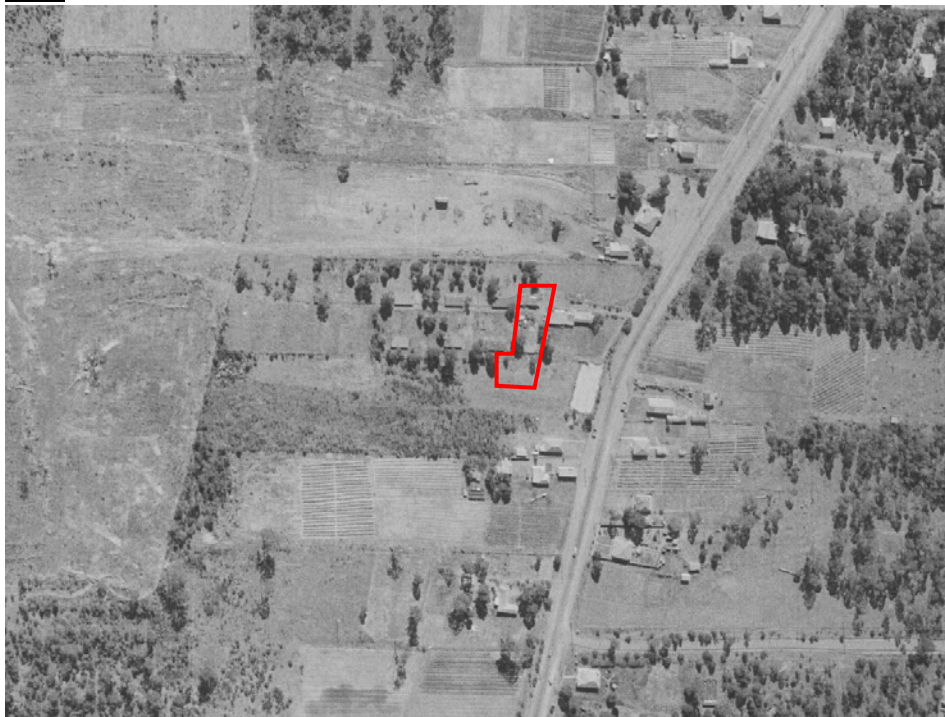
1955

The exact location of the site could not be identified due to the lack of common features compared with the current day layout. However, the site was likely in an area that had been cleared with small structures (potentially poultry sheds) constructed. The vegetation in the surrounding areas had been removed and the land use generally comprised rural residential with pockets of low density residential dwellings.

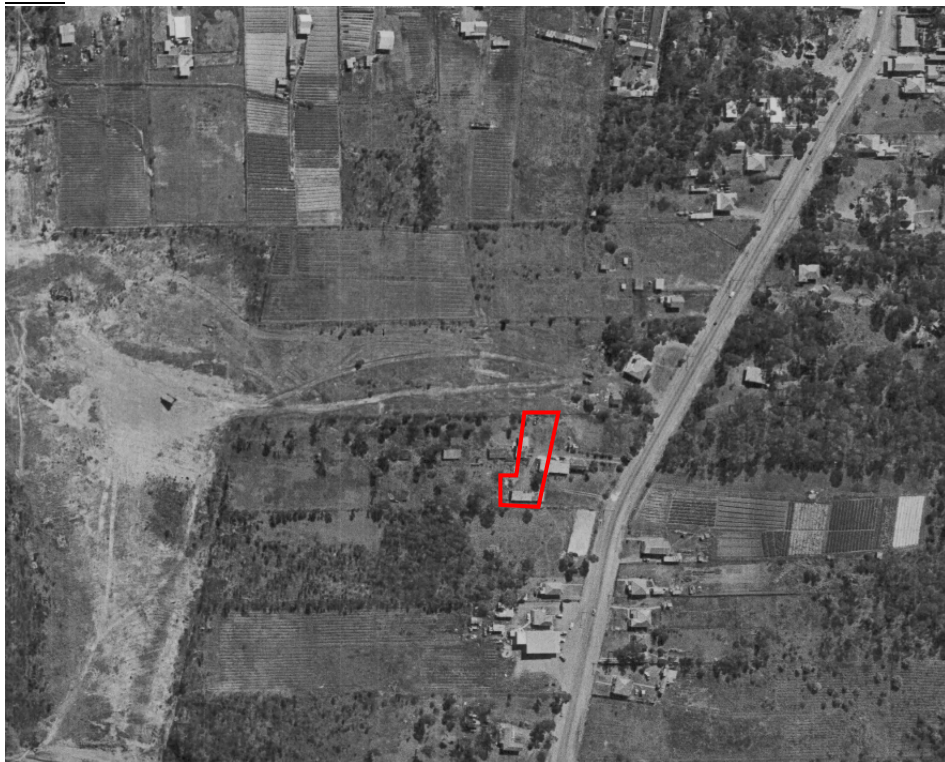
1965

The site appeared generally similar to the previous aerial photograph, however some of the small dwellings that were previously observed in the area of the site appeared to have been removed. The surrounding areas were

generally similar to the previous aerial with the exception of a larger building replacing a number of smaller building to the south of the site.

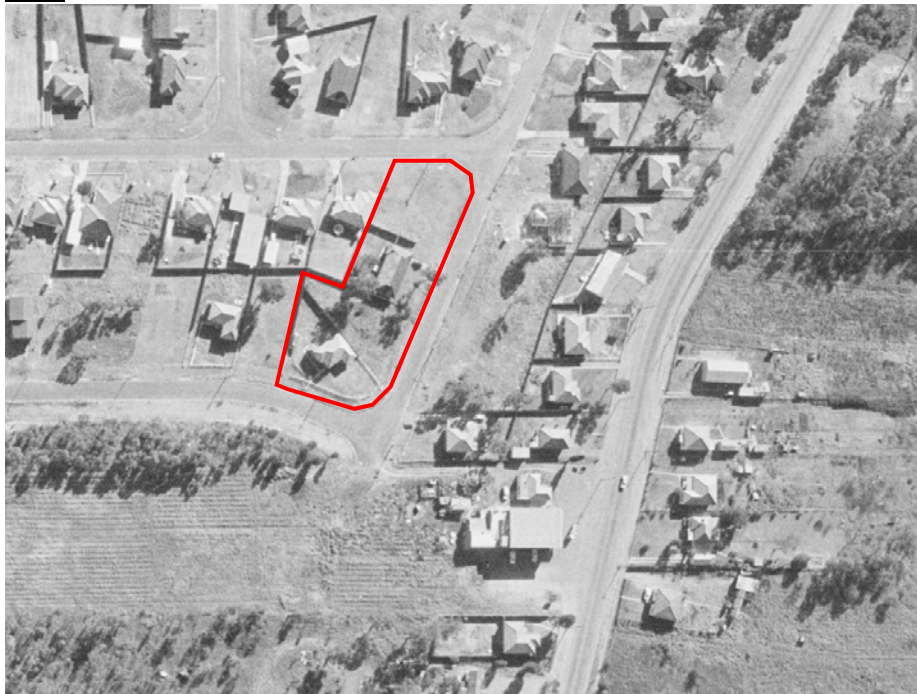
1970

The site was observed to have been subdivided into the four allotments that comprise the current site. A residential dwelling had been constructed at 36 McKay Avenue and 63 Lucas Avenue. In surrounding areas to the north, east and west, further subdivision and construction of low density residential dwellings was observed. A commercial building had been constructed to the south-east, in a similar location to the present day library.

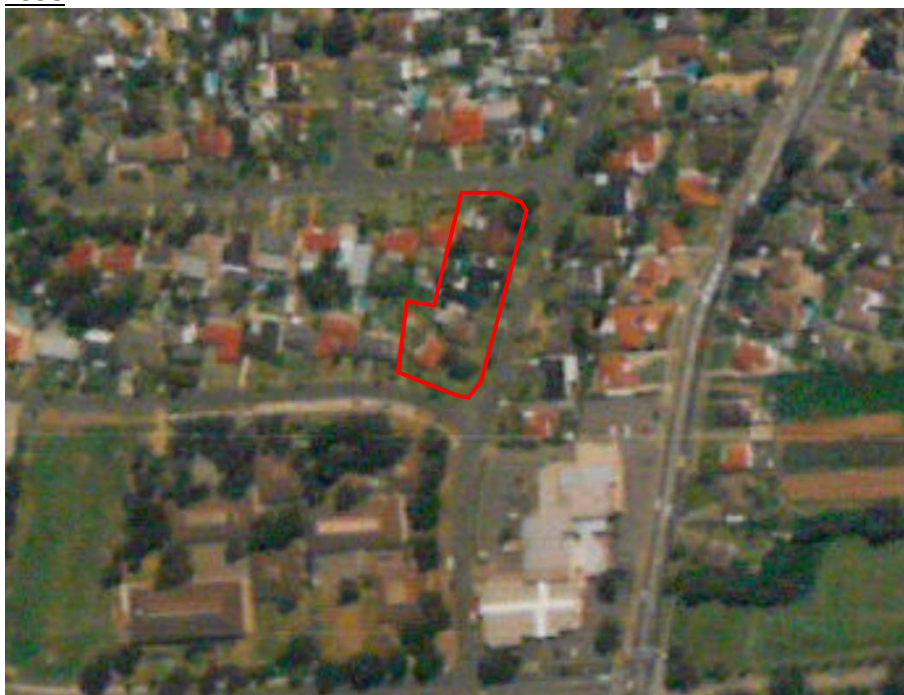
1998

Buildings appeared to have been constructed at 61 and 65 Lucas Avenue. A shed/garage had been constructed at 36 McKay Avenue. A shed and swimming pool had been constructed and 63 Lucas Avenue. A number of large buildings (the current location of Nuwarra Public School) were evident to the south of the site. A number of commercial buildings were constructed in the area to the south-east.

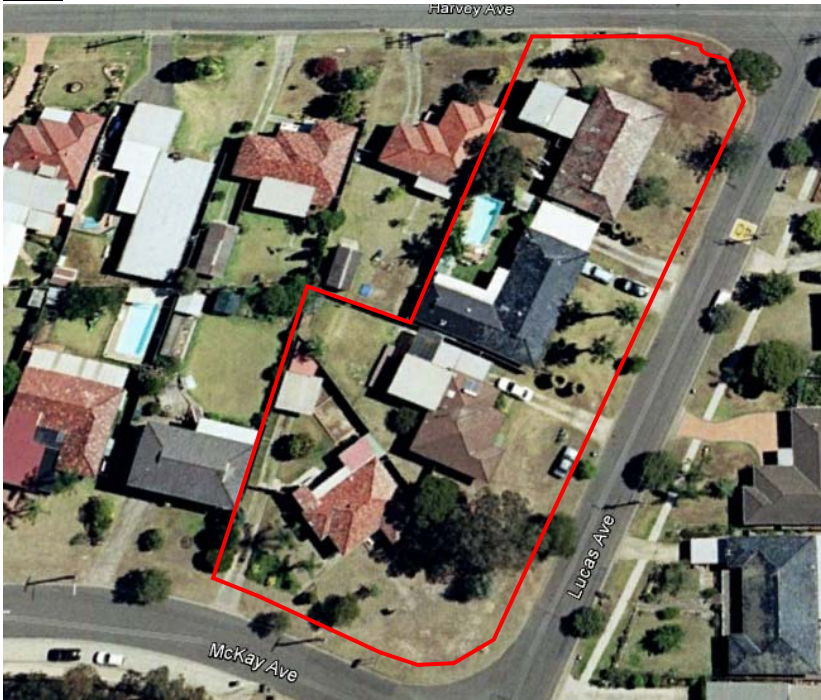
2007

The site and surrounding areas appeared generally similar to the previous aerial photograph.

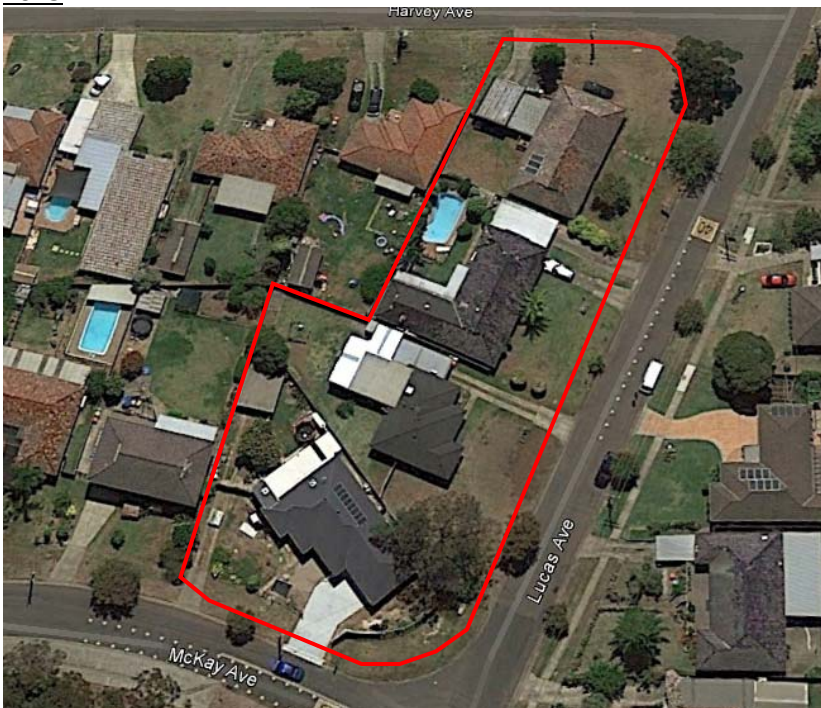
2015

The dwelling at 36 McKay Street appeared to have been removed and a newer dwelling constructed. The area to the south-east of the new dwelling appeared to have been filled. The remainder of the site and surrounding

areas appeared similar to the previous aerial photograph. The site appeared generally consistent with the layout observed in the site inspection discussed in **Section 4.1** (i.e. the current site layout).

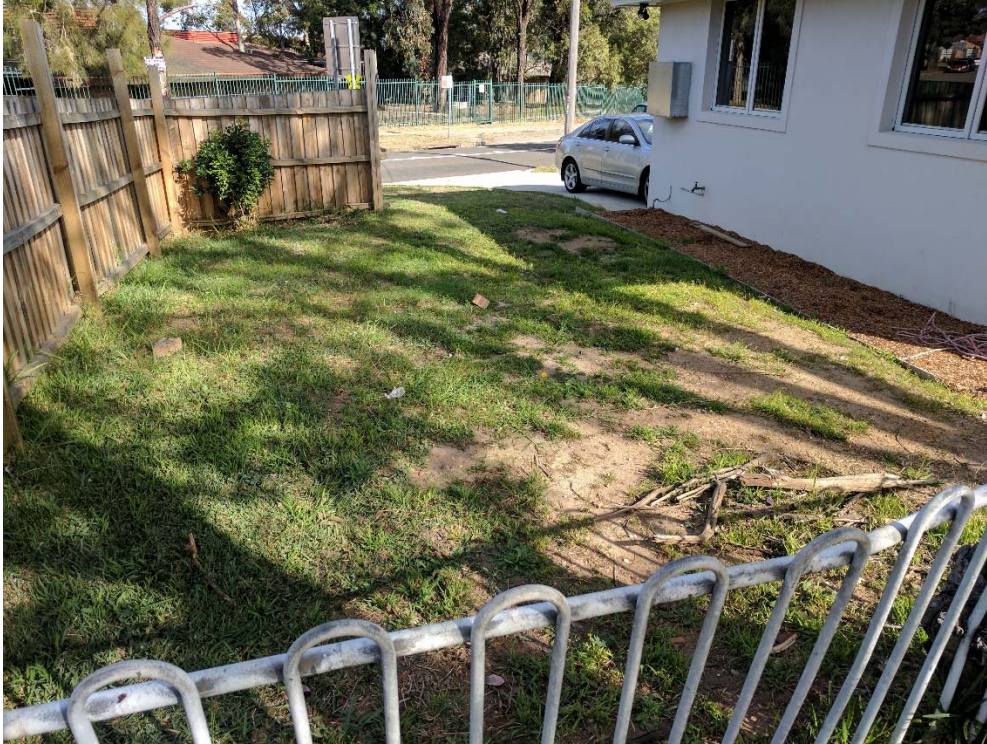
- The dwelling at 36 McKay Avenue appeared to be a new build (< 5 years old), constructed with cement render walls and corrugated iron roofing. In the area to the east and south of the dwelling, fill material was observed in the form of foreign materials within surface soils. The foreign materials included bricks and other building materials. No suspected ACM was observed.

Photograph 1: Side of the building at 36 McKay Avenue, looking south. The area to the left of the building appeared to consist of fill material. Bricks and other foreign materials were observed on the ground surface in this area.

It is recommended that prior to demolition of current site structures, a hazardous building materials survey (HAZMAT) should be completed. A Stage 2 ESA should be completed in accordance with NEPC (2013) and site soils should be appropriately classified for off-site disposal in accordance with the *NSW EPA Waste Classification Guidelines* (NSW EPA 2014).

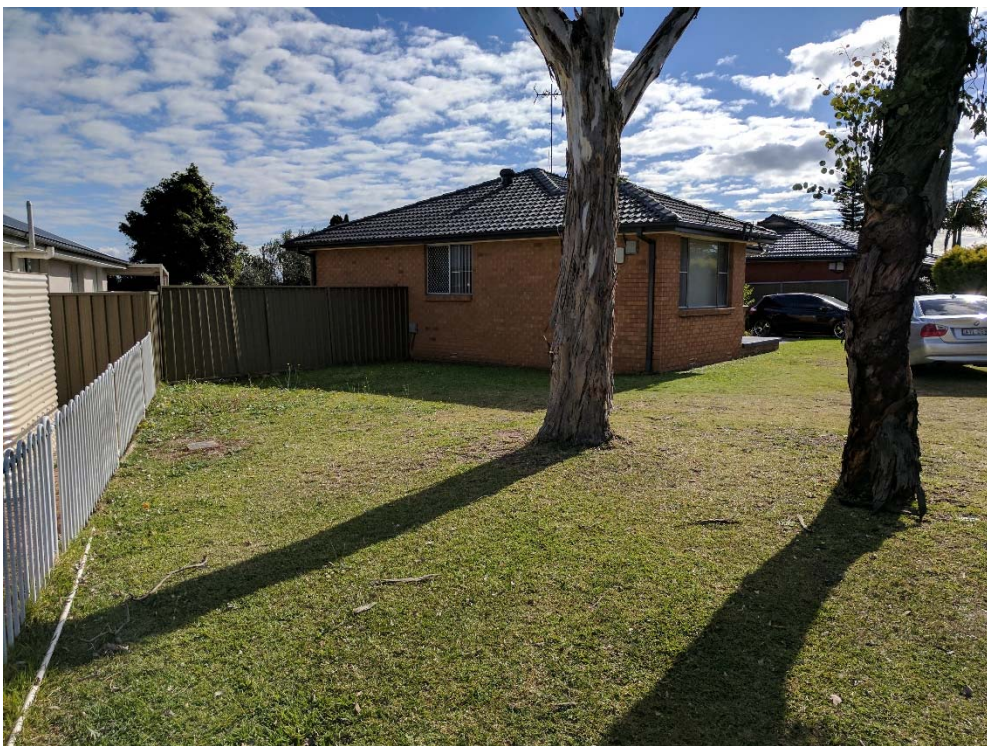
Photograph 2: The dwelling at 65 Lucas Avenue, looking north-west.

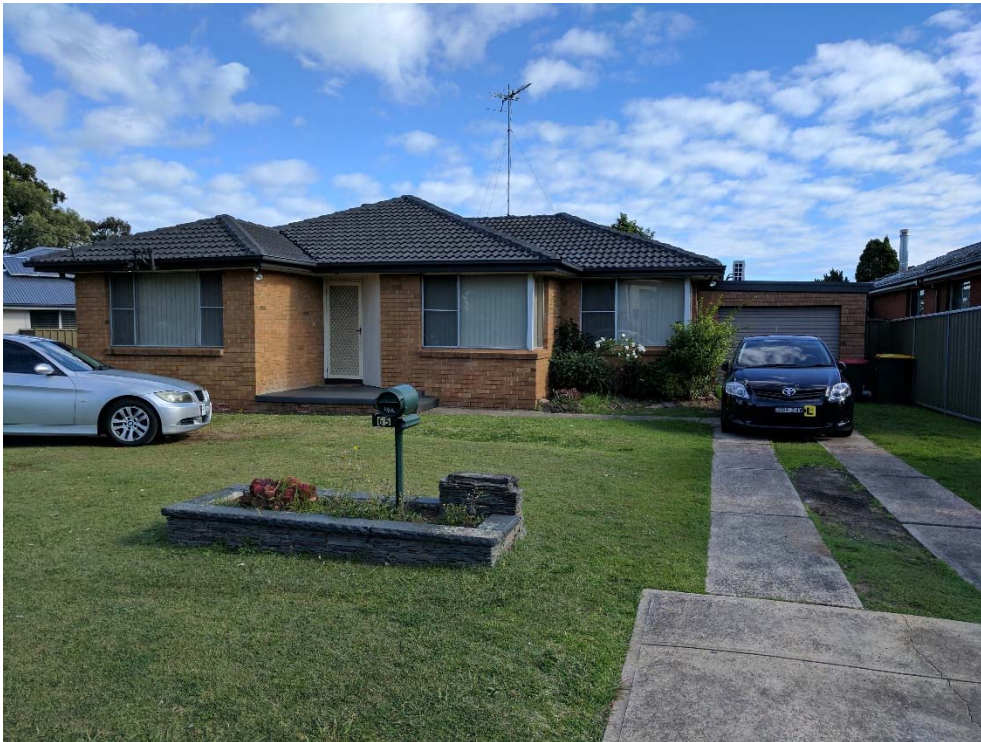
Photograph 3: The dwelling at 65 Lucas Avenue, looking west.

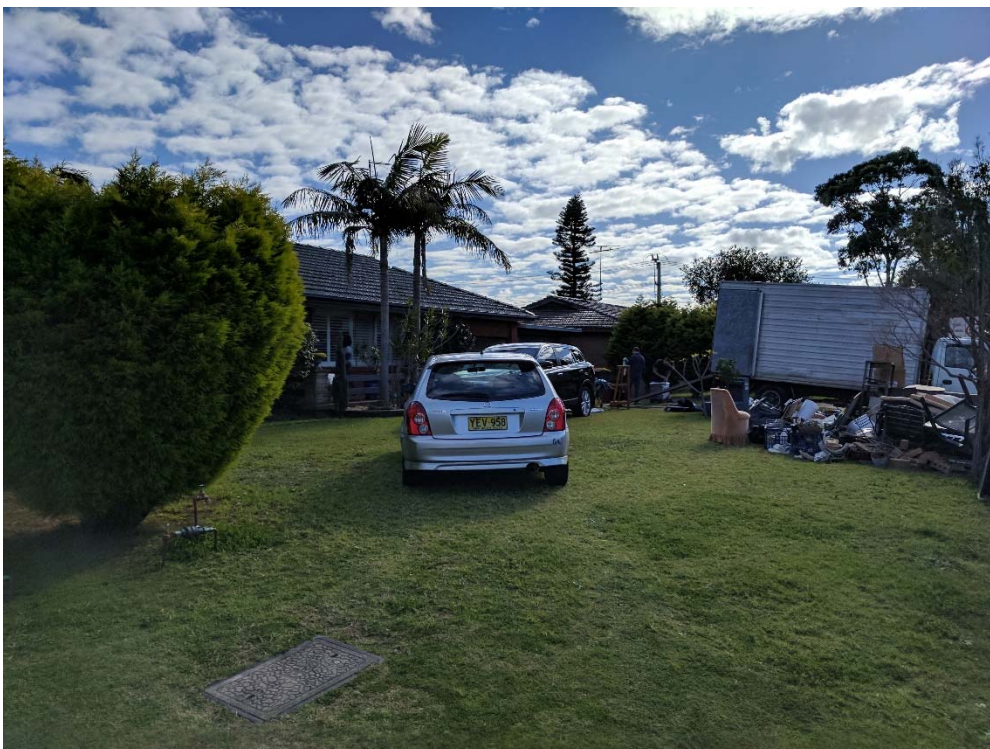
Photograph 4: The dwelling at 63 Lucas Avenue, looking north-west. The dwelling was in the process of being vacated at the time of inspection.

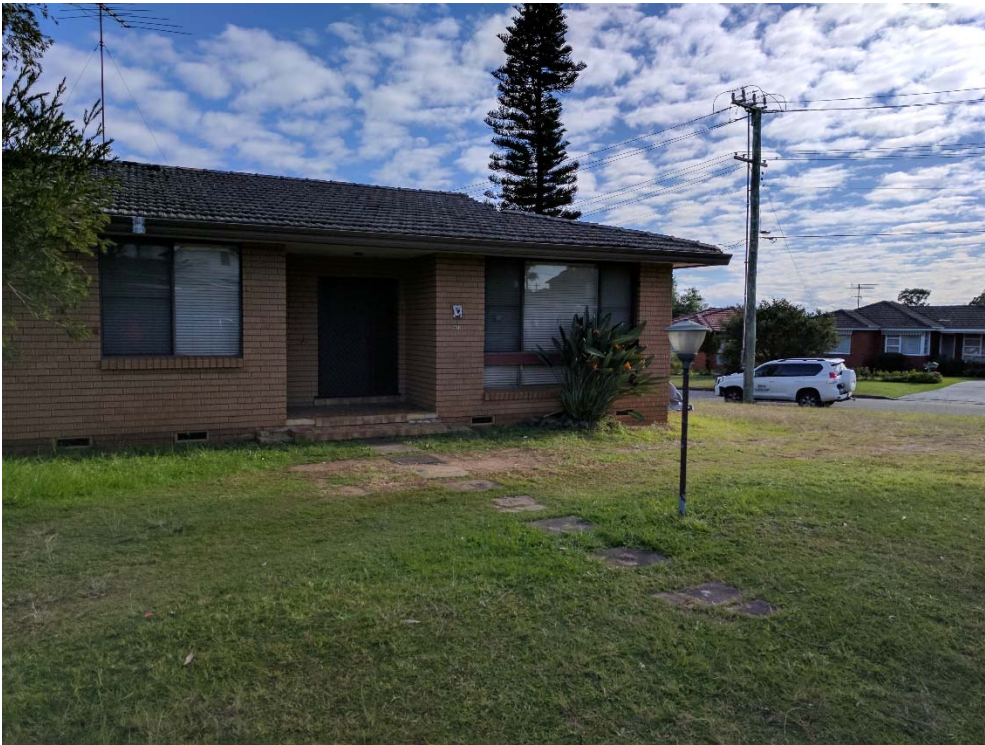
Photograph 5: The dwelling at 61 Lucas Avenue, looking west.

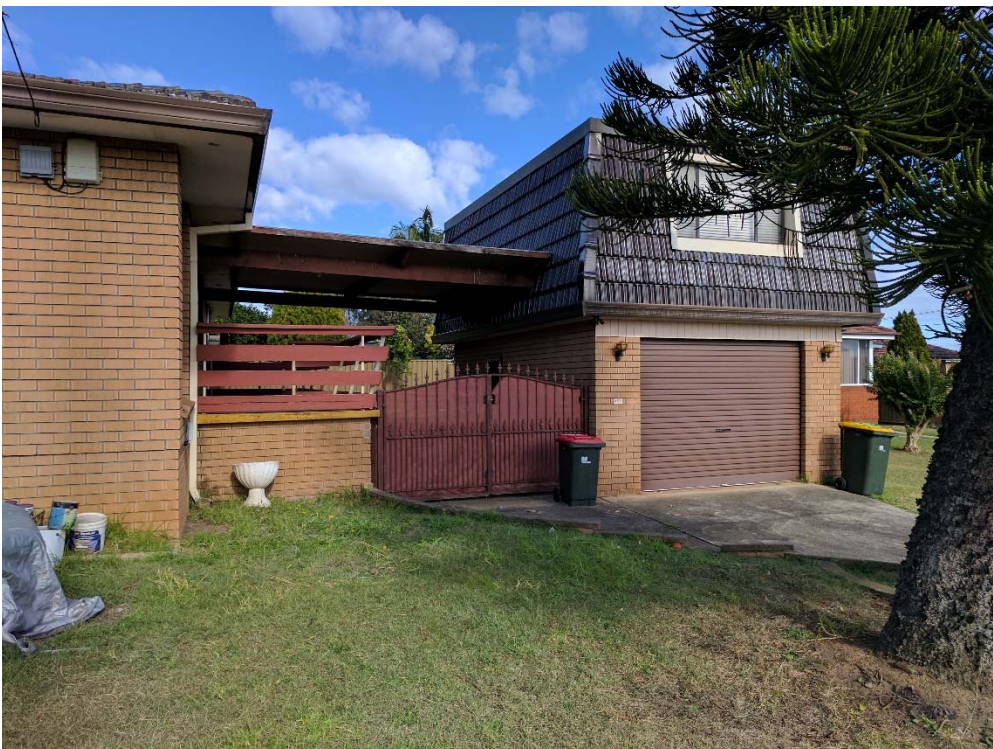
Photograph 6: The dwelling and garage at 61 Lucas Avenue, looking south.
